## **Wildlife Use of Road Mitigation Structures in Relation to Their Construction, Structural Characteristics, and Environmental Factors along a South Texas Highway**

A Thesis

May 2020

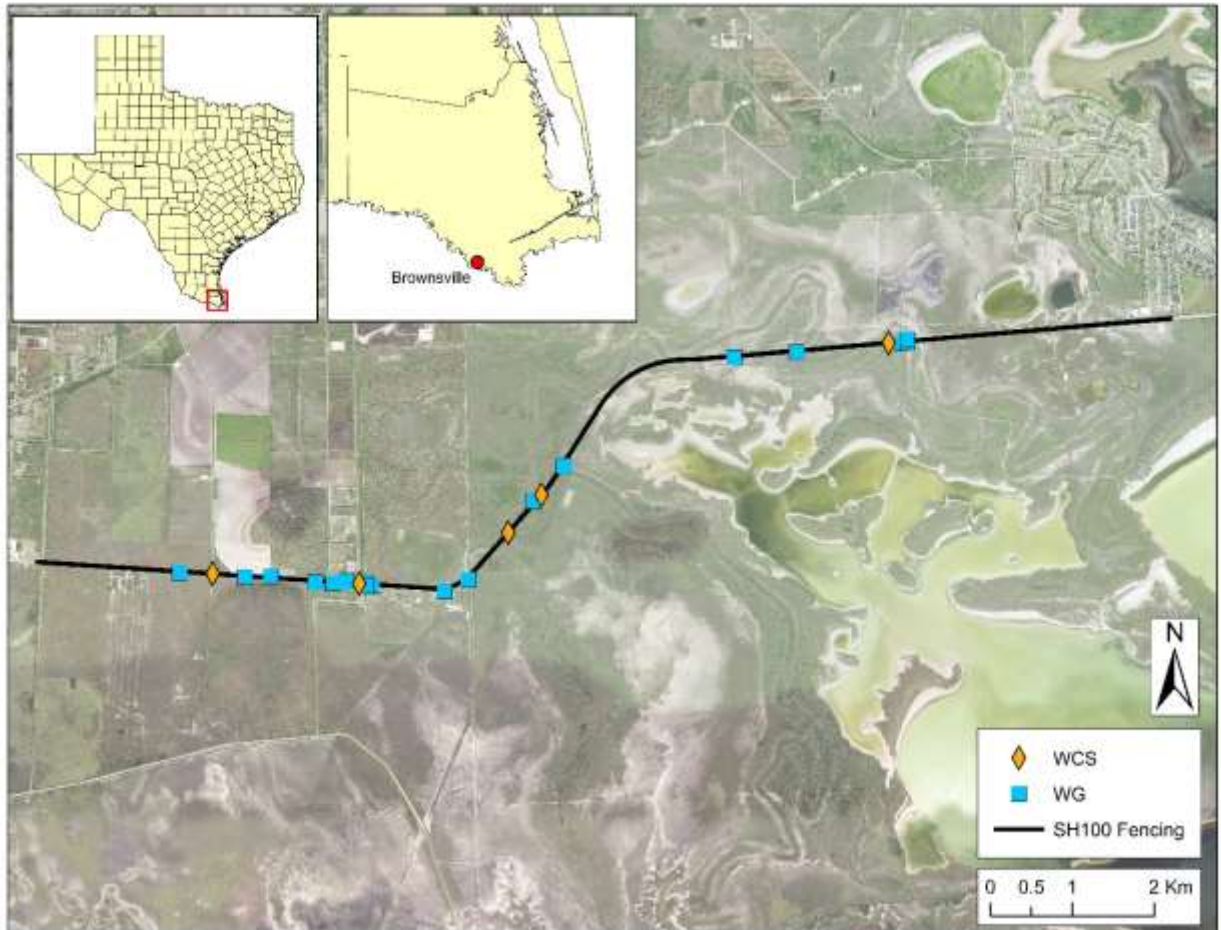
Figure 1. Wildlife crossing structures (WCS;  $n = 5$ ), 11.9 km of fencing, and wildlife guards (WG;  $n = 18$ ) constructed by the Texas Department of Transportation to address ocelot (*Leopardus pardalis albescens*) mortality along State Highway 100 in Cameron County, Texas, USA. All structures were monitored using remote cameras, and data were collected at WCS from January 2017 to May 2019 and at WG from April 2017 to May 2019.

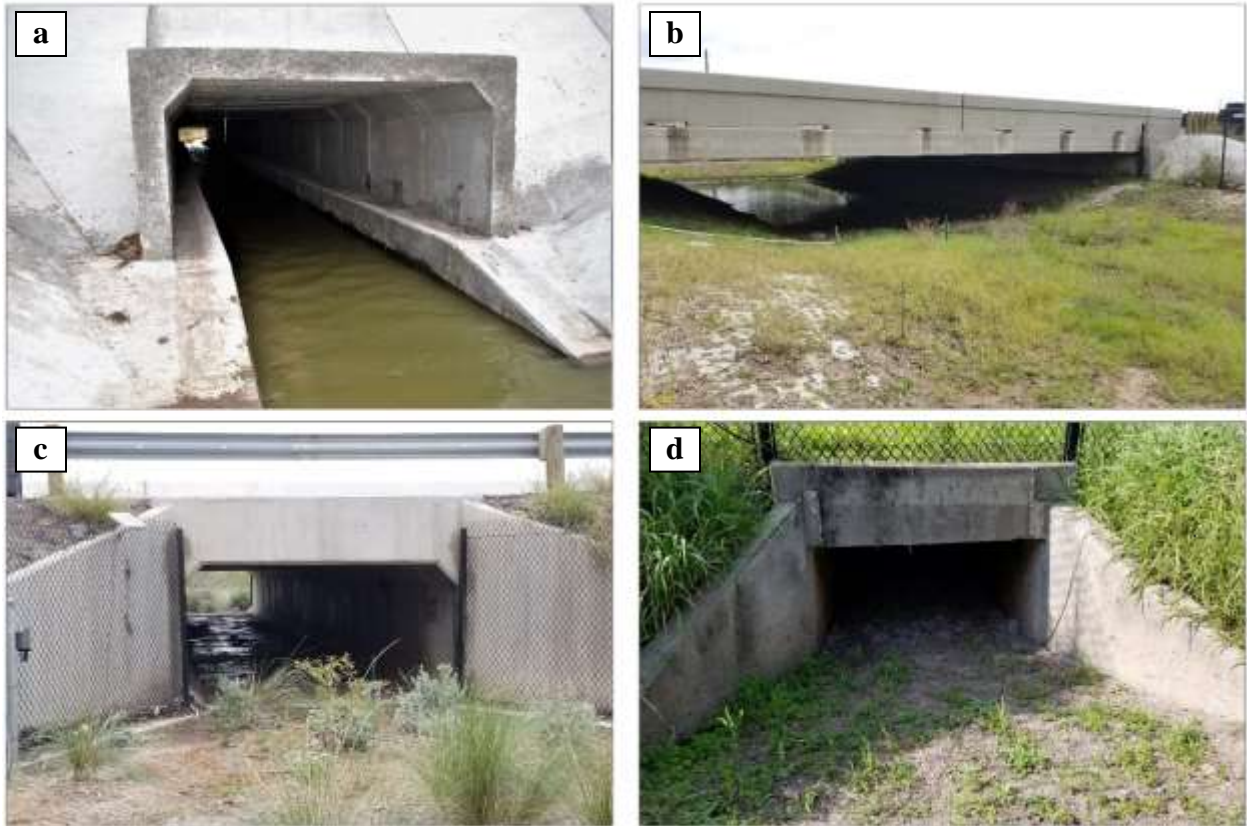
Figure 2. Four of the five wildlife crossing structures (WCS) constructed by the Texas Department of Transportation to address ocelot (*Leopardus pardalis albescens*) mortality along State Highway 100 in Cameron County, Texas, USA. From top left: WCS2 (a), WCS3 (b), WCS4 (c), and WC3A (d). WCS1 is not pictured because it has the same configuration as WCS2.

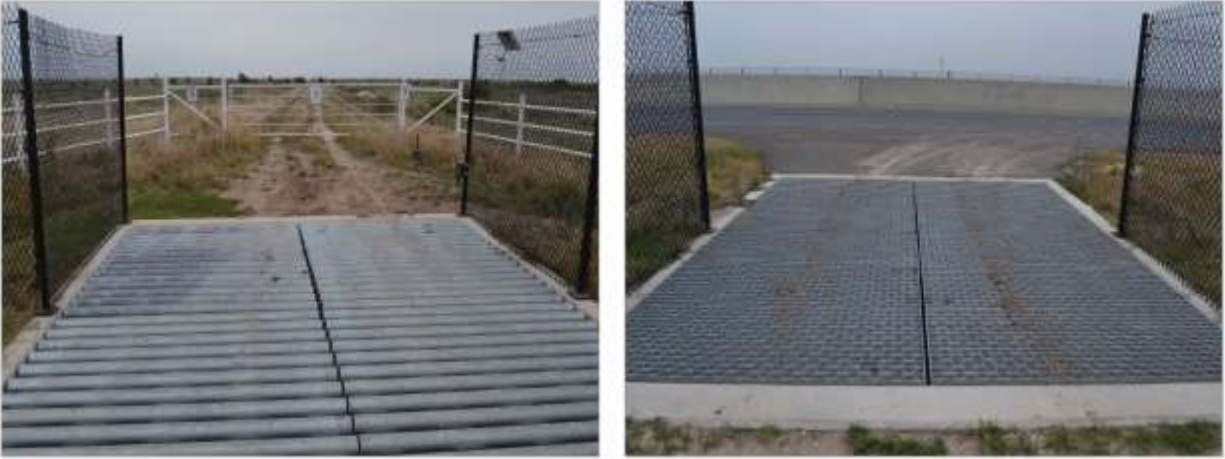
Figure 3. The two wildlife guard (WG) types constructed by the Texas Department of Transportation to address ocelot (*Leopardus pardalis albescens*) mortality along State Highway 100 in Cameron County, Texas, USA: pipe (left) and bridge grating (right). WG were monitored using remote cameras, and data were collected at these sites from April 2017 to May 2019.

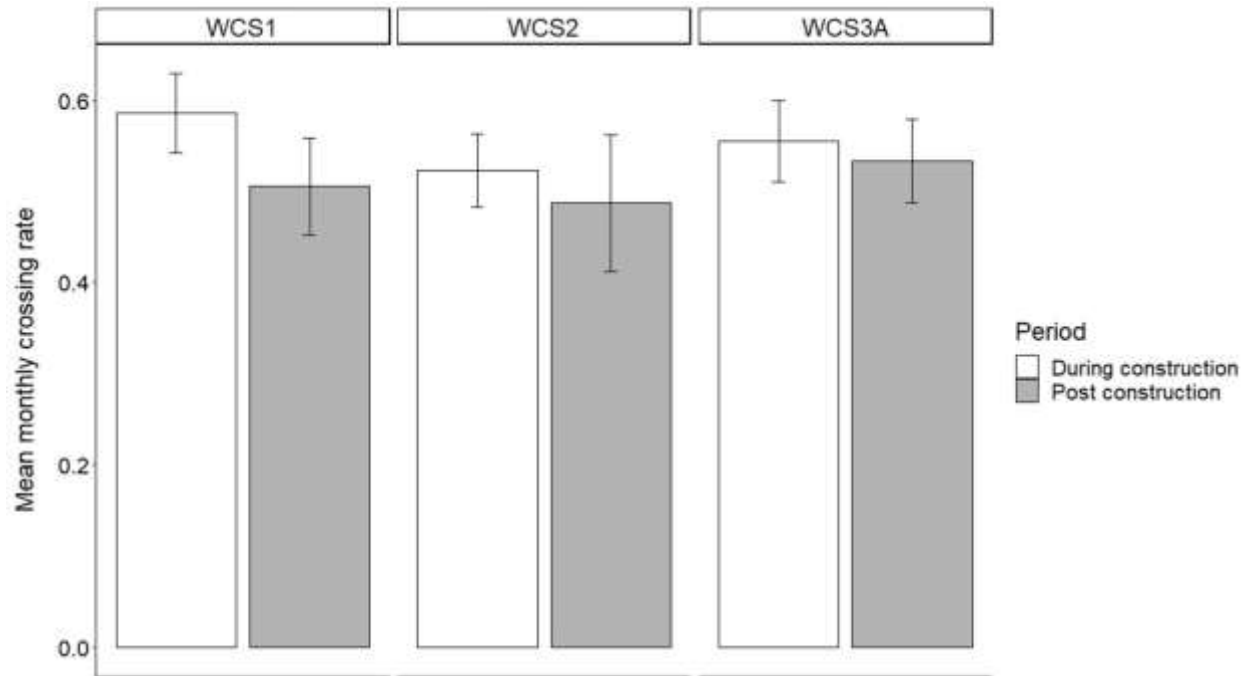
Figure 7. Bar graph showing mean monthly crossing rates  $\pm$  standard error of all species combined at each wildlife crossing structure (WCS) during construction (January 2017-May 2018) and post construction (May 2018-May 2019) along State Highway 100 in Cameron County, Texas, USA. Crossing rates were not significantly different between WCS1, WCS2, and WCS3A ( $P=0.714$ ) or between during construction and post construction ( $P=0.282$ ).

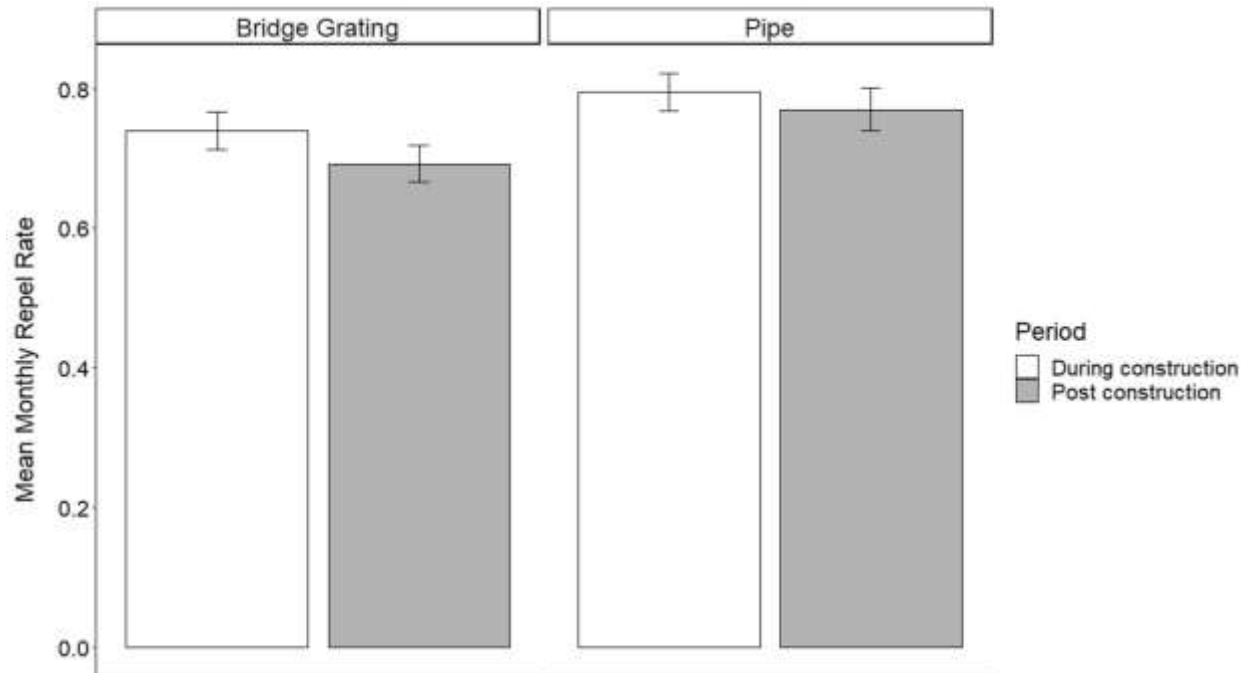
Figure 11. Bar graph showing mean monthly repel rates  $\pm$  standard error of all species combined at pipe and bridge grating wildlife guards during construction (Apr 2017-May 2018) and post construction (May 2018-May 2019) along State Highway 100 in Cameron County, Texas, USA. Repel rates were significantly higher at pipe wildlife guards ( $P=0.004$ ) but were not significantly different between during construction and post construction ( $P=0.195$ ).

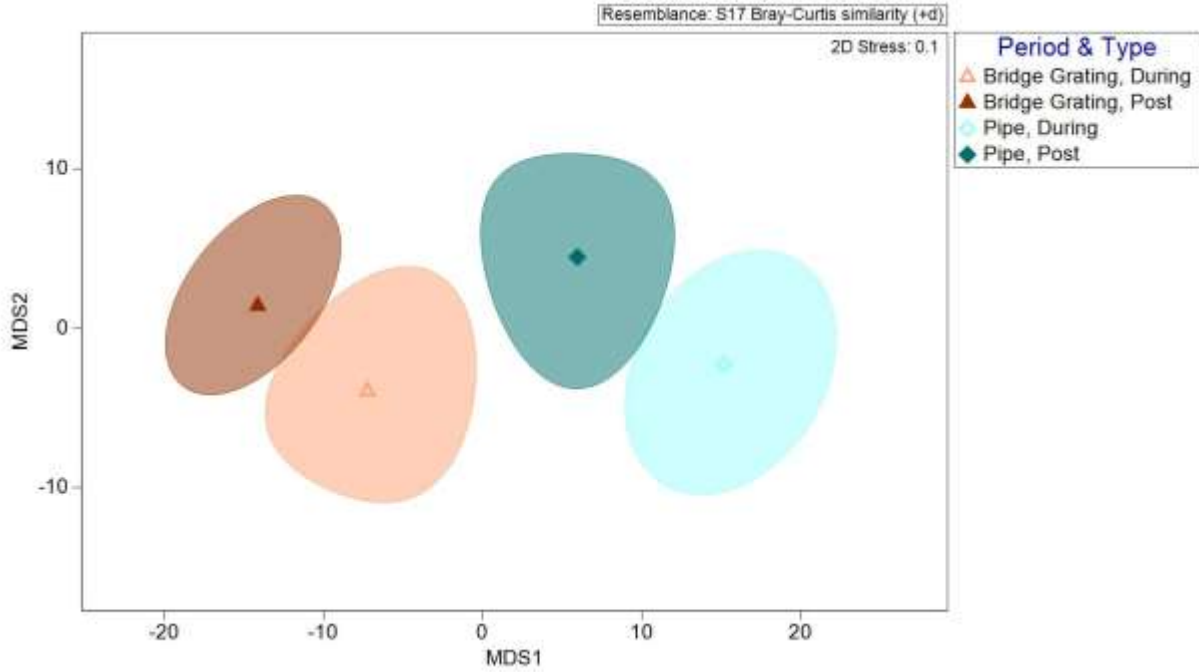
Figure 12. Bootstrapped metric MDS plot showing differences in monthly repel rates between communities observed at each wildlife guard type ( $P=0.012$ ) and between during construction (Apr 2017-May 2018) and post construction (May 2018-May 2019;  $P=0.010$ ) along State Highway 100 in Cameron County, Texas, USA. Differences are indicated by physical distance between bootstrapped averages surrounded by 95% confidence areas.

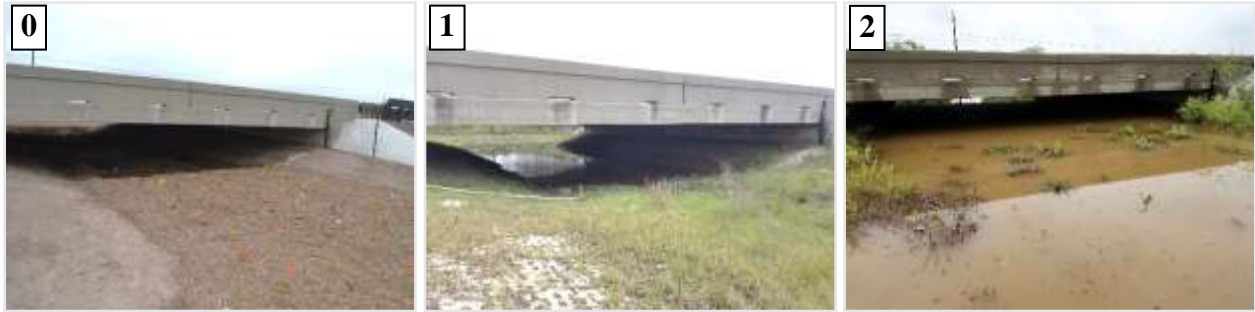
Figure 14. Water inundation at one wildlife crossing structure, located on State Highway 100 in Cameron County, Texas, USA, occurring between January 2018 and May 2019: little to no water (0); intermediate pooling of water (1); full of water (2).

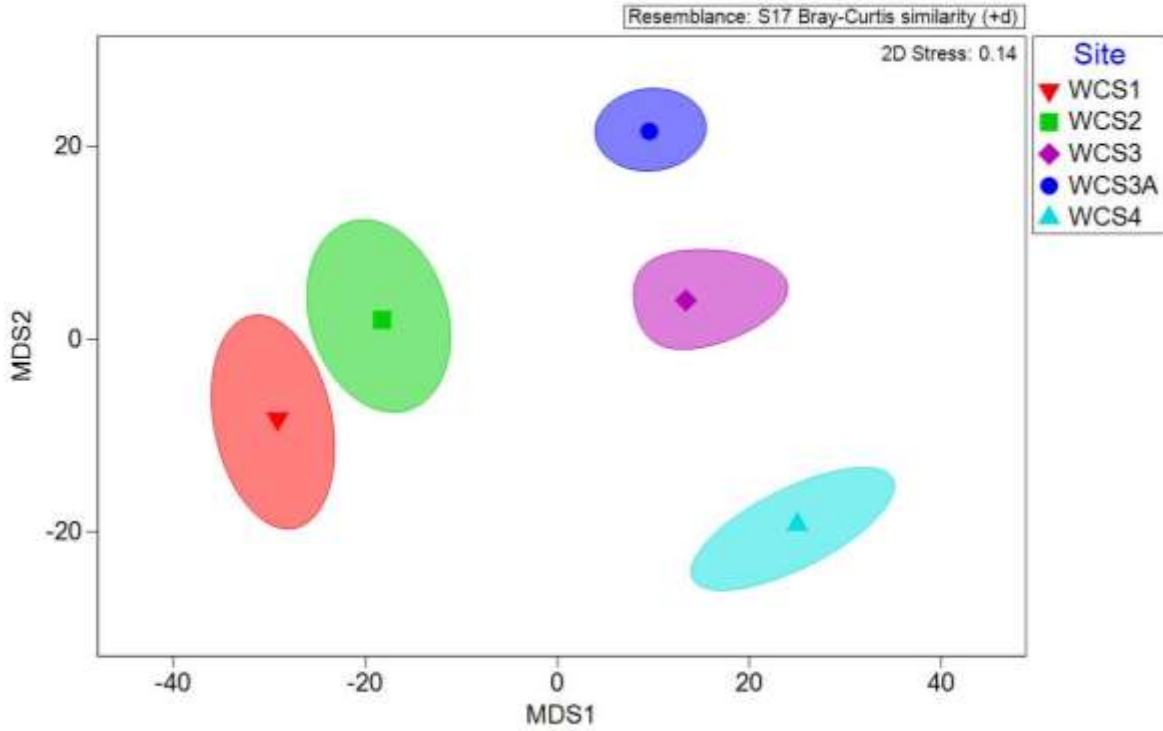
Figure 15. Bootstrapped metric MDS plot showing differences in wildlife communities crossing at all wildlife crossing structures ( $P \leq 0.001$ ) post construction (May 2018-May 2019) along State Highway 100 in Cameron County, Texas, USA. Differences are indicated by physical distance between bootstrapped averages surrounded by 95% confidence areas.

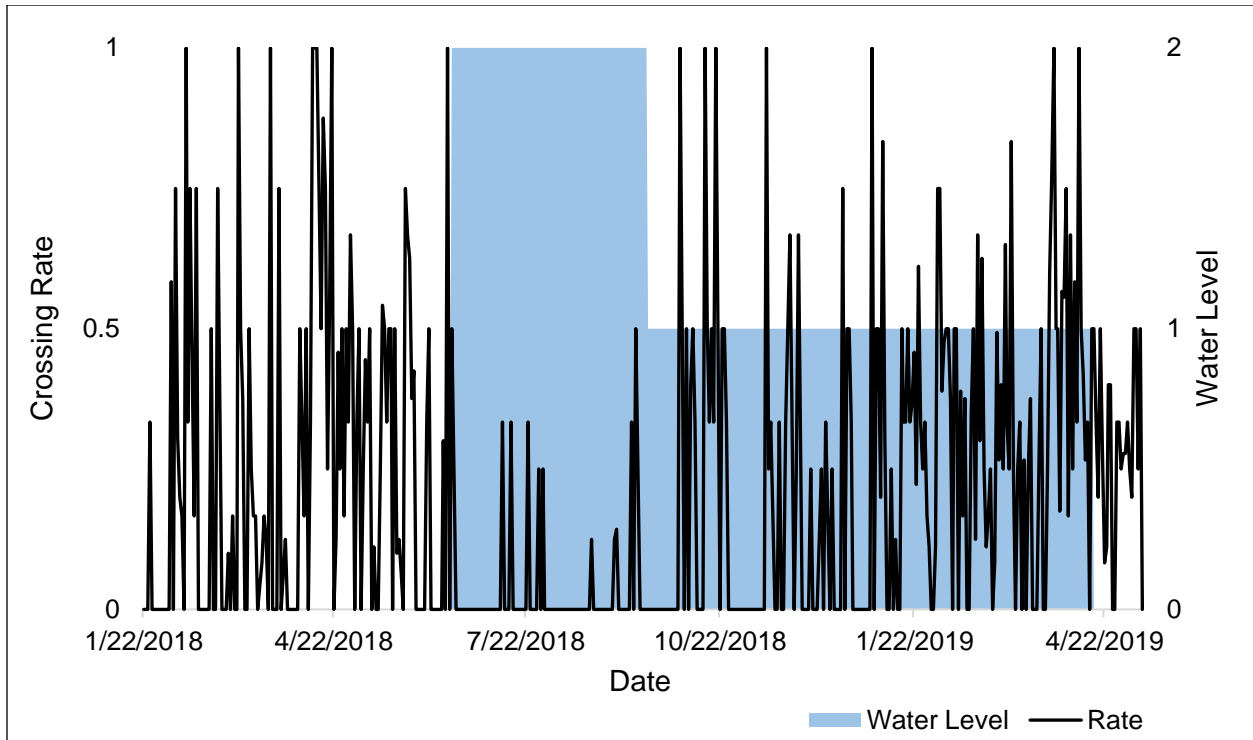
Figure 16. Daily crossing rates ( $\Sigma$  crossings/ $\Sigma$  total occurrences) of all wildlife compared to three assigned water levels at WCS3 for data collected from January 2018 to May 2019 in Cameron County, Texas, USA.
