ASSESSING THE PERFORMANCE OF RECONDITIONED RAILROAD
TAPERED-ROLLER BEARINGS USED IN FREIGHT RAIL SERVICE

A Thesis

MASTER OF SCIENCE IN ENGINEERING

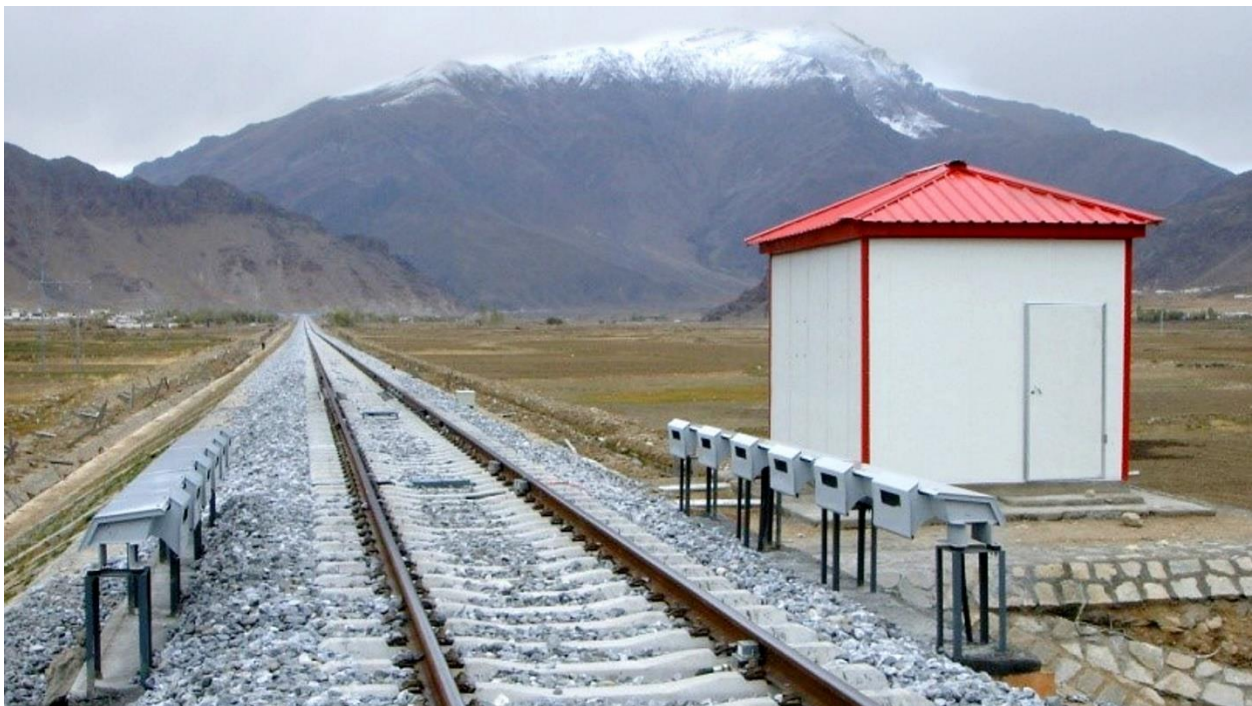
Figure 4: Photograph of Trackside Acoustic Detection System site [10]

The Trackside Acoustic Detection System (TADS™), pictured in Figure 4, alerts the conductor of high-risk bearings. While TADS™ are reliable in detecting end-of-life bearings, they are not capable of detecting bearings with small defects that are in the early stages of initiation and propagation [9]. Many defective bearings may never be detected by TADS™ because: (1) a high-risk defect is one that spans almost 90% of a bearing's raceway (i.e., a growler), and (2) there are less than 30 systems in service throughout North America, which means that many bearings may spend their entire service life without passing through a TADS™ station.

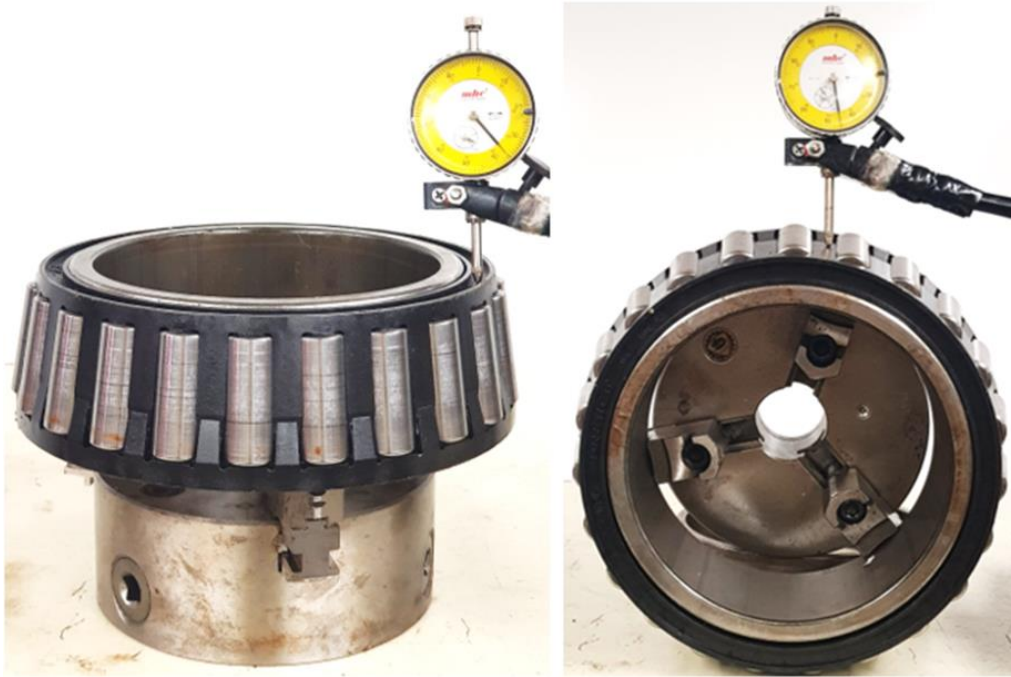
Figure 12. Inner ring (cone) assembly measurements: cage lift (left) and cage shake (right)

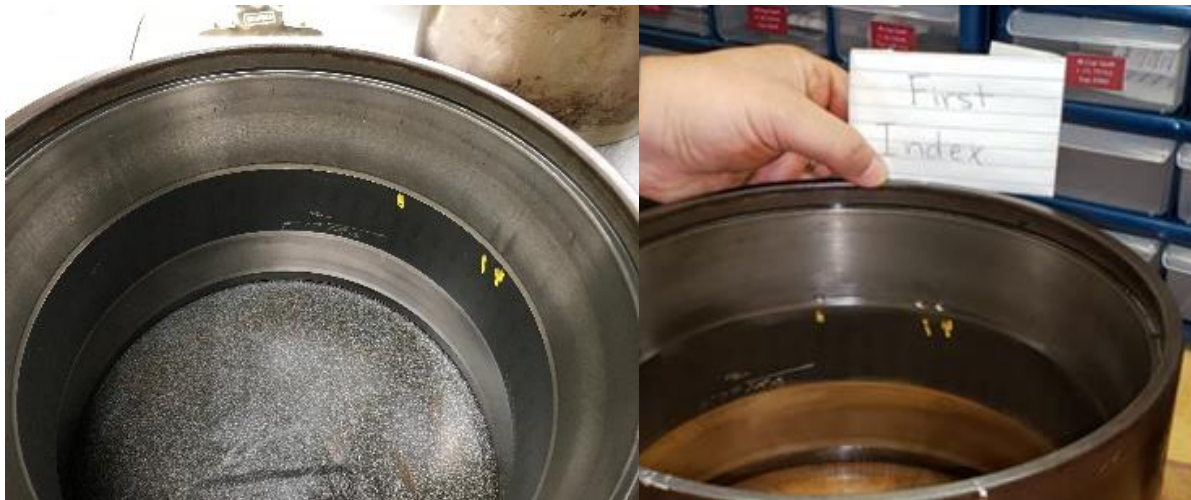
Figure 19: Picture on the left side shows test bearing 2 (B2) before the reconditioning process. The picture on the right shows test bearing 2 (B2) after it was reconditioned with the “Index I” region shown.

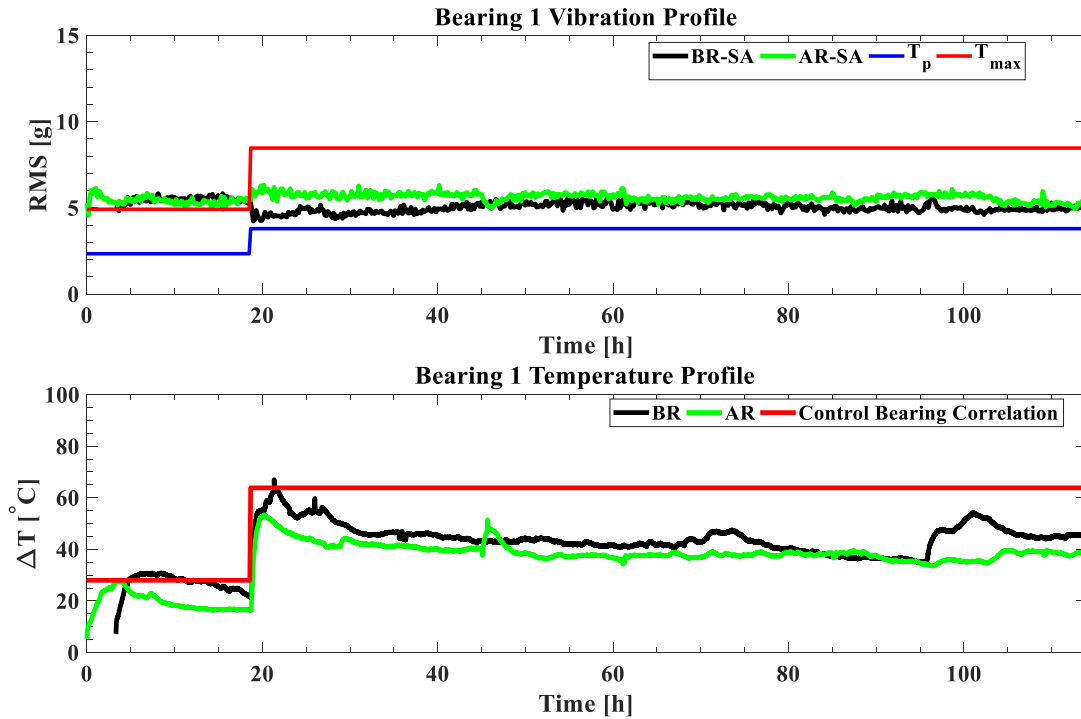
Figure 21: Vibration and temperature profiles for test bearing 1 (B1) before (BR) and after (AR) the reconditioning process

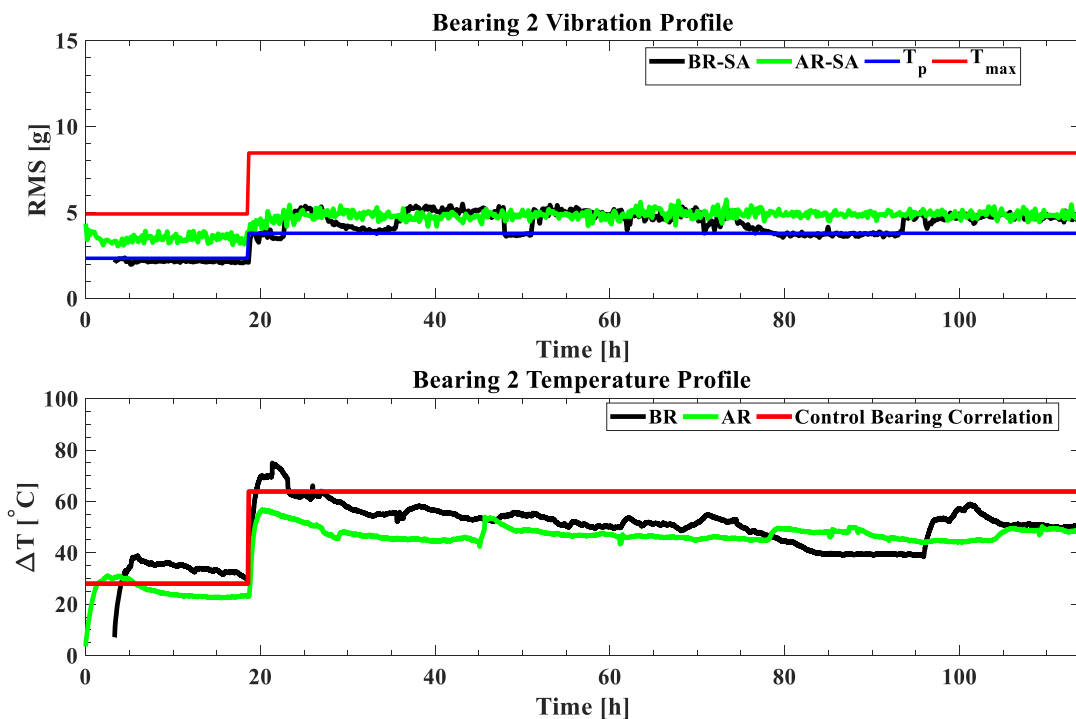
Figure 22: Vibration and temperature profiles for test bearing 2 (B2) before (BR) and after (AR) the reconditioning process

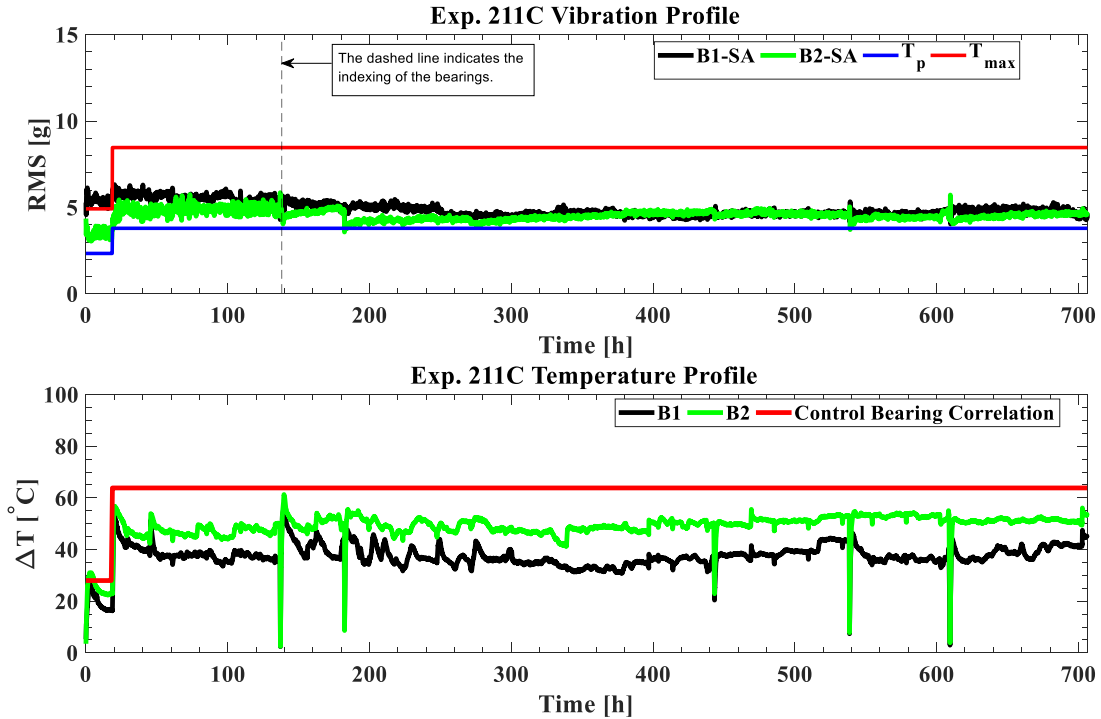
Figure 23: Vibration and temperature profiles for Experiment 211C before the complete teardown and inspection. The cups of the two test bearings were oriented with “Index I” in the top center location after 21,905 km (13,611 mi) of operation

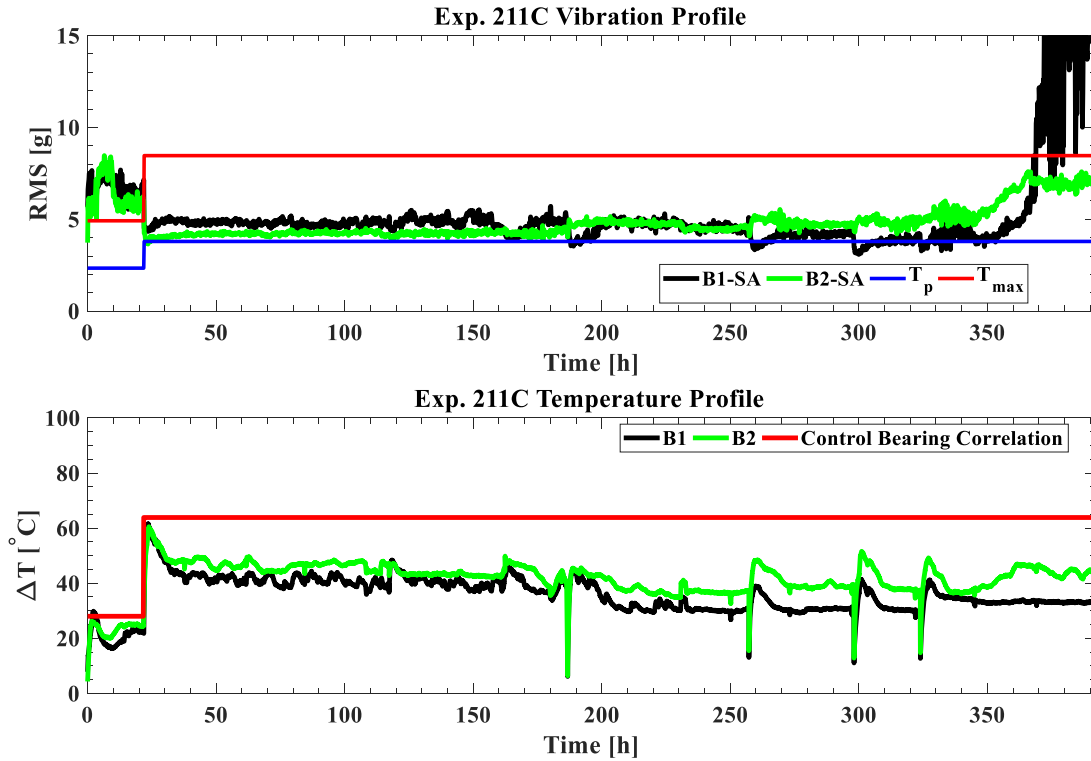
Figure 24: Vibration and temperature profiles for Experiment 211C after the completion of the first teardown and inspection

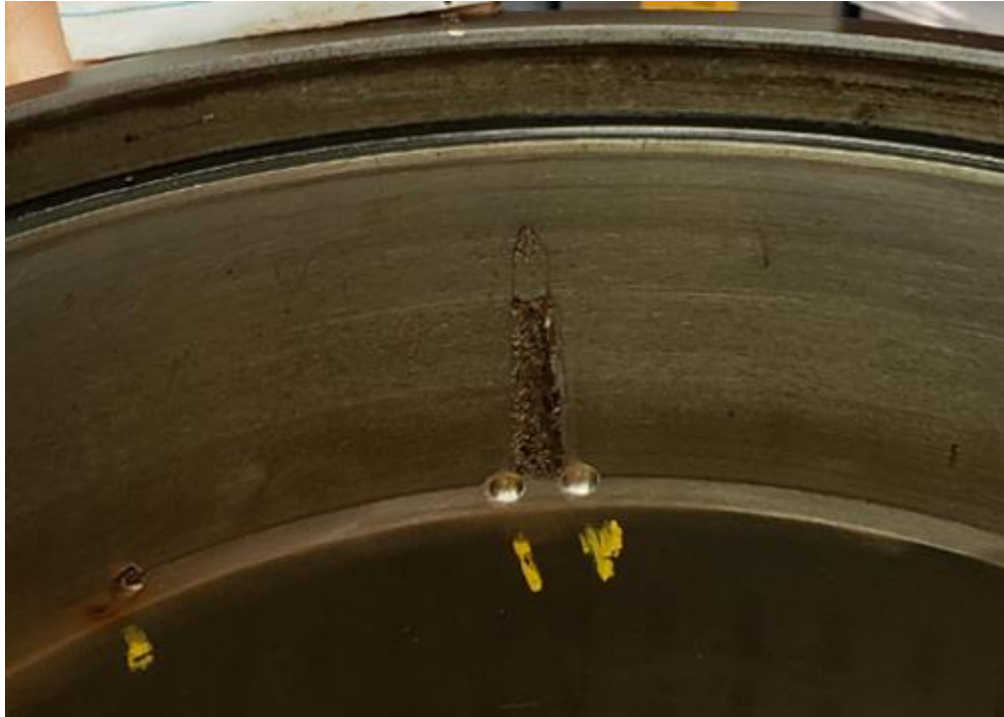
Figure 25: A picture of the defect that developed on test bearing 2 (B2) after 151,154 km (93,923 mi) of total operation since the bearing was reconditioned

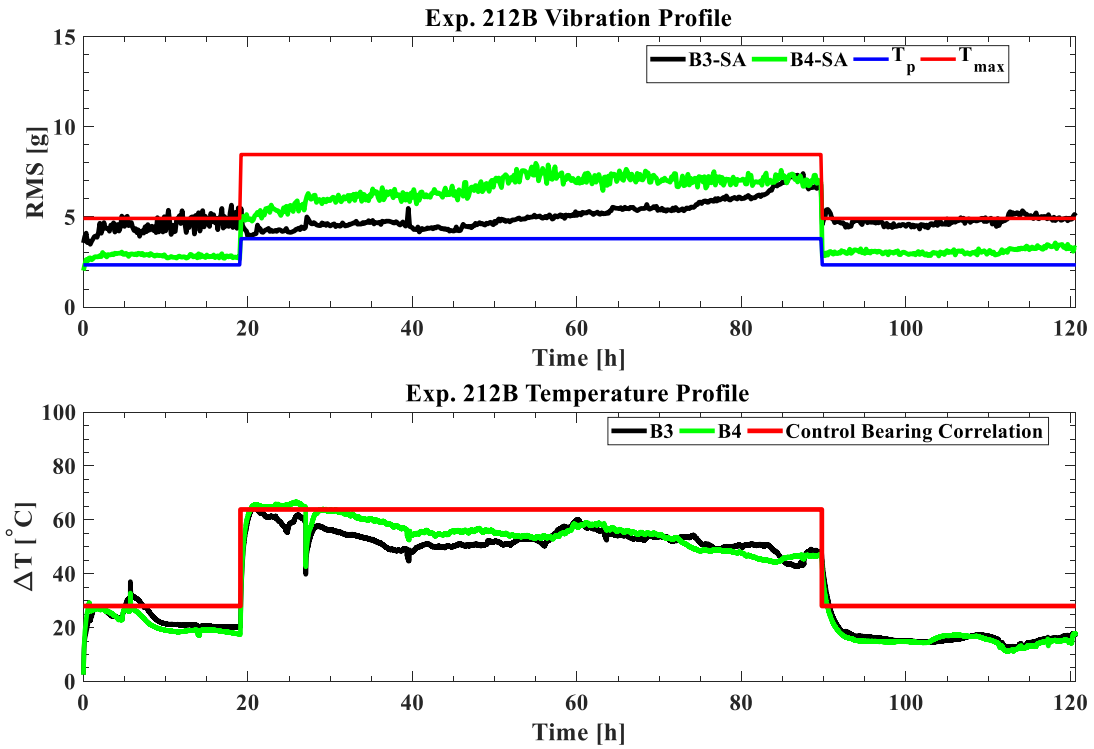
Figure 26: Vibration and temperature profiles for Experiment 212B where bearings 3 and 4 were tested

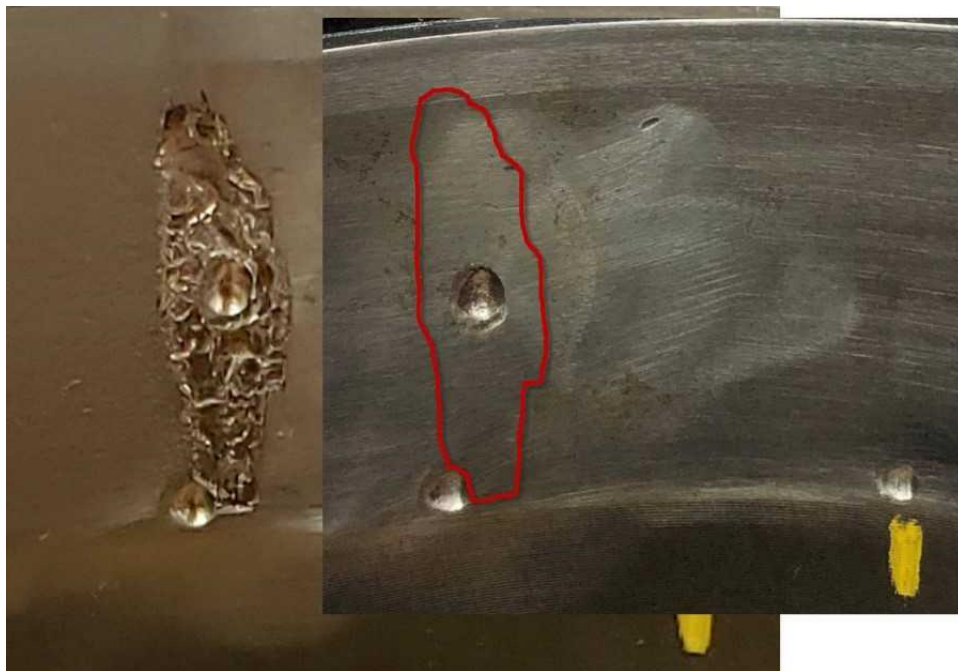
Figure 27: A picture of the defect that developed on test bearing 3 (B3) after 14,001 km (8,700 mi) of total operation since the bearing was reconditioned

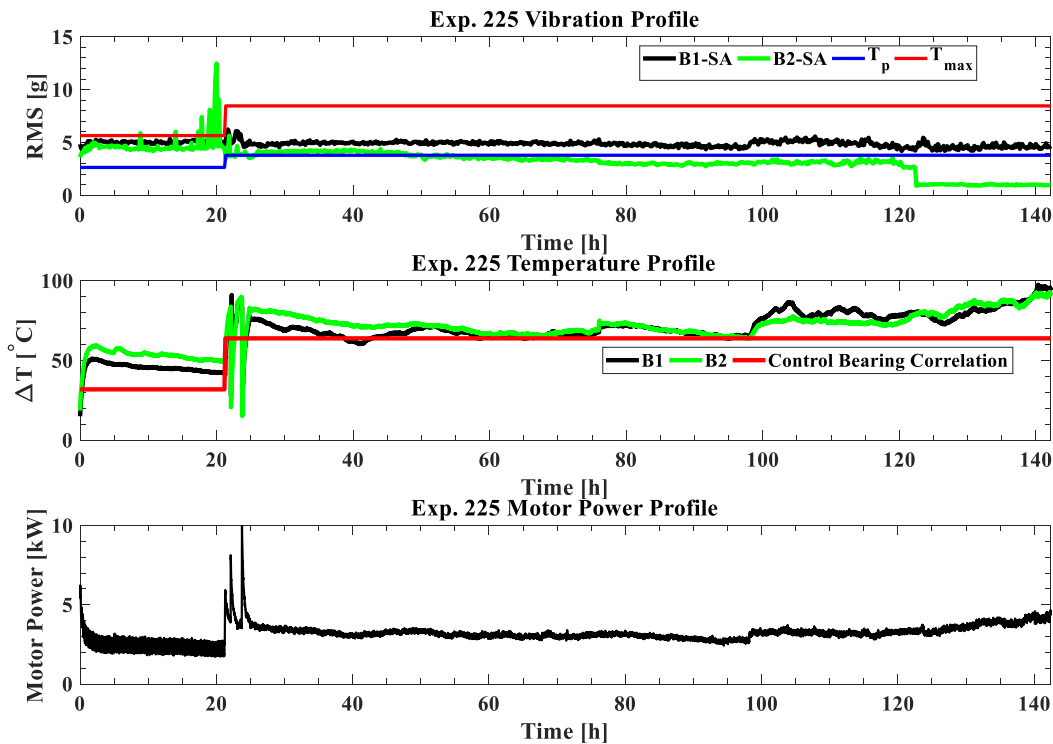
Figure 29: Vibration, temperature, and motor power profiles for Experiment 225

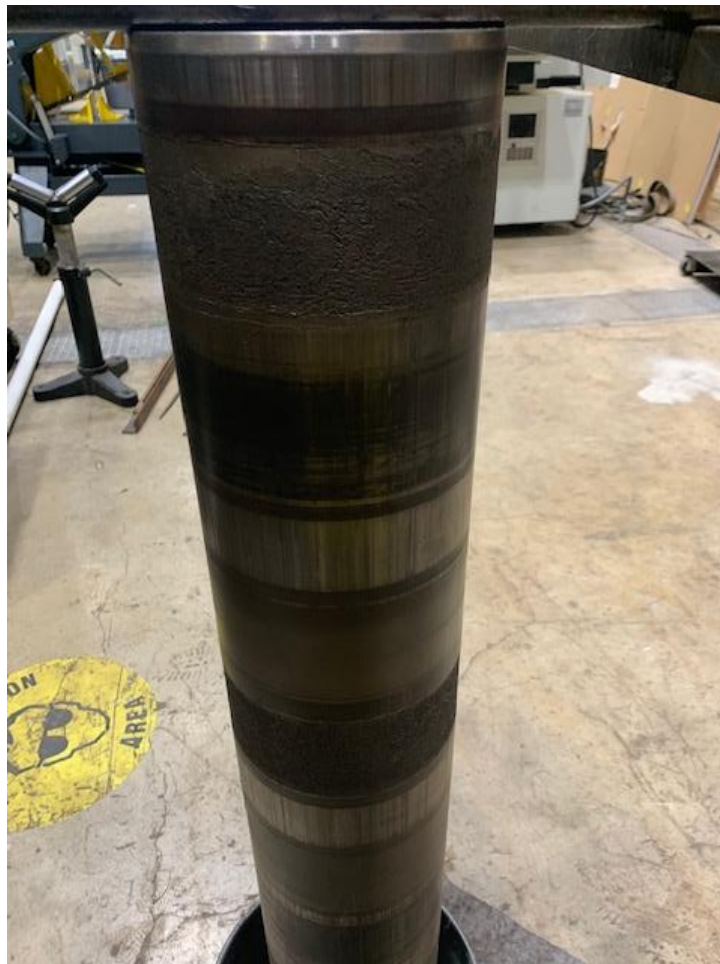
Figure 30: Experiment 225 axle damage

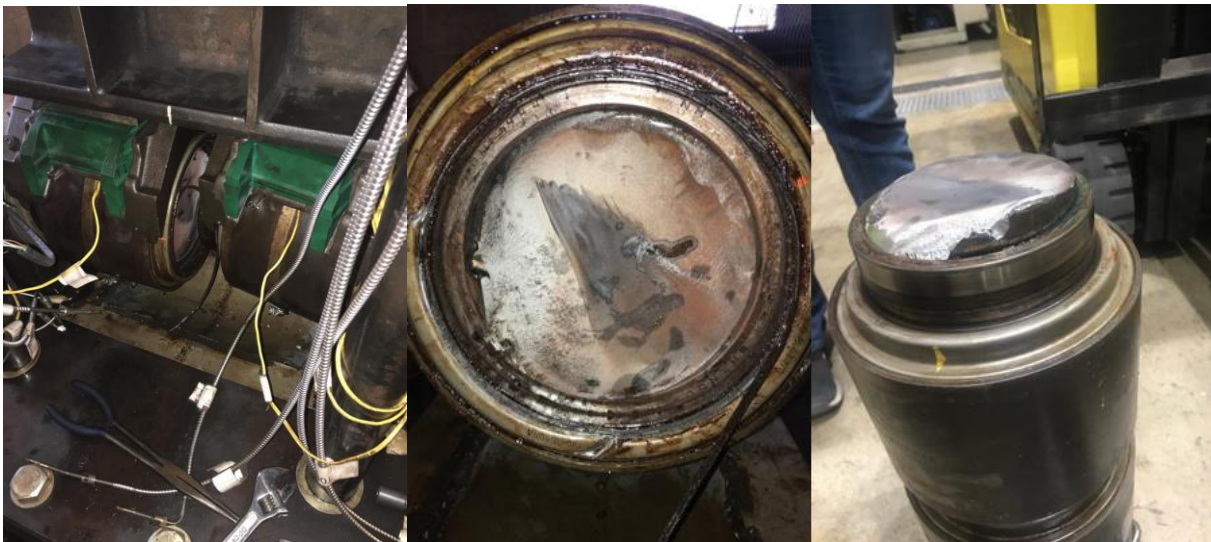
Interestingly, the test axle had sheared between the two test bearings (B1 and B2) and close to the middle of the axle length.

Figure 31: Experiment 227E axle damage

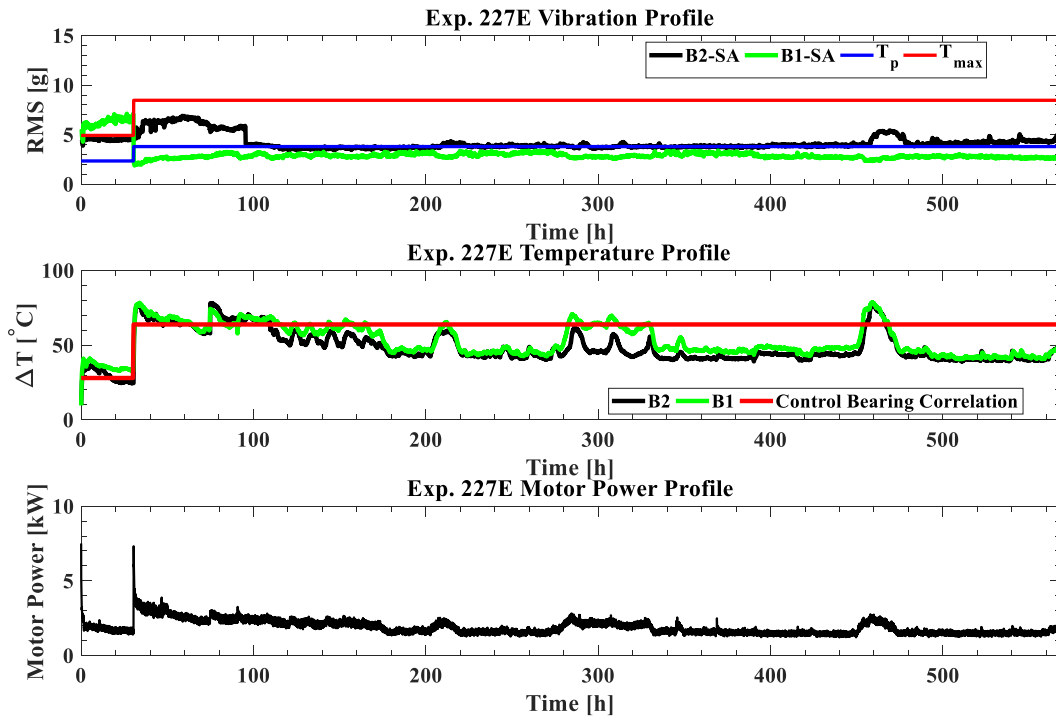
Figure 32: Vibration, temperature, and motor power profiles for Experiment 227E

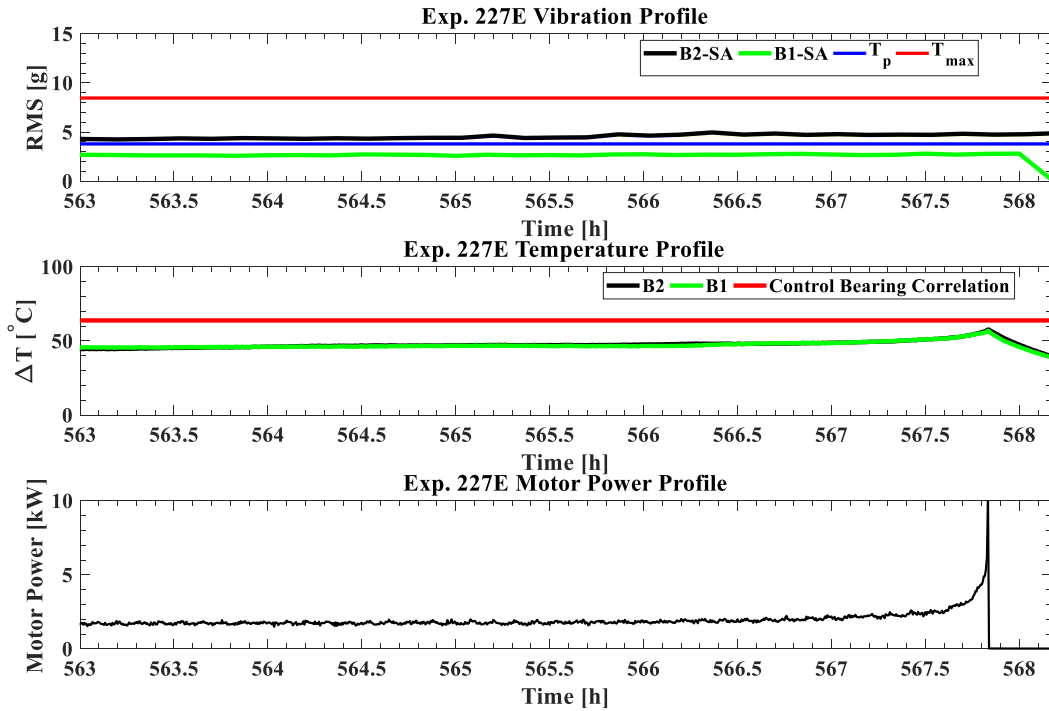
Figure 33: Vibration, temperature, and motor power profiles for Experiment 227E for the last 5 hours of operation

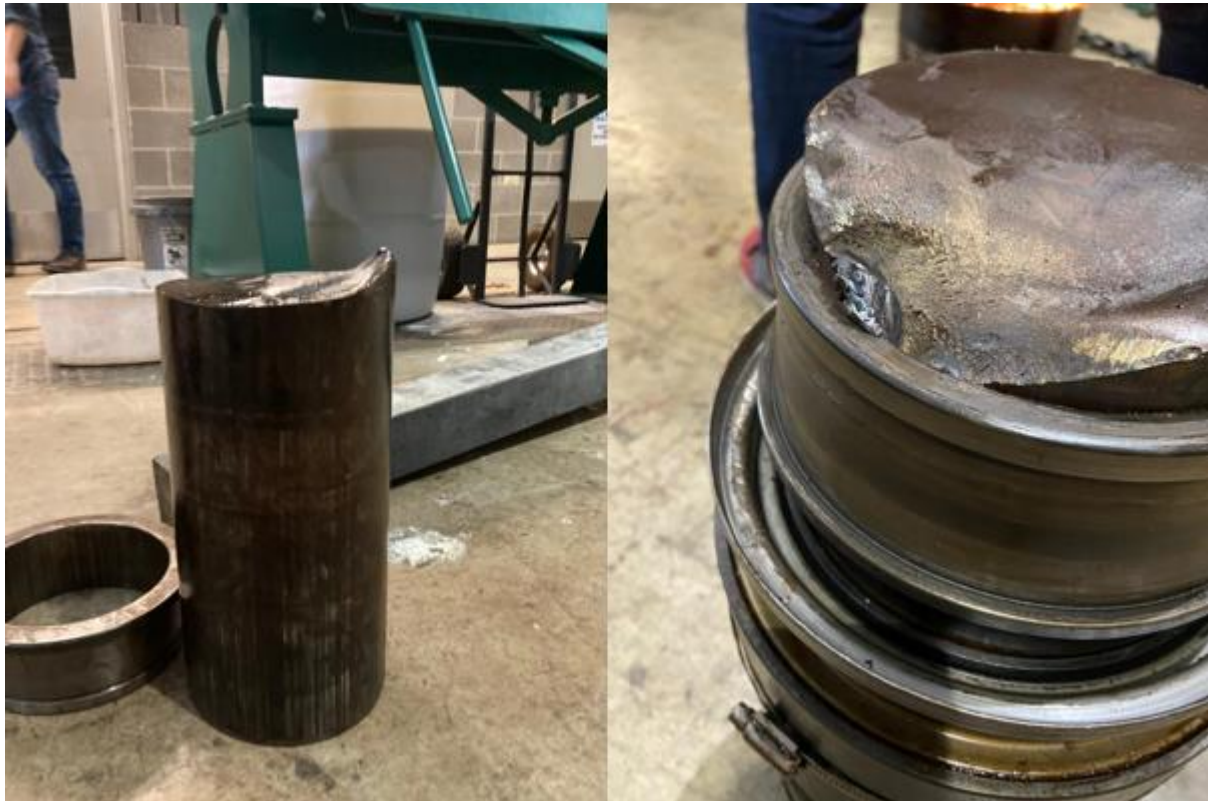
Figure 37: Experiment 229B axle damage

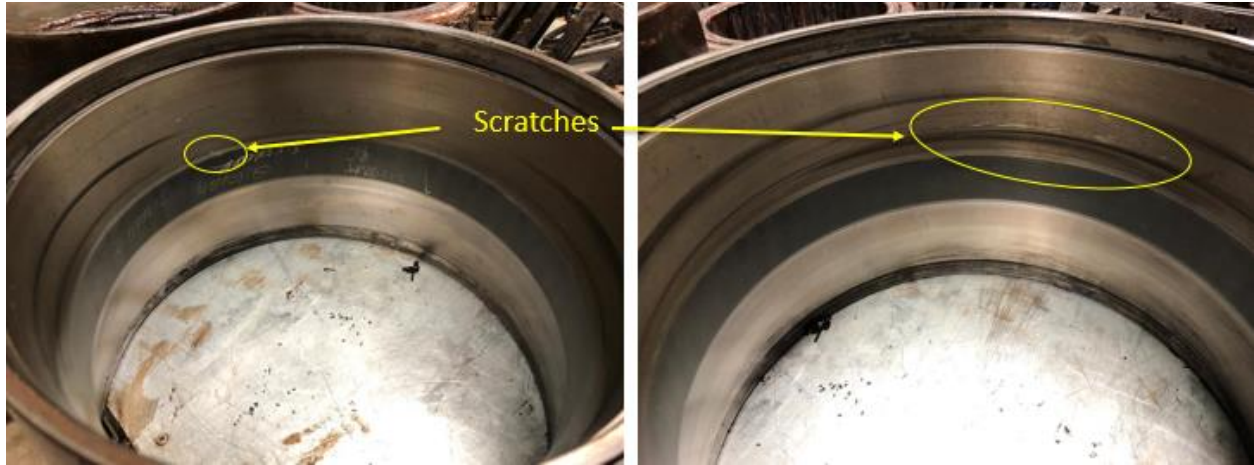
Figure 38: Damage on cup raceways of test bearing 6 (B6)

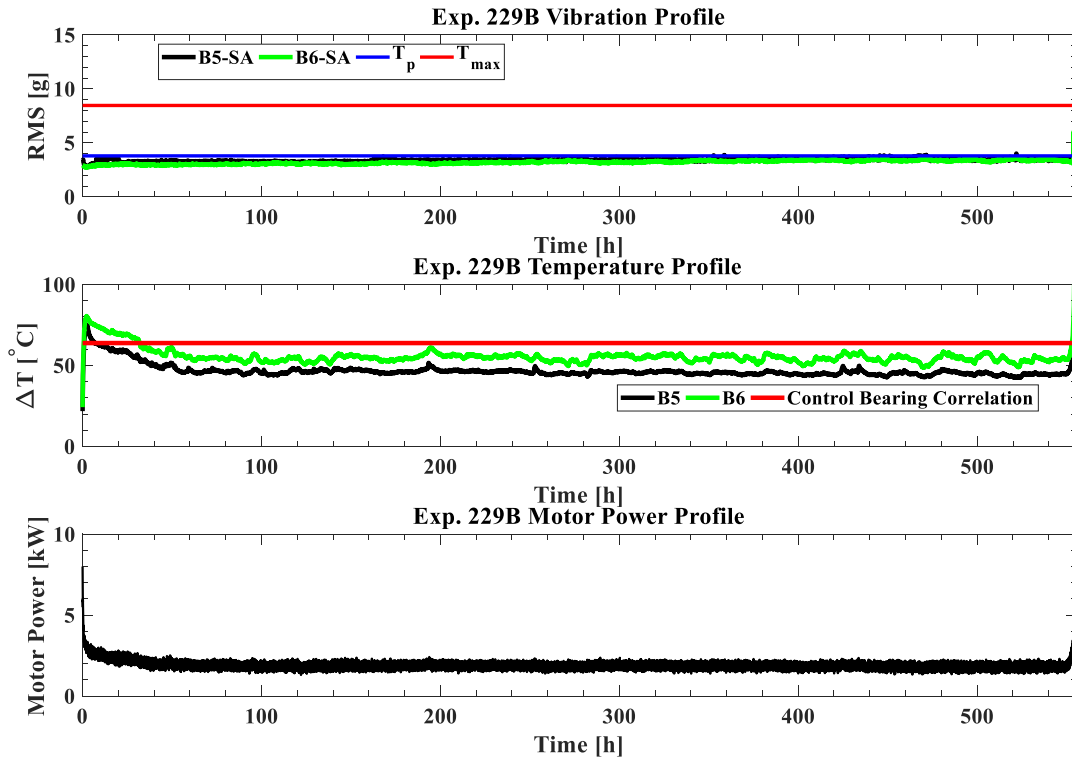
Figure 39: Vibration, temperature, and motor power profiles for Experiment 229B

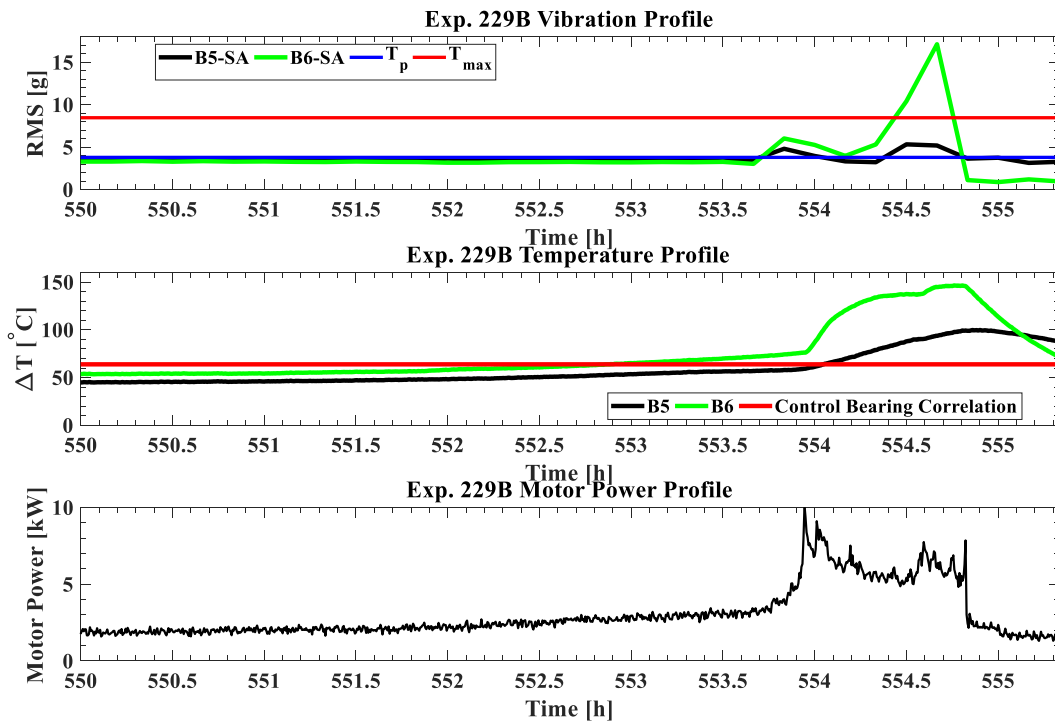
Figure 40: Vibration, temperature, and motor power profiles for Experiment 229B over the last five hours of operation

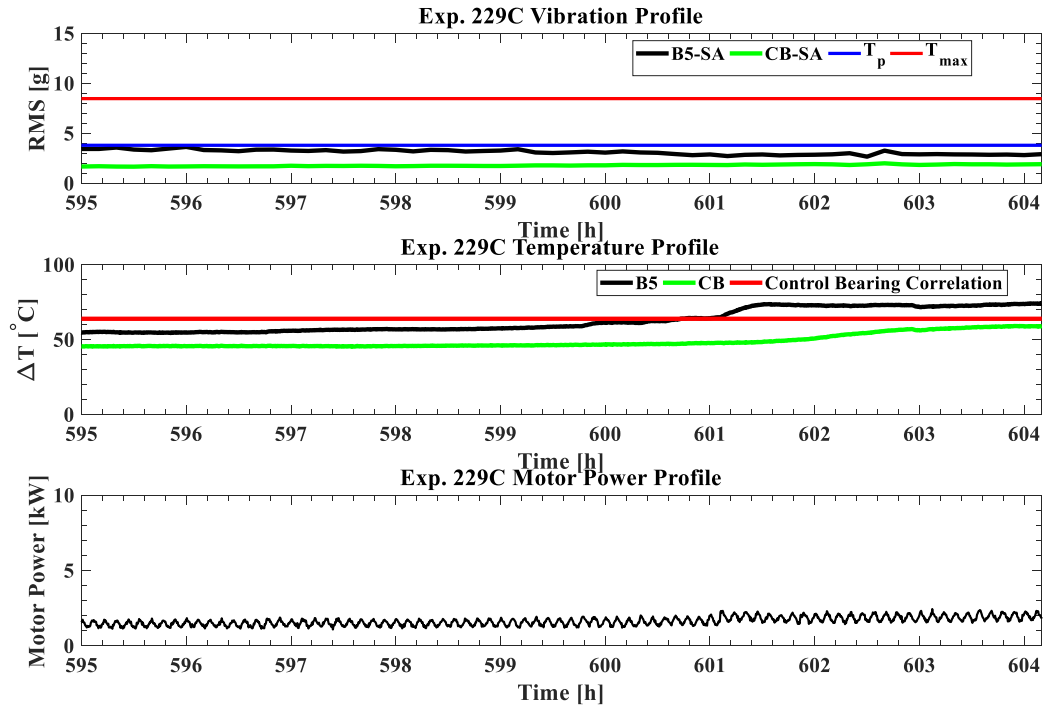
Figure 42: Vibration, temperature, and motor power profiles for Experiment 229C for the last 10 hours of operation

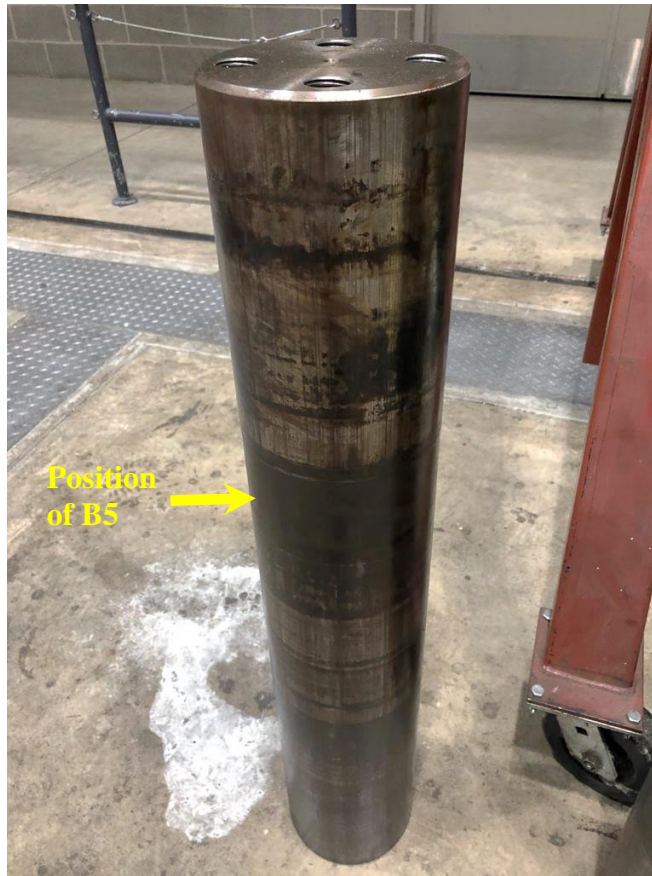
Figure 43: Experiment 229C axle damage

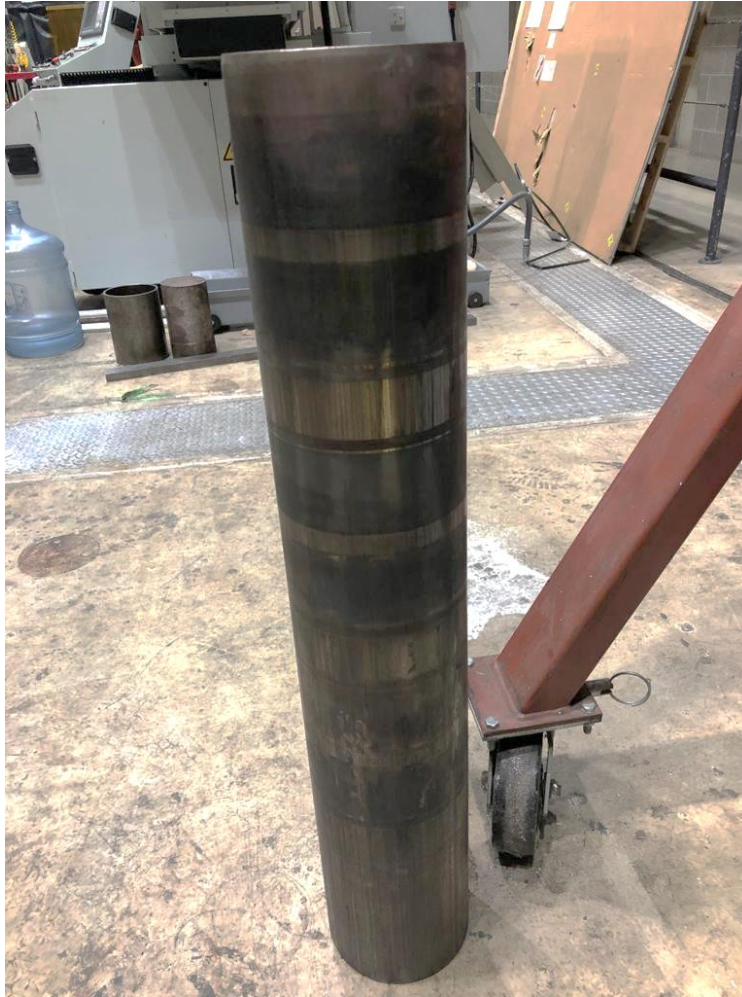
Figure 47: Experiment 230D axle damage
