Mechanisms of Environmentally Induced Crack Initiation in Humid Air for New-Generation Al-Zn-Mg-Cu Alloys

Mechanisms of environmentally induced crack initiation in humid air in new generation Al-Zn-Mg-Cu alloys

Abstract

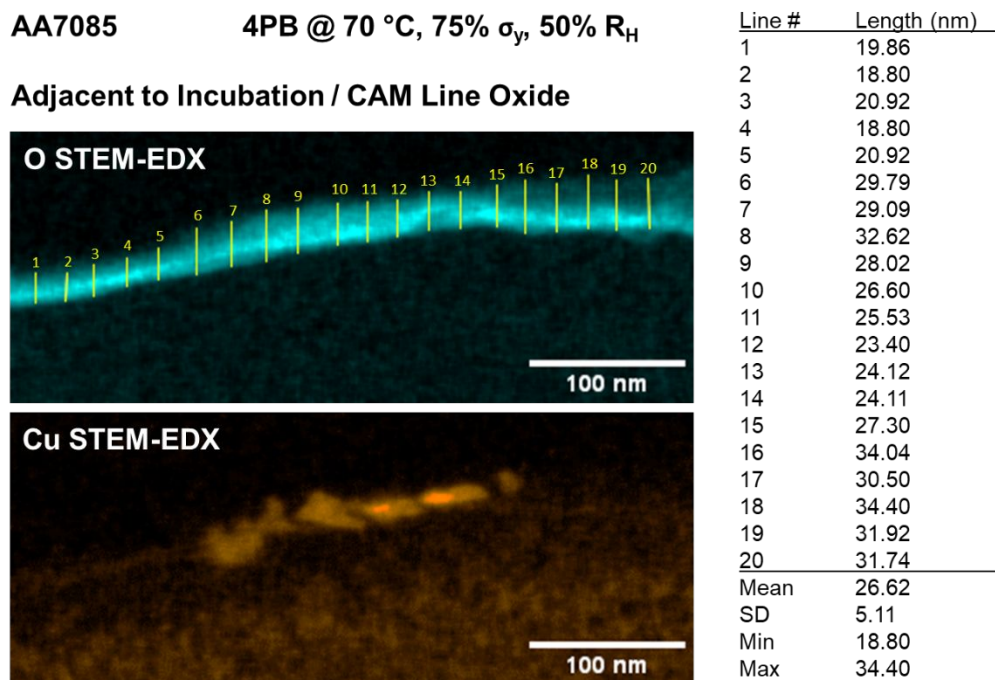
Figure S1. STEM-EDX spectrum maps of O and Cu showing the measurement of the oxide film thickness at a CAM line location
