UNIVERSITÀ DEGLI STUDI DI PADOVA

Dipartimento di Ingegneria Civile Edile e Ambientale

Laurea Magistrale a Ciclo Unico in Ingegneria Edile – Architettura

**SEISMIC VULNERABILITY ASSESSMENT OF  
CLUSTERED BUILDINGS  
IN THE HISTORICAL CENTER OF TIMISOARA:  
FRAGILITY CURVES FOR  
OUT-OF-PLANE LOCAL MECHANISMS OF COLLAPSE**

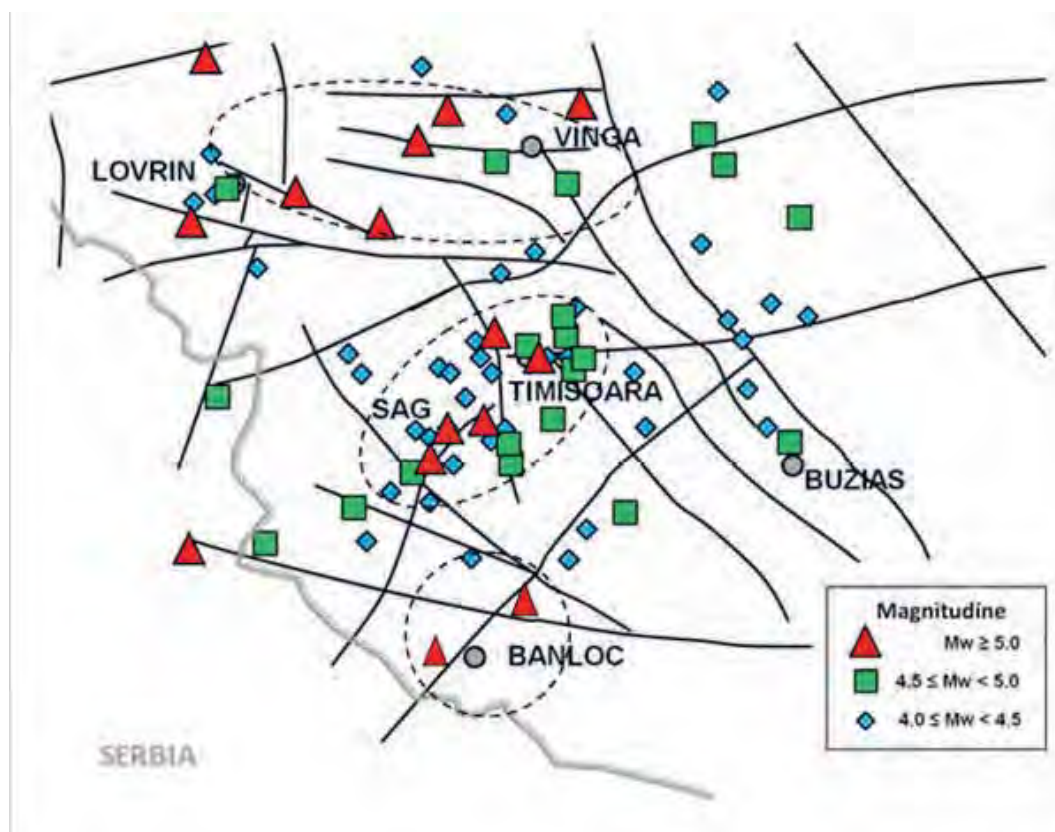
Fig. 1.3.4: Schematic representation of the seismotectonic of the area and relative fault lines.

The greatest earthquakes from this region have a seismic sources usually located at the intersection of seismic faults or near geological faults of different ages. The distribution of epicenters of the region recorded earthquakes shows that they can be clustered in three major areas, called “clusters”, defined by important seismic events having  $M \geq 5.0$ : the first one near Timisoara in correspondence of Sag ( $M=5.4$  on 27 May 1959) and Timisoara-Sacalaz (on 5 June 1443 and on 19 November 1879), the other two located at a critical distance from Timisoara, causing minimal effects on the buildings, one in Volteg-Barloc ( $M=5.6$  on 12 July 1991 and  $M=5.5$  on 2 December 1991) and the other between Lovrin and Vinga ( $M=5.3$  on 30 August 1941 and  $M=5.2$  on 8 July 1938). These clusters are concentrated on fault intersections, which had different principal directionalities: northeast-southwest, east-west and northnorthwest-southsoutheast<sup>18</sup>.

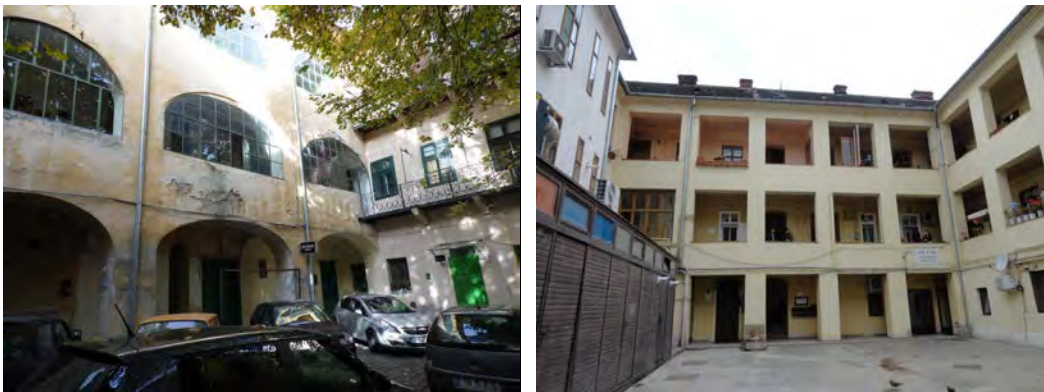
*Fig. 1.8.3: Arcades and loggias(US 42 and US 77)*

Other elements diffused in the district are arcade and loggias, usually around internal courtyards, and external stairs and added corps, typically in the back of the buildings. In some constructions it is possible to find also overhanging elements, both on the main façade or on the back of the building, and they are built not with regular solid bricks, but with largely holed bricks. Towering and standing out elements are very common too, particularly around major squares, where frontons were added later on the top of buildings. A very characteristic element, due to the plan shape of building, is the passage to the internal courtyard. This can be about 3 or 4 m large and vaulted, or just 1 or 2 m large but two stories high, but in both cases it is usually in strict relation with the stairs system.

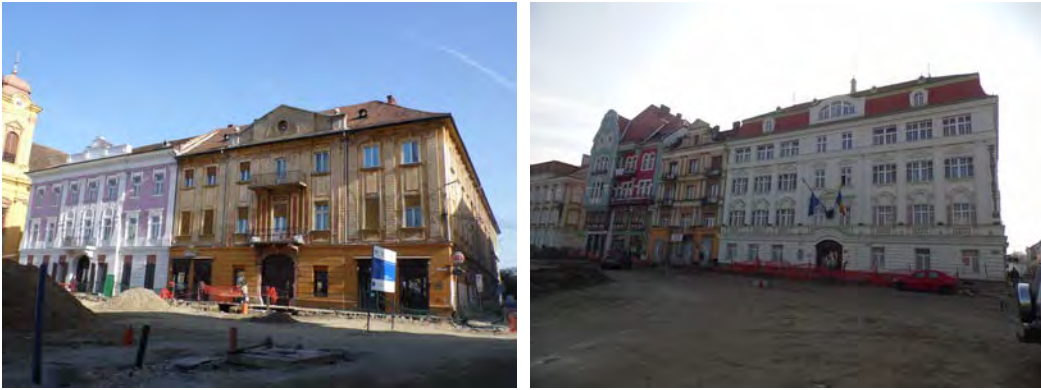
*Fig. 1.8.7: Widely holed facades(Blocks C9 and C16)*

The façade has usually a big number of windows and openings, so the open surface usually exceeds the 30% of the total surface, and this is the reason why soft story due to many and/or of large dimension holes is present in almost the totality of buildings.

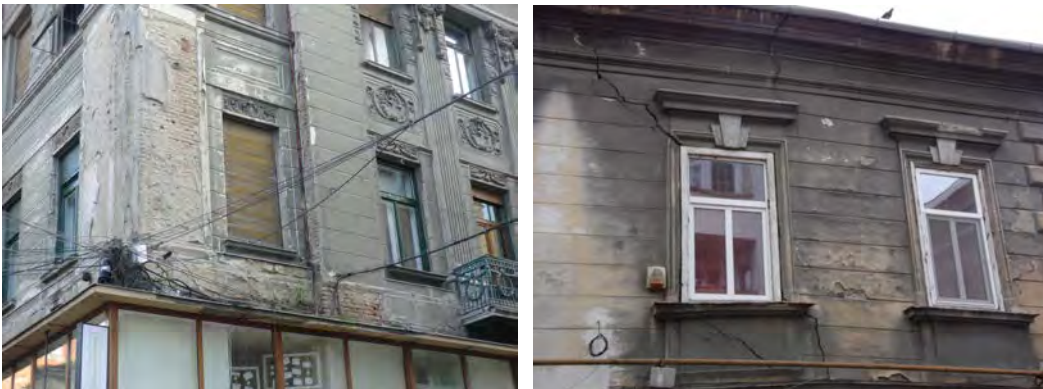
*Fig. 1.8.8: Non-structural and structural damage (US 133 and US 71)*

The majority of buildings is in good condition or with widespread damage on non-structural elements, but there are anyway many buildings in bad condition or with very serious damage. In these constructions the damage of plasters, coverings, tiles and chimneys is quite spread, but also in few cases very deep cracks and evident structural subsidence interest the construction. Even if the building from the outside seems in good conditions, it is not sure that has the same characteristics inside. It is very common indeed to restore just the outer part of the façade and leave the inner parts as they were.

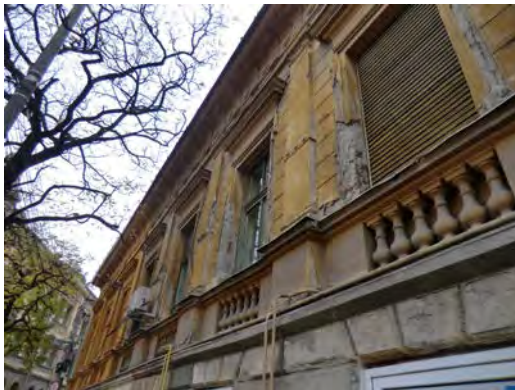
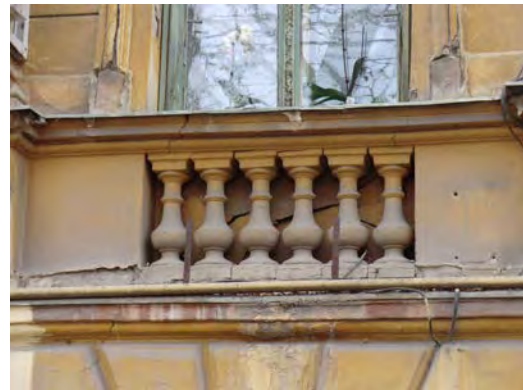
*Fig. 1.8.13: Non-structural and structural damage (US 208)*

Most of the buildings are in good or medium conditions, but there are some that are in bad conditions or with a medium structural damage. These units often shows deep cracks and evident deformations in the façade.

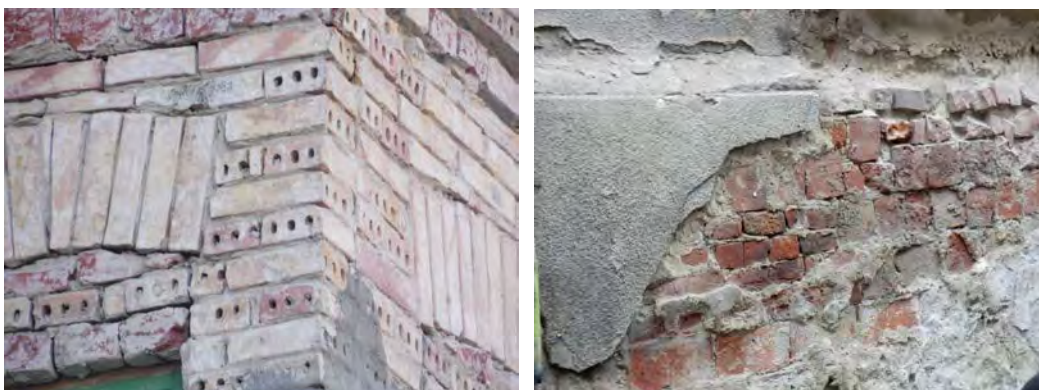
*Fig. 1.9.3: Holed bricks and irregular masonry (US 5 and US167)*

In few cases it is possible to see under the plaster layer that many bricks of different dimensions are used in the same wall. It is not known the nature or the motivation of this technique, but it is evident that it creates a wall of bad mechanical characteristics.

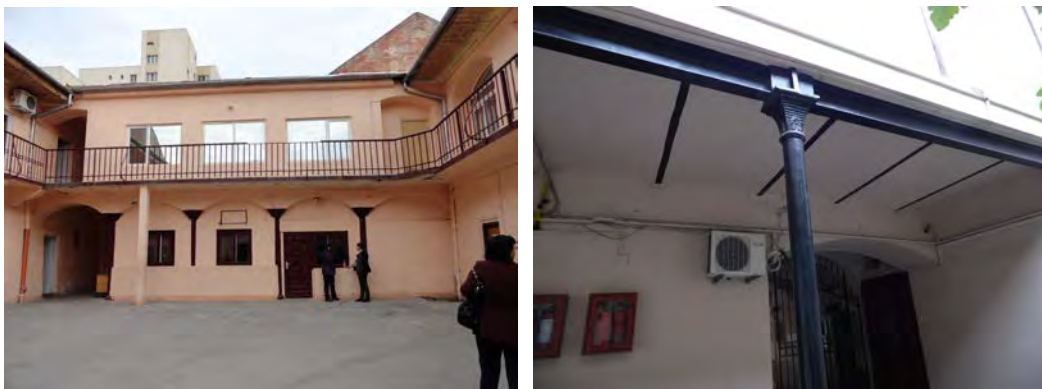
*Fig. 1.9.5: Solid metal columns(US 8 and US 28)*

A vertical element that is common to find in the city center is the metal column. There are two types of it: the first one is cylindrical and solid and it is usually collocated in the internal courtyard to support loggias or balconies, and the second one is reticular and it is the bearing structure of the entire ground floor. The reticular metal column is typical for buildings dated back between the end of the XIX century and the beginning of XX century and the principal examples are concentrated at the corner of Episcop Augustin Pacha Street and Eugeniu de Savoya Street. This vertical structure is usually combined with iron beams and very low brick vaults, creating a ground floor characterized by many and wide windows. Reticular columns are usually 60x60 cm and they distance 3 or 4 m from each other.

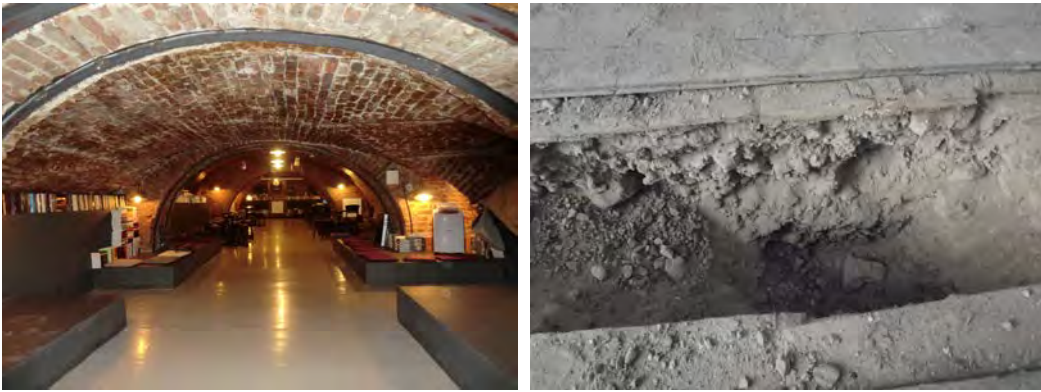
Fig. 1.9.12: Brick vault example and soil and shard filling (US 192 and US 130)

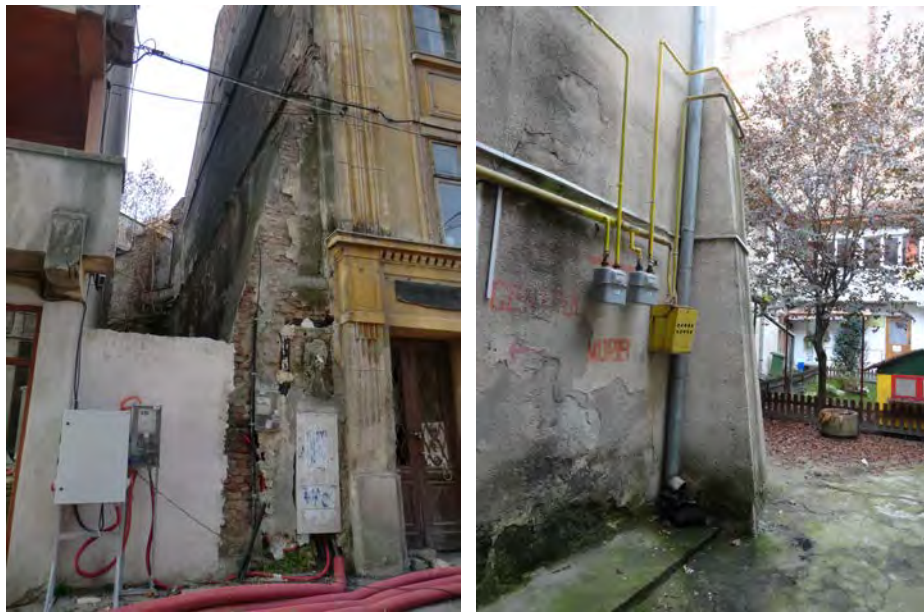
*Fig. 1.10.1: Spurs examples(US 194 and US 95)*

- Buttresses and/or spurs: just 3 buildings present this kind of reinforcement. They are collocated where there are not adjacent buildings to contrast the out of plan force, and they usually interest just the first storey.

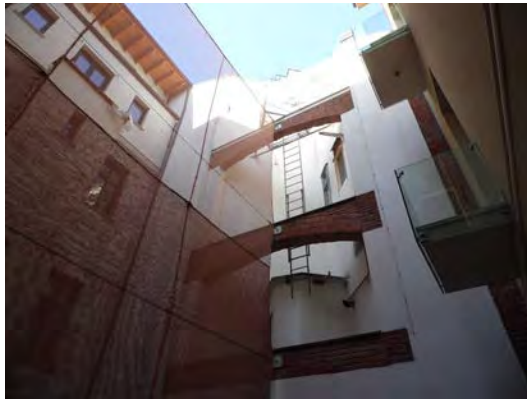
*Fig. 1.10.2: Contrast elements examples(US 5)*

- Contrast elements: the only example of this typology is a series of contrast arches between two walls of the same building. Masonry arches are collocated in correspondence of each storey, except the last one.

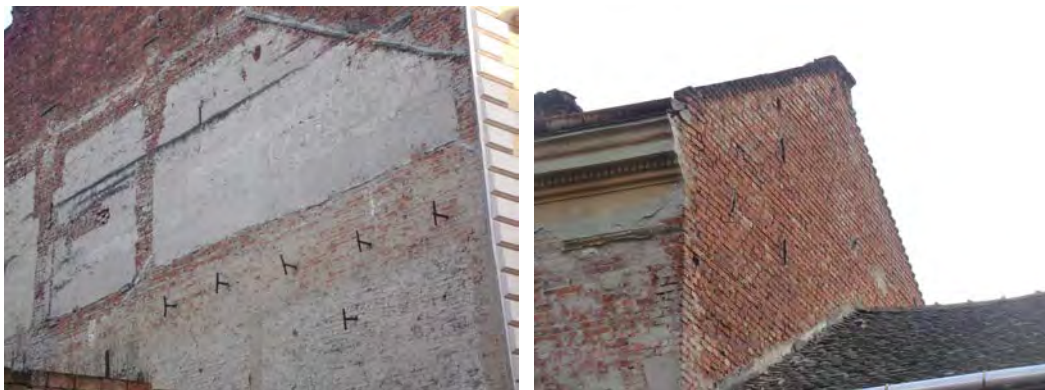
*Fig. 1.10.3: Tie rods examples(US 79 and US 237)*

- Tie rods: they are metallic elements that improve connections between masonry walls and horizontal structures, preventing the out of plan overturning. The presence of these elements do not assure automatically a reinforcing function, cause they can be ineffective in many ways. The wrong position or the wrong action direction are examples of their inefficiency. Tie rods in Timisoara are usually parallel to the main façade and are visible in the latest floors wall. The eventual presence of tie rods on the main façade is hidden by decorative elements and considering this condition it is not possible to tell for sure the efficiency of observed tie rods and for this reason they are considered ineffective.

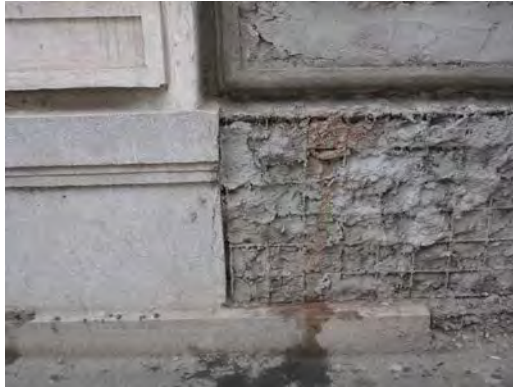
*Fig. 1.10.43: Reinforced plaster examples(US 17*

- Reinforced plaster: this intervention it is very difficult to recognize at finished work, cause the metal elements will be covered by the plaster layer. There is only one case in which the metal grid is visible, in a work in progress building.

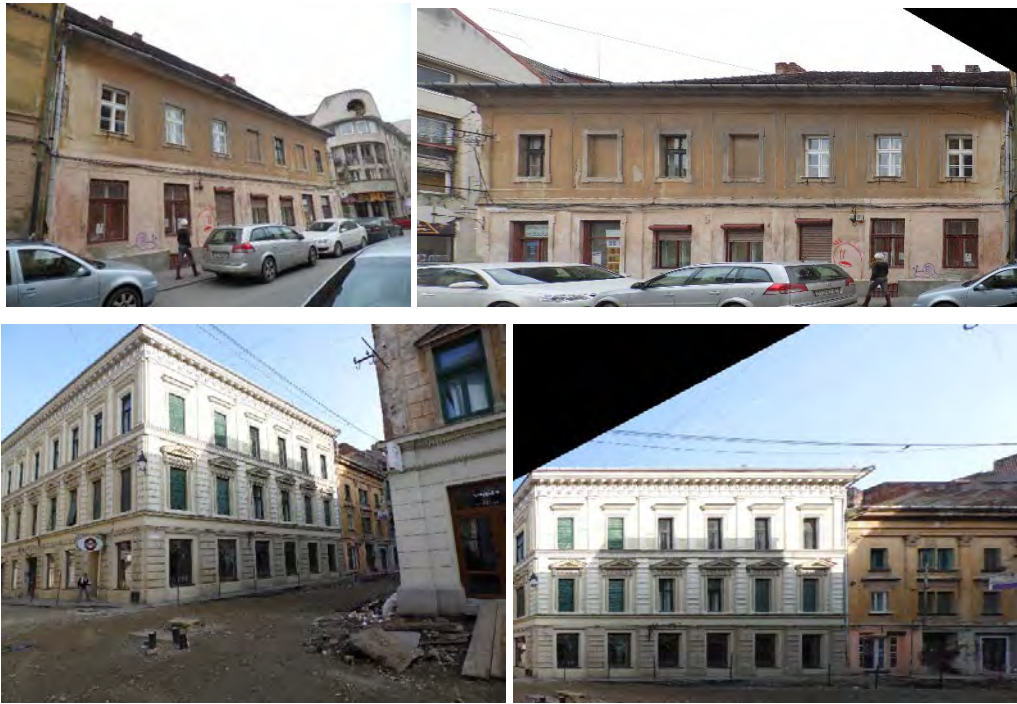
*Fig. 2.4.2: Perspective rectification of US 30 and US 86*

All the pictures of the building facade were processed through the perspective rectification carried out by RDF program and they have been analyzed to define the medium dimension of the windows openings and their position. In the following figures is shown the perspective rectification.

For each typology a large number of photos was straightened: the windows dimensions were compared and a medium value was determined. The French door were always located in correspondence of the floor, while the smaller windows were located at 1 m from the floor. All the classes are characterized by only one façade type, and consequently by one of these window positions, and only the class V has both possibilities: the windows located 1 m from the floor and the one located in correspondence of the floor.

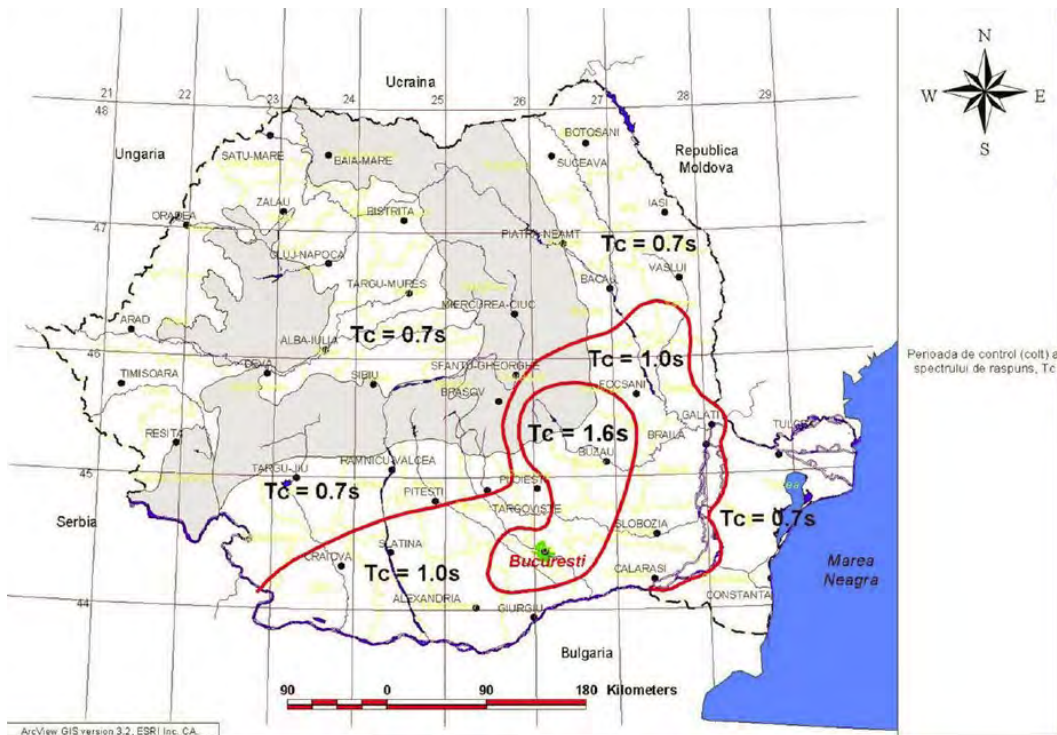
Fig.3.1.7: Romania in terms of zoning control period (corner),  $T_c$  response spectrum. Code design P100-1 / 2006

The Romanian Code subdivides the national territory in seismic zones, in which the hazard level is considered constant. The hazard seismic design is described by the horizontal peak ground acceleration  $a_g$ , determined by the average return period  $IMR$ . With the so defined  $a_g$  is possible to determinate the characteristic value of seismic action,  $A_{Ek}$ . The design value of seismic action is  $A_{Ed}$  and it is the result of the multiplication of the characteristic value for the importance and exposure factor of the construction:

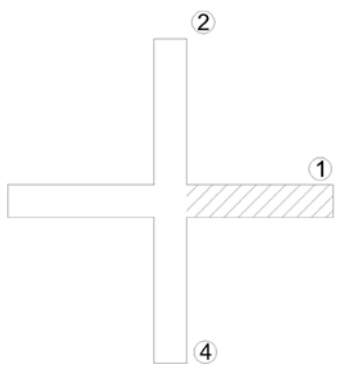
<p><b>INTERMEDIATE “T” NODE</b></p> <p>Possible breaking mechanisms:</p> <ul style="list-style-type: none"> <li>• Bending failure</li> <li>• Compression breaking of the arch</li> <li>• Separation of the wall perpendicular to the septum</li> </ul> <p>Mechanisms that cannot be activated:</p> <ul style="list-style-type: none"> <li>• Overturning of the wall shoulder perpendicular to the septum due to the thrust of the arch</li> </ul>

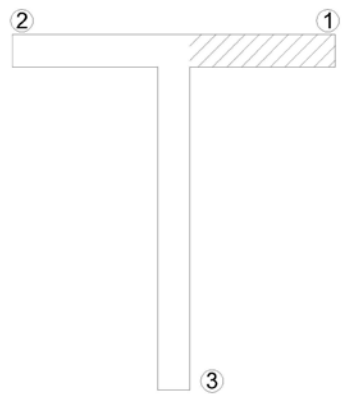
<p><b>ENDING “T” NODE</b></p> <p>Possible breaking mechanisms:</p> <ul style="list-style-type: none"> <li>• Bending failure</li> <li>• Compressive failure of the arch</li> <li>• Local overturning due to the thrust of the arch</li> </ul> <p>Mechanisms that cannot be activated:</p> <ul style="list-style-type: none"> <li>• Separation of the wall perpendicular to the septum</li> </ul>

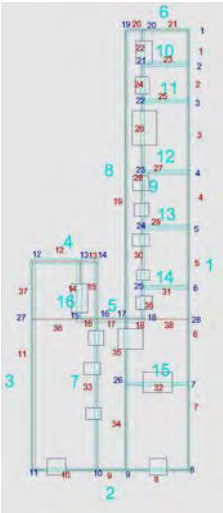
Building US 19B plan	Building characteristics

Walls material (A)	Material conservation (B)	Stories number	Horizontal structures (C)	Plan regularity (D)	
	3	2	1	3	3	
	Building height (cm)	Plan area (m <sup>2</sup> )	Floor warping (F)	Floors regularity (G) (irregular floor)		
	450	100	2	2 0		
	Ring beams number :0					
Restraint on walls parallel to direction: X Y						
Friction coefficient $\mu$ (+)	Tie roads number	Façade length (cm)	Friction coefficient $\mu$ (+)	Tie roads number	Façade length (cm)	
0.05		527	0.15		1890

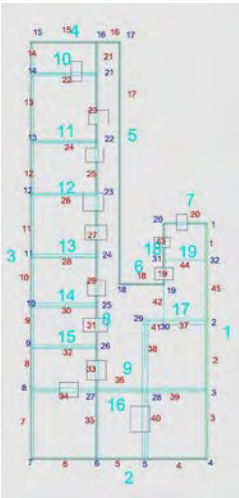
Building US 20 plan	Building characteristics

Walls material (A)	Material conservation (B)	Stories number	Horizontal structures (C)	Plan regularity (D)	
	3	2	2	3	3	
	Building height (cm)	Plan area (m <sup>2</sup> )	Floor warping (F)	Floors regularity (G) (irregular floor)		
	850	306.1	2	2 0		
	Ring beams number :0					
Restraint on walls parallel to direction: X Y						
Friction coefficient $\mu$ (+)	Tie roads number	Façade length (cm)	Friction coefficient $\mu$ (+)	Tie roads number	Façade length (cm)	
0.05		1287	0.15		3598

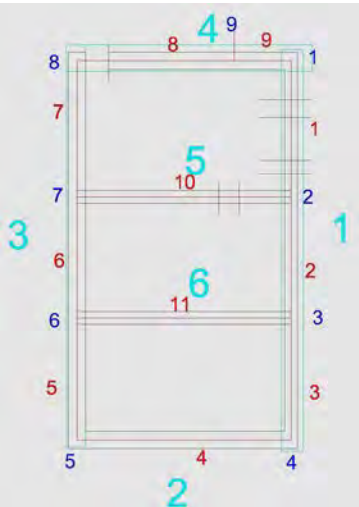
Building US 132C plan	Building characteristics

Walls material (A)	Material conservation (B)	Stories number	Horizontal structures (C)	Plan regularity (D)	
	3	3	4	3	3	
	Building height (cm)	Plan area (m <sup>2</sup> )	Floor warping (F)	Floors regularity <sup>2</sup> (G) (irregular floor)		
	1700	230	3			
	Ring beams number :0					
Restraint on walls parallel to direction: X Y						
Friction coefficient $\mu$ (+)	Tie roads number	Façade length (cm)	Friction coefficient $\mu$ (+)	Tie roads number	Façade length (cm)	
0.15		1294	0.05		1943

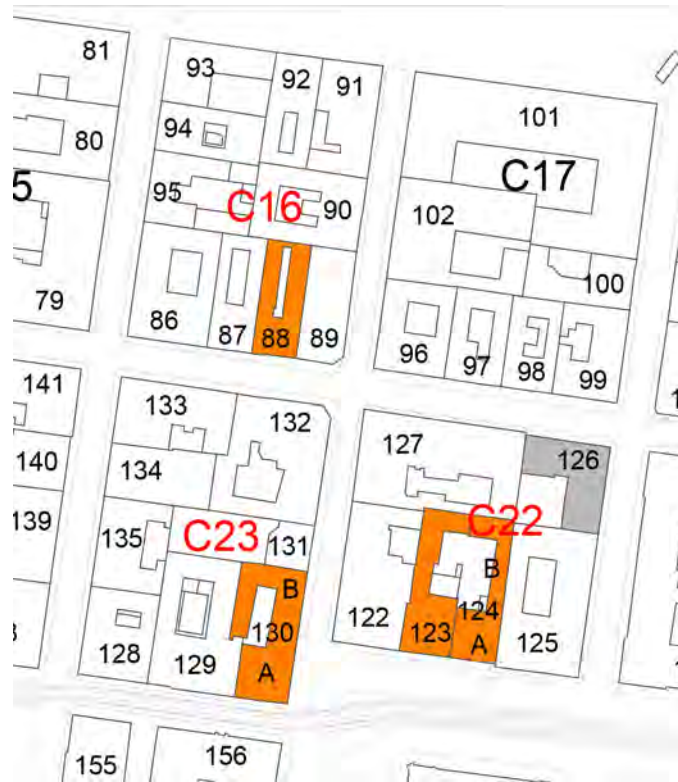
characterized by a wall thickness of 60 cm, US 130 belongs to micro-typology 3C, characterized by a wall thickness of 75 cm, and US 88 belongs to micro-typology 3D, characterized by a wall thickness of 90 cm. All the units have an average typological interstorey high of 4,3 m for the ground floor and 4,2 m for upper floors.

*Fig. 4.3.1: Analyzed structural units*

The following images show the subdivision in walls, septa and nodes of the analyzed structural units. For each unit, the real plan is compared with the survey one and eventual differences can be observed.

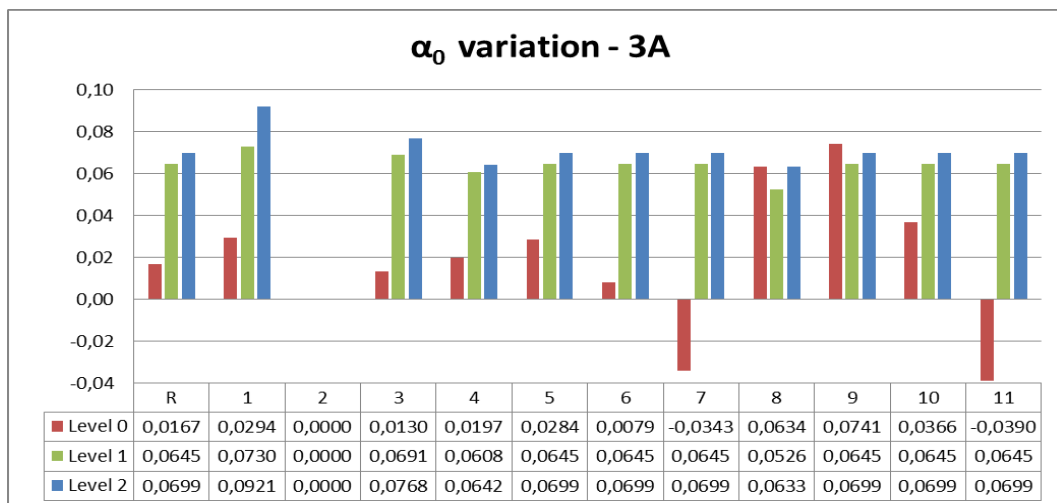
- Reaches the maximum for parameter 1 (constant wall thickness along the entire building height) in case of hinge at level 2 because the increment of the wall thickness in the upper floors improve the stabilizing action of the mechanism.

- Can be negative if the overturning moment is higher than the stabilizing moment when the mechanism is not activated. This condition should bring to the collapse of the analyzed wall without the intervention of the seismic action and, as the building is in fact not collapsed, it is not an acceptable result. This means that possibly there are reinforcing elements that have not be surveyed. Negative values of  $\alpha_0$  appear more often in buildings with one or two stories and with low wall thickness, as can be seen in annex D1. These cases will be analyzed considering the local mechanism of vertical bending in chapter 5.5.

Fig. 5.4.3: Variation of  $\alpha_0$  values – micro-typology 3A

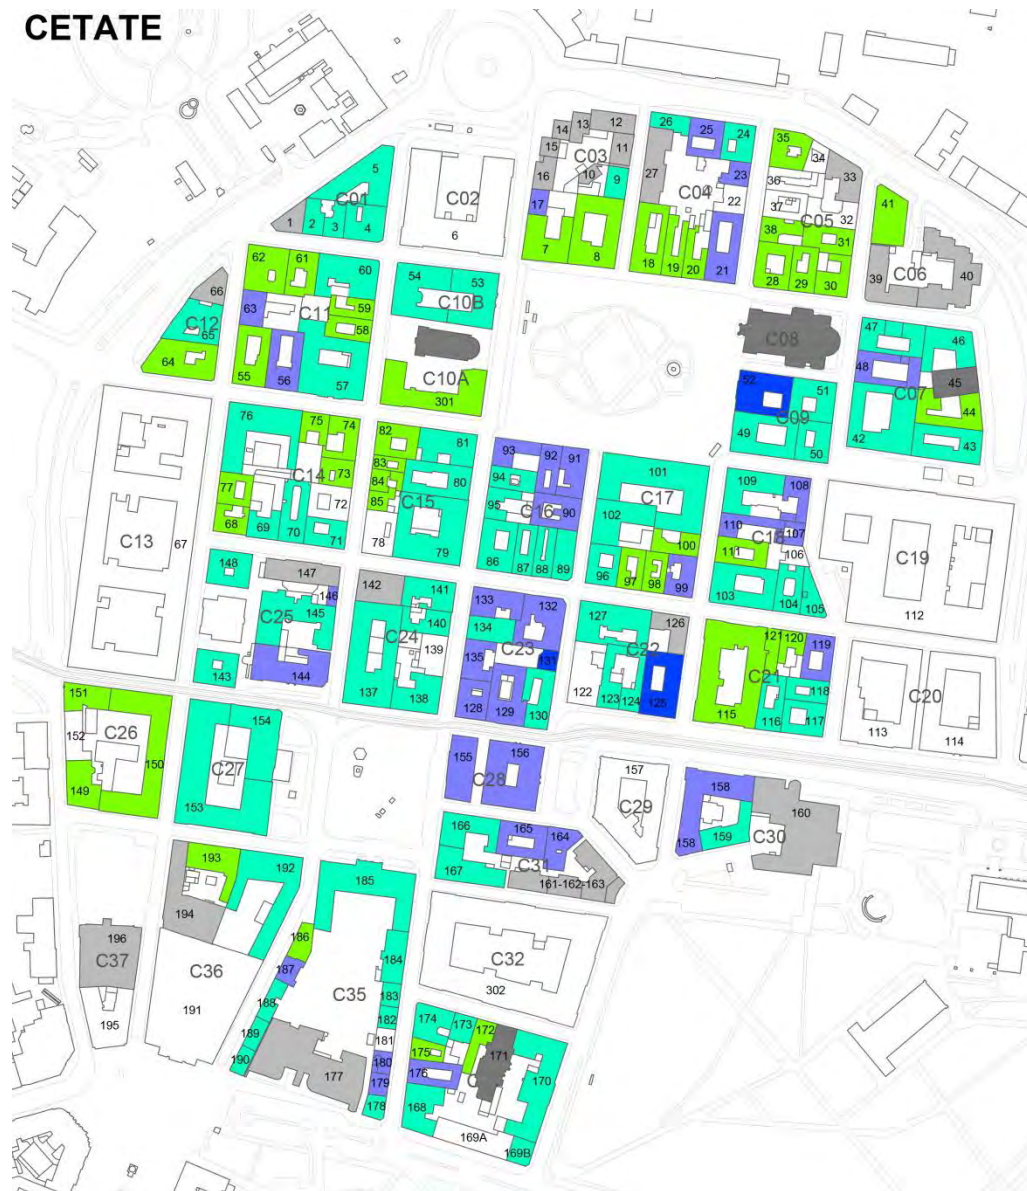
*Fig. 6.6.2: Vulnerability assessment of PL2 - simple overturning mechanism*

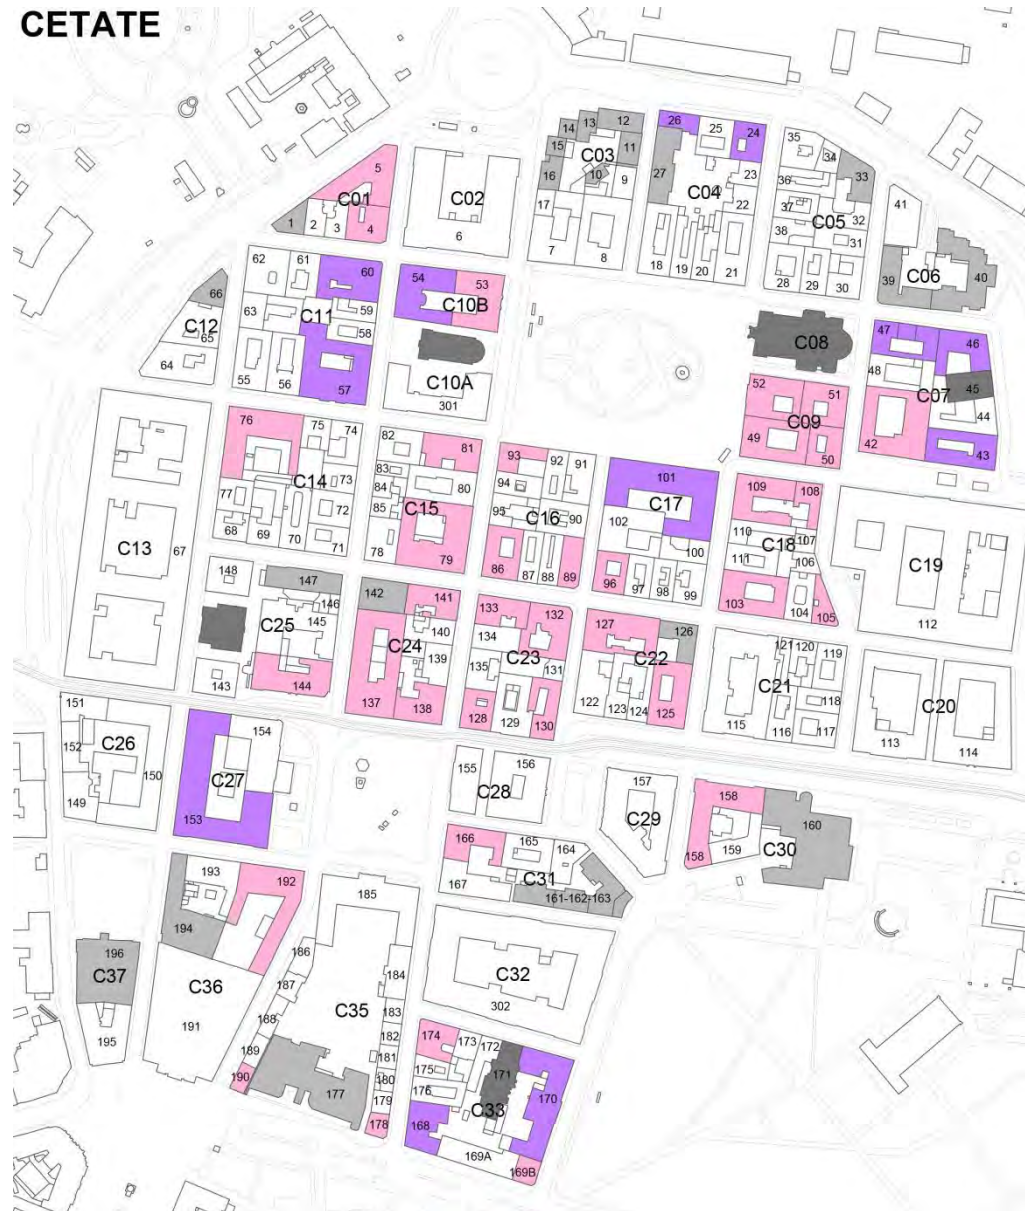
Fig. 6.6.4: Vulnerability assessment of PL1 - in-plane mechanism
