UNIVERSITÀ DEGLI STUDI DI PADOVA  
Dip. Territorio E Sistemi Agro-Forestali

Corso di laurea magistrale in Scienze Forestali e Ambientali

## **Terraced landscapes in Italy: state of the art and future challenges**

Laureanda  
Valeria Contessa  
Matricola n.  
1037829

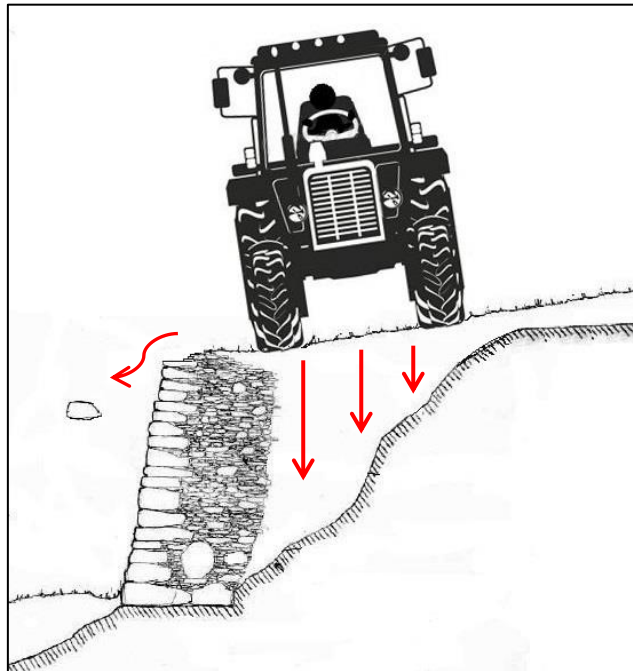
**Figure 1.9.** Degradation caused by a wrong use of machineries

They can be due to the indirect action of man, for example because of an excessive load on the terrace bed with grazing animals or machineries and to their disturbance action (fig. 1.9).

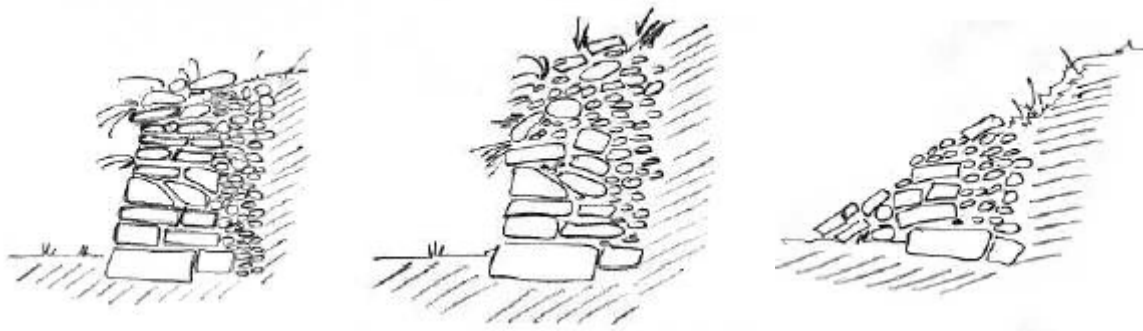
**Figure 1.11.** a) Localized degradation of wall top; b) Widespread degradation; c) Wall portion collapse (figures from Sangiorgi et al., 2006).

The collapse of the wall summit elements can be due to surface water runoff (when the wall head is made up of small sized elements) but it can be helped by an excess of vegetation that grows between the cracks of the wall itself. Collapses can be preceded by a localized or widespread degradation of the top (fig. 1.11 a and b), and for the manager this is the right moment to operate to stop the degradation phenomenon, before a collapse occurs (fig. 1.11 c).

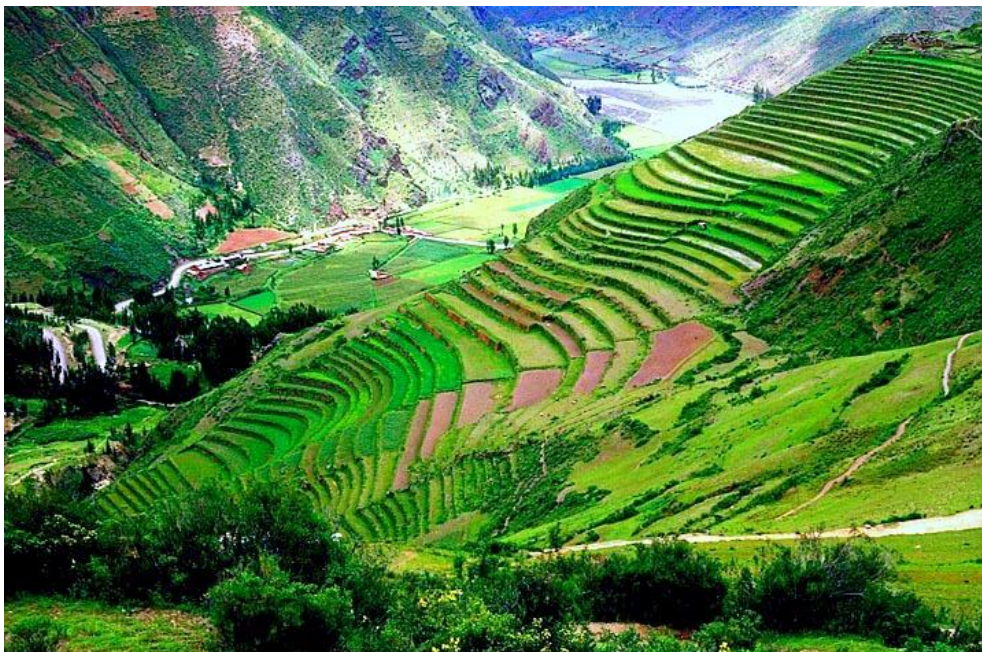
Figure 2.3. *Andenes* in Peru (picture from <http://empresasenperu.blogspot.it>)

In Peru cultivated terraces, called *andenes*, consist of dry stone walls and a filling of arable land (Fig. 2.3). Rocks used for construction are worked in order to fit together perfectly.

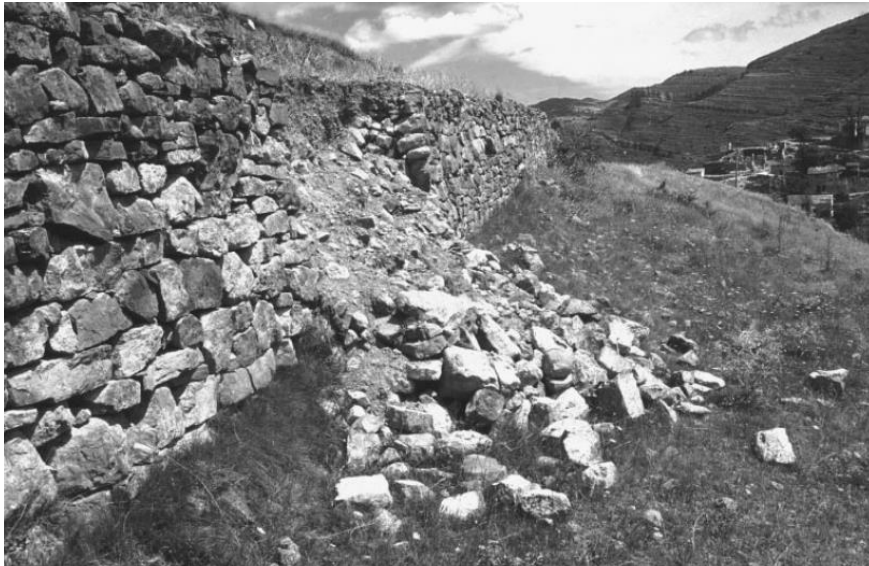
**Figure 2.6.** Collapse of a terrace wall at the foot of a hill near a village, resulting from hydrological pressure higher up (Leza Valley, La Rioja, northern Spain). Fields in this gently sloping area were only abandoned within the last 10 years (picture from Lasanta et al., 2001).

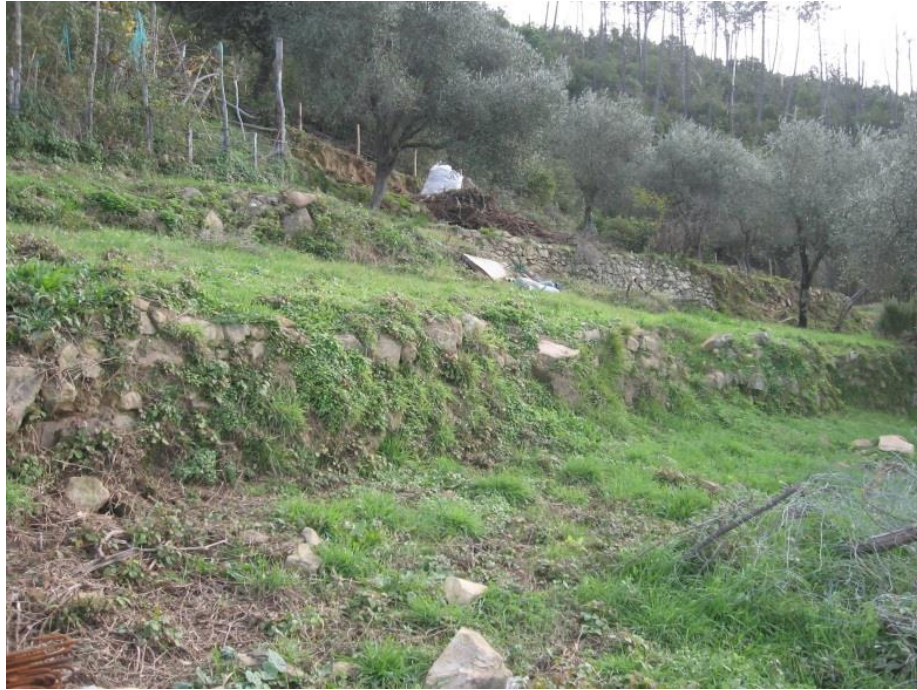
**Figure 3.4.** First terraces near the building. Olive trees are still in good conditions.

At present, the first terraces near the farm building have been cleared and still present olive trees in good conditions (fig. 3.4). Near the house the remains of vines pergolas and a vegetable garden can be found; the rest of the property is partially inaccessible due to vegetation regrowth. Even if the works of terraces cleaning from invasive vegetation are still ongoing, in most of the property no traces of cultivation are any more visible and the walls are seriously damaged (fig. 3.5).

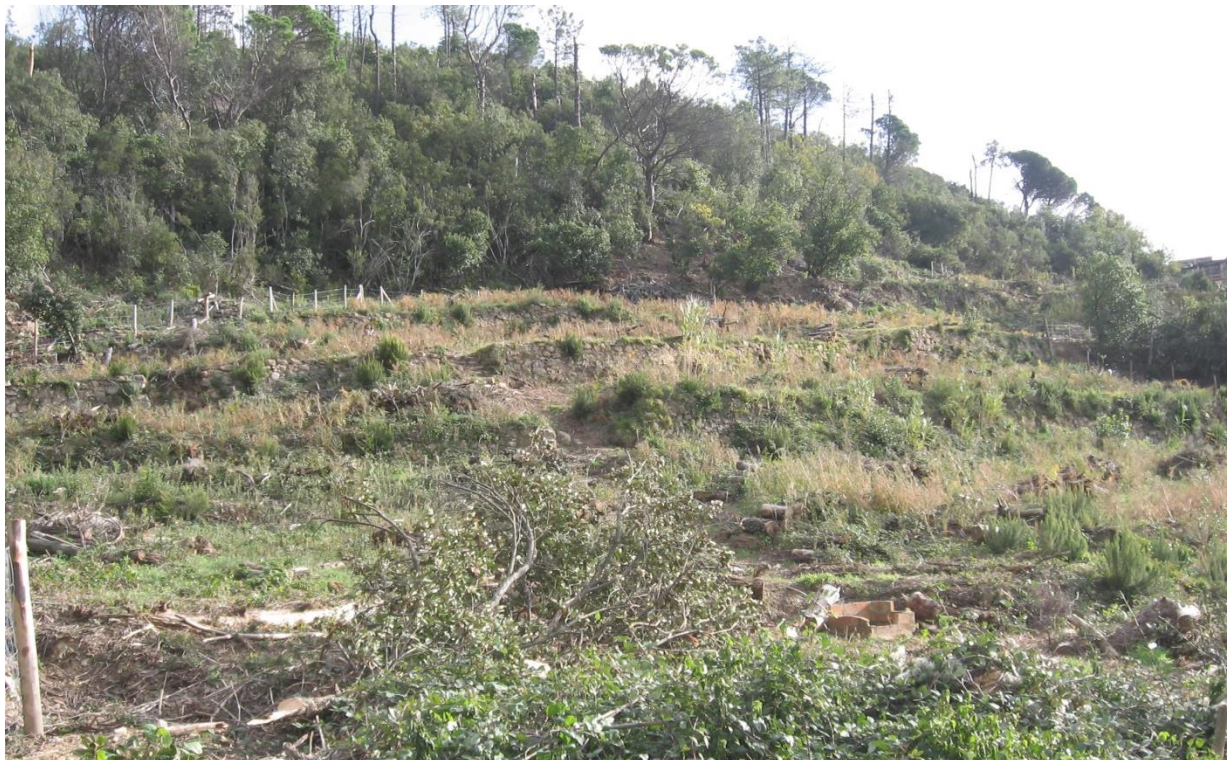
**Figure 3.5.** Another section of the property. Even if terraces have been cleared by the most of the invasive vegetation, most of the walls are seriously damaged and without traces of old cultivations.

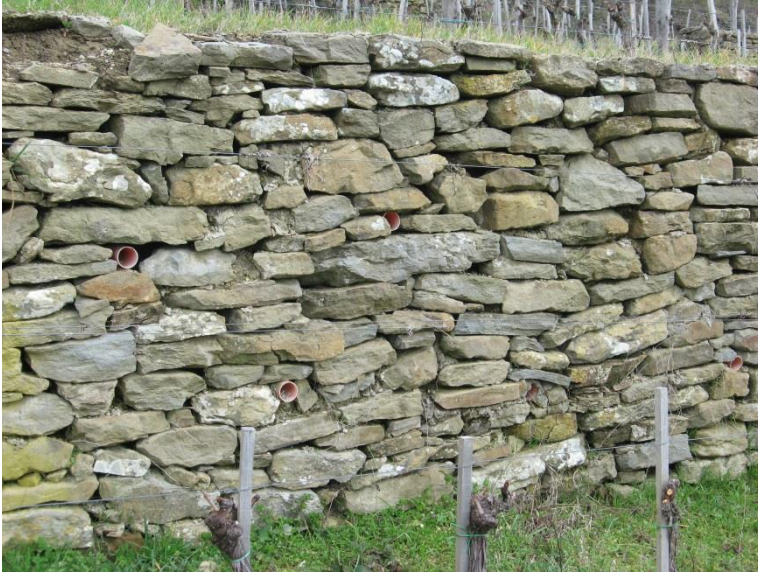
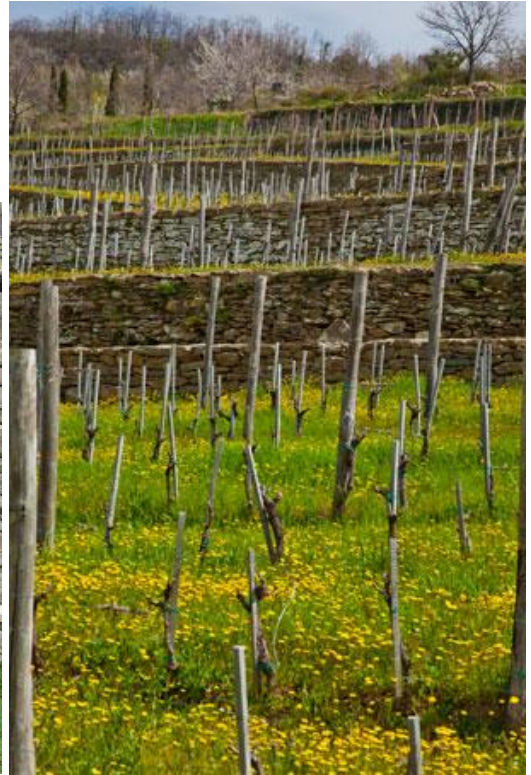
**Figure 18.9.** a) reconstructed terrace wall; b) newly planted vineyards (second picture from <http://www.fattoriadilamole.it/>).

A terraces restoration activity was started in 2002, during which some walls have been rebuilt from scratch (fig. 3.9 a). The system of *acquadocci* has been also restored (fig. 3.10).

This terraces restoration and the subsequent planting of new vineyards (fig. 3.9 b), aimed to a viticulture with a high degree of mechanization, keeping at the same time the landscape typical elements unchanged, which, restored and enhanced, are an integral part of the system.

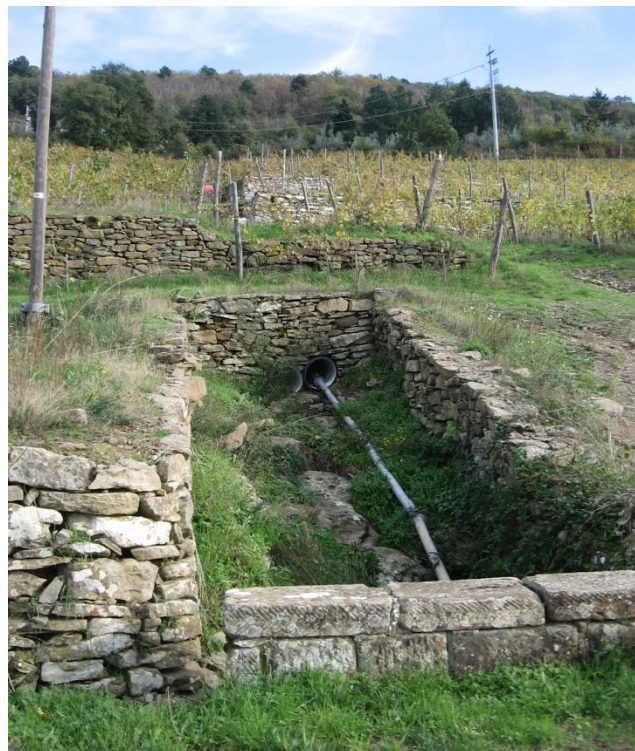
**Figure 3.10.** *Acquidoccio* in Lamole.

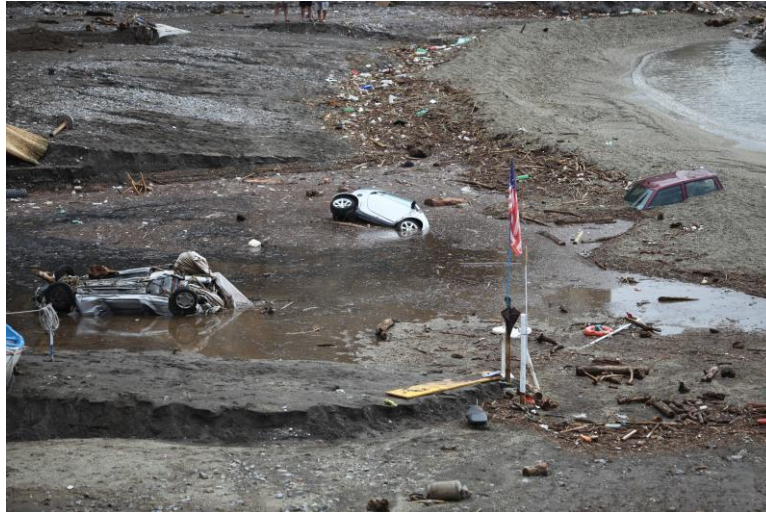
**Figure 3.15.** Part of the alluvial debris fan formed on the beach of Atrani after the flood.

The final result was the formation of an alluvial debris fan with heteromorphous and heterogeneous alluvial material, distributed over an area of about 15,000 m<sup>2</sup> with a protraction of the shore line of about 40 m (fig. 3.15).

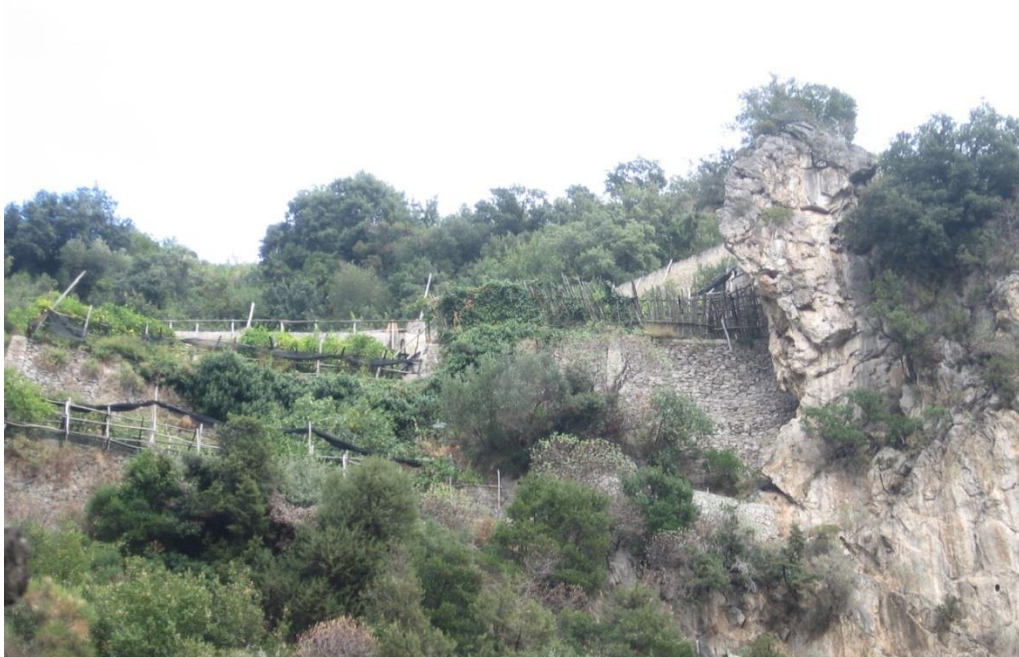
**Figure 20.16.** Spectacular terrace wall almost 10 m high built on a vertical rock cliff in Maiori.

The thickness of walls is on average 40 cm and their height depends on slope gradient, arriving safely at 3-5 meters, with exceptions of spectacular walls that exceed even 7 meters height (fig. 3.16) and are built in incredible places, perched over the sea.

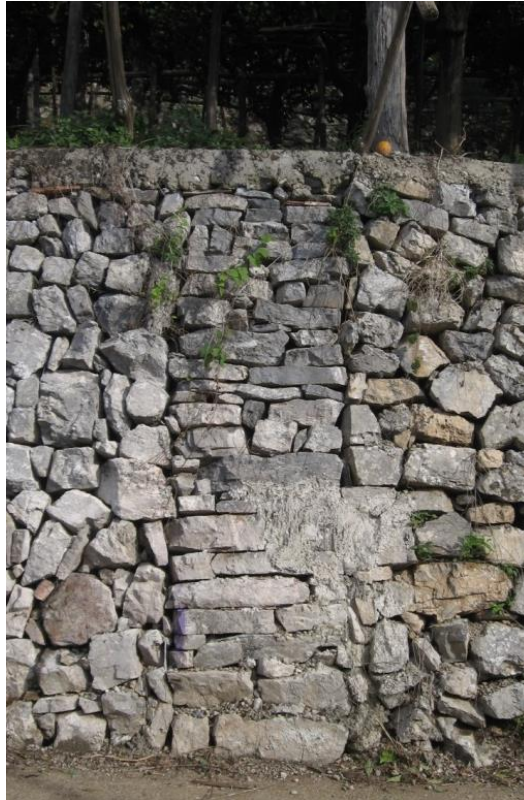
**Figure 3.17.** Flat stones in shape of piers in the middle of terrace walls in Minori.

Noticeable is the technique of placing flat stones in shape of piers in the middle of walls, to increase their stability (fig. 3.17).

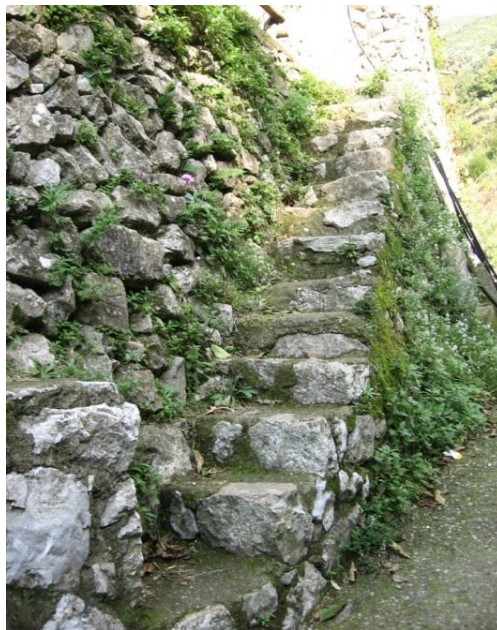
**Figure 21.18.** Connecting stairs in Cetara.

The connection between one terrace and the other is often carried out by stairs excavated directly in the terraces walls (fig. 3.18) or even by bigger stones placed in line inside terraces walls, acting as a stair.

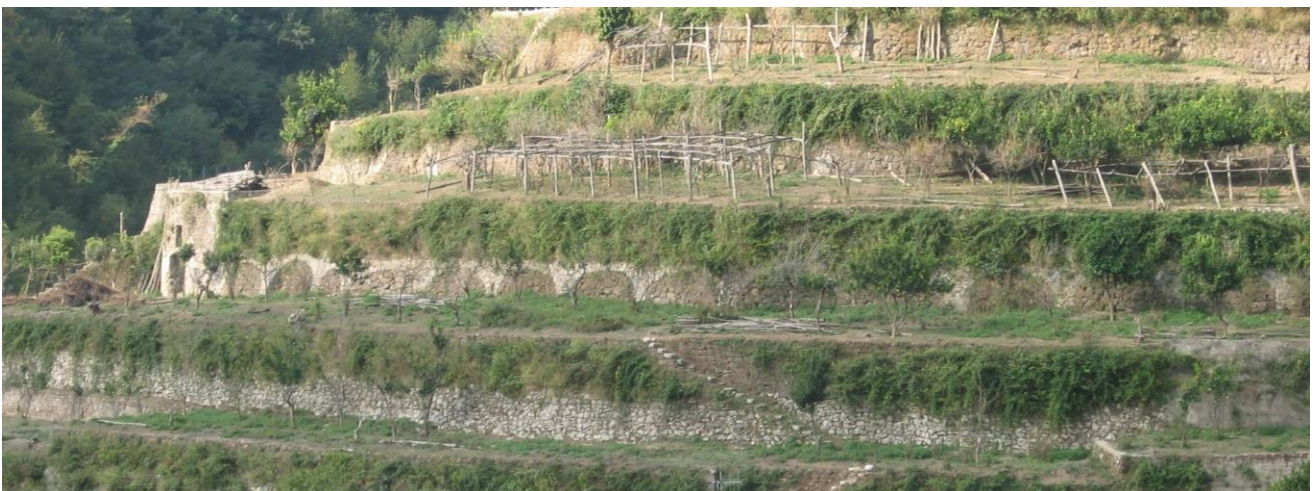
**Figure 3.20.** Terraces with supporting arches in Maiori. The area was abandoned but now is under restoration.

Usually the piers are built 2 meters from each other. Some walls show even arches instead of piers (fig. 3.20 and 3.21 a and b).

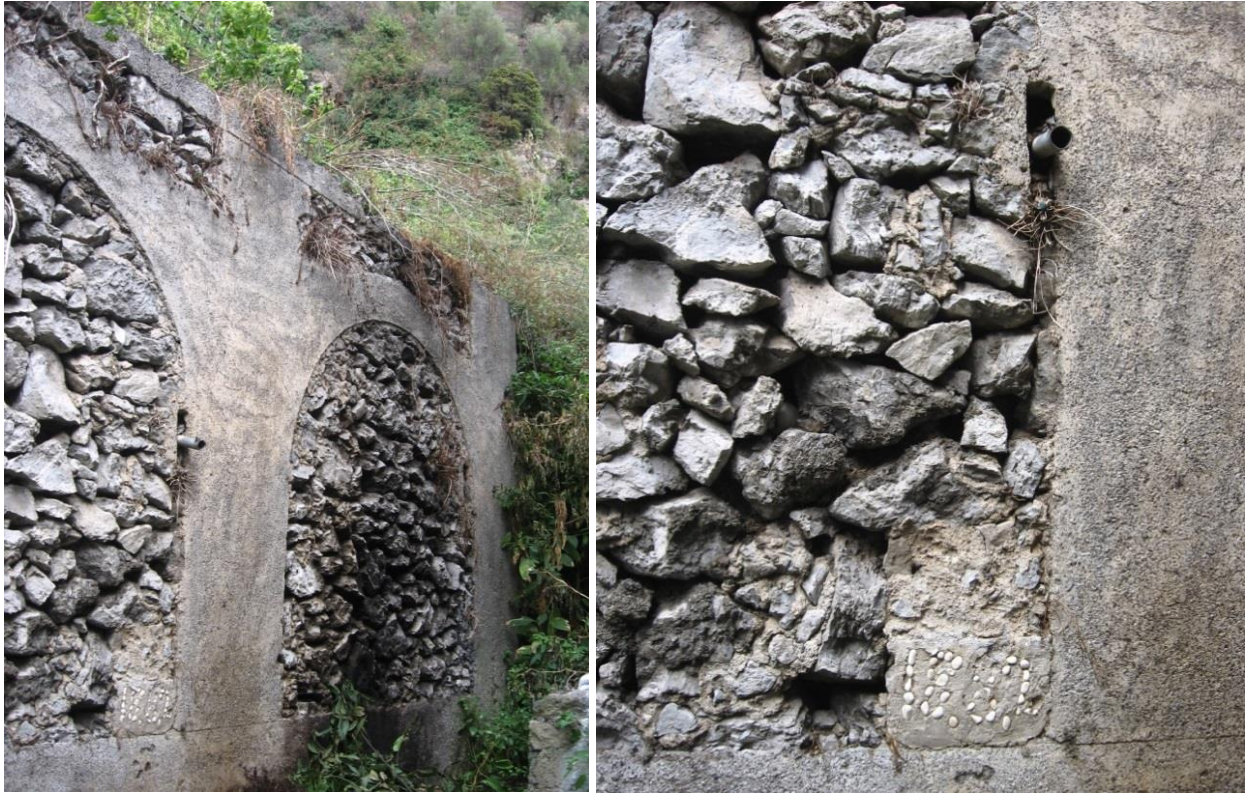
**Figure 3.21.** a) Terrace wall with supporting arches in Maiori; b) at the basis of the wall the year of construction can be read: 1887.

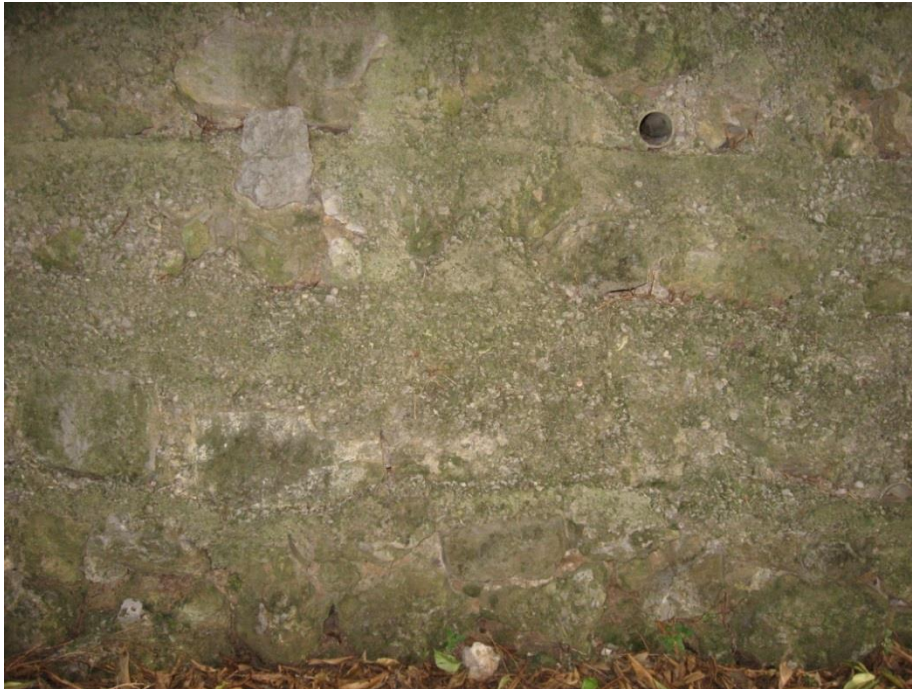
**Figure 3.23.** Terrace wall repaired with concrete in Tramonti.

Some modern walls are held together by concrete, often in places where there has been a failure and a quick and economic restoration was needed (fig. 3.23).

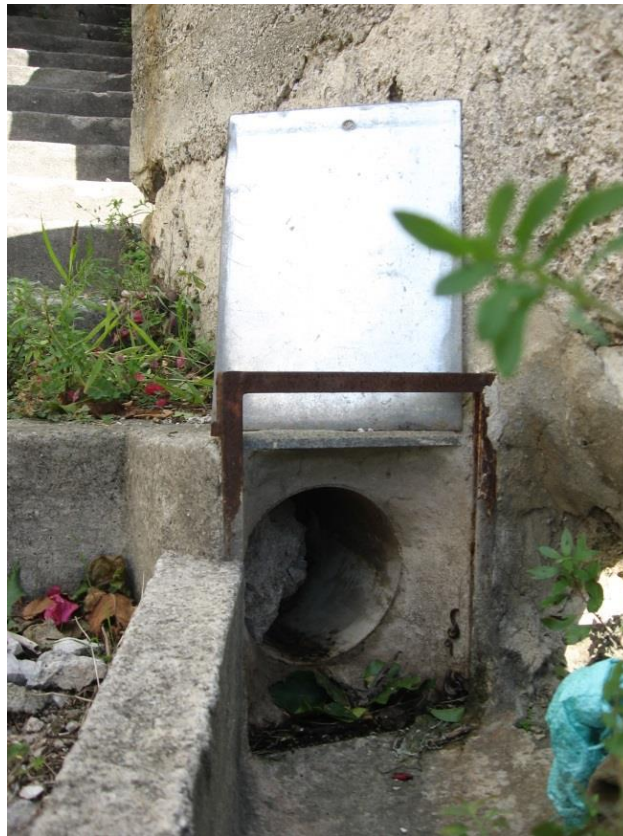
**Figure 3.25.** Disused bulkhead in a channel in Minori.

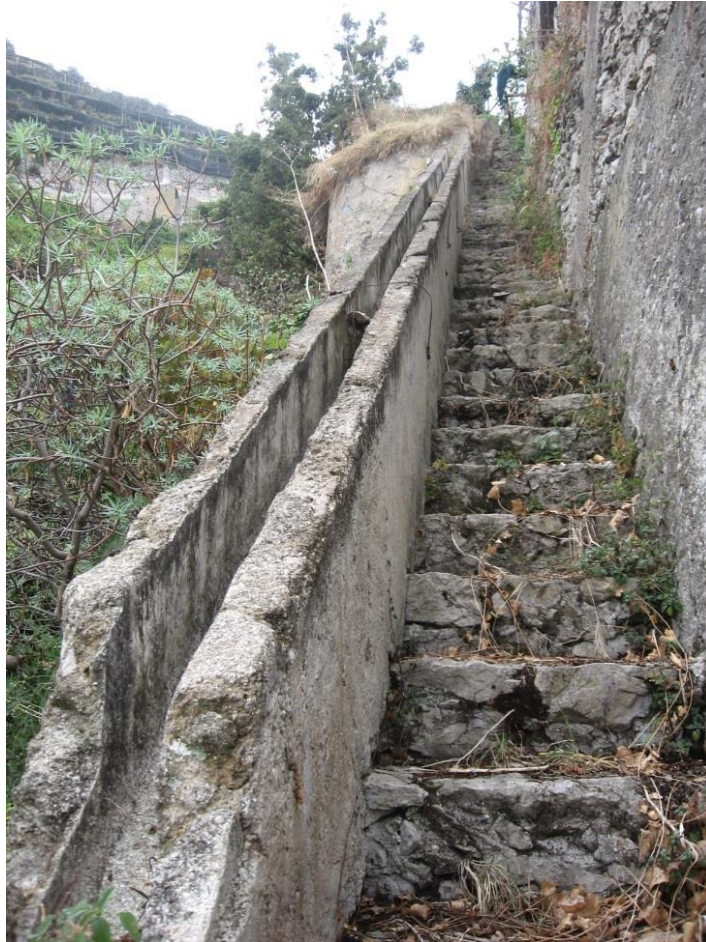
**Figure 3.26.** Water conduit on a handrail at the side of a stairway in Maiori.

The water was usually introduced into each artificial channel through bulkheads that regulated the flow (fig. 3.25). Water was then brought to the plots through pipelines in mortar or tuff. These pipelines were leaning against terraces walls, and almost always flanked by stairs and narrow streets; often the same stairs were used for water redistribution, thus contributing to slow down its flow velocity on the slope. Small conduits realized on handrails at the side of the stairs can be found too (fig. 3.26).

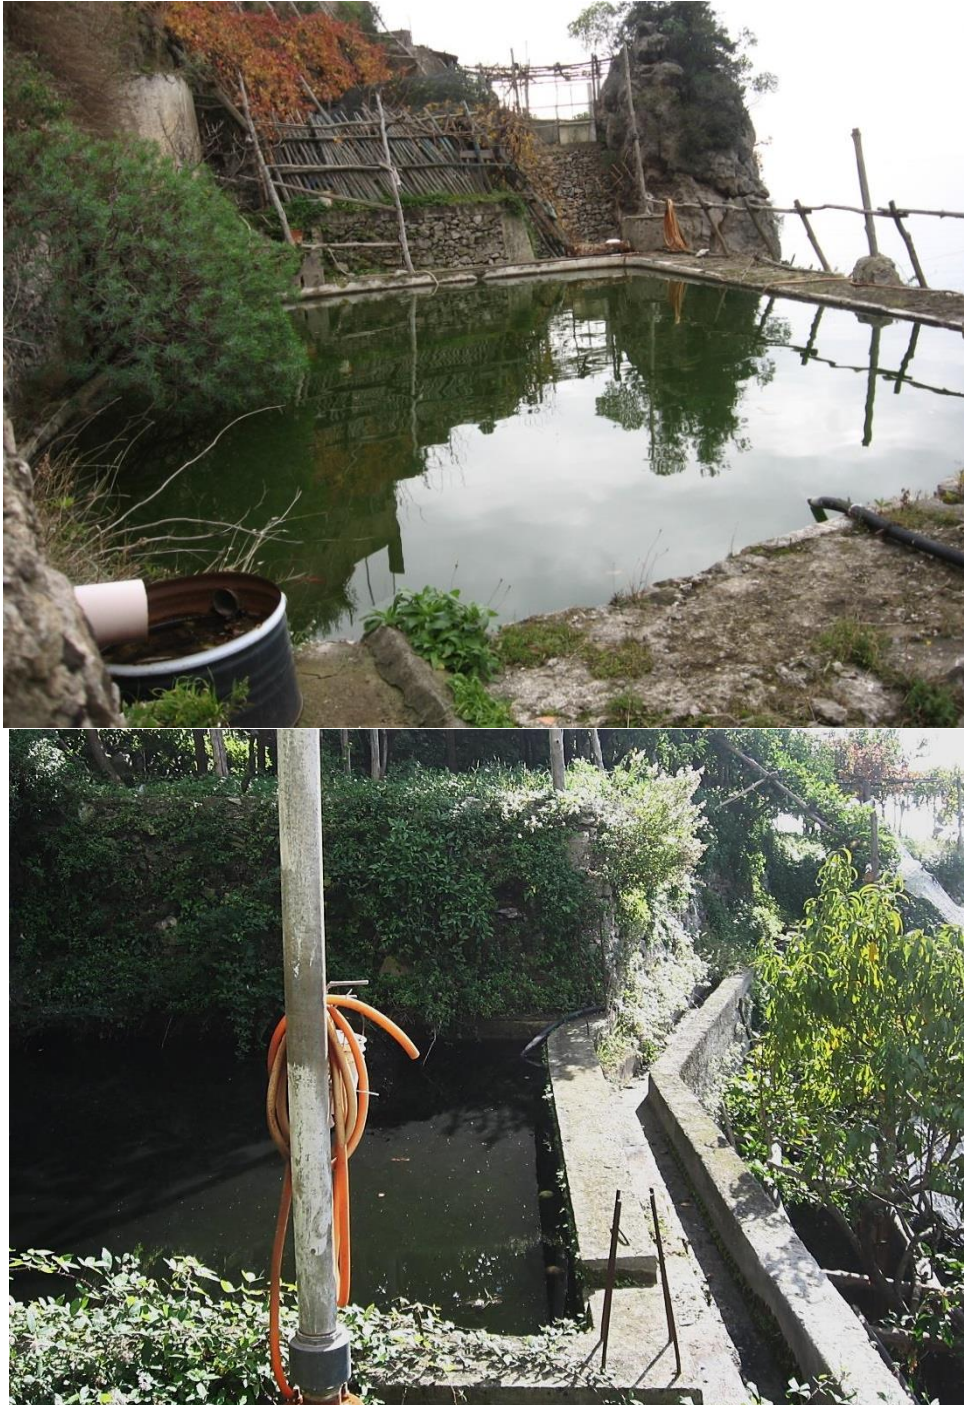
**Figure 3.27.** a) pool for water collection for irrigation in Maiori; b) water pool and Minori, it can be noted the mortar channel for redistribution of water in excess on the terraces.

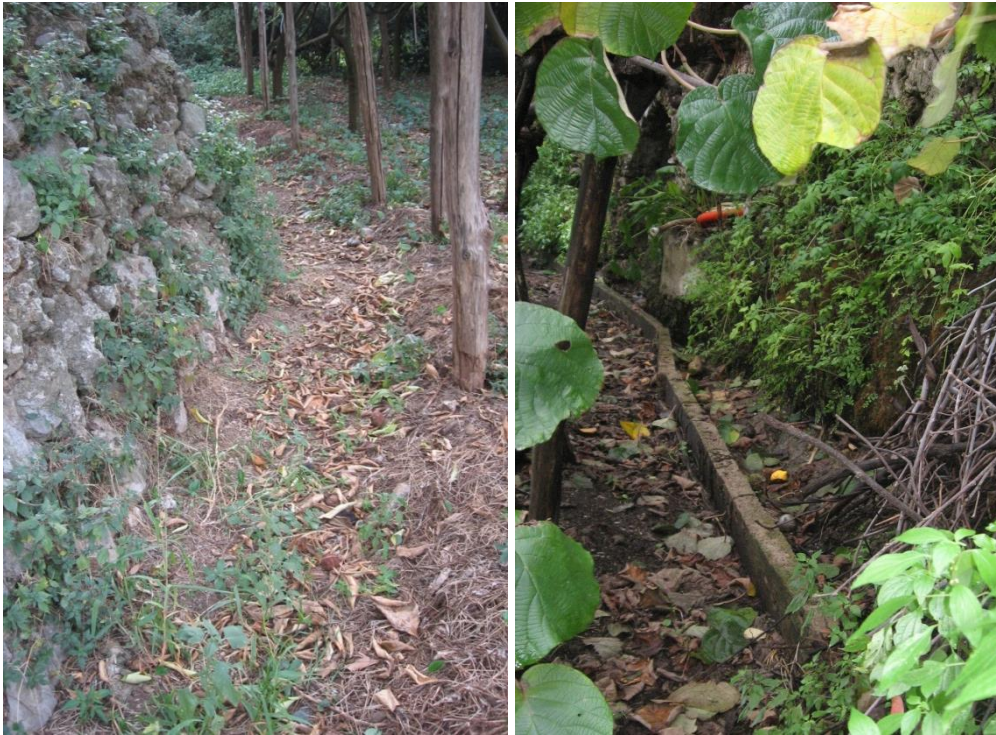
**Figure 3.28.** a) *lavinari* at the bottom of a terrace in Tramonti; b) *lavinari* with wooden supports at the bottom of a terrace in Maiori.

Drainage water in excess filtrating from terraces walls is collected and channeled through small channels built at the bottom of every terrace, called *lavinari*, usually just furrows in the ground, other times built in stone, turf, mortar or even with wooden supports (fig. 3.28 a and b). These channels lead to the same network used to collect rainfall, so the water in excess was either collected in stone pools, either directed to natural streams or to artificial channels flowing directly into the sea.

The *lavinari* had also an irrigation function. During the farmer's weekly water availability time frame, one terrace after the other was irrigated with water from pools or artificial channels by

means of *lavinari*, watering one tree after the other by deviating the water flow and creating small pools around every tree, until all the water was absorbed. Nowadays this system has been mostly substituted by plastic tubes for irrigation.

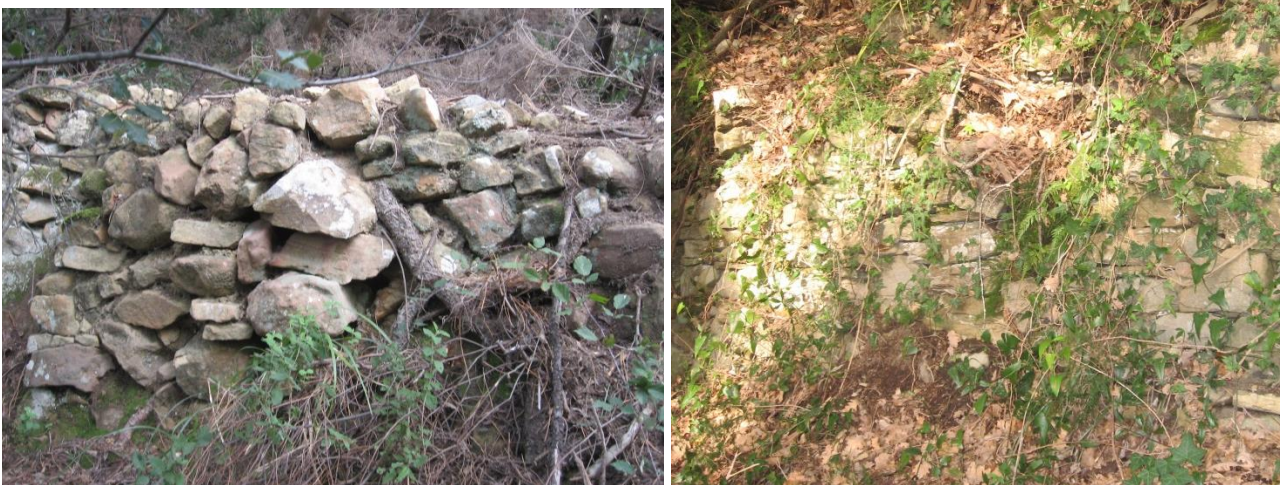
**Figure 4.1.** Bulging and partial degradation in terrace walls in *Case Lovara*.

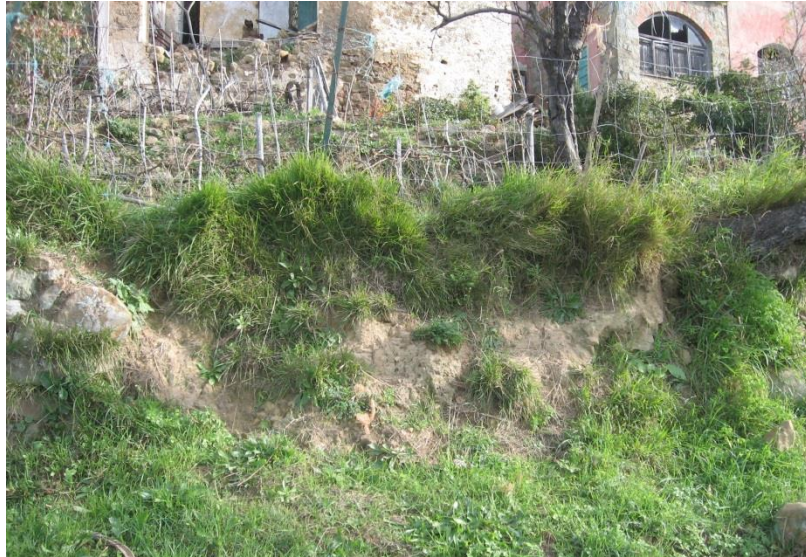
**Figure 4.2.** Collapsed section of a terrace wall.

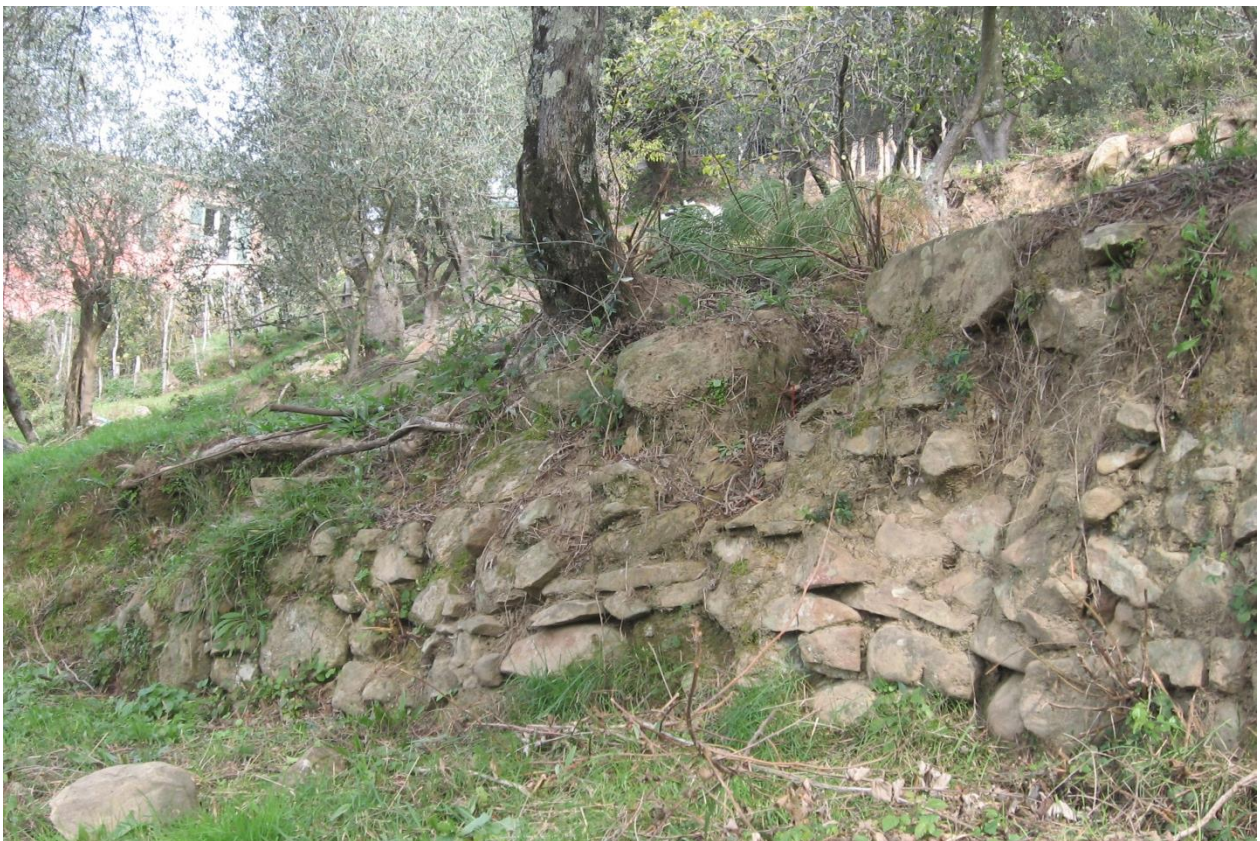
**Figure 4.3.** Partial terrace wall failure.

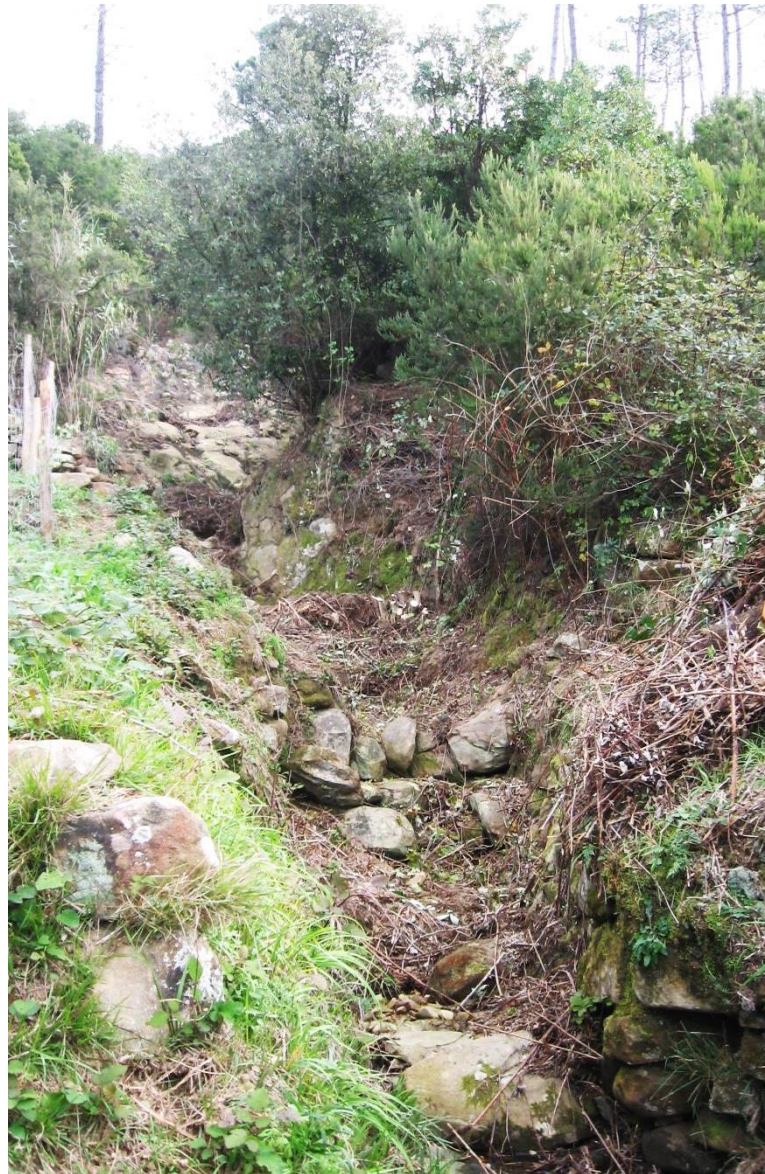
**Figure 4.4.** Drainage collection channel, abandoned and obstructed by invasive vegetation (now partially removed) and debris.

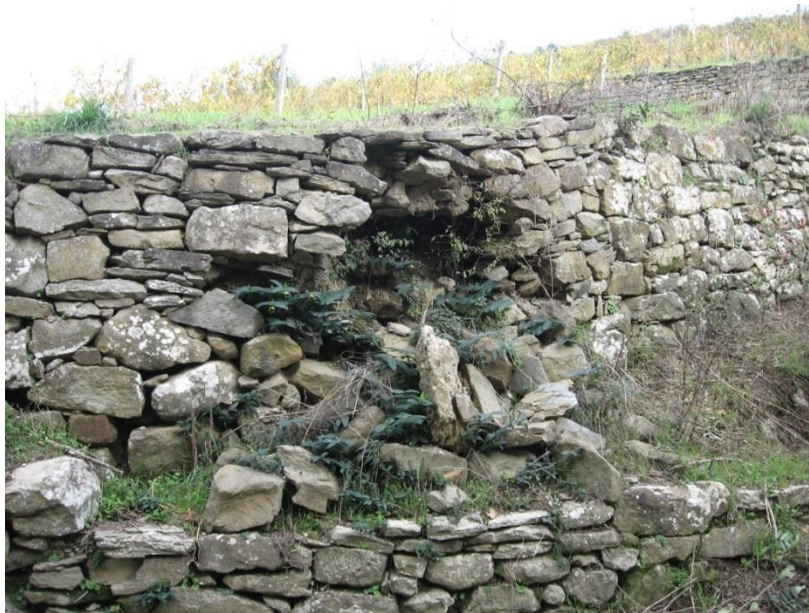
**Figure 4.5.** Collapse in an old manufacture wall.

Wall portions already affected by collapses can be detected in the old manufacture walls (fig. 4.5).

Obvious phenomena of bulging can be detected as well, both on the old walls both on those of more recent construction, more or less localized over the entire height of the walls. These bulging phenomena imply the existence of an area that may evolve, with time, to the collapse of the whole terrace belt.

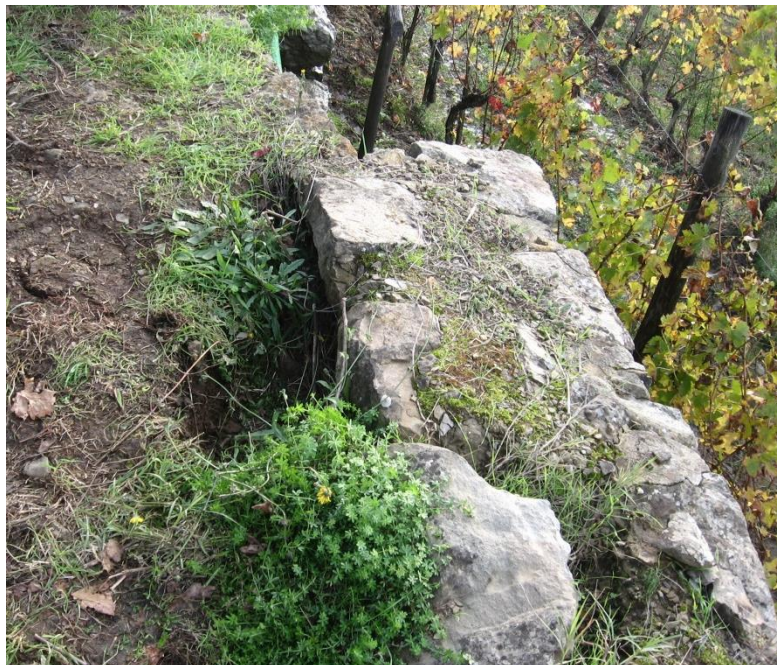
**Figure 4.7.** A new wall seen from the top. It can be noted that because of the bulging the wall has slightly shifted onwards.

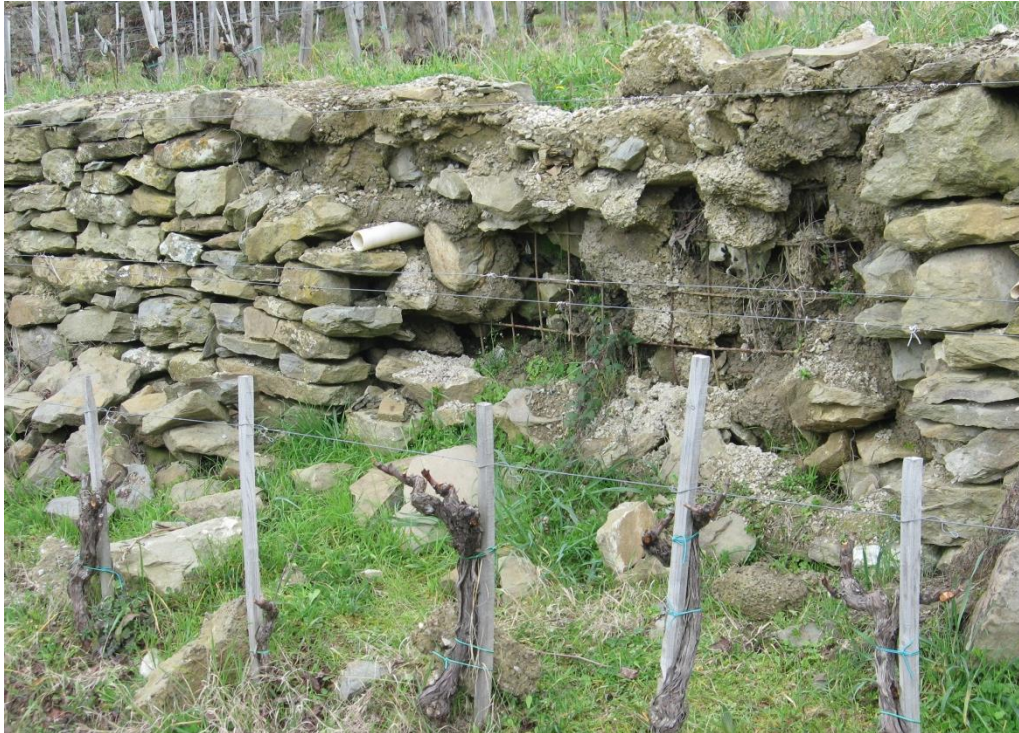
**Figure 4.8.** A new manufacture wall, already fallen. Drainage plastic pipes can be seen (picture by S. Calligaro).

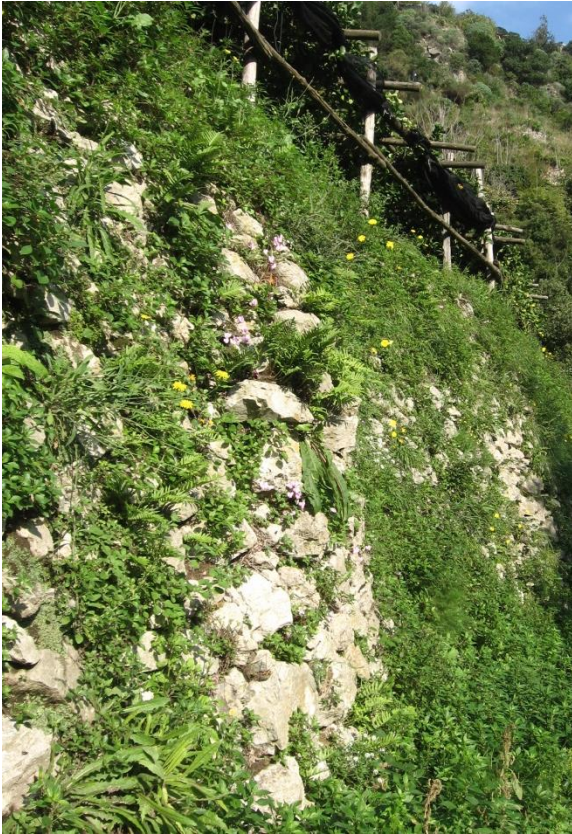
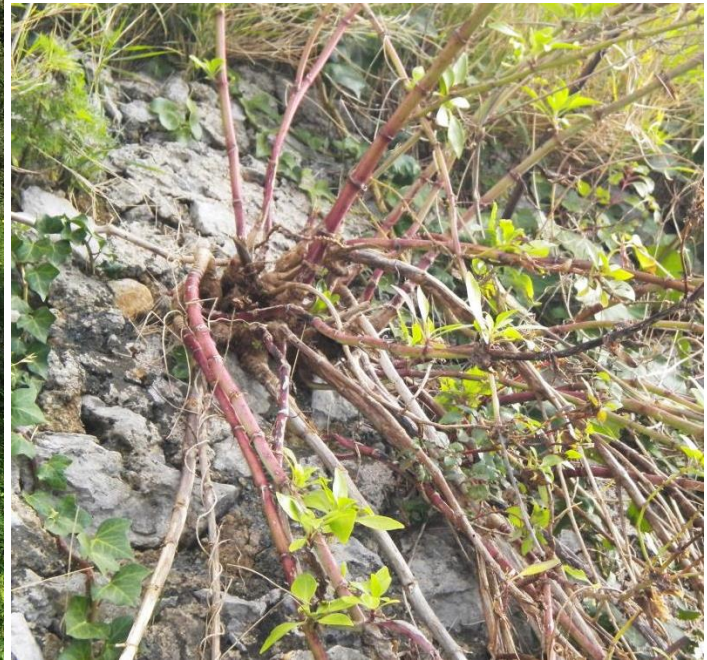
**Figure 4.9.** a) bulging in the wall middle part in Cetara; b) wall top degradation due to arboreal invasive vegetation growth.

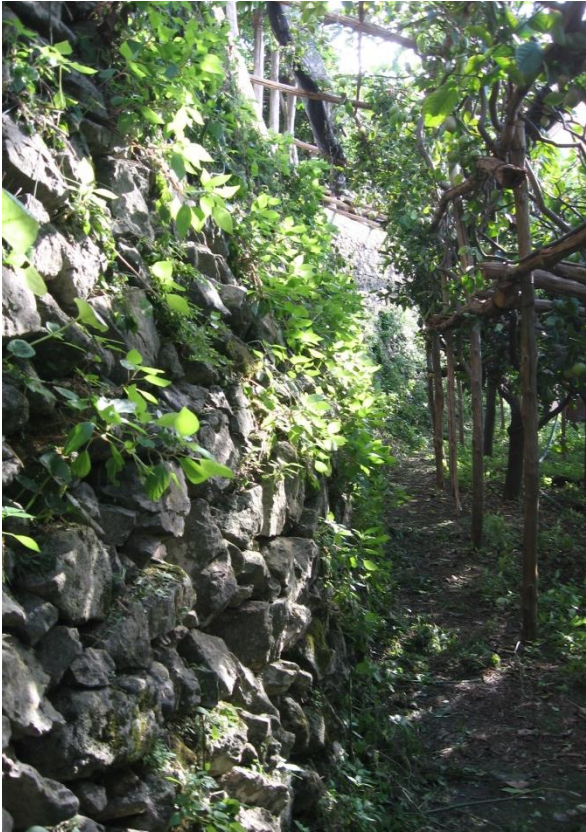
**Figure 4.10.** Bulging in the wall middle part in a cultivated terrace in Minori.

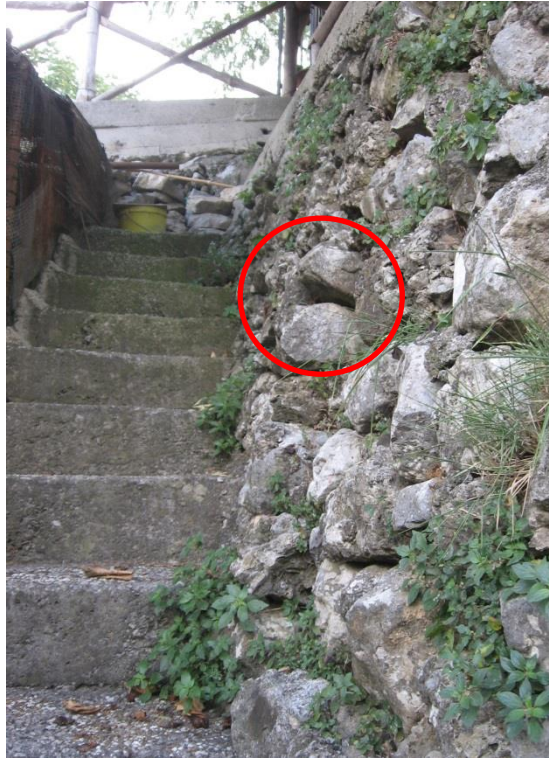
**Figure 4.11.** Bulging in the wall middle part in Tramonti.

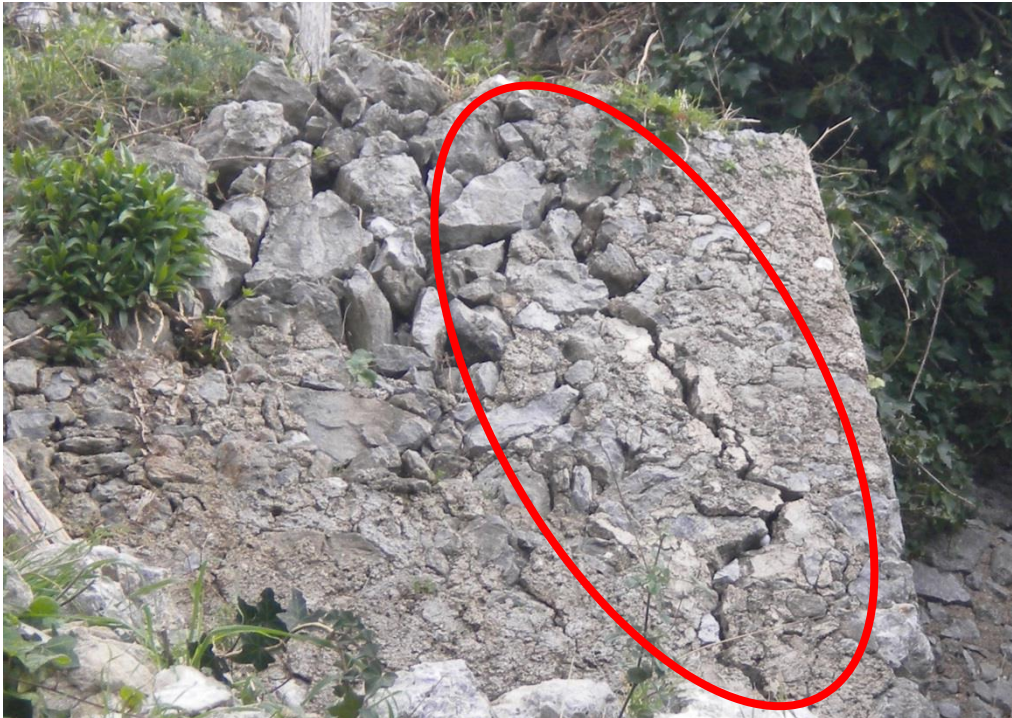
**Figure 4.1222.** Crack in a wall pillar in Maiori.

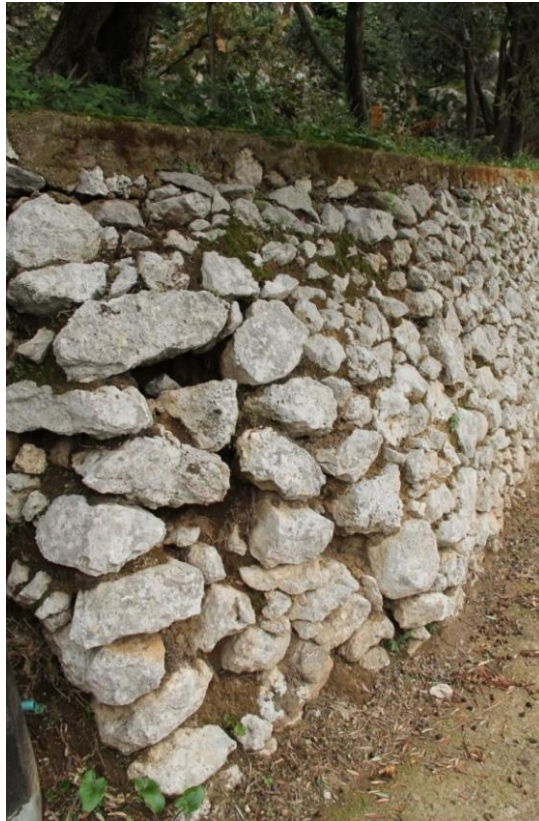
**Figure 233.** Gaps in the wall in Ravello.

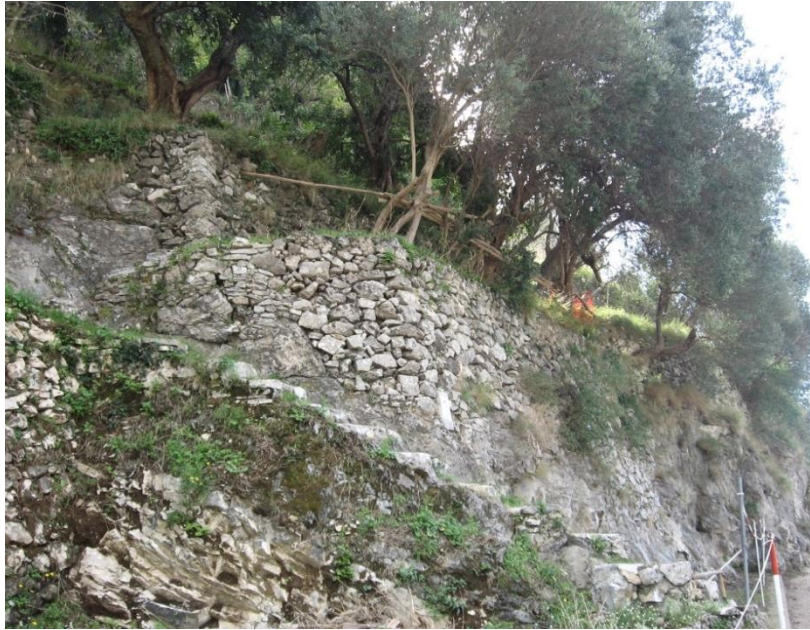
**Figure 4.14.** Terraces cultivated with olive groves in Minori. Terrace walls show a poor building technique respect to walls supporting citrus groves.
