UNIVERSITÀ DEGLI STUDI DI PADOVA  
Dip. Territorio E Sistemi Agro-Forestali

Corso di laurea magistrale in Scienze Forestali e Ambientali

## **Terraced landscapes in Italy: state of the art and future challenges**

Laureanda  
Valeria Contessa  
Matricola n.  
1037829

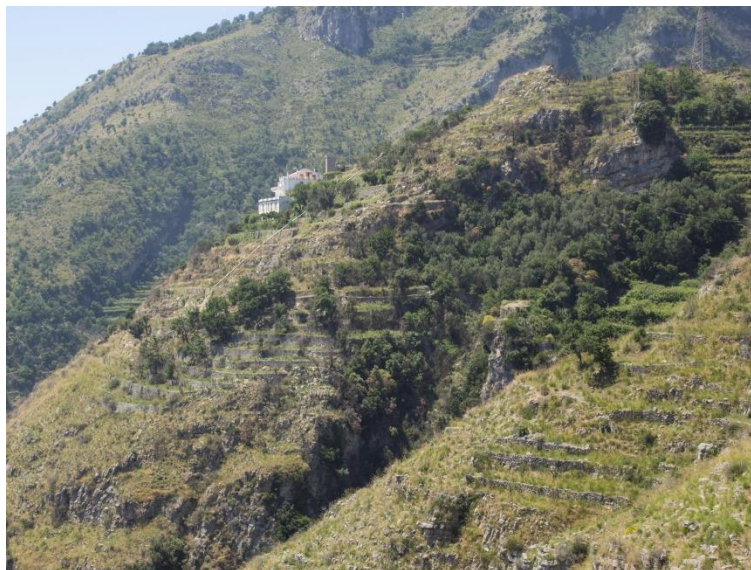
**Figure 4.15.** Abandoned terraces in Furore.

Degradation problems because of abandonment are more visible in mountain areas (fig. 4.15), where terraces are cultivated with less profitable crops, like olive trees.

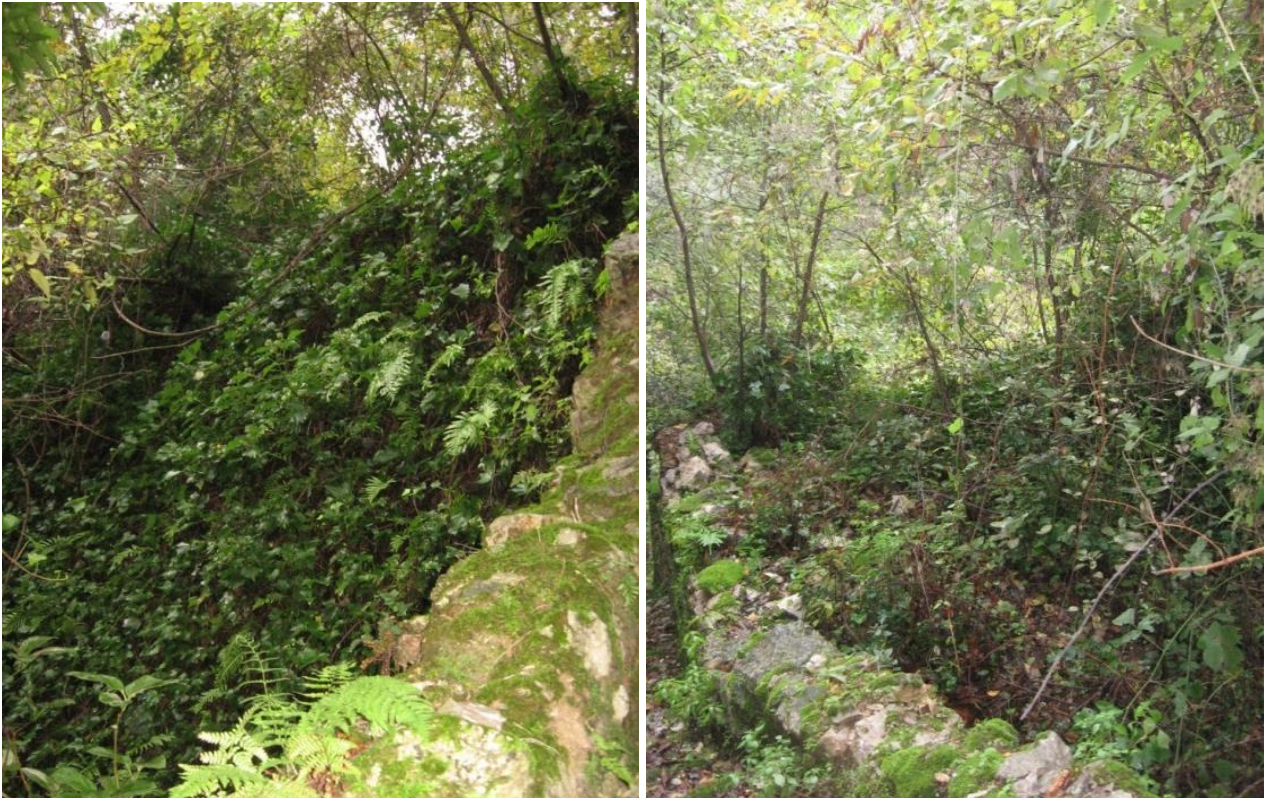
**Figure 4.16.** Abandoned terraces in Maiori municipality.

But even if abandoned, dry-stone walls seem to resist very well under the coverage of invasive vegetation, which usually grows with incredible speed and colonizes in one month an abandoned terrace (fig. 4.16).

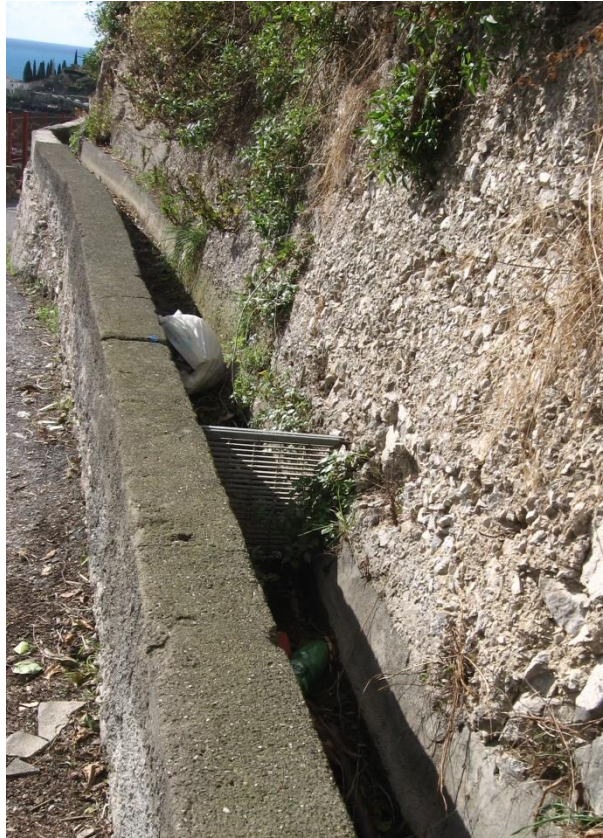
**Figure 4.17.** Stone channel full of garbage in Minori.

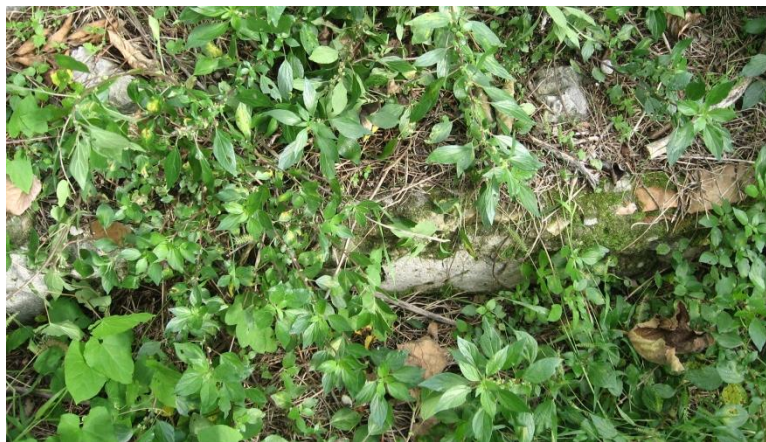
**Figure 4.18.** Pipeline in mortar full of vegetal debris and invasive vegetation in Maiori.

Therefore all the systems of stone channels, bulkheads, mortar pipelines and ditches, that twist and turn from the springs to the village centers downstream, is often neglected and these artificial channels are full of debris or garbage (fig. 4.17 and 4.18).

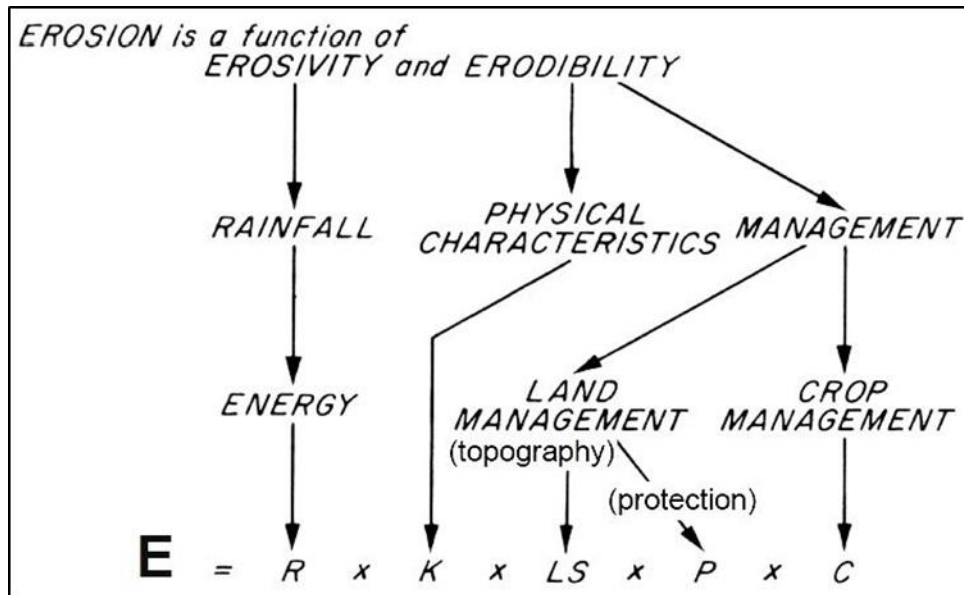
Figure 5.2. The Universal Soil Loss Equation.

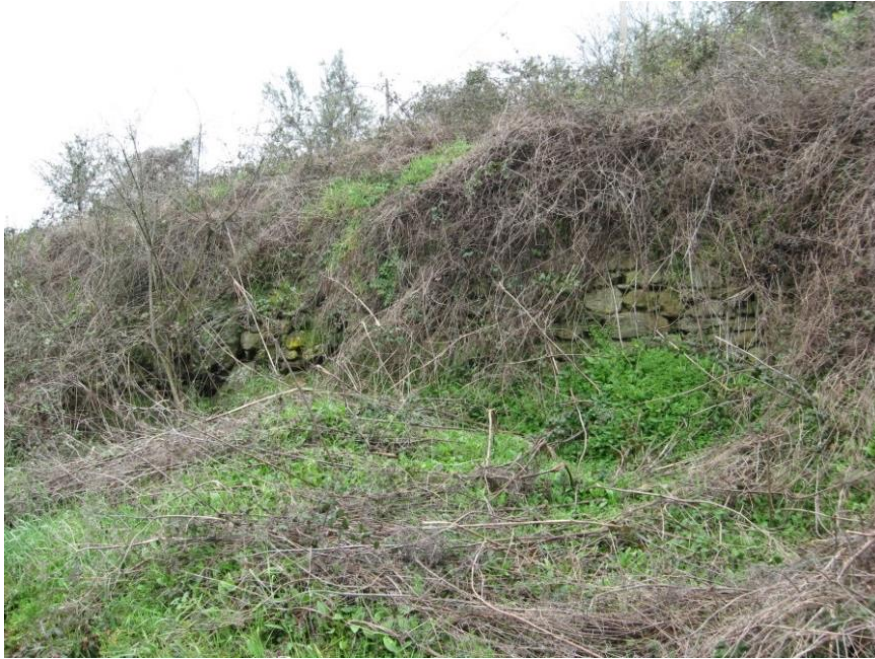
**Figure 5.3.** Abandoned terraces before restoration in Lamole, Chianti area (picture by S. Calligaro).

In Fig. 5.3 abandoned terraces before restoration and in Fig. 5.4 the actions of vegetation removal during terraces restoration works in Lamole, Chianti are shown.

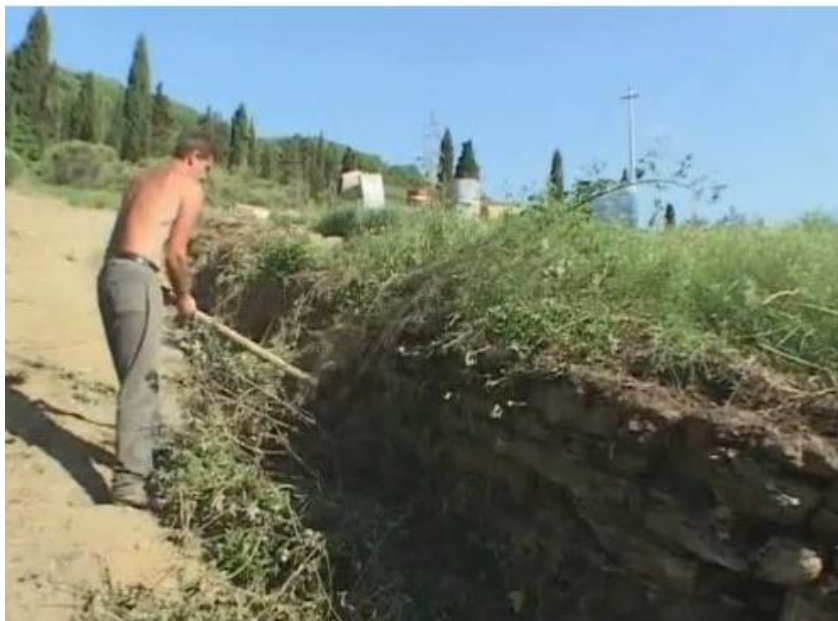
**Figure 5.4.** Invasive vegetation removal in Lamole (picture from <http://www.fattoriadilamole.it/>)

The removal of invasive vegetation is the first step of an abandoned terraced site restoration, in order to be able to carry on with the works.

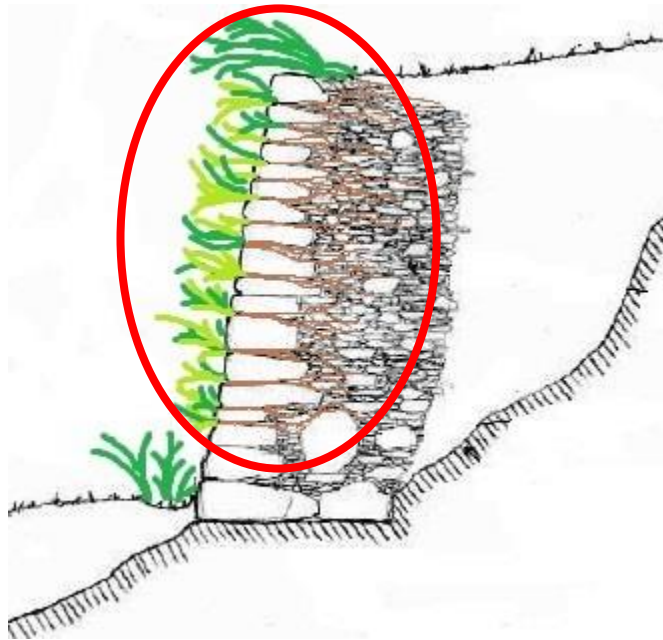
**Figure 5.5.** Invasive vegetation on a dry stone wall.

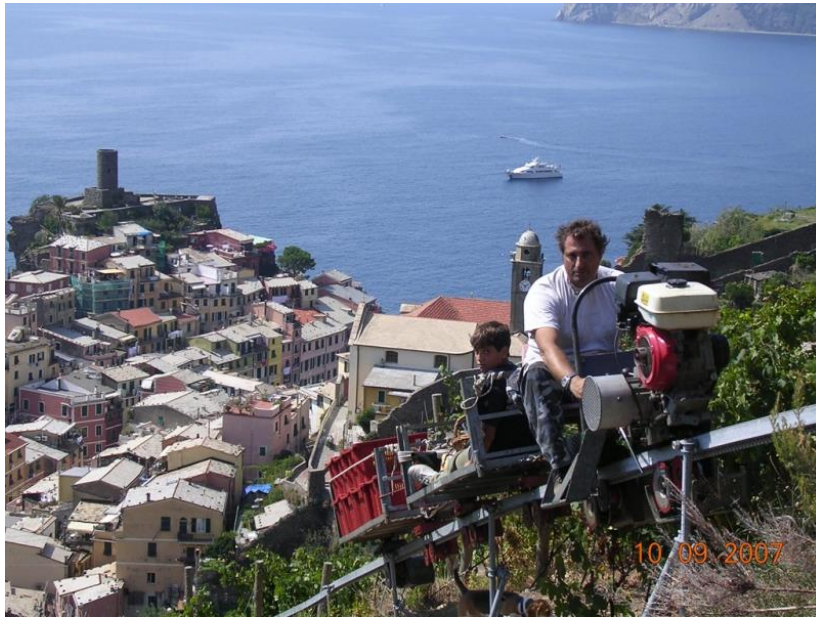
**Figure 5.6.** Farmers on a monorail in Vernazza, Cinque Terre (picture from <http://www.bistromare.it>).

However, monorails are present in some areas of Cinque Terre (fig. 5.6) and Amalfi Coast, usually utilized during fruits harvesting.

Their use should be encouraged for restoration works as well, and construction of new monorails is also an action to implement in those marginal areas.

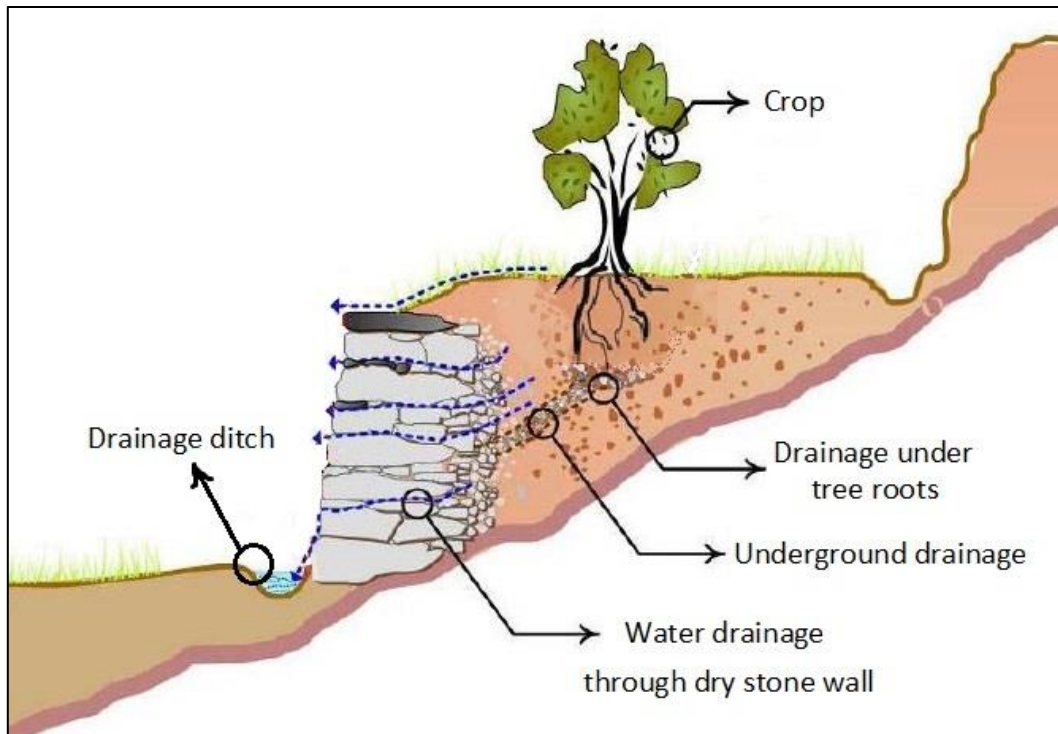
**Figure 5.7.** Drainage ways in a terrace.

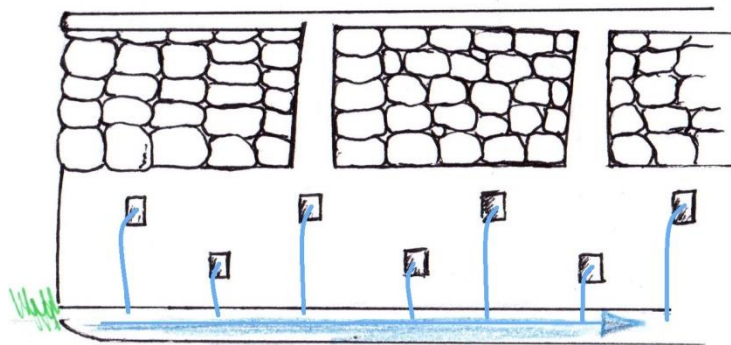
**Figure 5.824.** Drainage holes in a dry stone wall built with mortar.

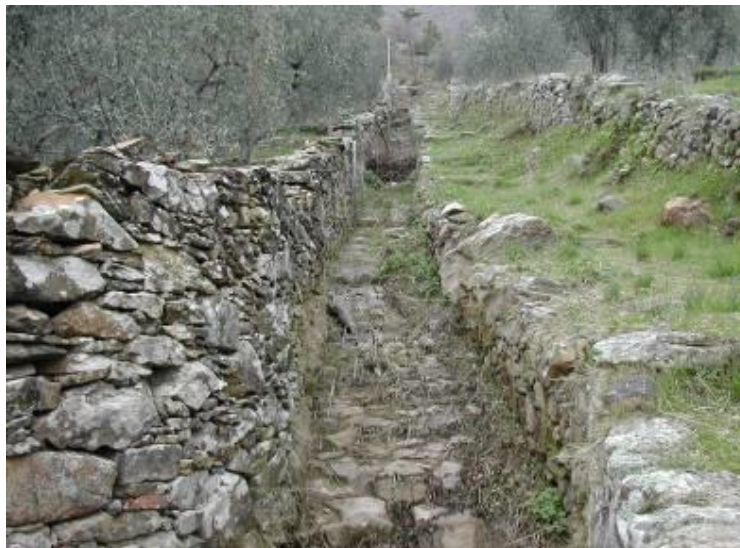
**Figure 5.10.** Channel for surface water drainage in Tuscany (picture from Rizzo et al., 2009).

New channels for surface water drainage can be built on the edge of the paths, along one or two sides (fig. 5.10), or transversely to them, especially in stepped or sloped paths. They can be self-sufficient or variously connected to walls and path delimitation works.

The connections between the stones forming these channels can be done “dry” or with mortar.

The dimensions of lateral ditches vary in relation to the quantity of water which is expected to be drained, to the slope and the length of the tract that the water has to travel.

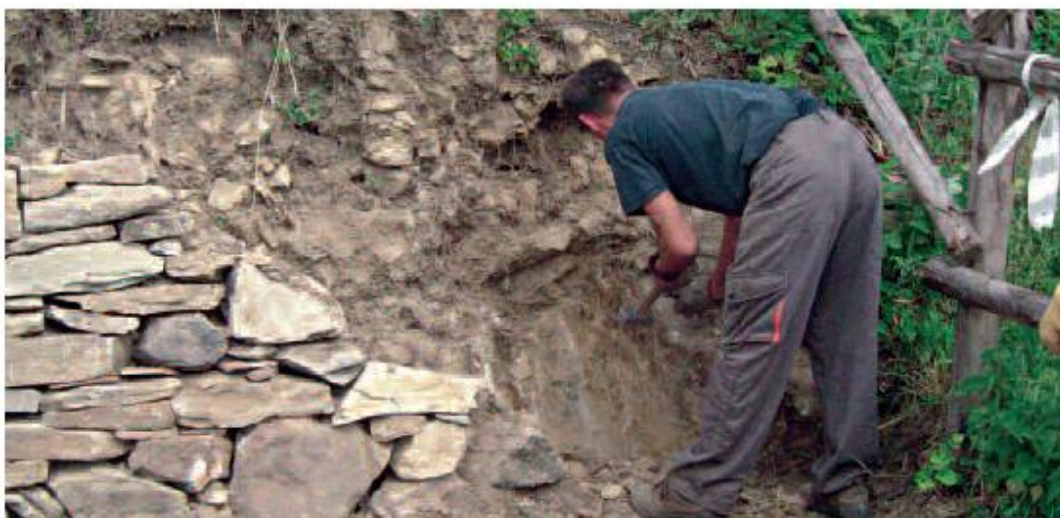
**Figure 5.14.** Remaining part of the wall in the form of a ladder to prepare the junction (picture from Sangiorgi et al., 2006)

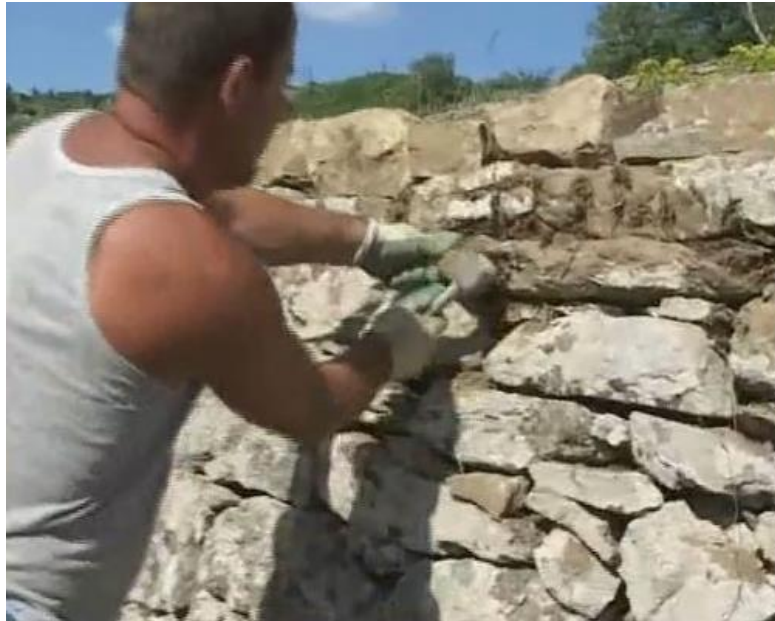
**Figure 5.16.** Stone settling during a dry wall construction in Lamole (picture from <http://www.fattoriadilamole.it/>).

The wall construction is done by placing successive stone layers distributed over the entire width. The stones should be deposited on a layer of fine gravel and settled in with a hammer or a rubber mallet (fig. 5.16).

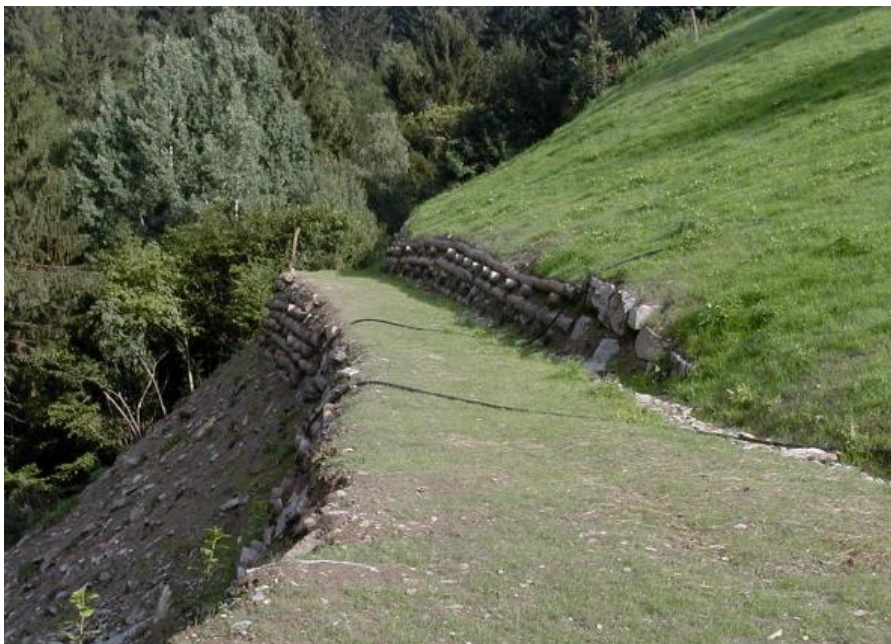
Figure 5.21. Slope restored with a wooden cribwall (original picture from D'Agostino, 2013).

This structure can be implemented by placing a gravel draining layer at its top. Moreover, to implement the gravel draining function, a drainage polyethylene pipe can be placed, parallel to the slope profile, in the back of the structure, draining in a ditch at the foot of the cribwall. Large nails or reinforcement bars are required to secure the logs or timbers together. A picture of a slope restored with this technique is showed further below (Fig. 5.21).

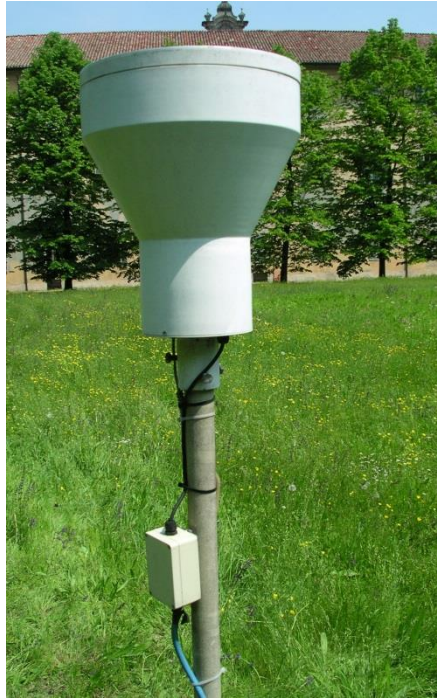
**Figure 5.28.** Example of rain gauge (picture from <http://personalpages.to.infn.it>)

First of all, in order to analyse the response of a terraced area to rainfall events, monitoring should start from rainfall data collection with a **rain gauge** (fig. 5.28).

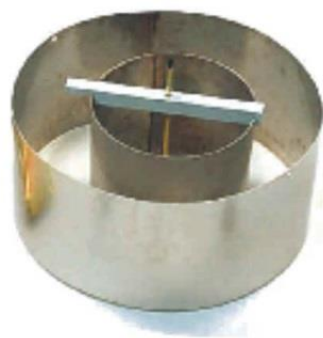
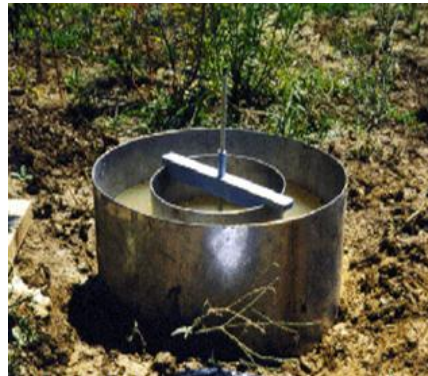
**Figure 5.29.** Double ring infiltrometer (pictures from <http://www.gisiberica.com> and <http://informes-unt.hostoi.com>)

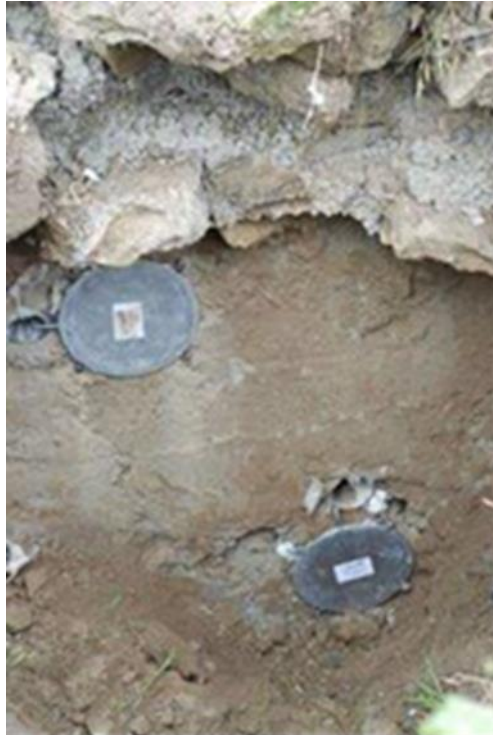
**Figure 5.30.** Total pressure cells installed behind the wall in Lamole, Chianti.

To this purpose behind the wall some **total pressure cells** can be installed (fig. 5.30).

A total pressure cell measures the combined pressure of effective stress and pore-water pressure. Their typical applications include monitoring total pressure exerted on a structure to verify design assumptions and determining the magnitude, distribution, and orientation of stresses.

In Lamole the cells have been positioned by performing an excavation behind the wall (fig. 5.30), subsequently reclosed with the same excavation material, carefully trying to restore the initial condition.

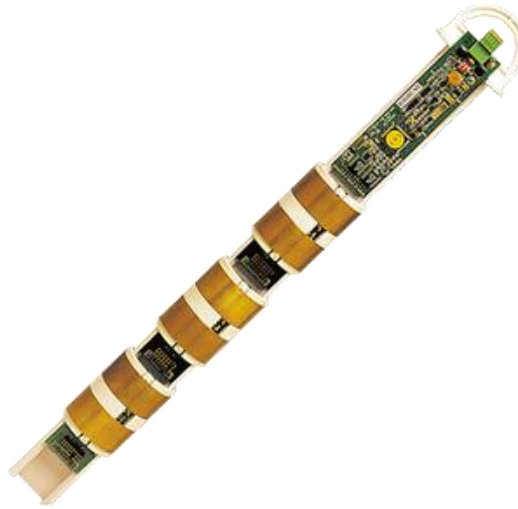
**Figure 5.31.** A capacitance probe (picture from <http://www.campbellsci.com/enviroscan>).

The first is constituted by a series of **capacitance probes** (fig. 5.31) installed along a vertical as close as possible to the back of the wall (depending on the thickness of the draining layer).

**Capacitance sensors** (or dielectric sensors) use capacitance (the ability of a body to store an electrical charge) to measure the dielectric permittivity of a surrounding medium.

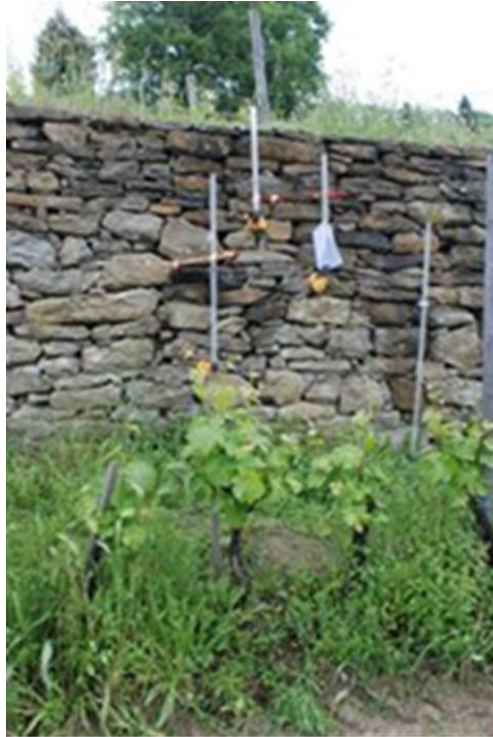
**Figure 5.32.** Four open standpipe piezometers in Lamole.

The second system installed in Lamole consists of four open standpipe **piezometers** horizontally inserted at different depths along the wall height, positioned exploiting the discontinuity between one stone and another, and the spaces left by drainage pipes (fig. 5.32).

A **piezometer** is either a device used to measure static liquid pressure in a system by measuring the height to which a column of the liquid rises against gravity, or a device which measures the groundwater pressure (more precisely, the piezometric head) at a specific point.

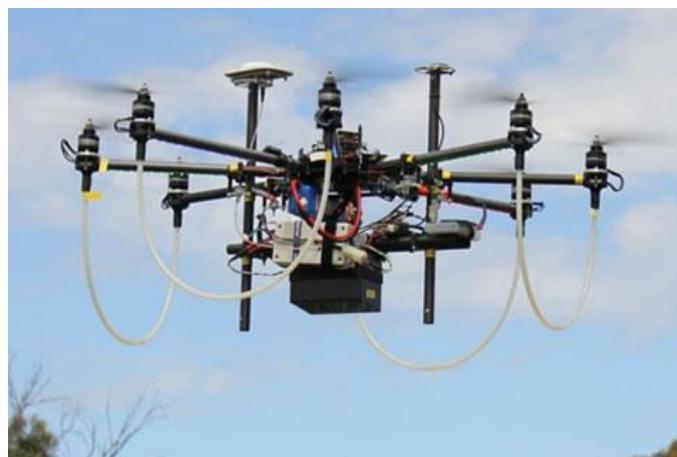
**Figure 6.3.** UAV for lidar survey (picture from [www.terraluma.net](http://www.terraluma.net/))

Recently, improvements in small-scale technology have enabled the use of Unmanned Aerial Vehicles (UAVs) (fig. 6.3) as an alternative remote sensing platform offering a distinctive combination of very high resolution data capture at a significantly lower survey cost.

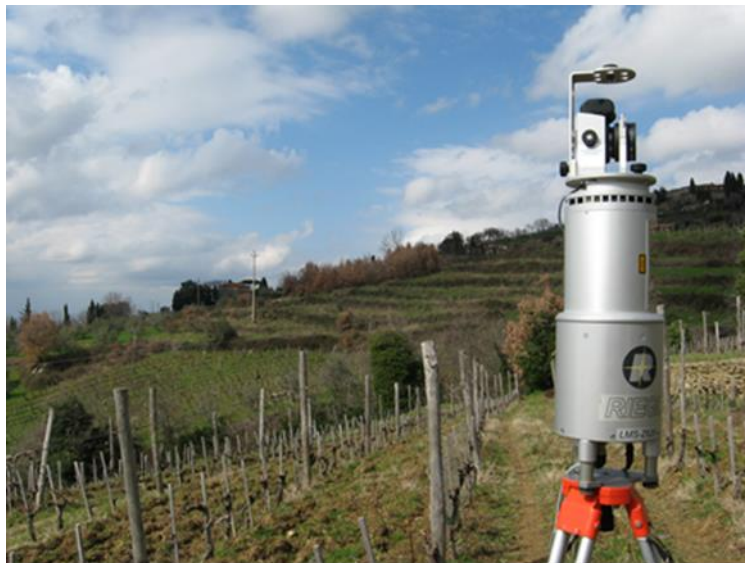
**Figure 6.5.** Terrestrial Laser Scanner Riegl LMS-Z620 with camera, used in Lamole site (picture by S. Calligaro).
