UNIVERSITÀ DEGLI STUDI DI PADOVA
FACOLTÀ DI INGEGNERIA

TESI DI LAUREA MAGISTRALE IN INGEGNERIA CIVILE
CURRICULUM EDILE

**SEISMIC ANALYSIS AND SIMULATION OF
COLLAPSE MECHANISM
OF A MASONRY CHURCH**

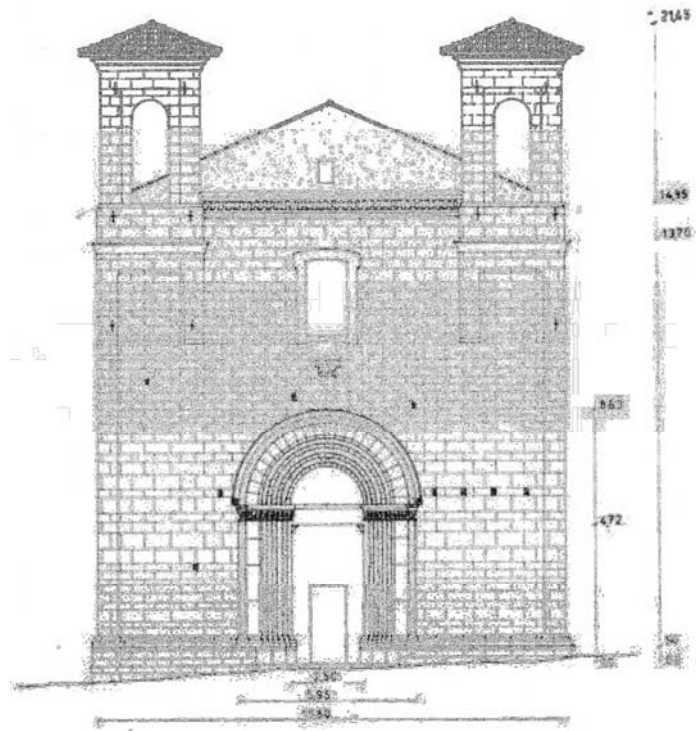
Figure 3.2 - Main façade.

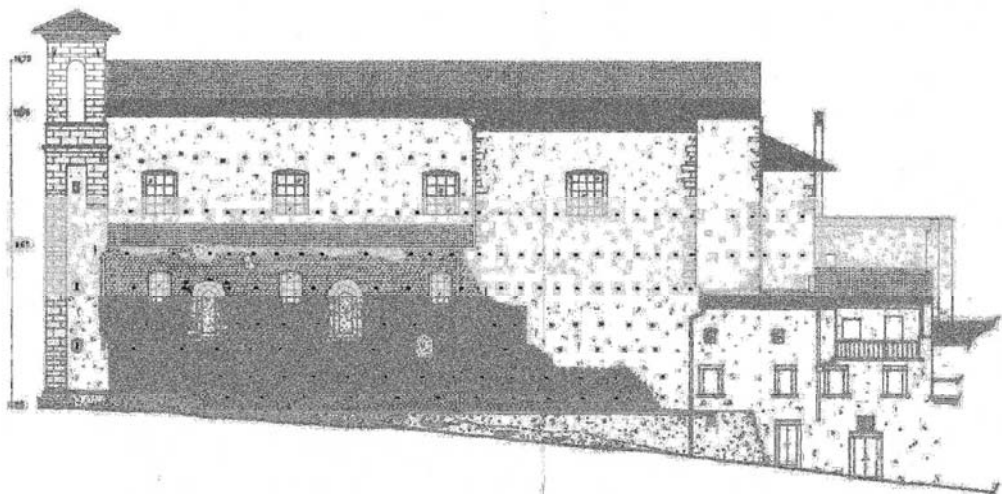
Figure 3.3 - North elevation – Via de Neri.

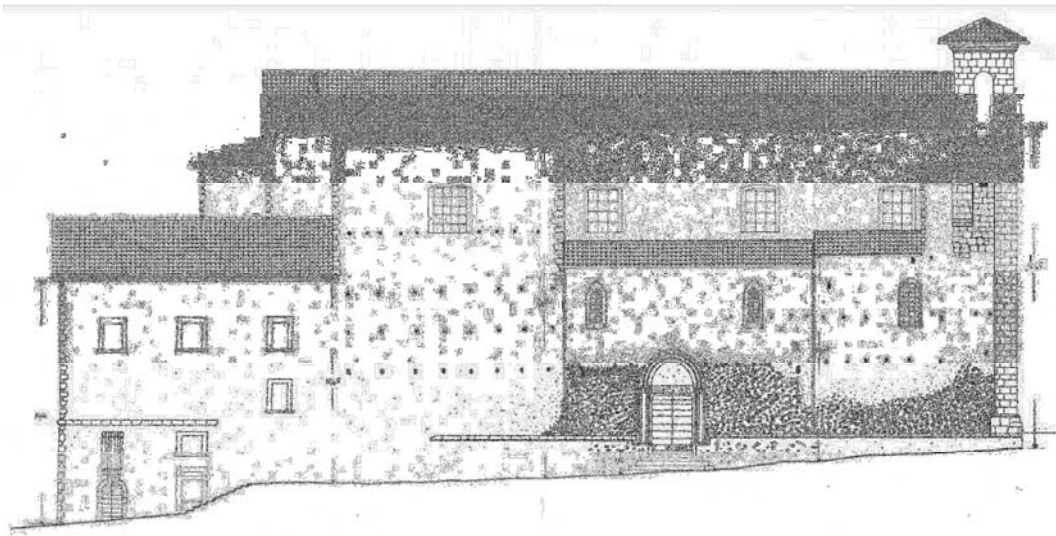
Figure 3.4 - South elevation – Piazza della Prefettura.

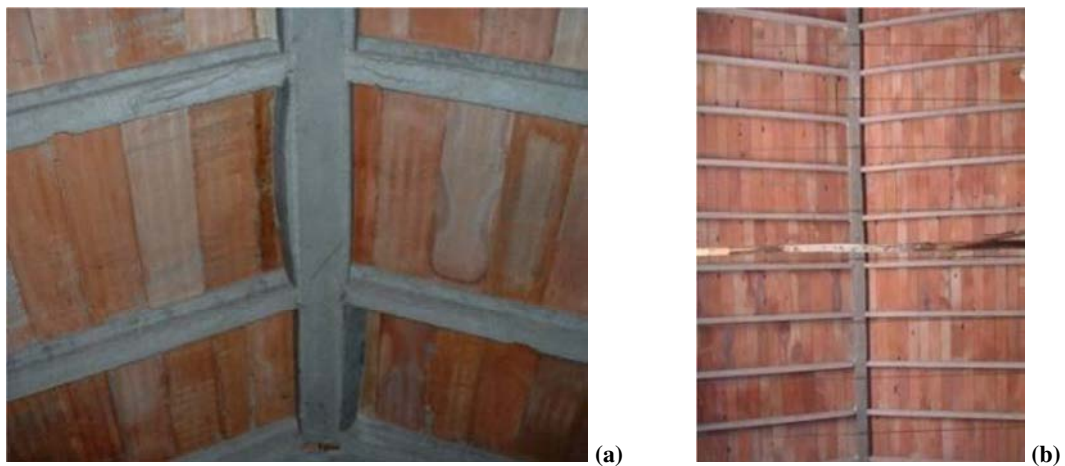
- Remove the old wooden roof and replacing it with one made in prefabricated beams and hollow flat blocks bricks. In order to make this type of self-supporting coverage of the steel tie rods were positioned parallel to the warping in correspondence of each joist. The ridge beam, on which the joists are joined, however, was built in situ.

Figure 3.10 - Covering made by prefabricated beams.

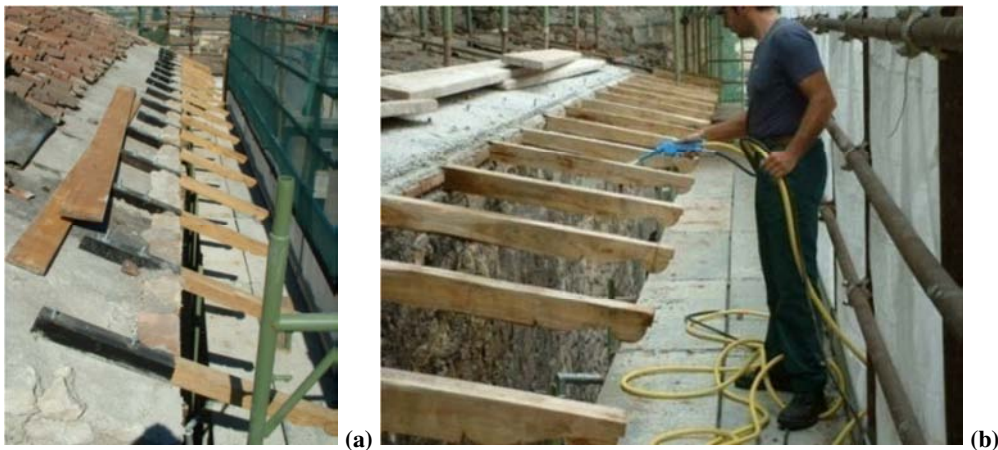
Its supporting structure was performed with wooden elements of rectangular cross-section fixed on the outer walls. The anchored part of these joists was then covered with a layer of cement mortar on which was applied a layer of insulation. Above this plan were laid planks of wood, which were lying on the tiles.

Figure 3.12 - New eaves.

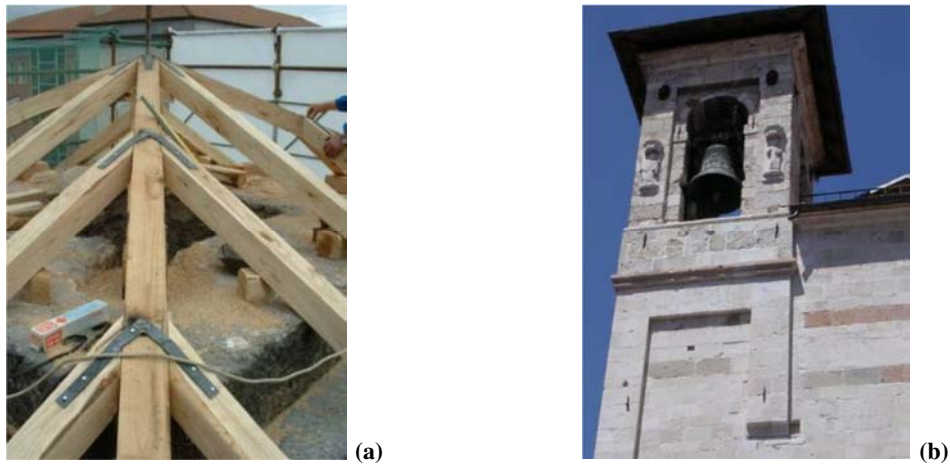
- Installation of a wooden roof on the bell towers and replacement of old containment ties. The old wooden roof of the two belfries has been replaced with a more wood but with metal reinforcements applied to connections. Above this structure has been applied a state insulation which also performs the function of support for the tiles.

Figure 3.13 - New bell towers roof.

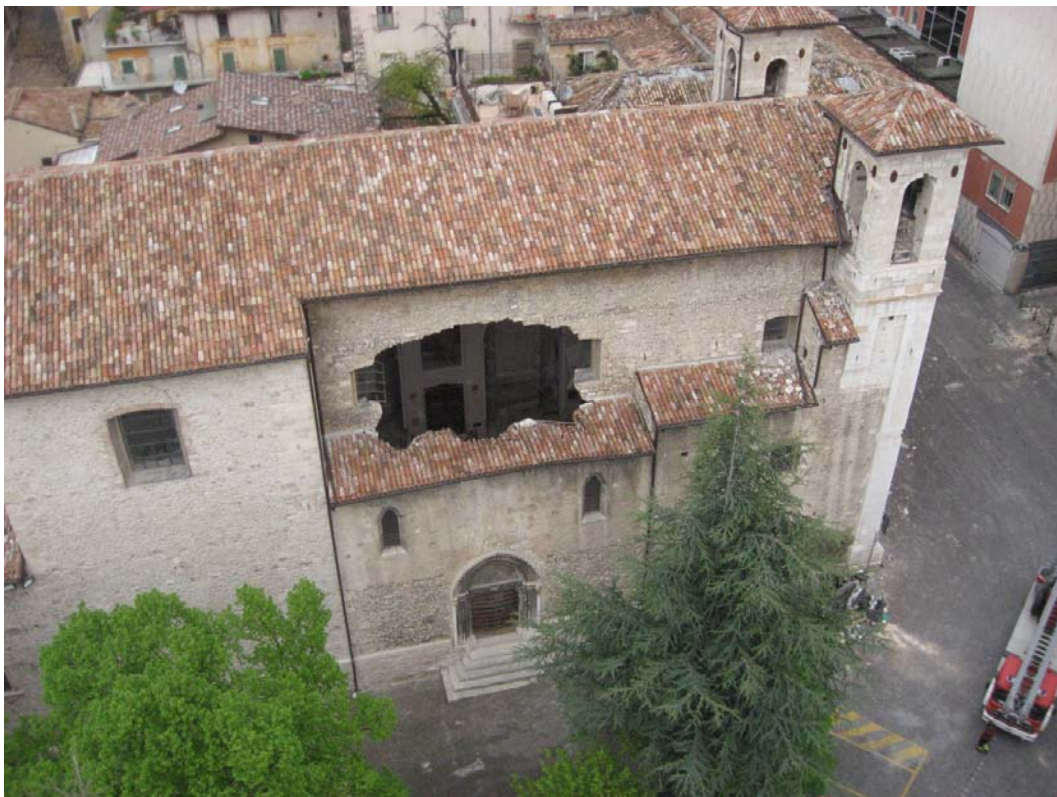
The inspection after the earthquake has revealed severe damage to the church immediately after the earthquake. In particular, the total collapses were detected in the apse, the collapse of two arches on which set the dome of the transept, a portion of the wall of the lateral façade in the left side, a considerable portion of the chapels in the left side, the separation of right facade from its orthogonal walls, and the almost total collapse of the barrel vault of the nave. Instead the tie beams, in the bell towers, ensured a good response abutment towers during the seismic shock.

Figure 4.1 – San Marco church, left façade.

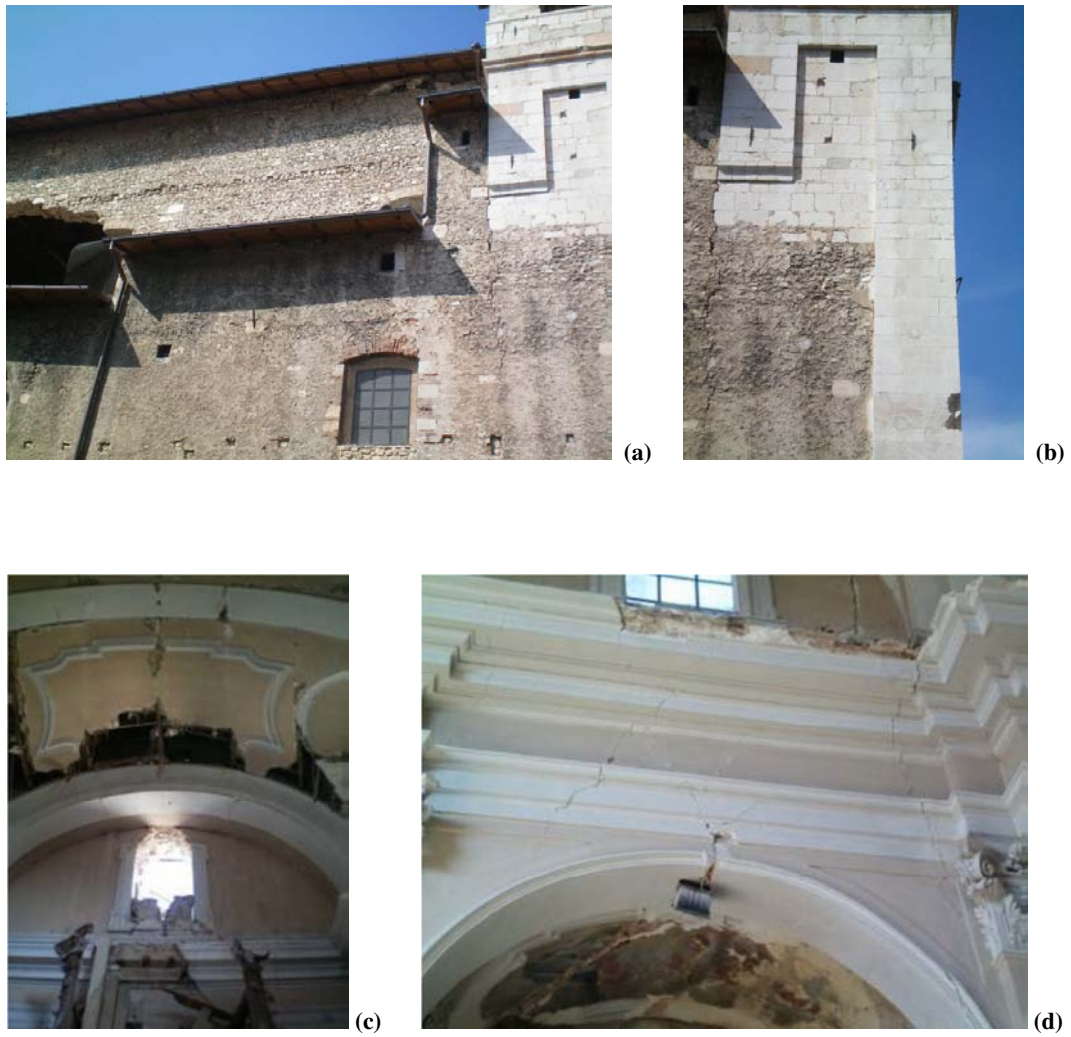
Figure 5.4 - Out-of-plane movement of the main façade.

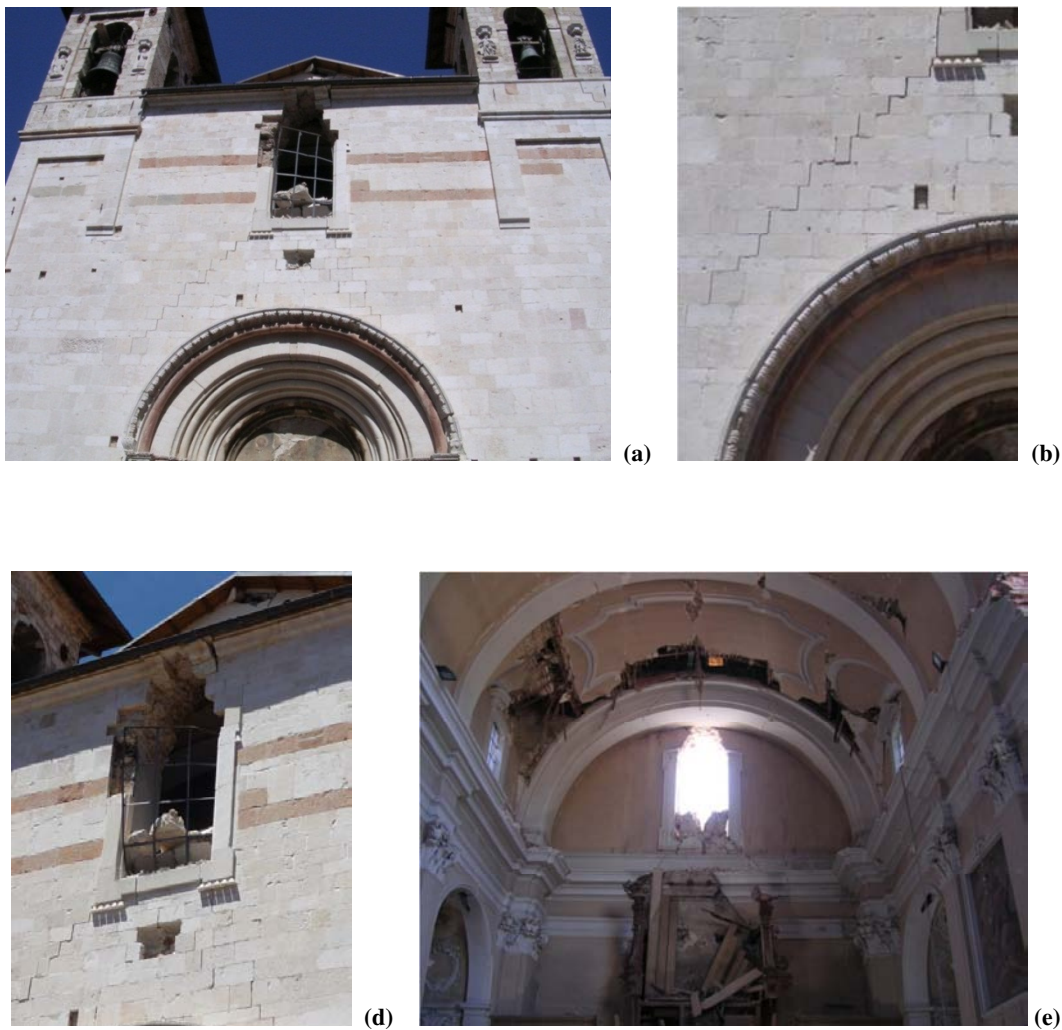
Figure 5.5 - In-plane movement of the main façade.

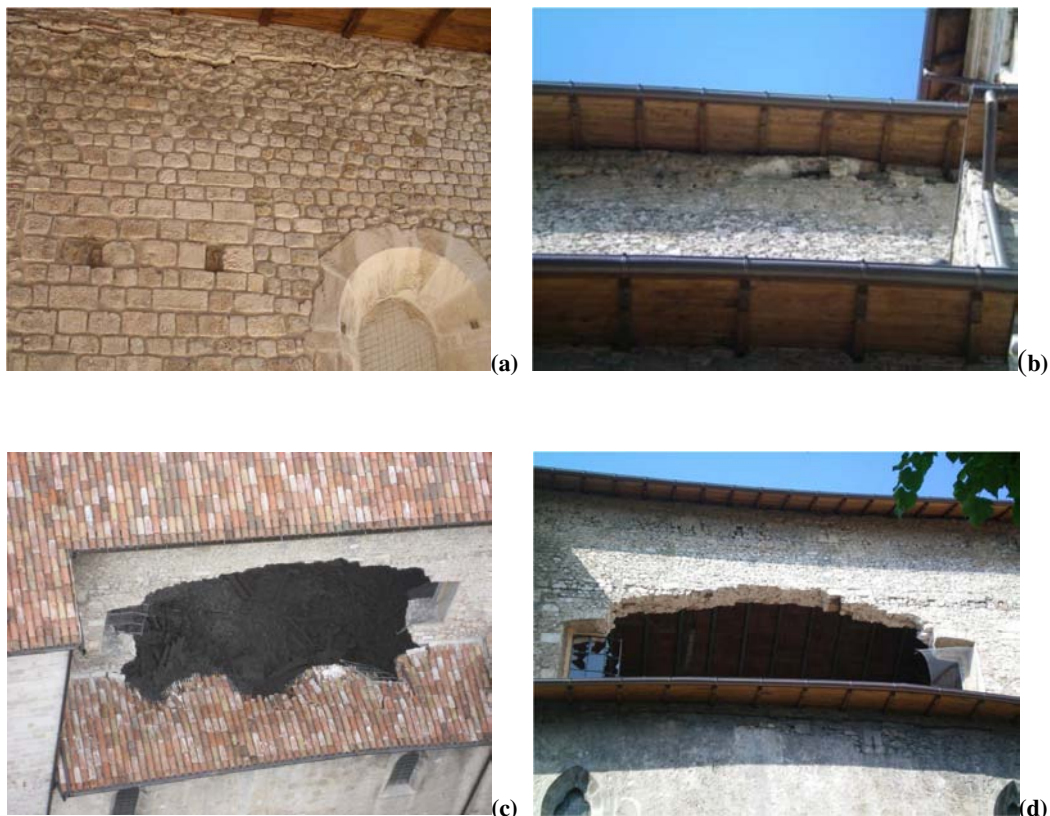
Moreover, we studied the possible horizontal deflection of the masonry strip between the two covers, different in height, on the left side facade. This strip is assumed to be well connected to the wall of the transept and to the buttress which is located in the point where the height of the cover changes. The flexion in this section is therefore due to the instability of the buttresses.

Figure 5.6 - Lateral façade.

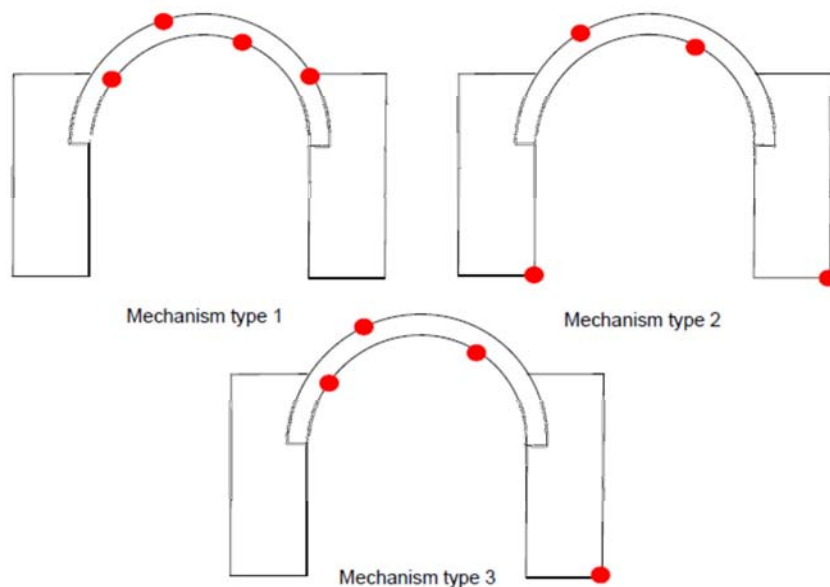
The test of this collapse was divided into four parts. Firstly, we calculated the activation coefficients of the mechanism related only to the arch, without taking into account the buttresses. Secondly, we hypothesized the possible overturning of one and then of both buttresses at the base of the arch. Finally, the last estimated case of loss of balance concerned the union of the 2-3 vaults.

Figure 5.8 - Arches collapse mechanisms.

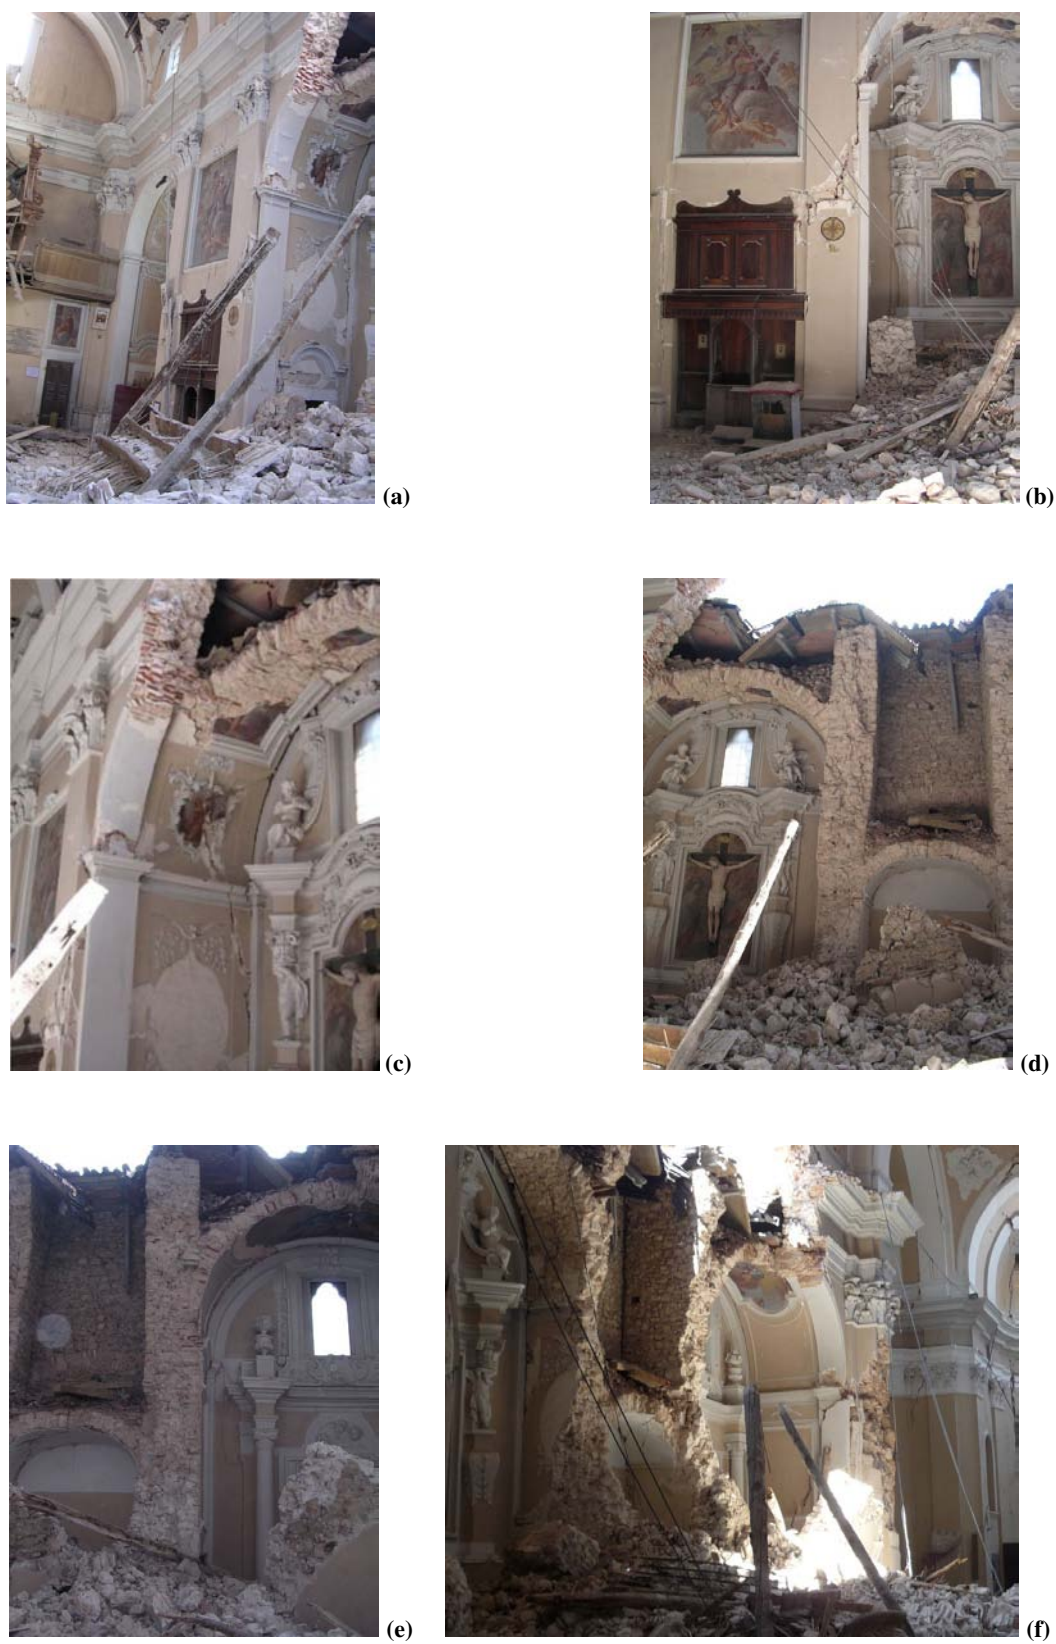
Figure 5.9 – Chapels vaults collapse.

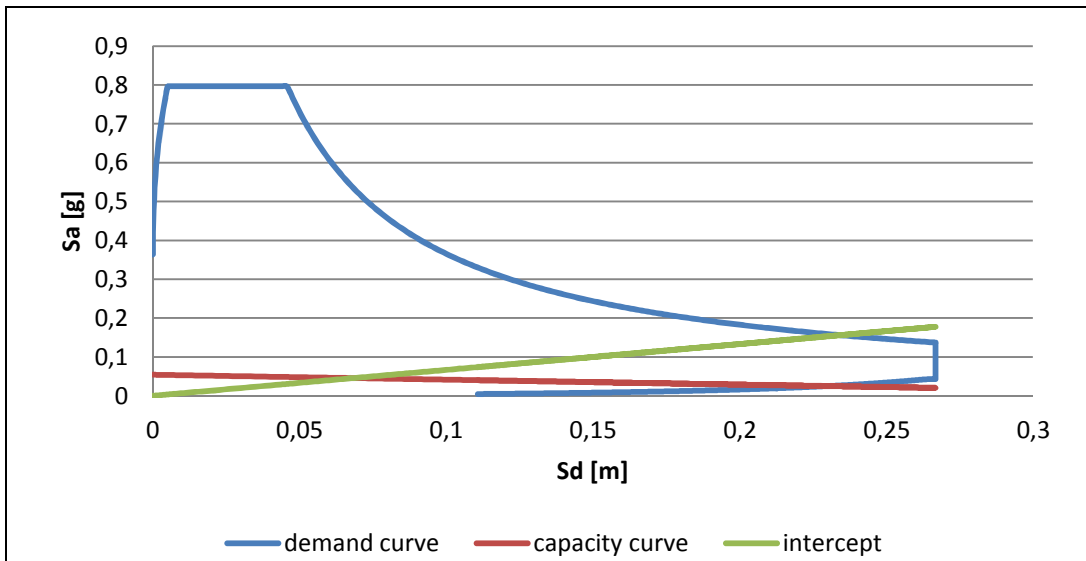
Figure 5.10 - Non-linear analysis of the buttress.

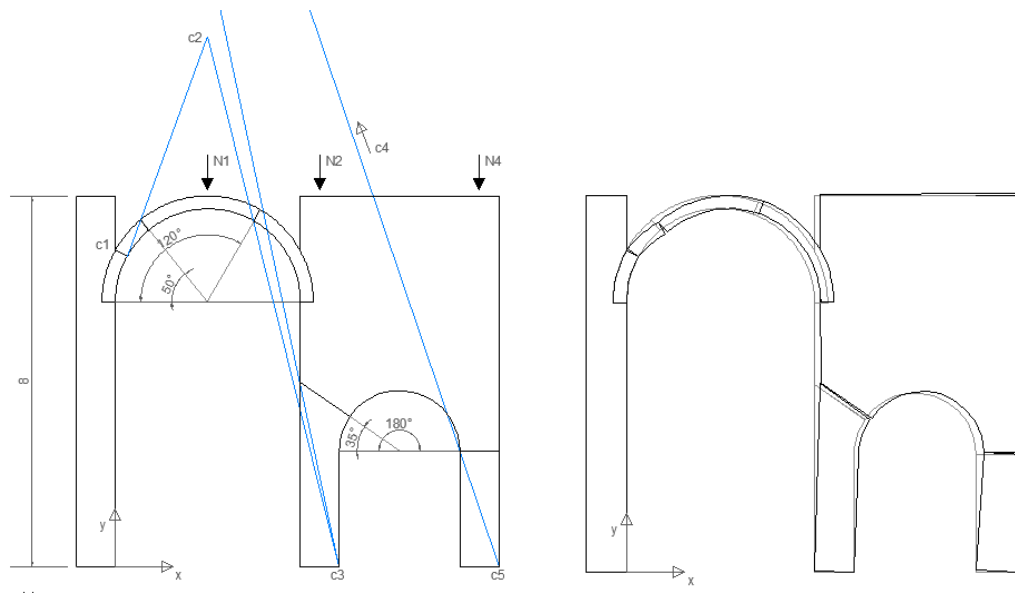
Loss balance of two consecutive arches with resisting spandrels			
Arches:			
	Geometrical properties		
	B	0.85	m
H	8	m	
s	0.85	m	
Re1	2.28	m	
Ri1	2	m	
L1	4	m	
θ1	29	°	
θ2	50	°	
θ3	110	°	
θ4	244	°	
Re2	1.58	m	
Ri2	1.3	m	
L2	2.6	m	
β1	35	°	
β2	180	°	
β3	230	°	
	Loads		
	PVg	28.8	KN
N1	636.96	KN	
D1	2.00	m	
PP	115.6	KN	
N2	342.37	KN	
D2	4.425	m	
PVp	19.38	KN	
N3	342.37	KN	
D3	7.875	m	
PP	115.6	KN	
Material properties			
fc	4	MPa	
ft (5% fc)	0.2	MPa	
γ	20	KN/m ³	
$c = \frac{a}{g} = 0.099$

Figure 5.15 – collapse mechanism of two consecutive arches with resisting spandrels case b.

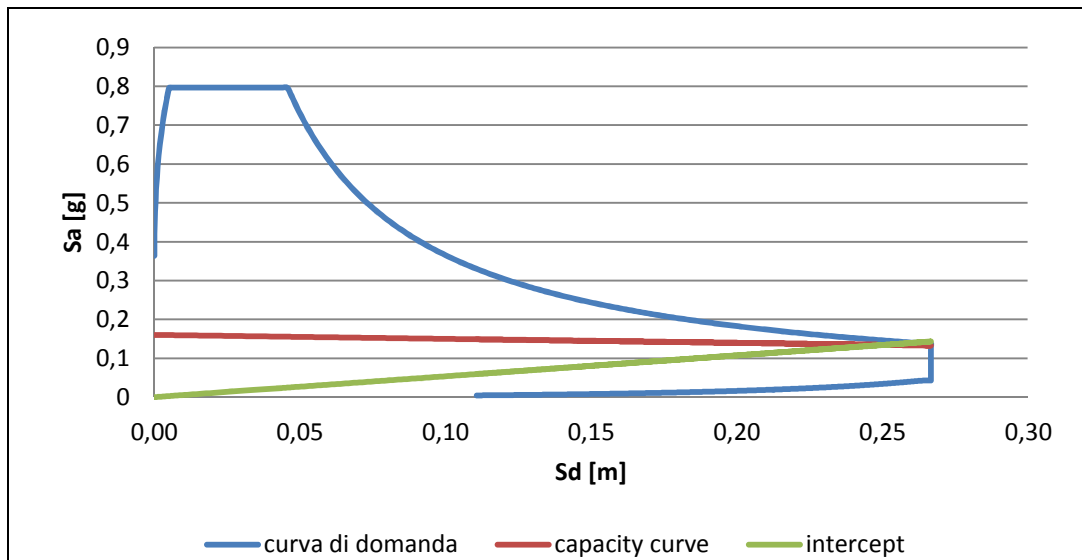
$$c = \frac{a}{g} = 0.163$$

Figure 5.16 - Non-linear analysis of the main façade (partially connected).

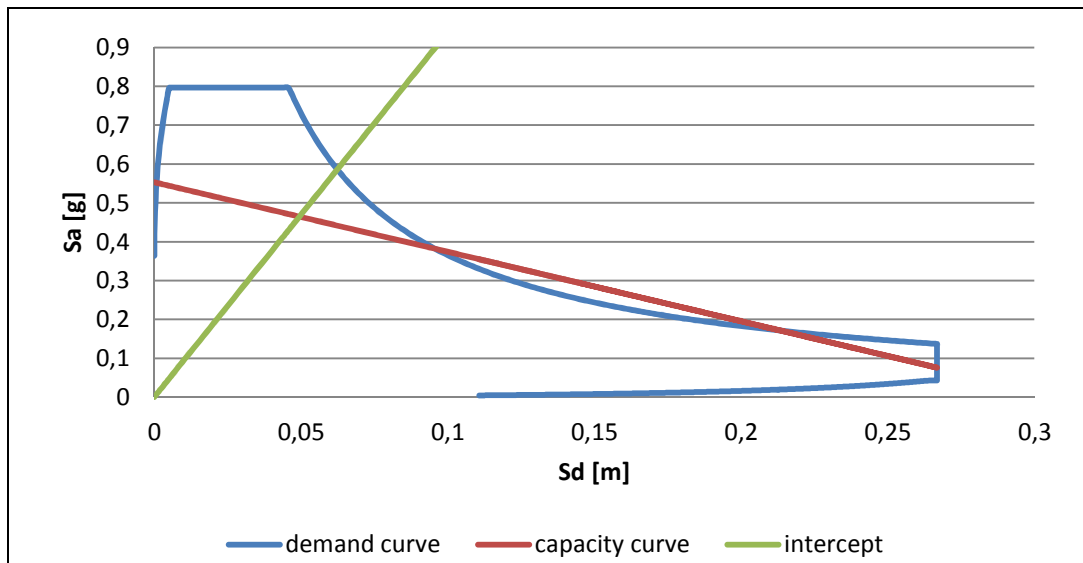
Geometrical properties			H1	7.5	m	B1	0.80	m	Loads			P1	120.00	KN	N1	39.24	KN	Material properties			fc	4	MPa	ft (5% fc)	0.2	MPa	γ	20	KN/m ³
Geometrical properties																																
H1	7.5	m																														
B1	0.80	m																														
Loads																																
P1	120.00	KN																														
N1	39.24	KN																														
Material properties																																
fc	4	MPa																														
ft (5% fc)	0.2	MPa																														
γ	20	KN/m ³																														
$c = \frac{a}{g} = 0.517$

Figure 5.17 - Non-linear analysis of the top wall of the lateral façade (vertical deflection).

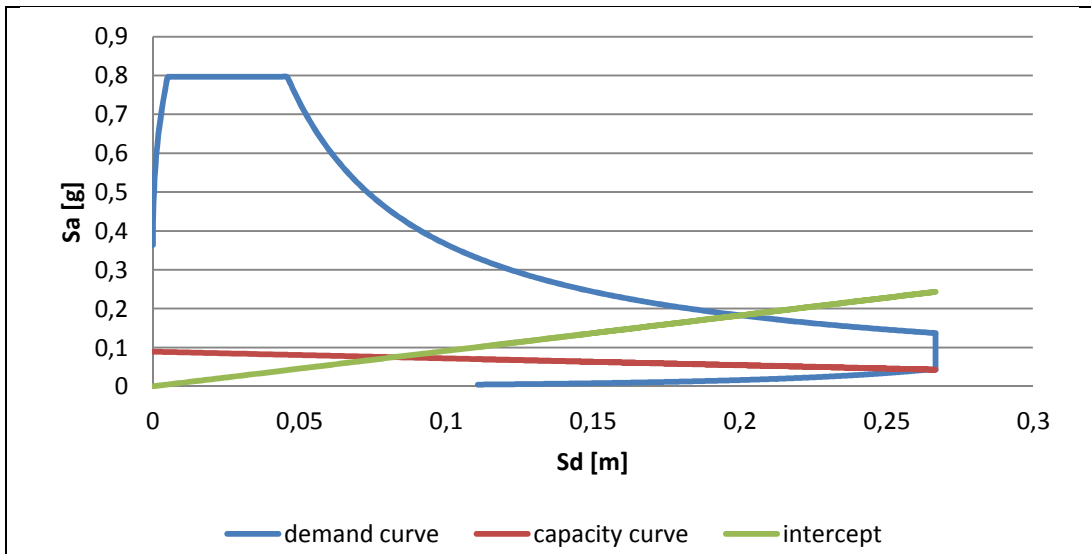
Out of plane movement of a monolithic wall simply supported			
Lateral facade - top wall			
	Geometrical properties		
	H1	7.5	m
	B1	0.80	m
	Loads		
	P1	120.00	KN
	N1	39.24	KN
	N1o	-	KN
D1	0.65	m	
Material properties			
fc	4	MPa	
ft (5% fc)	0.2	MPa	
γ	20	KN/m ³	
$c = \frac{a}{g} = 0.099$

Figure 5.18 - Non-linear analysis of the top wall of the lateral facade (overturning).

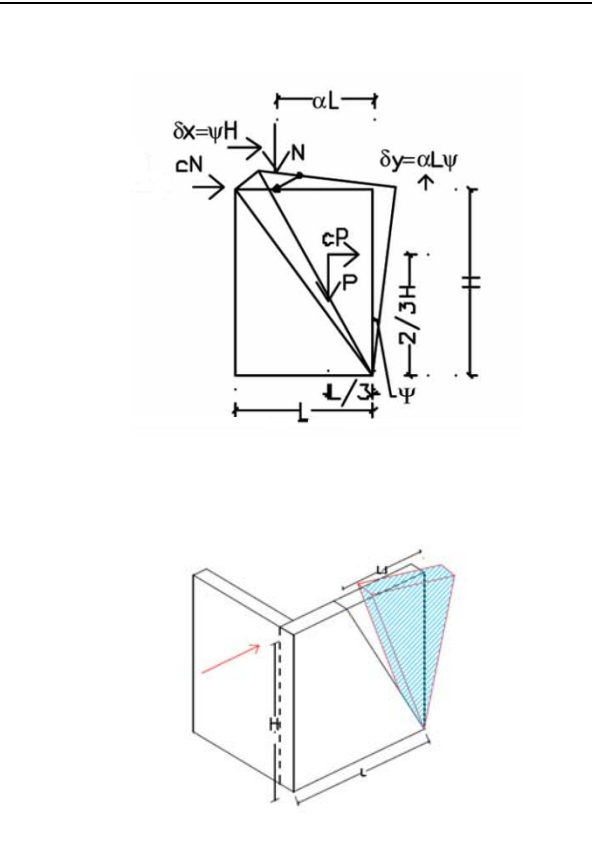
Plane movement of a limited portion of the wall

Geometrical properties		
H	15	m
B	2.5	m
L	16.0	m
L1	8.00	m
Loads		
P	3000	KN
N	440	KN
$\alpha L1$	1.75	
Material properties		
f_c	4	MPa
f_t (5% f_c)	0.2	MPa
γ	20	KN/m ³

$$c = \frac{a}{g} = \frac{P \frac{L1}{3} + N \alpha L1}{P \frac{2}{3} H + N H} = 0.349$$

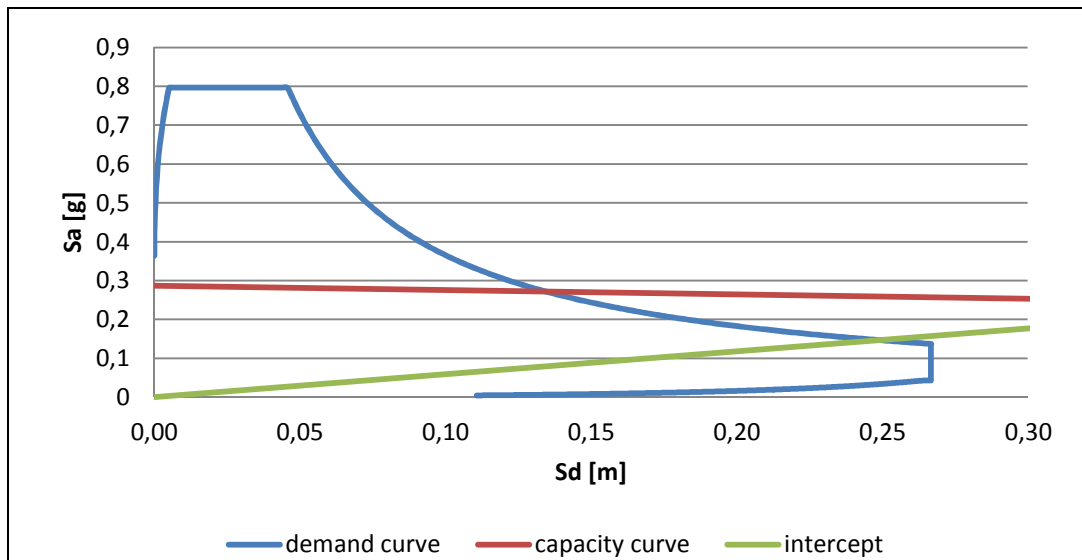
Figure 5.19 - Non-linear analysis of the frontal façade (in-plane movement).

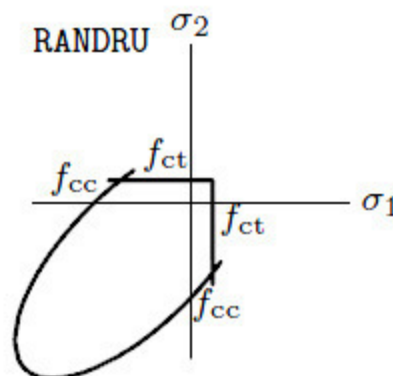
The material model used for the behaviour of masonry combines a smeared cracking model for tension (Rankine failure criterion), with a plasticity model for compression (Drucker-Prager failure criterion).

Figure 6.1 – Rankine/Drucker-Prager model

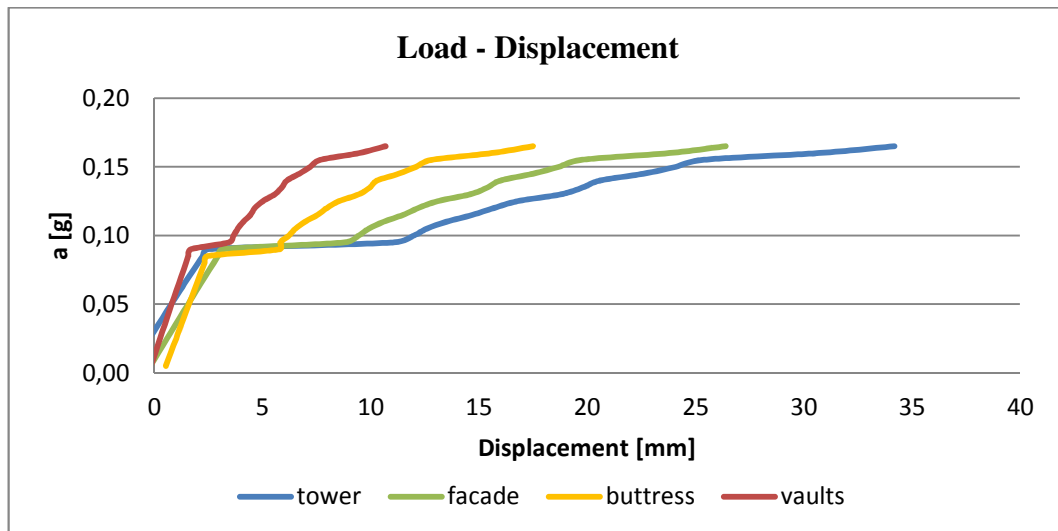
Figure 6.6 – Capacity curves at the control point at the top of the tower, top of the nave wall, top of buttress and on the vaults (reference case).

In the X direction, the collapse mechanisms are the loss of balance of the chapel's vaults and the overturning of the facade. The first mechanism begins with the cracking of chapel vaults, which corresponds to an acceleration of 0.095g. The second mechanism begins at an acceleration of 0.095g, then the capacity increases up to the ultimate value of 0.170g, which corresponds to the overturning of the facade and the parting of the nave wall.

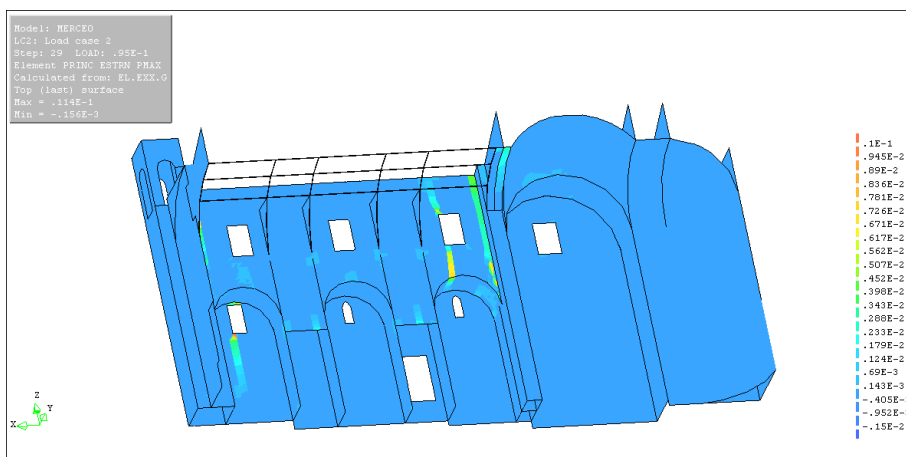
Figure 6.7 – Initial principal tensile strain, X direction (vaults view) in reference case.

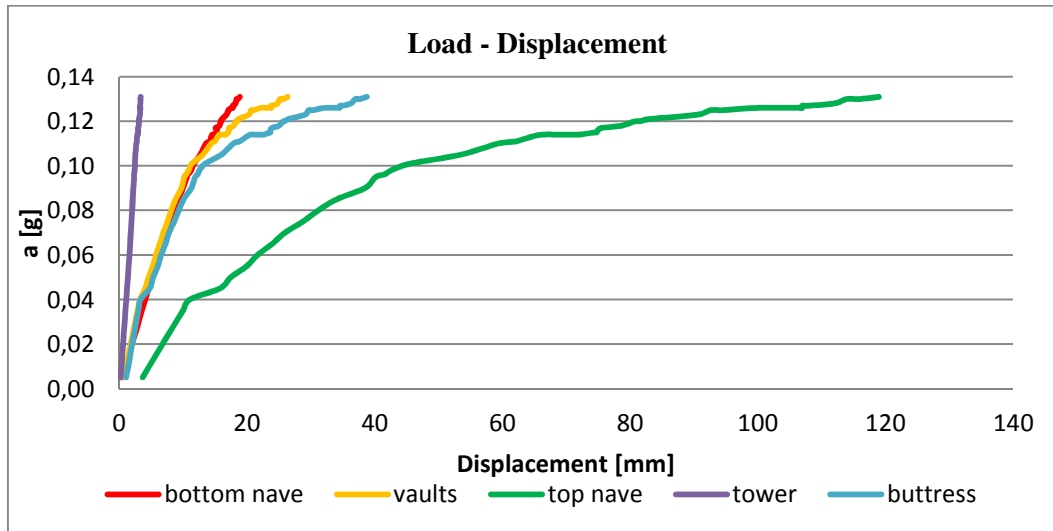
Figure 6.13 – Capacity curves at the control point at the top of the tower, top of the bottom wall on the left facade, top of the top wall on the left facade, top of buttress and on the vaults (reference case).

In the Y direction, the cause of the collapse is the crash of the material of the lateral facade. This mechanism starts at an acceleration of 0.045g that corresponds to the initial local destruction of the connection between the nave walls and the bells towers. Then the capacity increases up to the ultimate value of 0.131g.

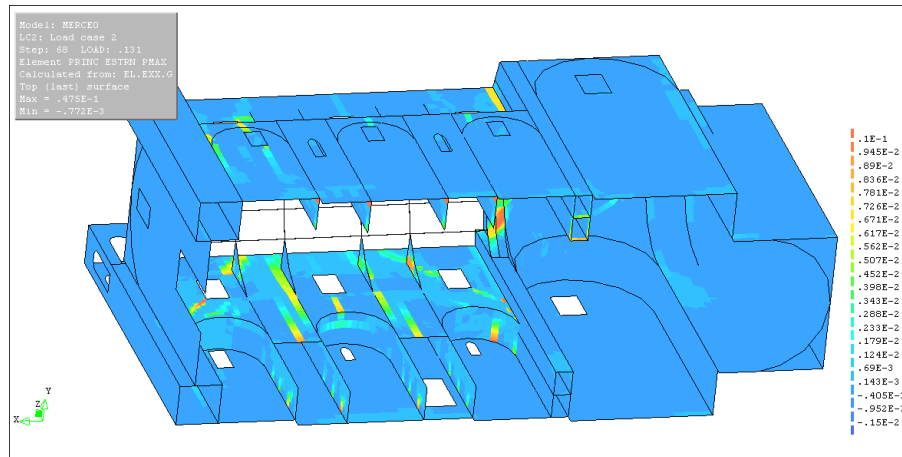
Figure 6.14 - Ultimate principal tensile strain, Y direction (internal view) in reference case.

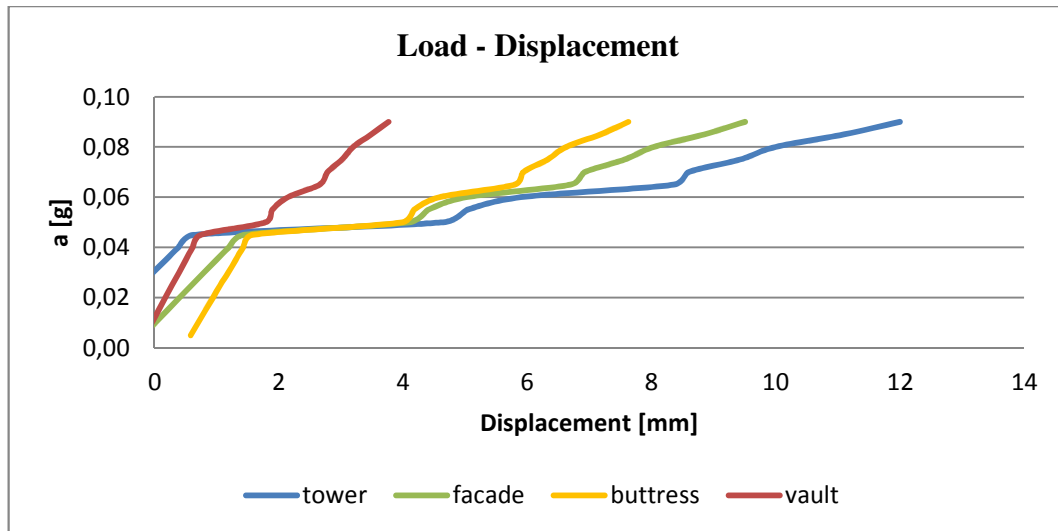
Figure 6.17 - Capacity curves at the control point at the top of the tower, top of the nave wall, top of buttress and on the vaults (weak buttresses case).

The collapse mechanism is the same as previous case (loss of balance of the chapel's vaults and the overturning of the façade). However, the capacity curves shown a very different ultimate load factor. In the previous analysis the ultimate acceleration was equal to 0.170g; in this analysis the ultimate value is of 0.095g. The cracks of vaults and of the upper part of the buttresses start at a value of the acceleration equal to 0.050g. This value can be compared with the value obtained for the overturning of the buttresses in the kinematics analysis ($c=0.060$). This assumption seems quite correct because it is closest to the results obtained with the kinematics analysis ($c=0.099$).

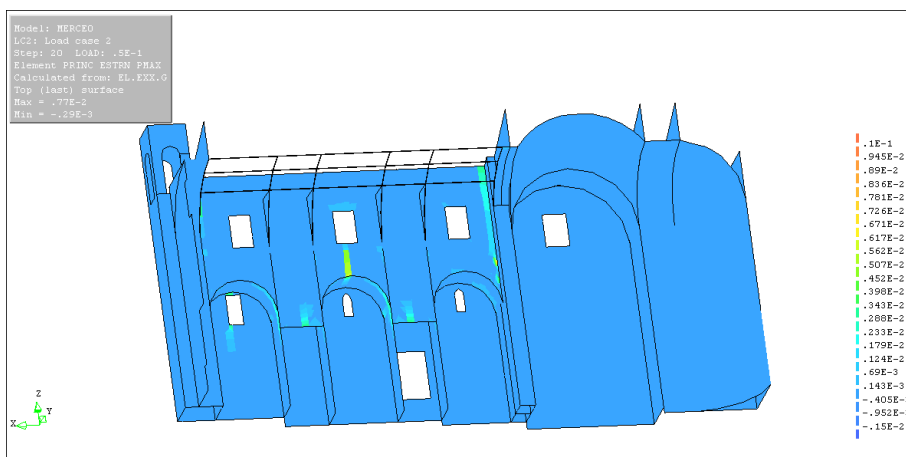
Figure 6.18 - Initial principal tensile strain, X direction (vaults view) in weak buttresses case.

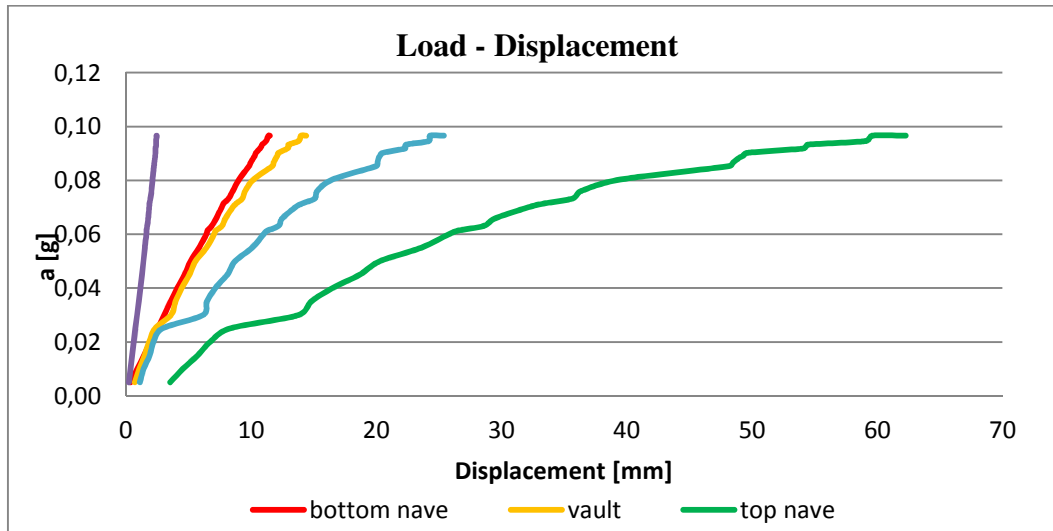
Figure 6.24 – Capacity curves at the control point at the top of the tower, top of the bottom wall on the left facade, top of the top wall on the left facade, top of buttress and on the vaults (weak buttresses case).

In this case the ultimate value is 0.097g, in the previous analysis was equal to 0.131g. This decrease is due to the poor resistance of the buttresses supporting the top wall on the left facade.

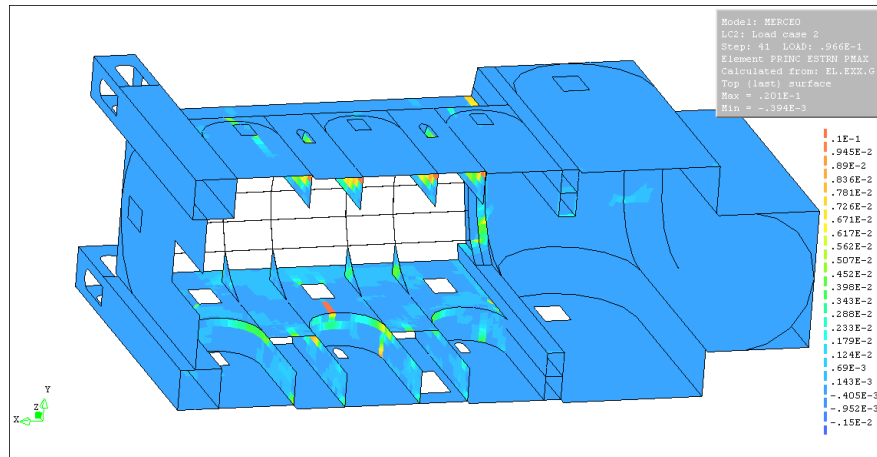
Figure 6.25 - Ultimate principal tensile strain, Y direction (internal view) in weak buttresses case.

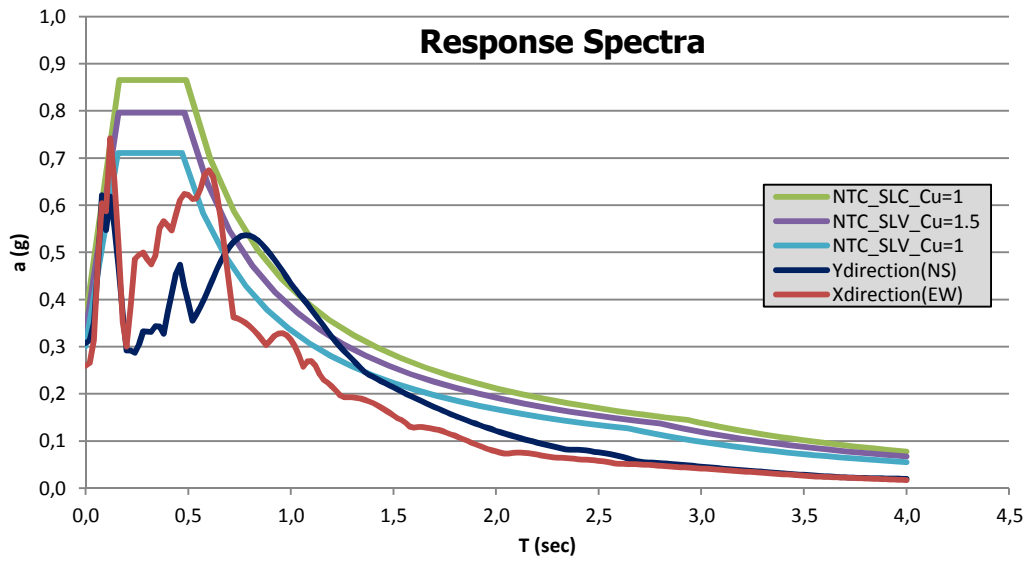
In the following figure, the obtained spectra for the main horizontal directions Y (NS) and X (EW), which are carried out using the accelerogram that was measured at the station AQU, have been compared with different elastic response spectra according to the Italian seismic code [DM 14/01/2008].

Figure 7.4 – comparison between response spectra.

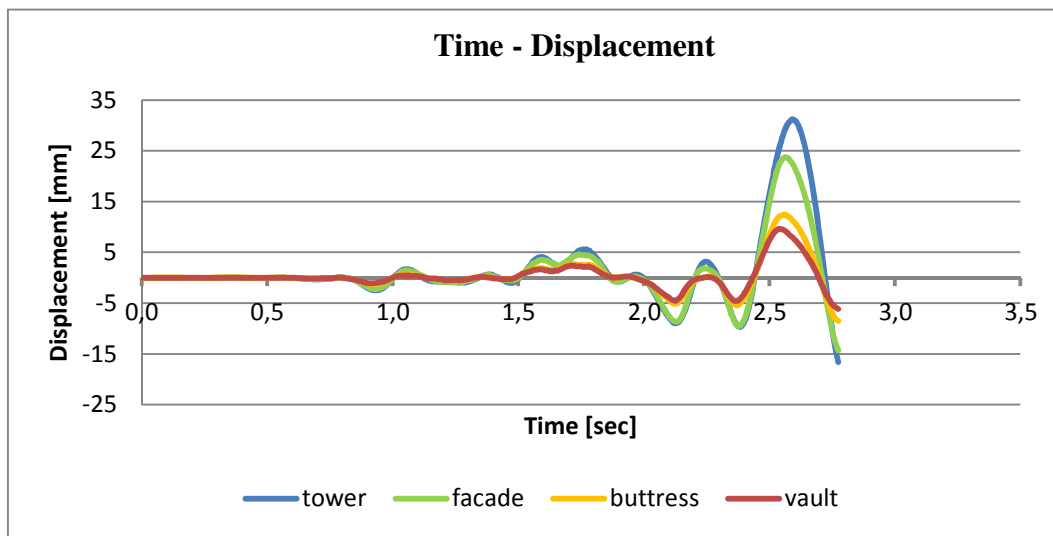
Figure 7.5 – Time-Displacement curve at the top of the tower, top of the nave wall, top of buttress and on the vaults.

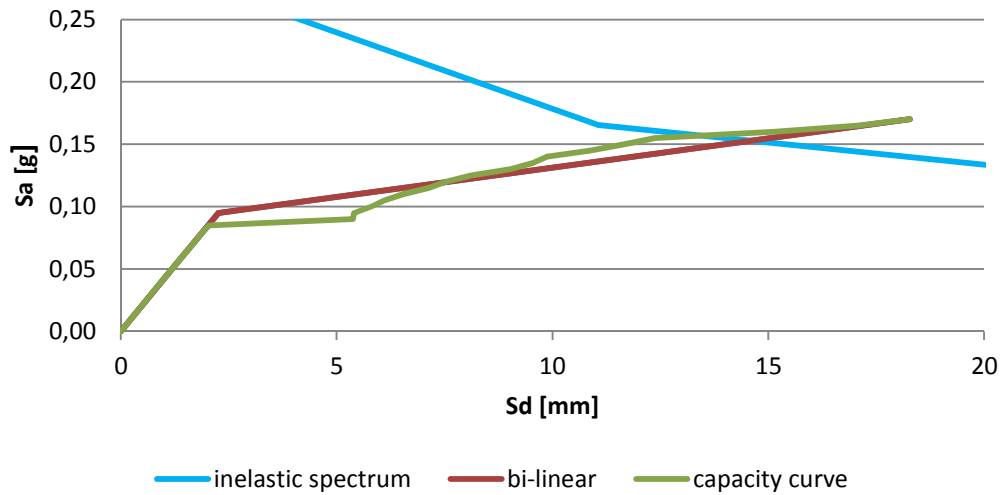
Figure 7.12 – Displacement request at the top of the buttress obtained from the N2 method (X direction).

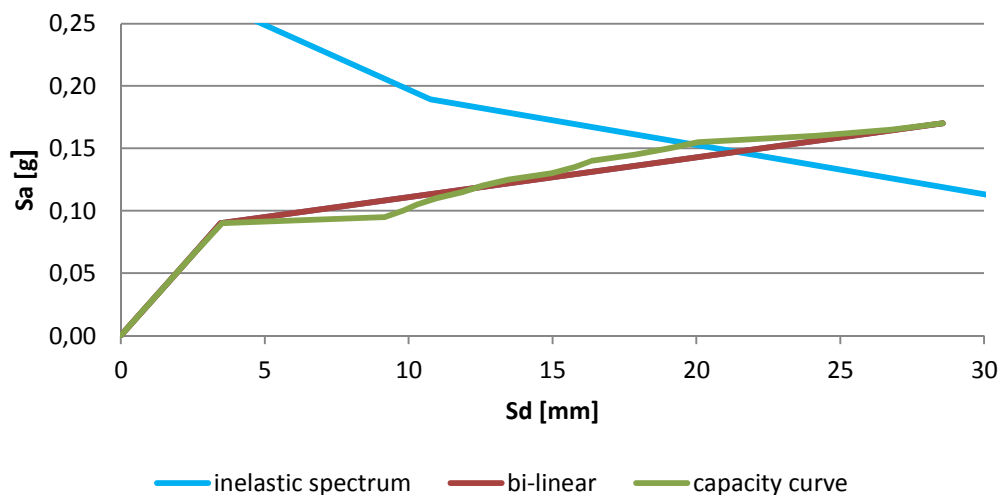
Figure 7.11 – Displacement request at the top of the main facade obtained from the N2 method (X direction).

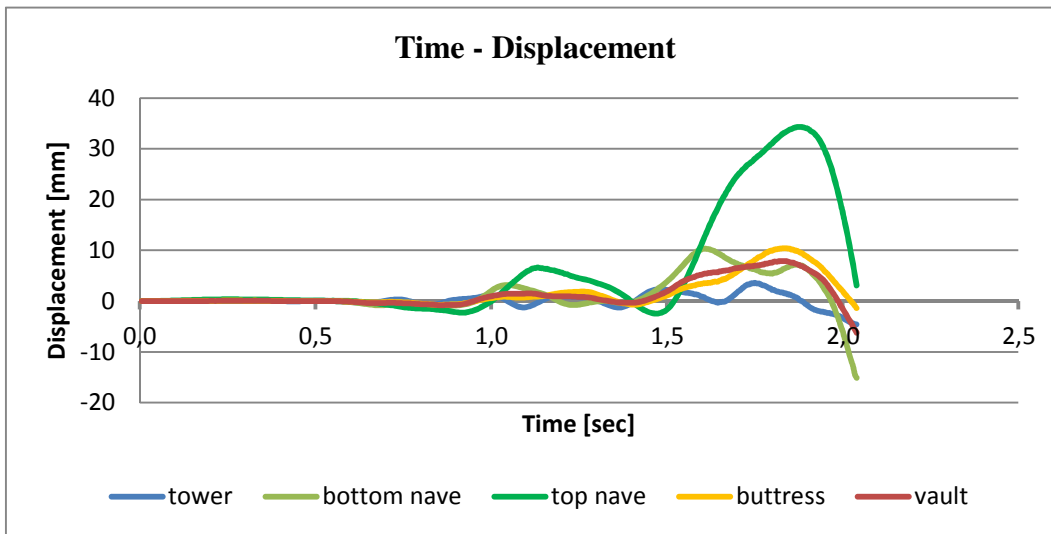
Figure 7.13 – Time-Displacement curve at the top of the tower, top of the bottom wall on the left facade, top of the top wall on the left facade, top of buttress and on the vaults.

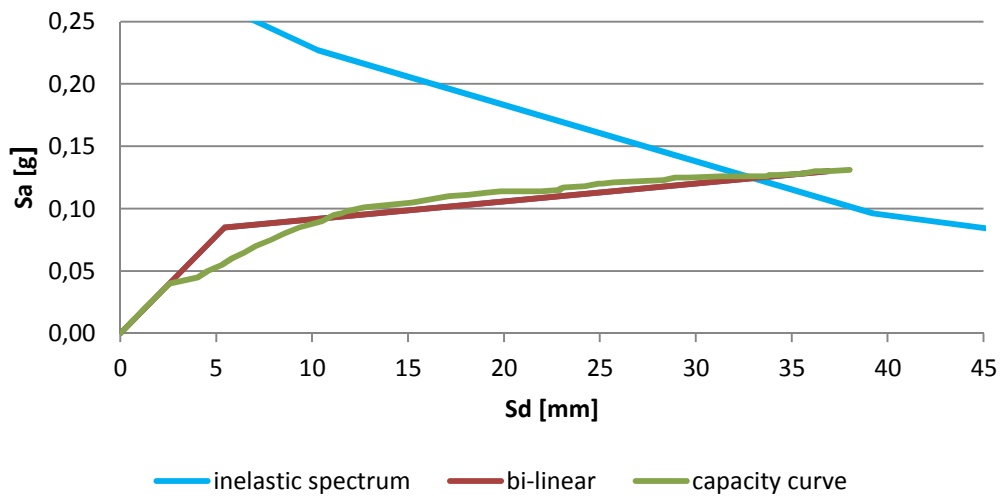
Figure 7.17 - Displacement request at the top of the buttress obtained from the N2 method (Y direction).
