UNIVERSITÀ DEGLI STUDI DI PADOVA
FACOLTÀ DI INGEGNERIA

TESI DI LAUREA MAGISTRALE IN INGEGNERIA CIVILE
CURRICULUM EDILE

**SEISMIC ANALYSIS AND SIMULATION OF
COLLAPSE MECHANISM
OF A MASONRY CHURCH**

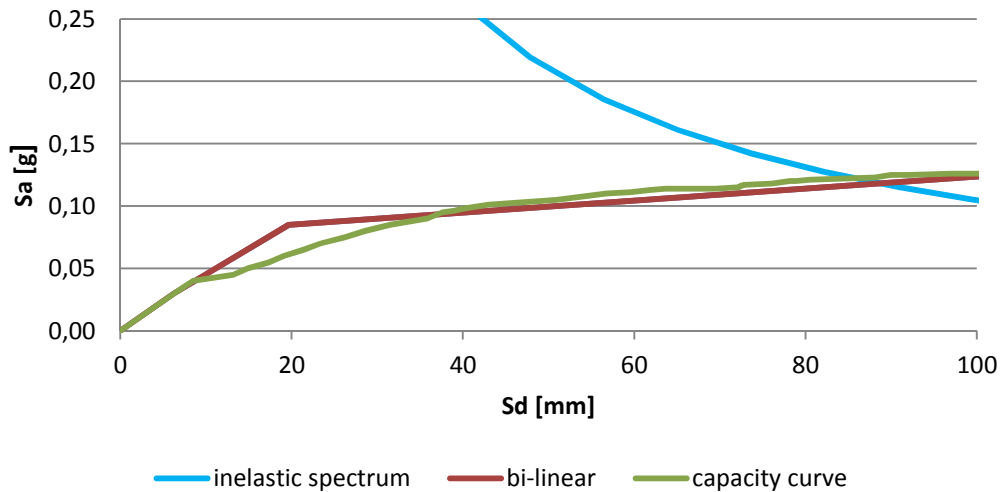
Figure 7.18 - Displacement request at the top of the top wall of the nave obtained from the N2 method (Y direction).

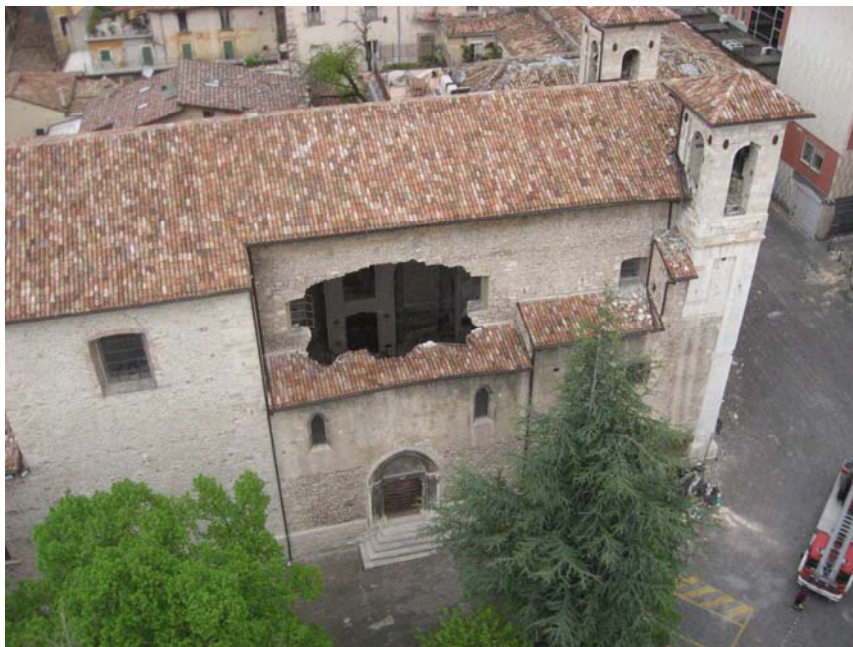
Figure A1.15 – left façade collapse

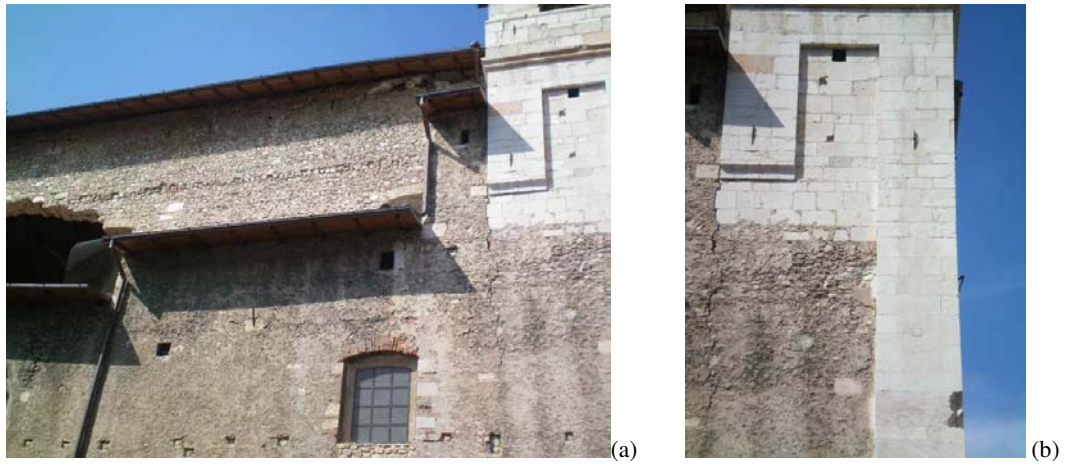
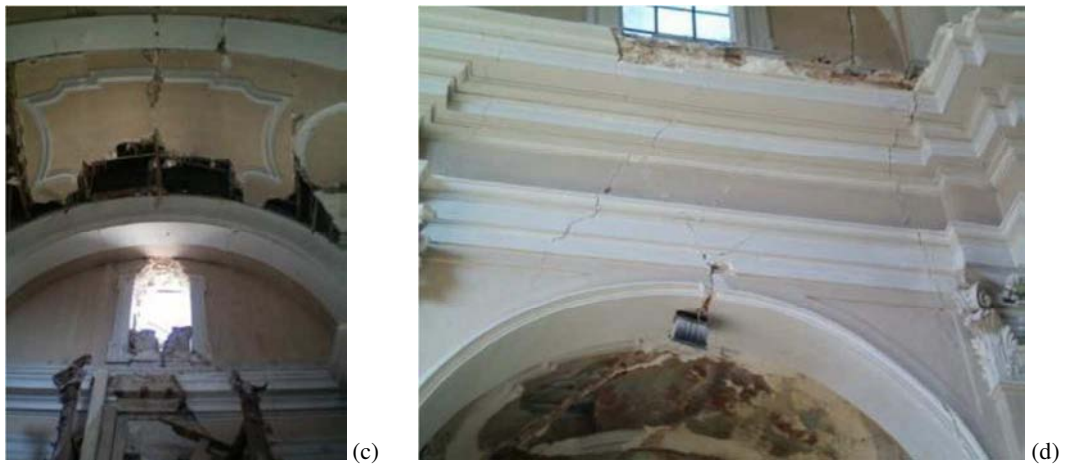
Figure A1.16 - Out-of-plane movement of the main façade.

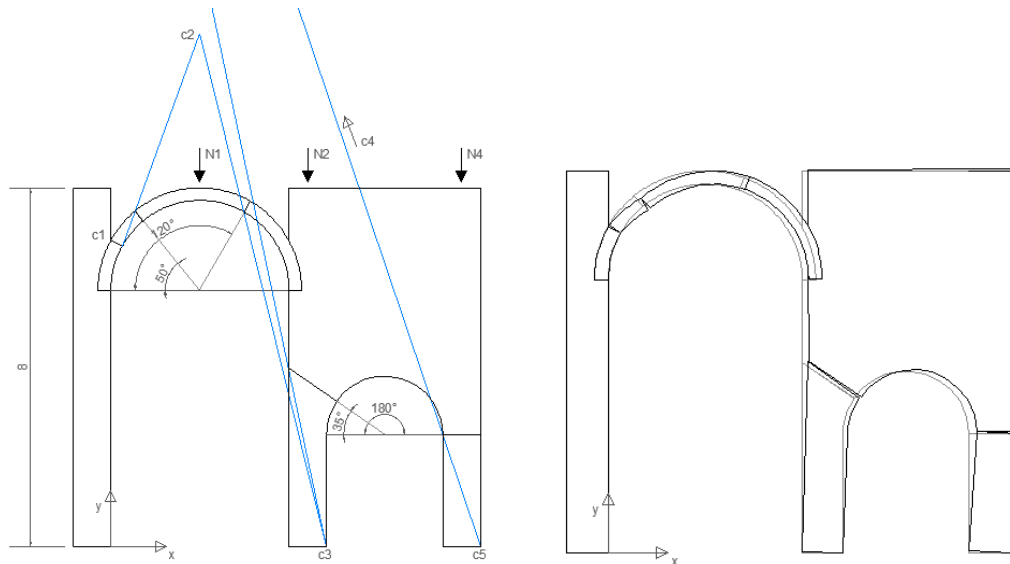
Figure A2.10 – collapse mechanism of two consecutive arches with resisting spandrels case b.

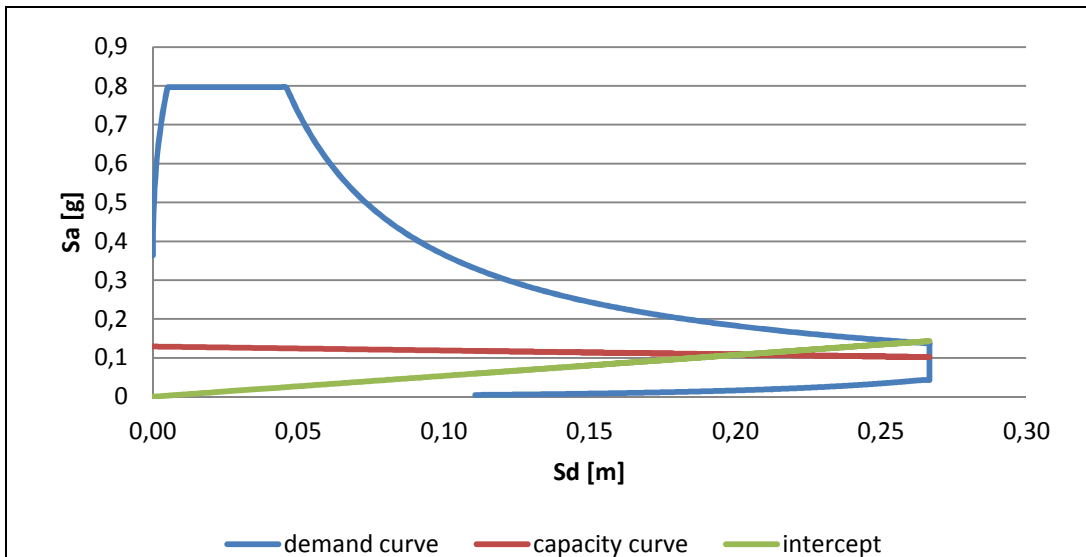
Figure A2.11 - Non-linear analysis of the main façade (simply supported)

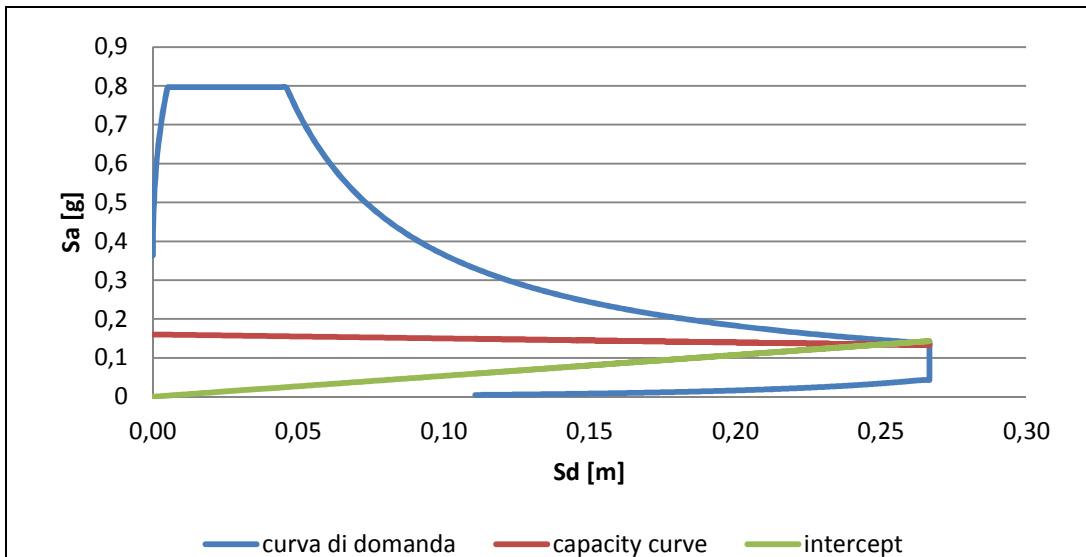
Figure A.2.12 - Non-linear analysis of the main façade (partially connected).

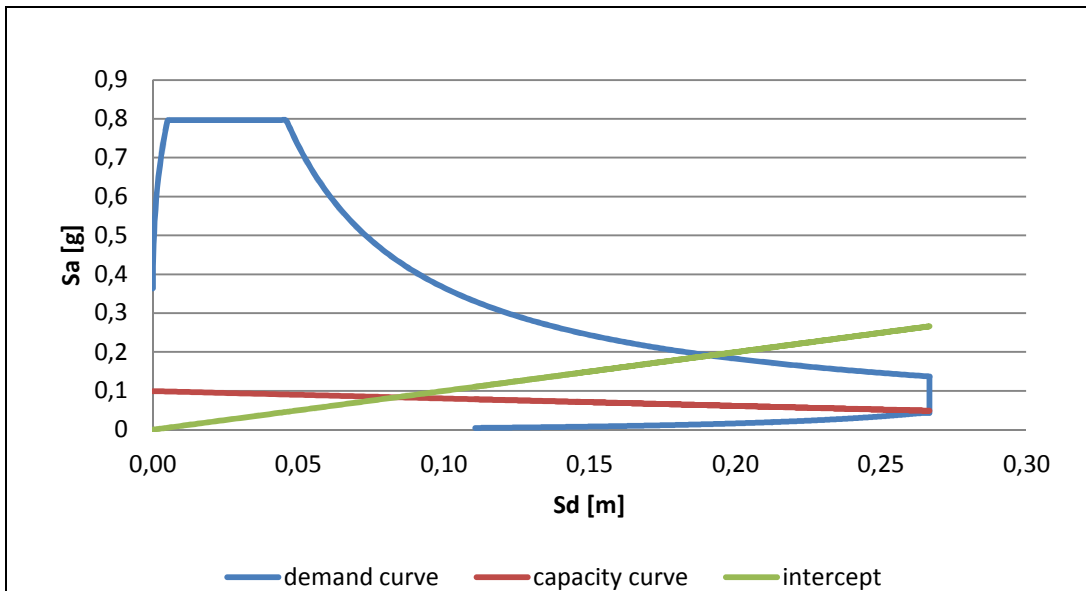
Figure A2.13 - Non-linear analysis of the lower wall of the lateral façade (simply supported)

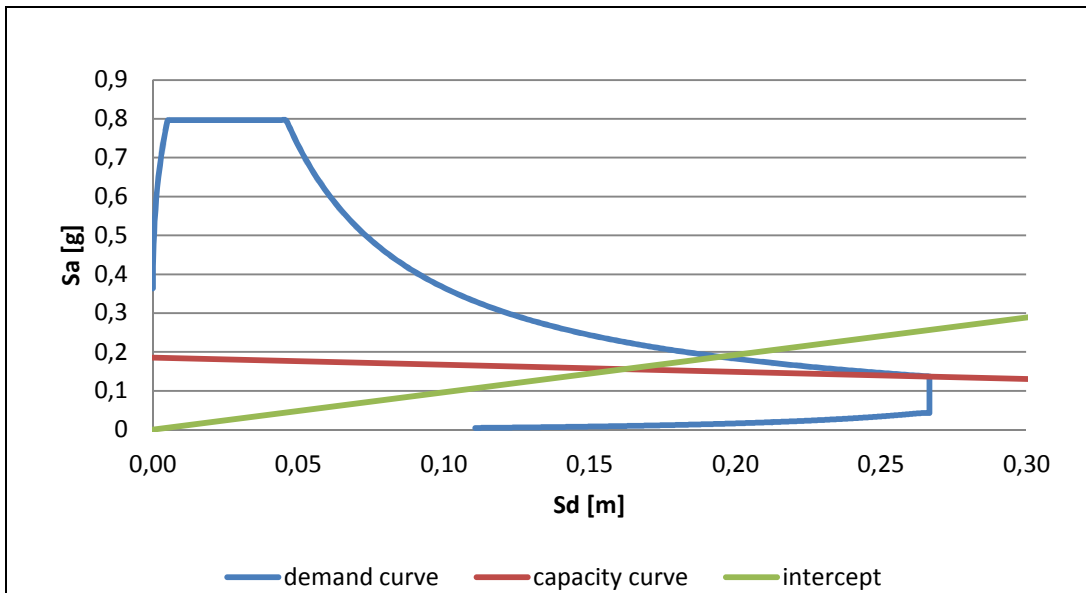
Figure A2.14 - Non-linear analysis of the lower wall of the lateral façade (horizontal deflection)

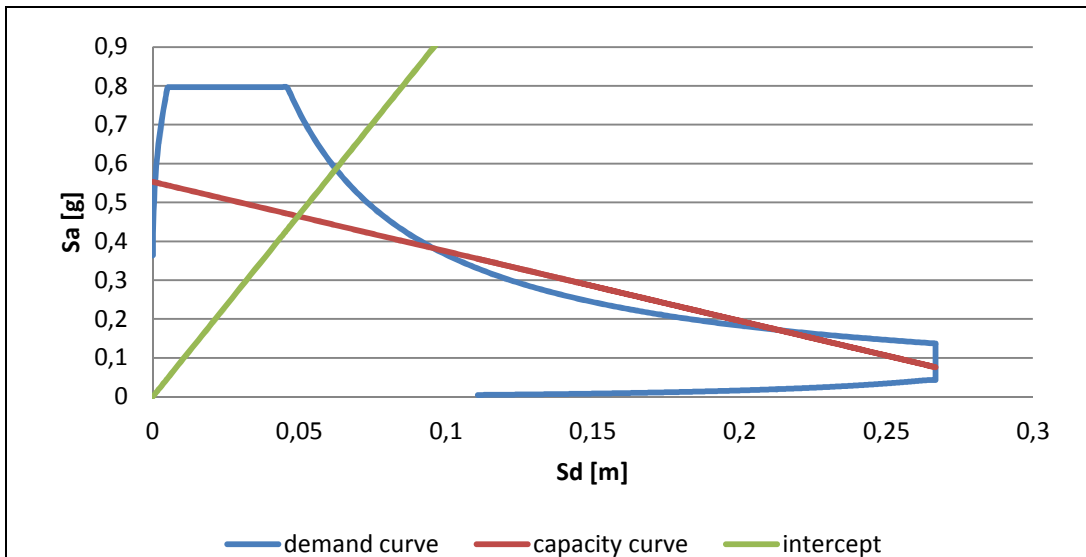
Figure A2.15 - Non-linear analysis of the top wall of the lateral façade (vertical deflection).

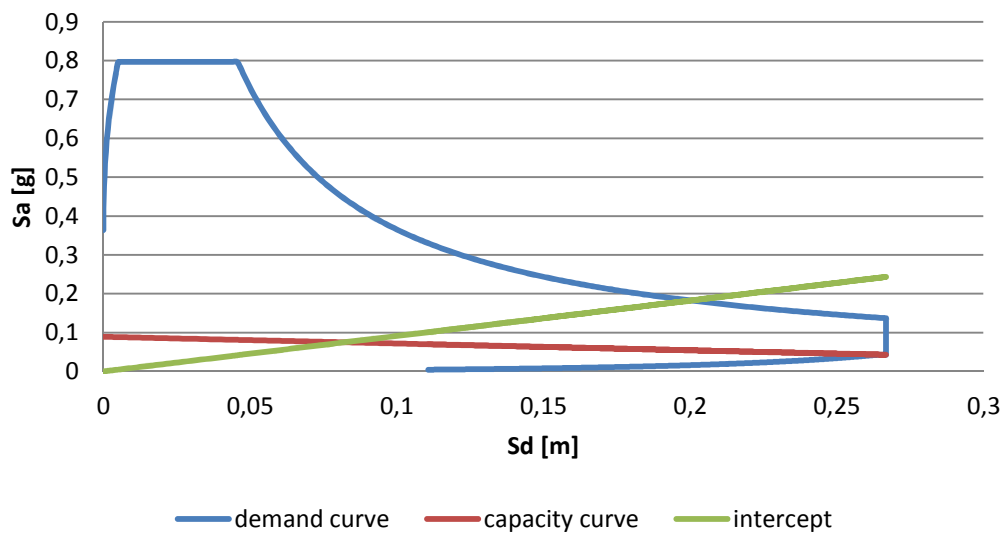
Figure A2.16 - Non-linear analysis of the top wall of the lateral facade (overturning).

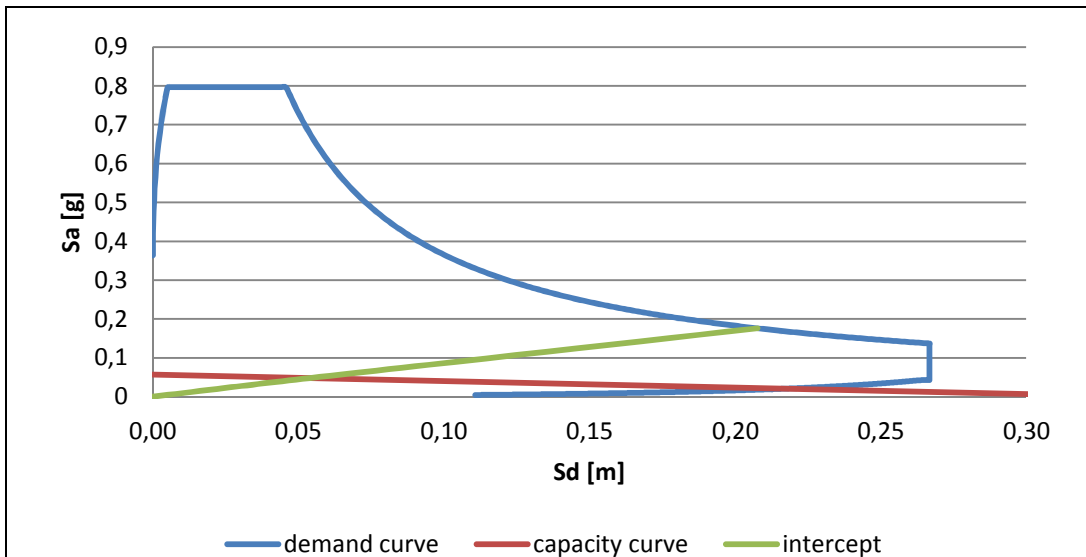
Figure A2.17 - Non-linear analysis of the top wall of the lateral façade (horizontal deflection)
