EVALUATION OF MULTIPLE CORROSION PROTECTION SYSTEMS FOR REINFORCED CONCRETE BRIDGE DECKS

Pooya Vosough Grayli

Submitted to the graduate degree program in Civil, Environmental, & Architectural Engineering
and the Graduate Faculty of the University of Kansas in partial fulfillment of the requirements
for the degree of Doctor of Philosophy.

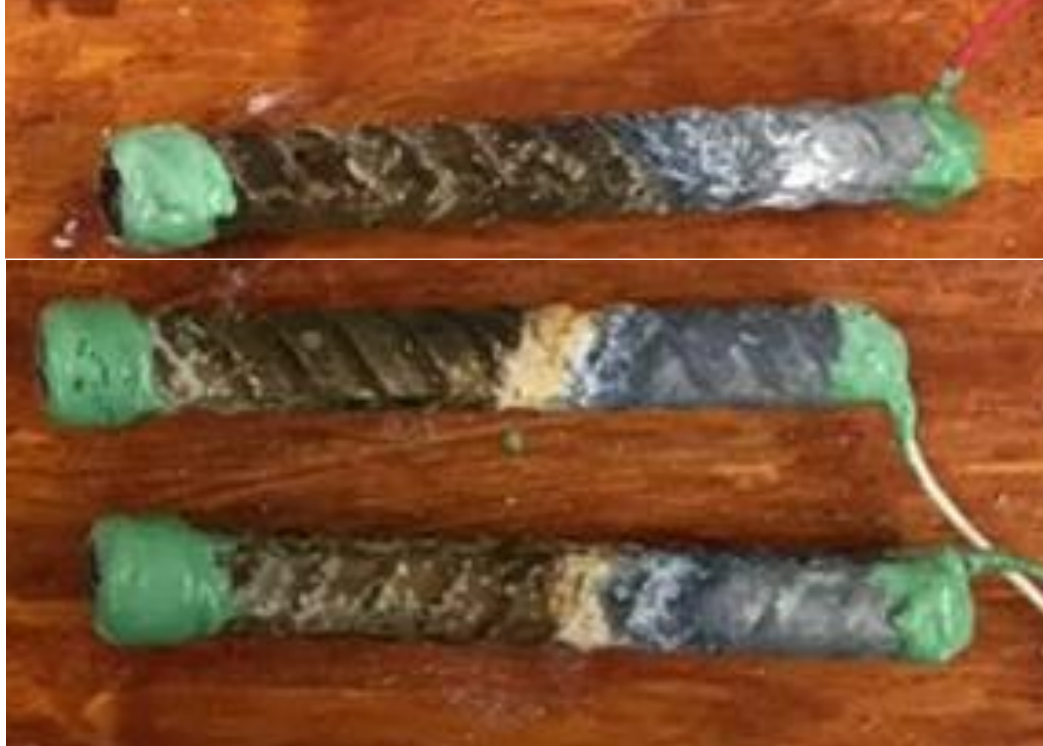
Figure 2.4: Specimen A767-1 anode bar (top) and cathode bars (bottom) after 15 weeks of rapid macrocell testing

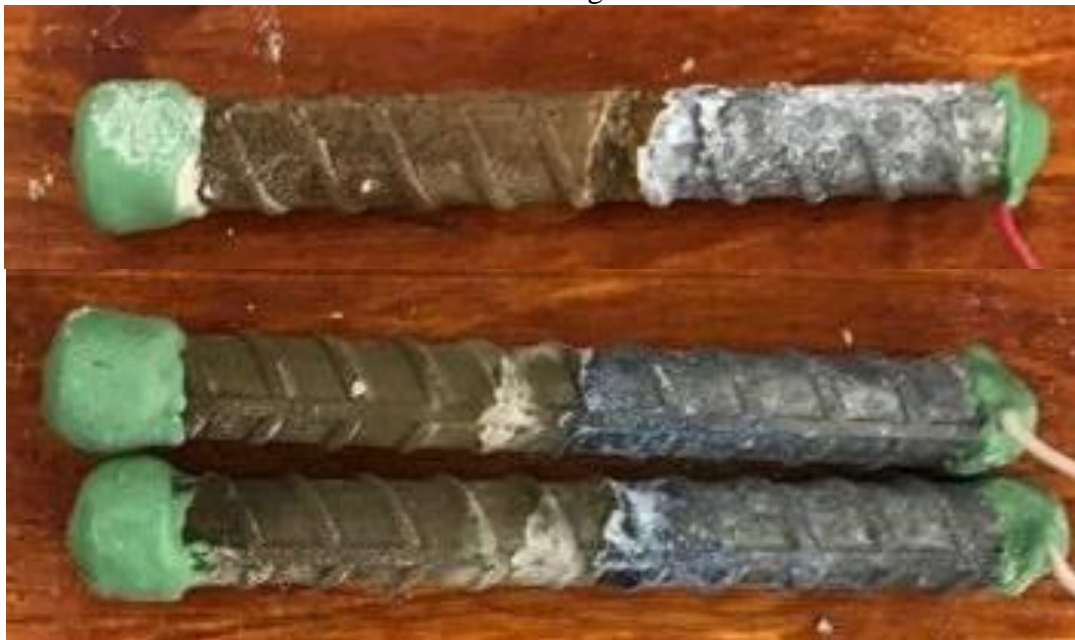
Figure 2.5: Specimen A1094-4 anode bar (top) and cathode bars (bottom) after 15 weeks of rapid macrocell testing

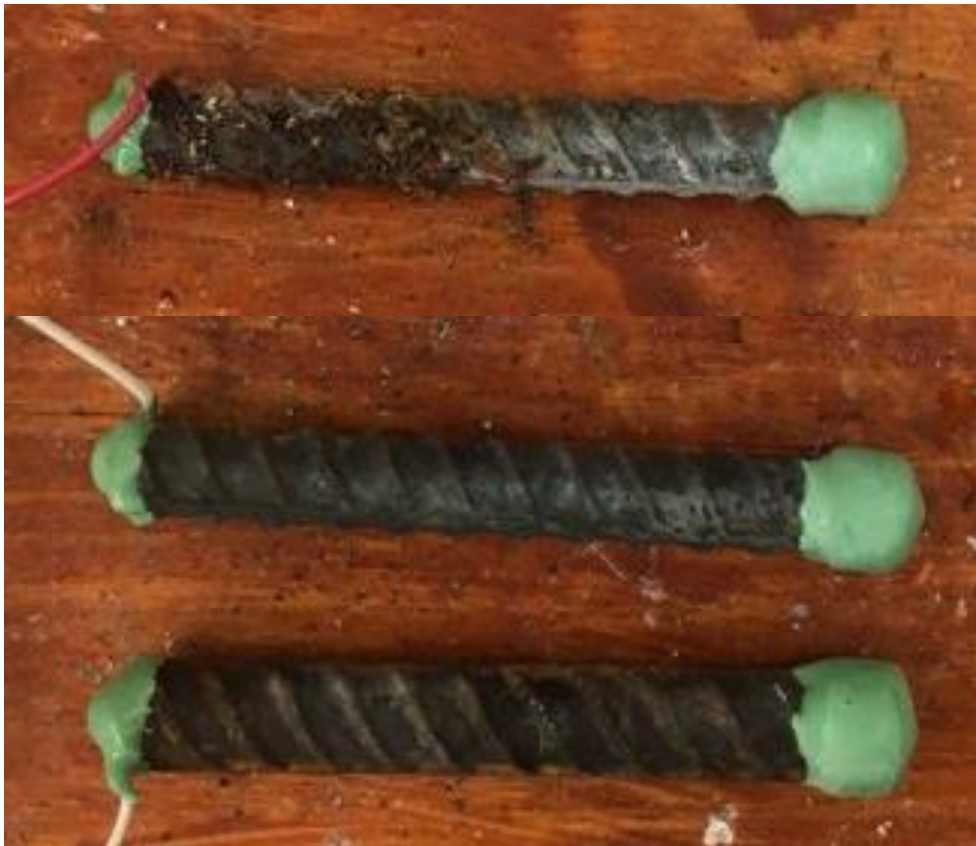
Figure 3.13: Specimen Conv-B-5 anode bar (top) and cathode bars (bottom) after 15 weeks of rapid macrocell testing

level. The corrosion above 3 in. is due to more oxygen availability above the solution surface. Also, corrosion products tend to separate from the surface of the bar in the pore solution, reducing the amount of corrosion products remaining on the bar in this region. No corrosion products were found on the cathode bars (the bars immersed in the pore solution without NaCl).

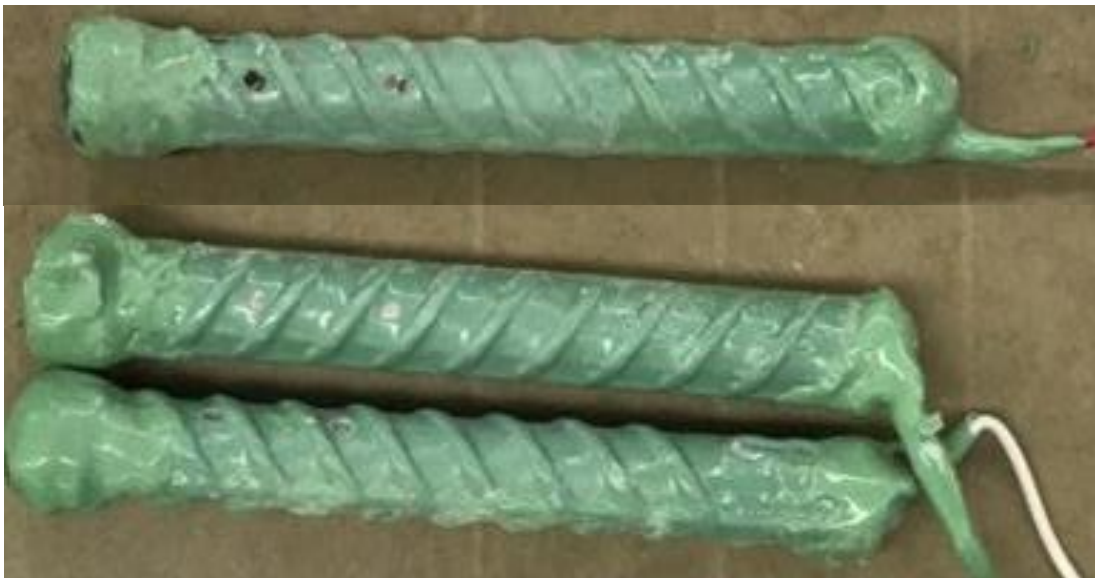
Figure 3.14 shows specimen ECR1-2 after 15 weeks of testing. Some of the intentional damage sites on the anode bars had rust, while others appeared clean. No blistering was visible on the undamaged portions of the coating. No signs of corrosion were visible on undamaged bars; Figure 3.15 shows specimen ECR1-Bent-5 after testing; no signs of corrosion are visible. The darkened area in the figure is the area patched after being damaged due to bending.

Figure 3.14: Specimen ECR1-2 anode bar (top) and cathode bars (bottom) after 15 weeks of rapid macrocell testing

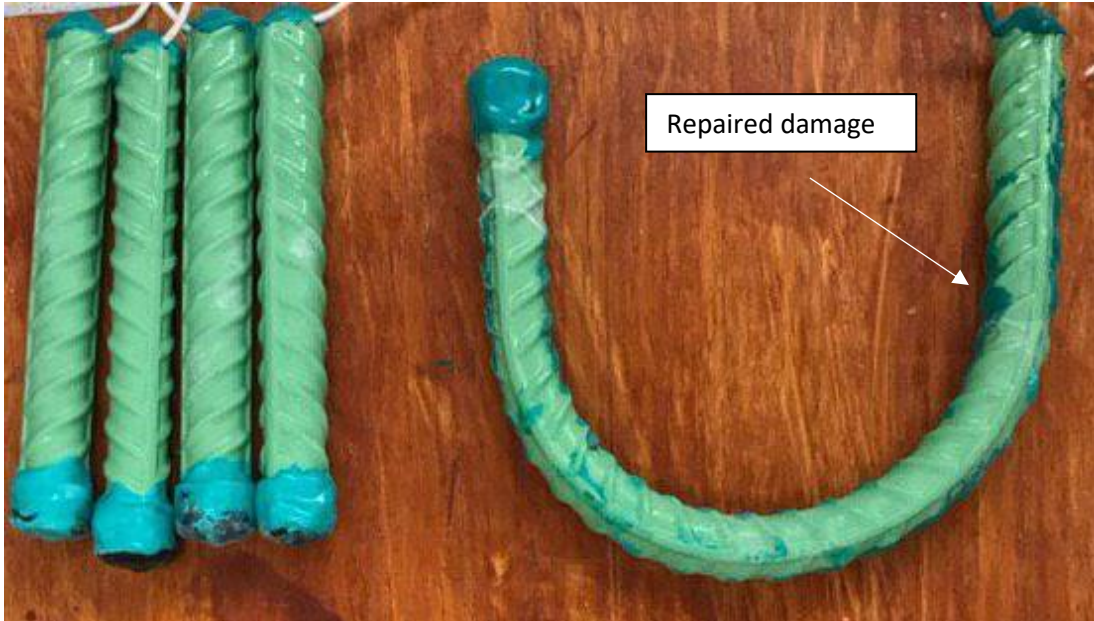
Figure 3.15: Specimen ECR1-5 anode bar (right) and cathode bars (left) after 15 weeks of rapid macrocell testing

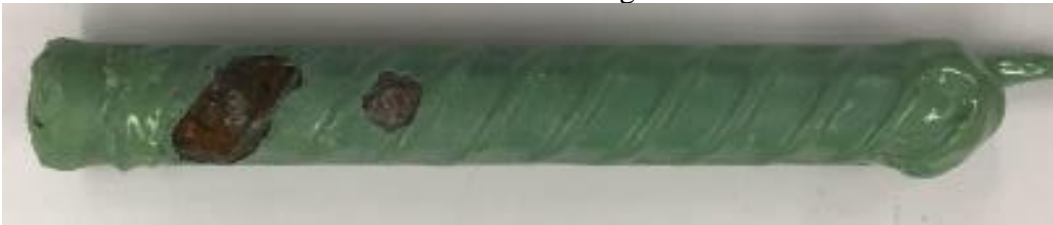
A disbondment test, as described in Chapter 2, was performed on the anodes of all damaged ECR after testing. Figure 3.16 shows the anode bar for specimen ECR1-2 after the disbondment

test; a portion of the coating disbonded from the underlying metal both at sites without and with visible corrosion at the hole. Figures 3.17 and 3.18 show the anode bar for specimen ECR1-UV-1000-4 before and after the disbondment test, respectively. Figures 3.19 through 3.21 show the anode bars for ECR specimens with 500, 200, and 100 hours of UV exposure, respectively, after the disbondment test; corrosion products were visible at all damage sites and the coating peeled back readily; UV caused discoloration on the coating of ECR specimens, even on bars with lower periods of exposure. Figure 3.22 shows specimen ECR-UV-1000-ND-6 after the test; no disbondment occurred on any of the undamaged bars.

Figure 3.16: Specimen ECR1-2 anode bar after disbondment test

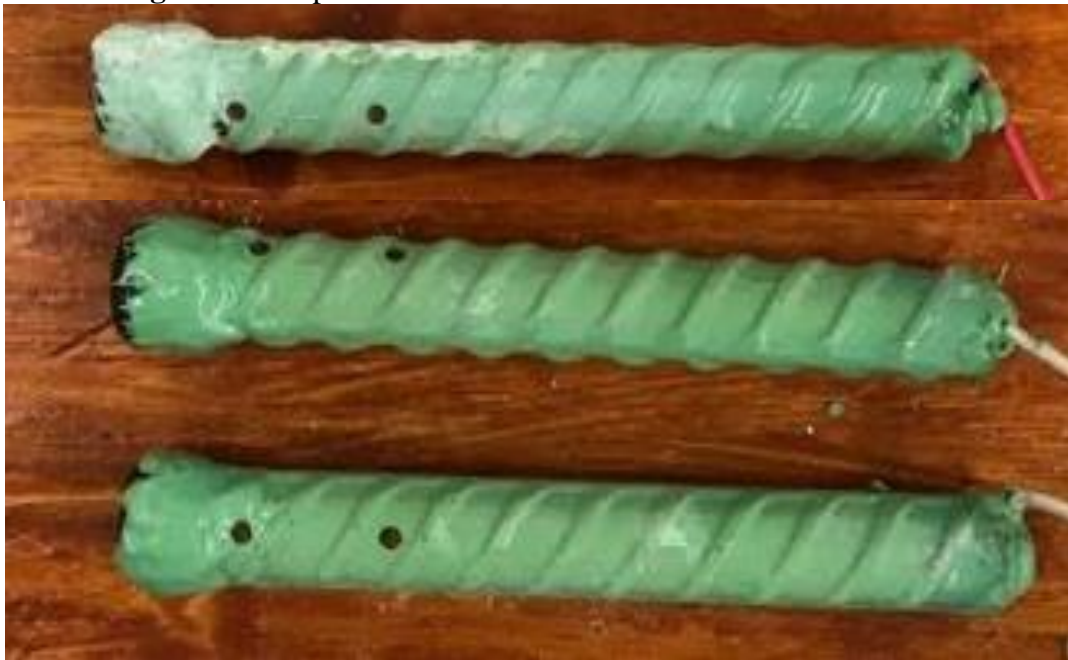
Figure 3.17: Specimen ECR1-UV-1000-4 anode bar (top) and cathode bars (bottom) after 15 weeks of rapid macrocell testing

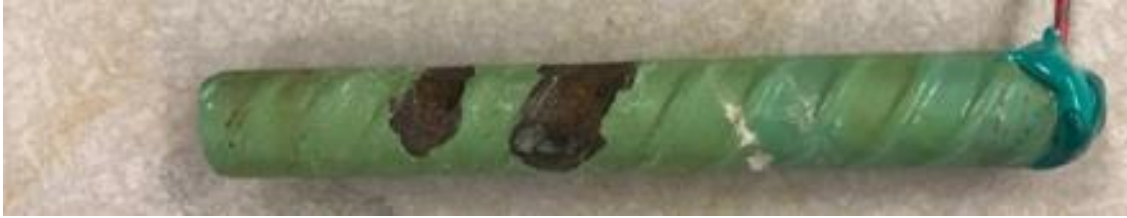
Figure 3.18: Specimen ECR1-UV-1000-4 anode after disbondment test

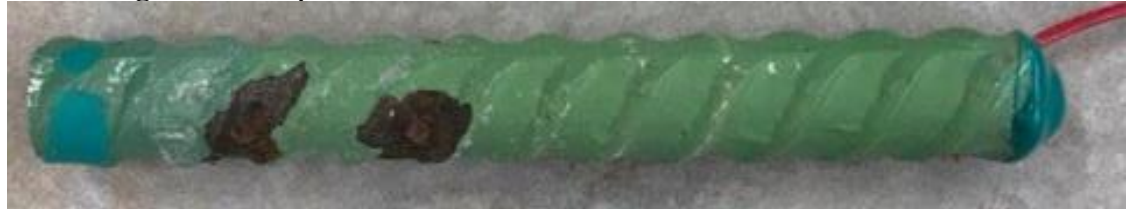
Figure 3.19: Specimen ECR1-UV-500-5 anode bar after disbondment test

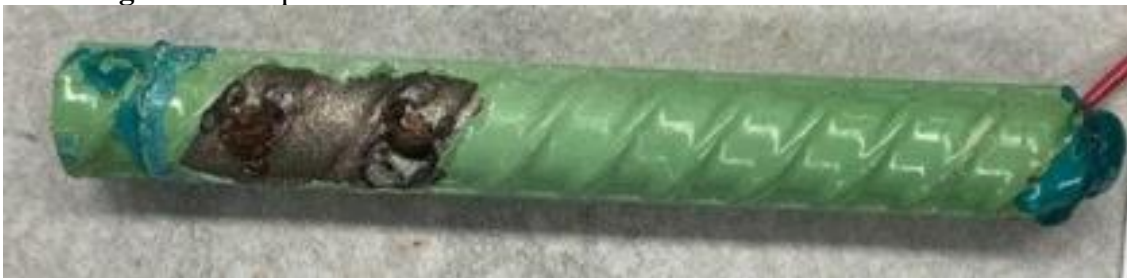
Figure 3.20: Specimen ECR2-UV-200-3 anode bar after disbondment test

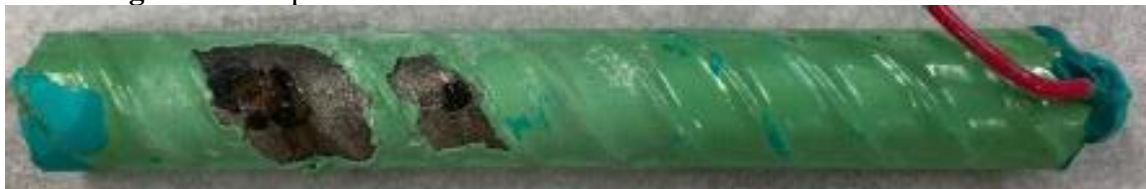
Figure 3.21: Specimen ECR2-UV-100-4 anode bar after disbondment test

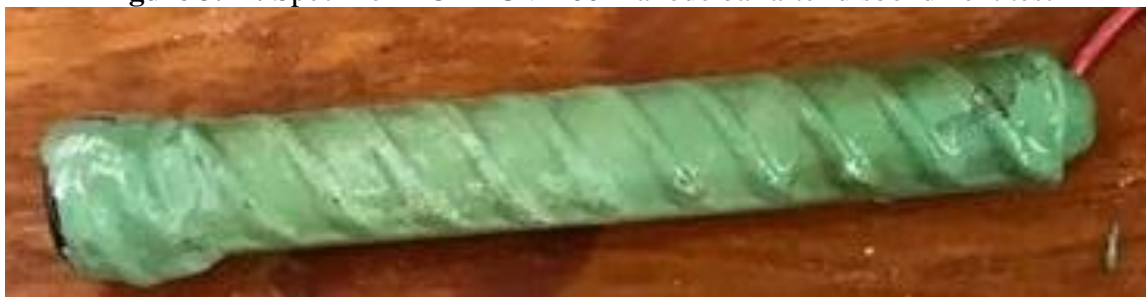
Figure 3.22: Specimen ECR-UV-1000-ND-6 anode bar after 15 weeks of rapid macrocell testing

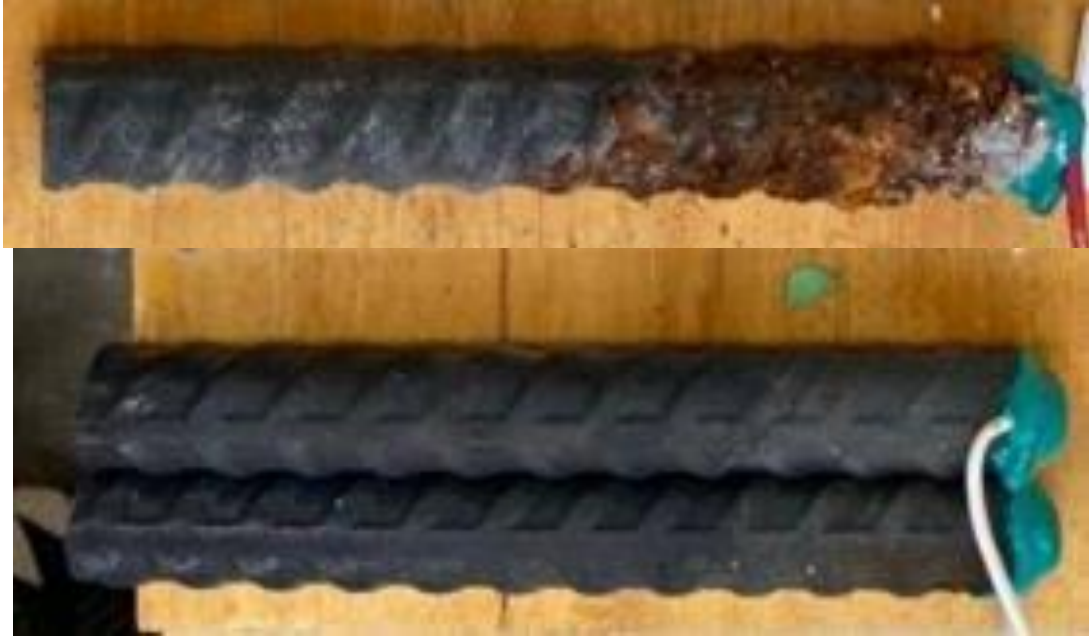
Figure 3.23 shows specimen ChromX-6 after 15 weeks of testing and is representative of the ChromX specimens in the rapid macrocell test; corrosion products are visible on the anode bar, particularly at and above the 3-in. pore solution level. No corrosion products were observed on the cathode bars.

Figure 3.23: Specimen ChromX-6 anode bar (top) and cathode bars (bottom) after 15 weeks of rapid macrocell testing

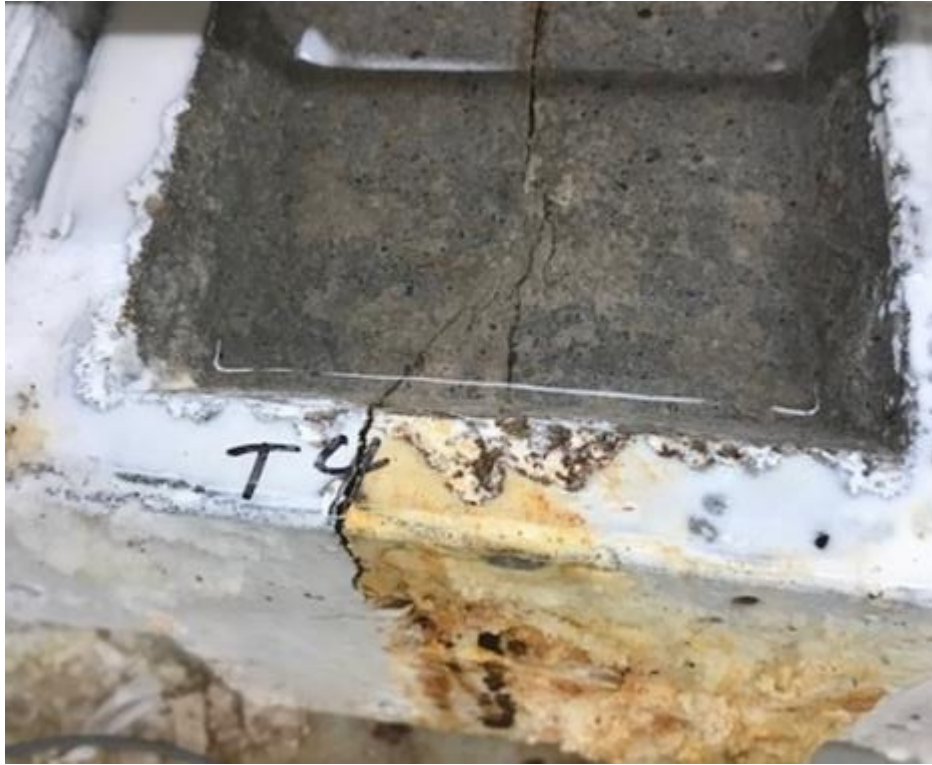
Five out of the seven cracked beam specimens with Conv-B reinforcement (Conv-B-3 through Conv-B-7) exhibited enough corrosion to crack the concrete (Figure 3.28). These specimens were removed from testing at weeks 49, 67, 77, 83, and 84 (Table 3.11).

Figure 3.28: Cracking of the concrete in specimen Conv-B-3 during the cracked beam test

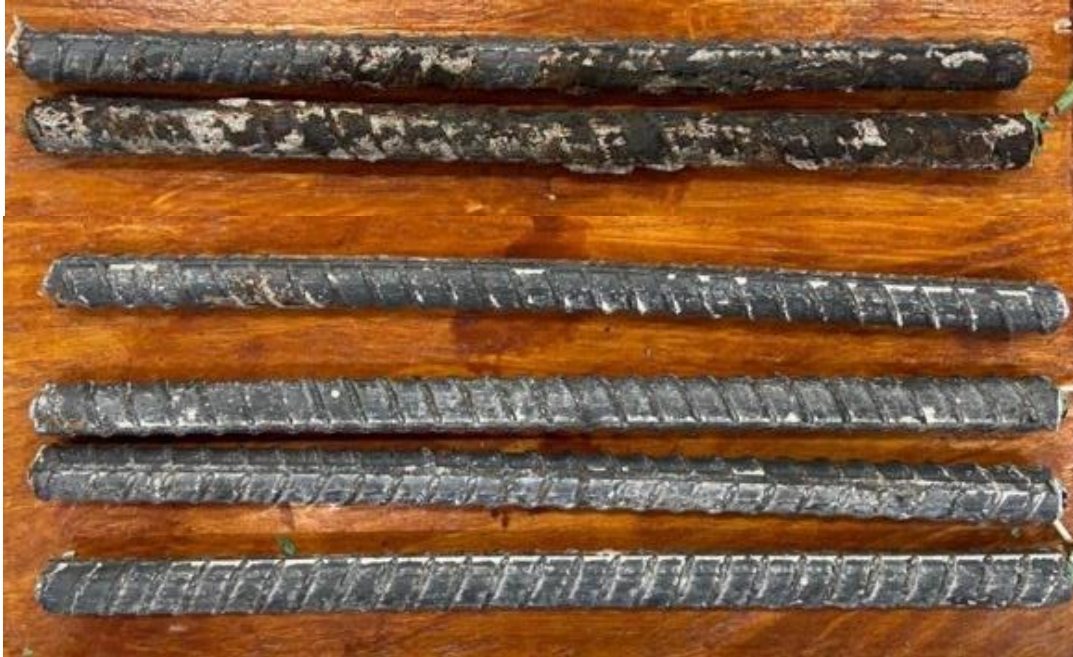
Figure 3.55 shows the bars from specimen SE-Conv-C-1 after 96 weeks of testing and is representative of all conventional reinforcement in the Southern Exposure test. A moderate amount of corrosion was visible on both top bars, although corrosion did not cover the entire surface of the bars. Corrosion caused staining on the surface of the specimens, as shown in Figure 3.56. A small amount of corrosion was visible on the bottom bars.

Figure 3.55: Top bars (top) and bottom bars (bottom) of specimen SE-Conv-C-1 after 96 weeks of testing

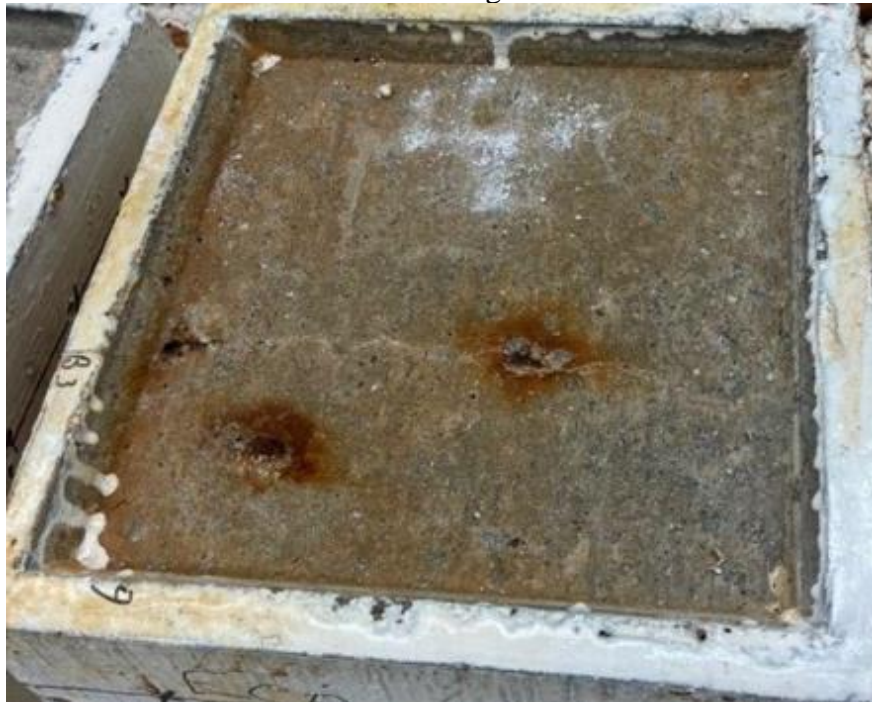
Figure 3.56: Surface staining on Southern Exposure specimen with conventional reinforcement

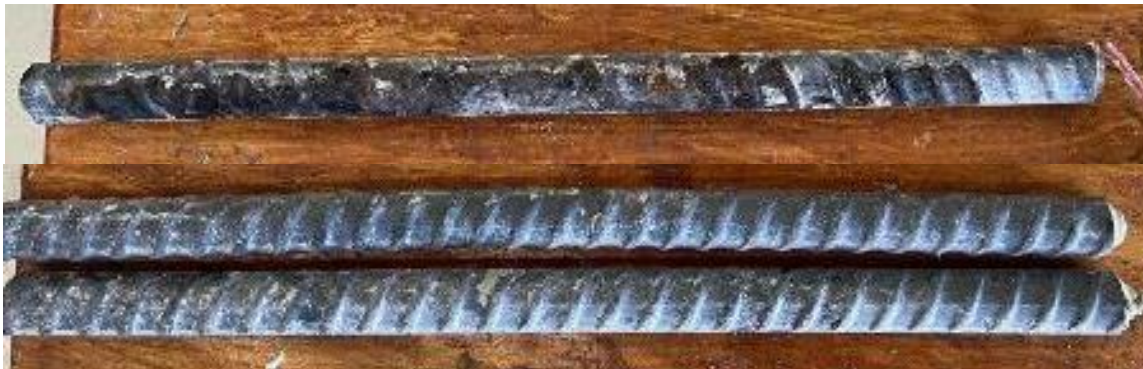
Figure 3.57 shows the bars from specimen CB-Conv-B-4 after 96 weeks of testing and is representative of all conventional reinforcement in the cracked beam test. A heavy amount of corrosion was visible on the top bar, with some pitting and deeper localized corrosion occurring,

particularly in the region directly under the 6-in. simulated crack. Similar to the Southern Exposure specimens, most cracked beam specimens with conventional reinforcement exhibited staining on the surface, as shown in Figure 3.58. Light or no corrosion products were visible on the bottom bars.

Figure 3.57: Top bar (top) and bottom bars (bottom) of specimen CB-Conv-B-4 after 96 weeks of testing

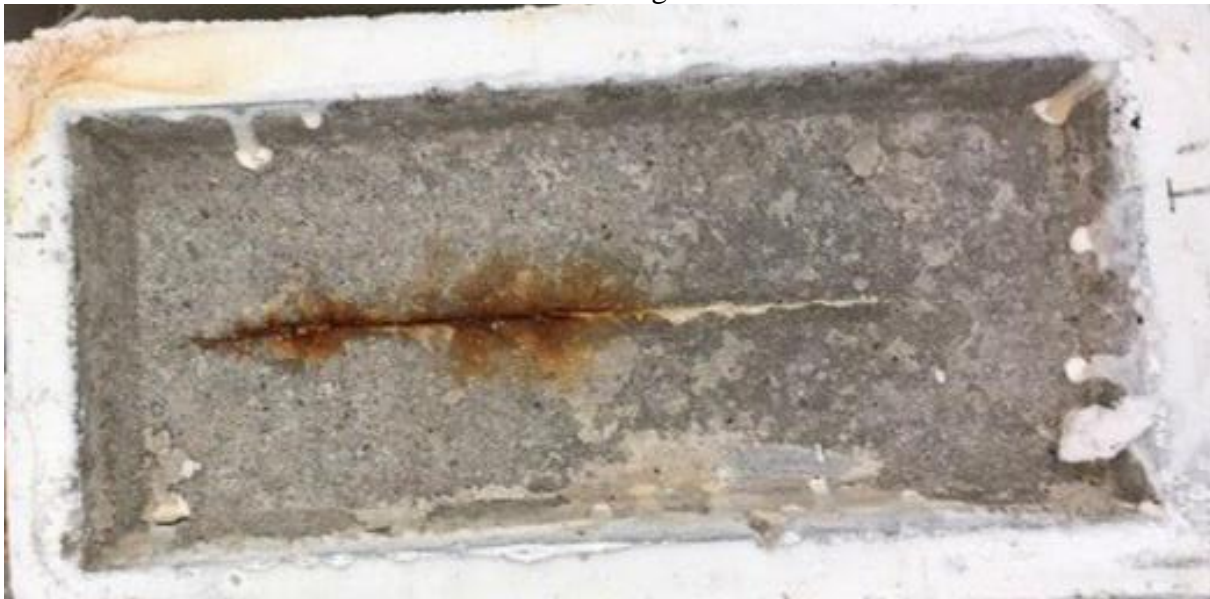
Figure 3.58: Surface staining on the cracked beam specimen with conventional reinforcement

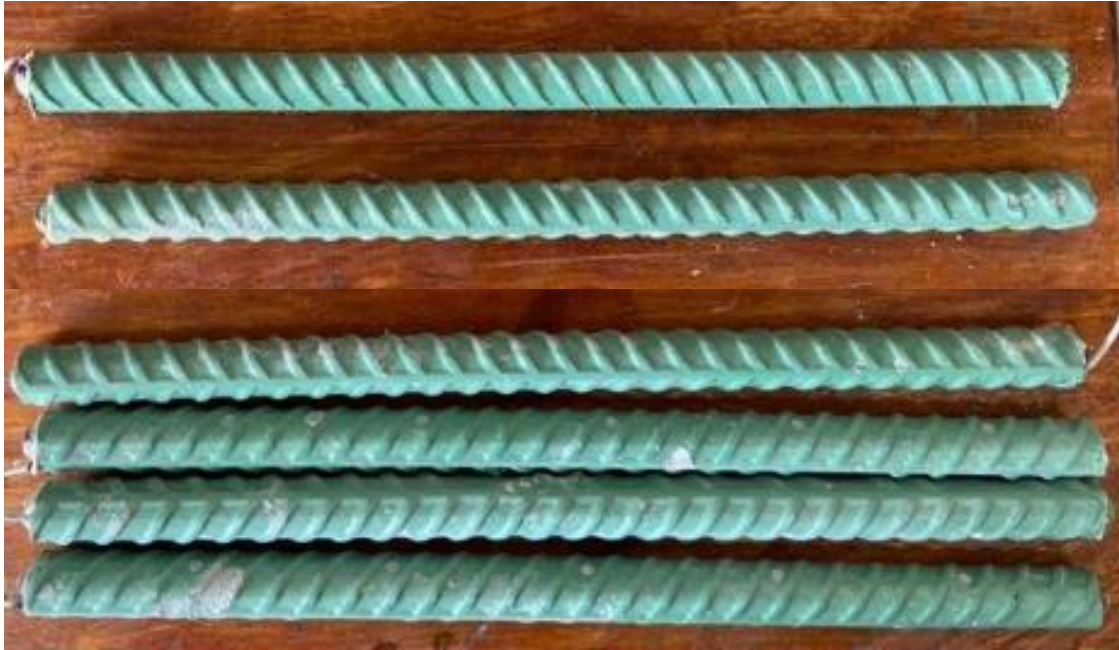
Figure 3.59 shows the bars from specimen SE-ECR1-2 after 96 weeks of testing and is representative of all damaged ECR in the Southern Exposure test. A minimal amount of corrosion damage was visible; corrosion was typically limited to small amounts at the damage sites. Figure

Figure 3.59: Top bars (top) and bottom bars (bottom) of specimen SE-ECR1-2 after 96 weeks of testing

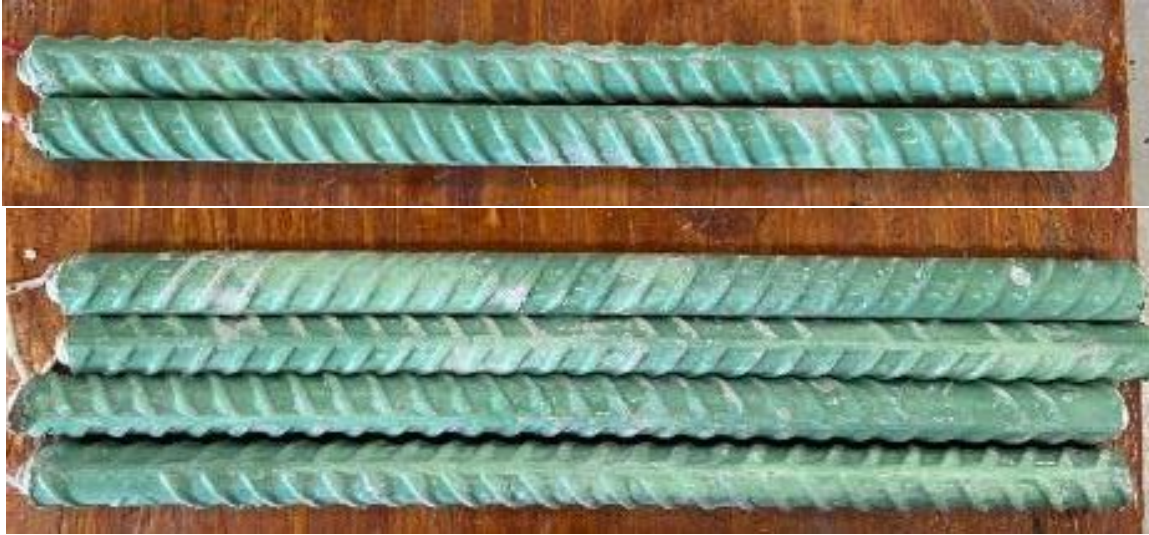
3.60 shows the top bar of specimen SE-ECR1-1 after the disbondment test; no disbondment was observed on any Southern Exposure specimens. Figure 3.61 shows undamaged ECR specimen SE-ECR1-ND-2 after 96 weeks of testing. No corrosion was observed on any ECR1-ND specimens.

Figure 3.61: Top bars (top) and bottom bars (bottom) of specimen SE-ECR1-ND-2 after 96 weeks of testing

Figure 3.66 shows the bars from specimen SE-ECR1-UV-1000-1 after 96 weeks of testing and is representative of all ECR-UV-1000 Southern Exposure specimens on which much larger amounts of corrosion damage were visible than on damaged ECR specimens without UV exposure. Figure 3.67 shows a top bar of specimen SE-ECR1-UV-1000-1, which exhibited total disbondment; damaged ECR bars exhibited disbondment after exposure, and the entire coating easily peeled back for most of the bars. This is in contrast to the specimens without UV exposure that did not show any disbondment (Figure 3.61).

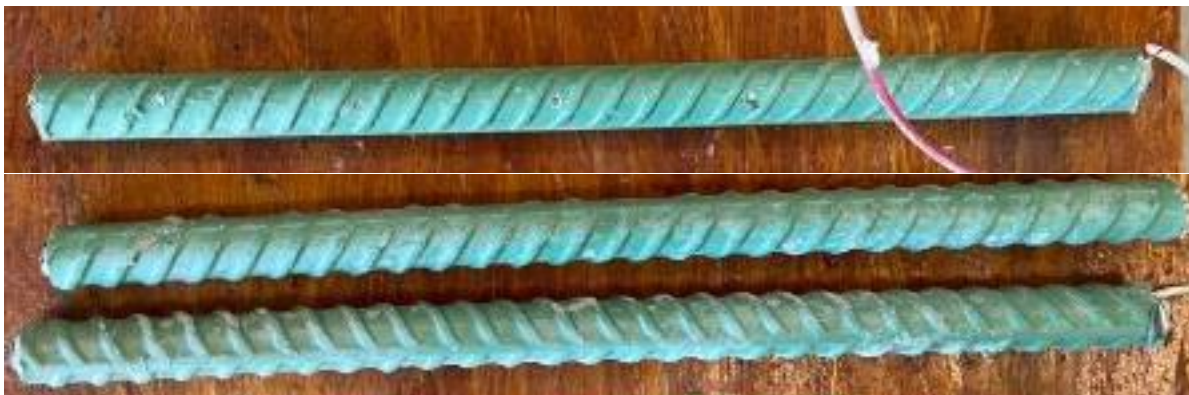
Figure 3.62 shows the bars from specimen CB-ECR-3 after 96 weeks of testing and is representative of all damaged ECR in the cracked beam test. A minimal amount of corrosion damage was visible on the bars, limited to the damage sites in the top bar. Figure 3.63 shows the top bar of CB-ECR1-2 after the disbondment test. Unlike the damaged bars in the Southern Exposure test, damaged ECR bars without UV exposure exhibited disbondment in the cracked beam test, with corrosion underneath the undamaged portions of the coating.

Figure 3.62: Top bar (top) and bottom bars (bottom) of specimen CB-ECR1-3 after 96 weeks of testing

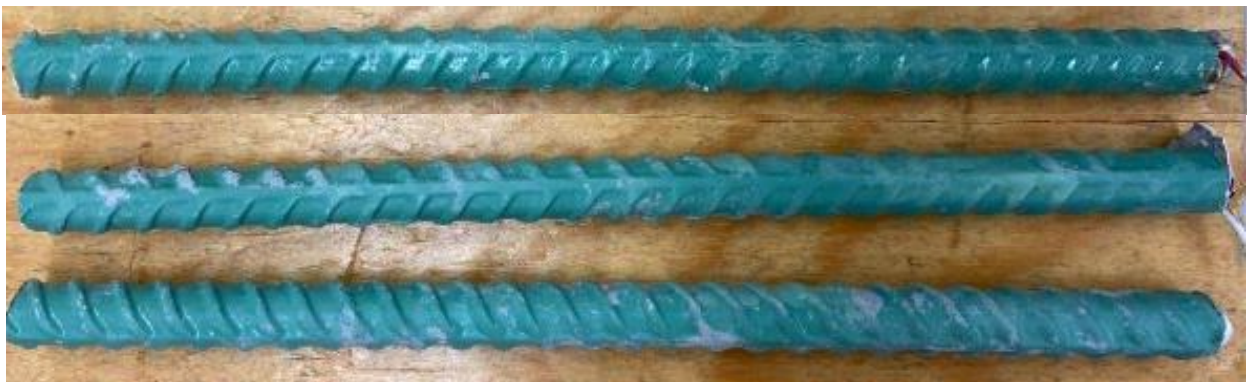
Figures 3.64 and 3.65 show undamaged ECR after 96 weeks of testing in the cracked beam test. Two out of three of the undamaged ECR specimens showed no visible corrosion (Figure 3.64); specimen CB-ECR1-ND-1, however, showed some rust buildup at a previously unnoticed damage site in the coating (Figure 3.65). Disbondment tests were not performed on the undamaged bars.

Figure 3.64: Top bars (top) and bottom bars (bottom) of specimen CB-ECR1-ND-2 after 96 weeks of testing

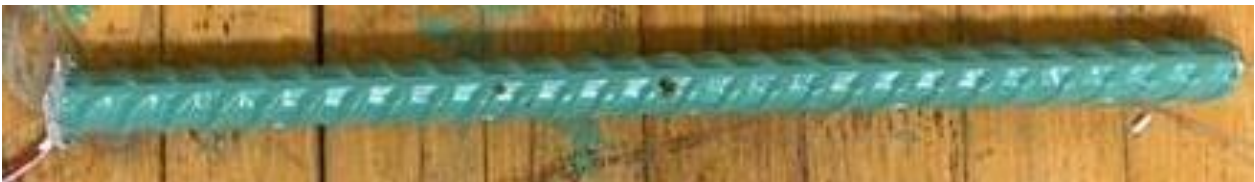
Figure 3.65: Top bar of specimen CB-ECR1-ND-1 after 96 weeks of testing

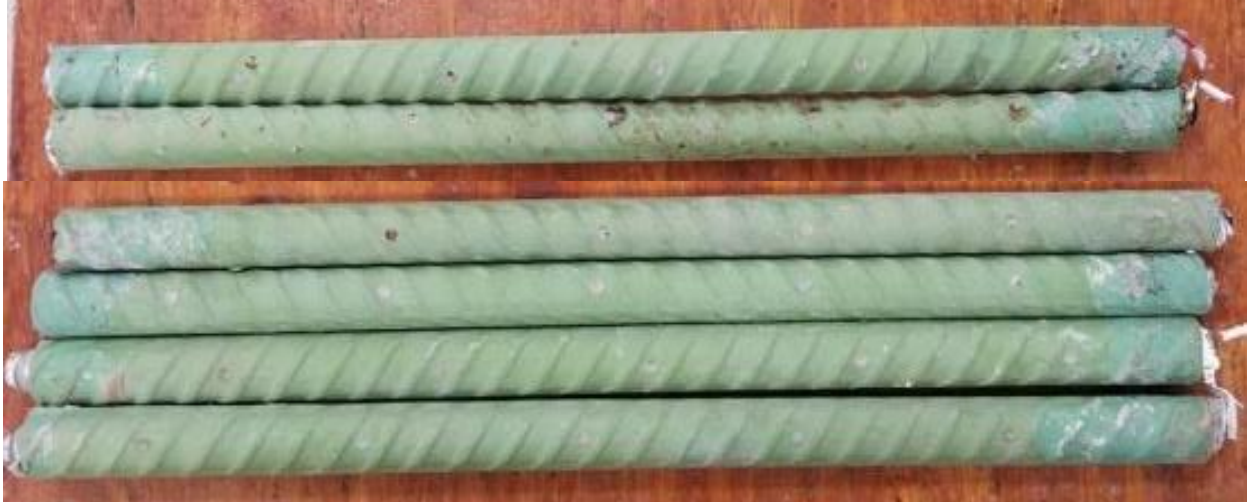
Figure 3.66: Top bars (top) and bottom bars (bottom) of specimen SE-ECR1-UV-1000-1 after 96 weeks of testing

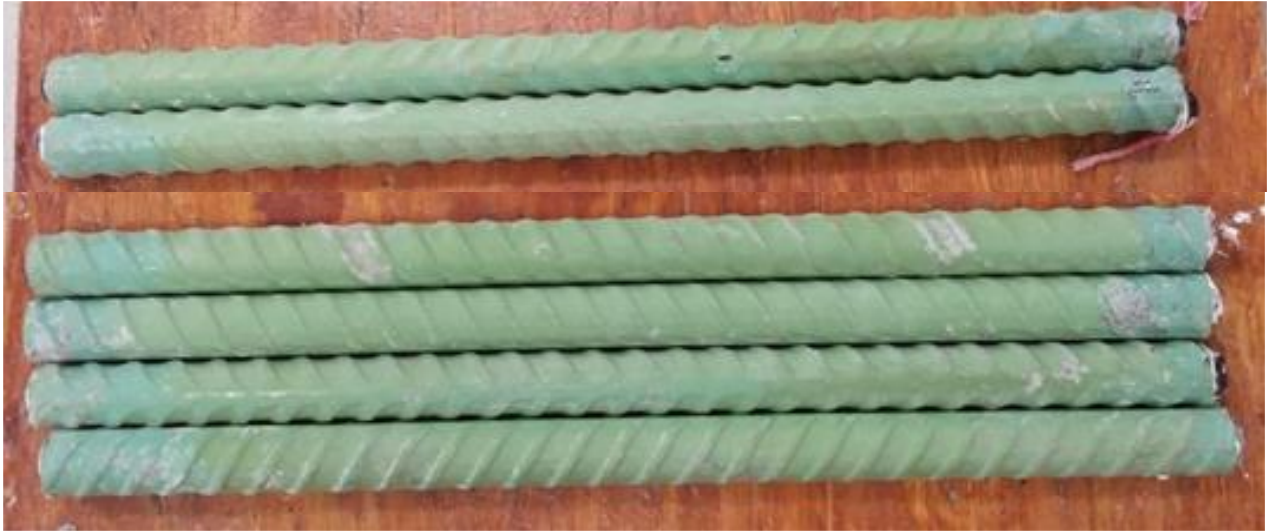
Figure 3.68 shows the bars from specimen SE-ECR1-UV-1000-ND-1 after 96 weeks of testing and is representative of all ECR1-UV-1000-ND specimens in the Southern Exposure test. Minimal to no corrosion damage was observed on the bars, but discoloration from the UV exposure was visible.

Figure 3.68: Top bars (top) and bottom bars (bottom) of specimen SE-ECR1-UV-1000-ND-1 after 96 weeks of testing

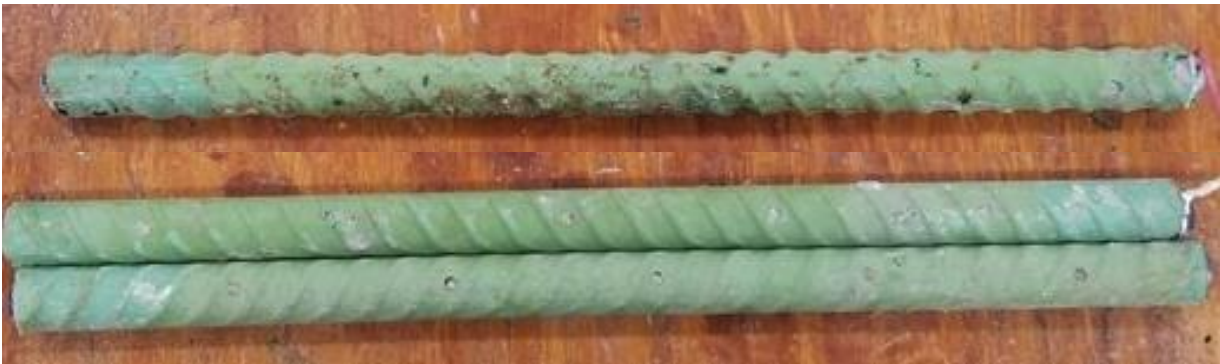
Figure 3.69 shows the bars from specimen CB-ECR1-UV-1000-1 after 96 weeks of testing and is representative of all ECR1-UV-1000 cracked beam specimens on which larger amounts of corrosion damage were visible than for the damaged ECR specimens without UV exposure. Blistering and cracking of the coating were observed on all top bars. Figure 3.70 shows the top bar of specimen CB-ECR1-UV-1000-2 after the disbondment test; damaged ECR bars with UV exposure exhibited disbondment after exposure, and the entire coating easily peeled back on every bar tested.

Figure 3.69: Top bar (top) and bottom bars (bottom) of specimen CB-ECR1-UV-1000-2 after 96 weeks of testing

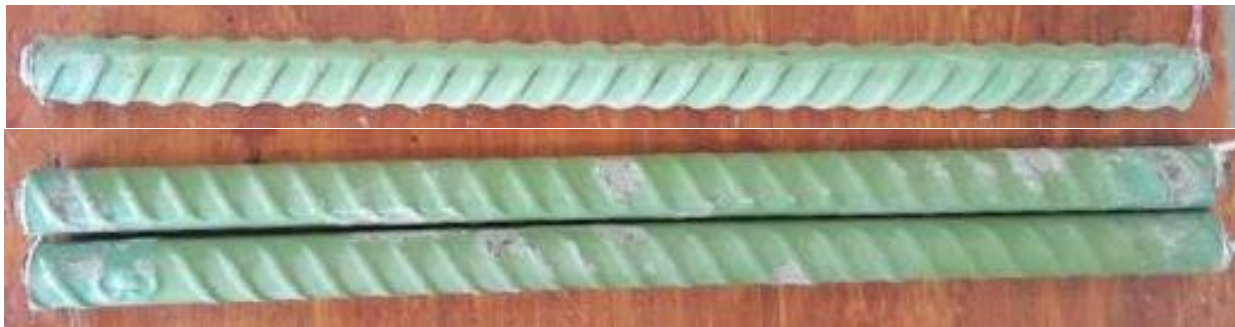
Figure 3.71 shows the bars from specimen CB-ECR1-UV-1000-ND-1 after 96 weeks of testing and is representative of all ECR1-UV-1000-ND specimens in the cracked beam test. Similar to the undamaged cracked beam without UV exposure, minimal to no corrosion damage was observed on the bars, but discoloration from the UV exposure was visible. No disbondment was observed.

Figure 3.71: Top bar (top) and bottom bars (bottom) of specimen CB-ECR1-UV-1000-ND-1 after 96 weeks of testing

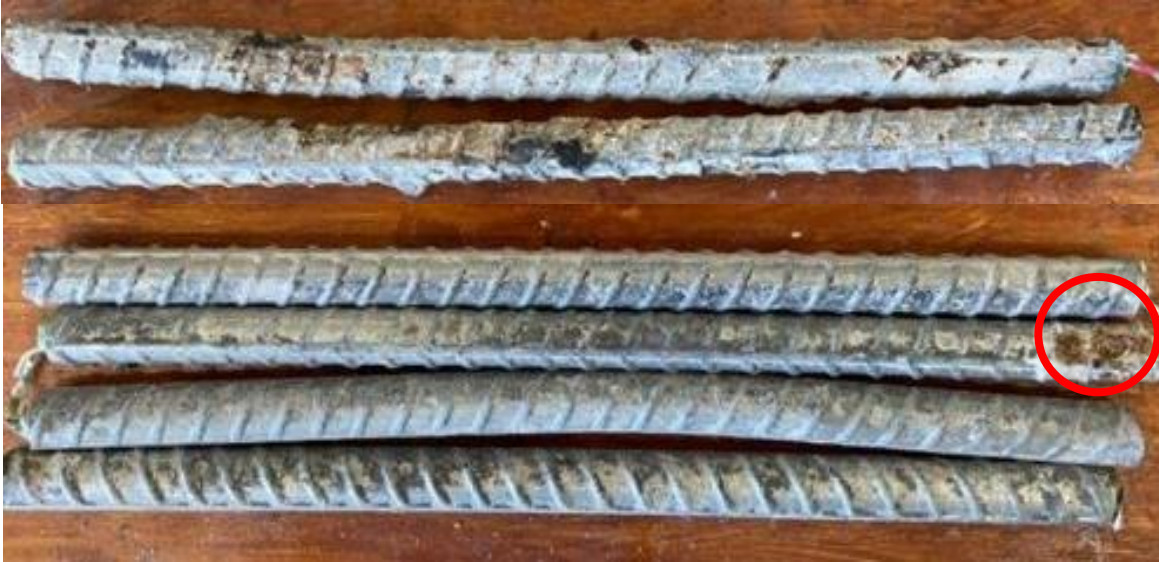
Figure 3.72 shows the bars from specimen SE-A767-2 after 96 weeks of testing and is representative of most of the A767 specimens in the Southern Exposure test. The top bars exhibited moderate to heavy amounts of corrosion with both zinc corrosion products (white) and steel corrosion products (orange-brown) visible. Corrosion was uneven; the zinc coating was intact in several places. Corrosion was present on the bottom as well the as top bars (Figure 3.72), explaining the “negative” corrosion loss observed. This also occurred on two out of six A767 Southern Exposure specimens.

Figure 3.72: Top bars (top) and bottom bars (bottom) of specimen SE-A767-2 after 96 weeks of testing

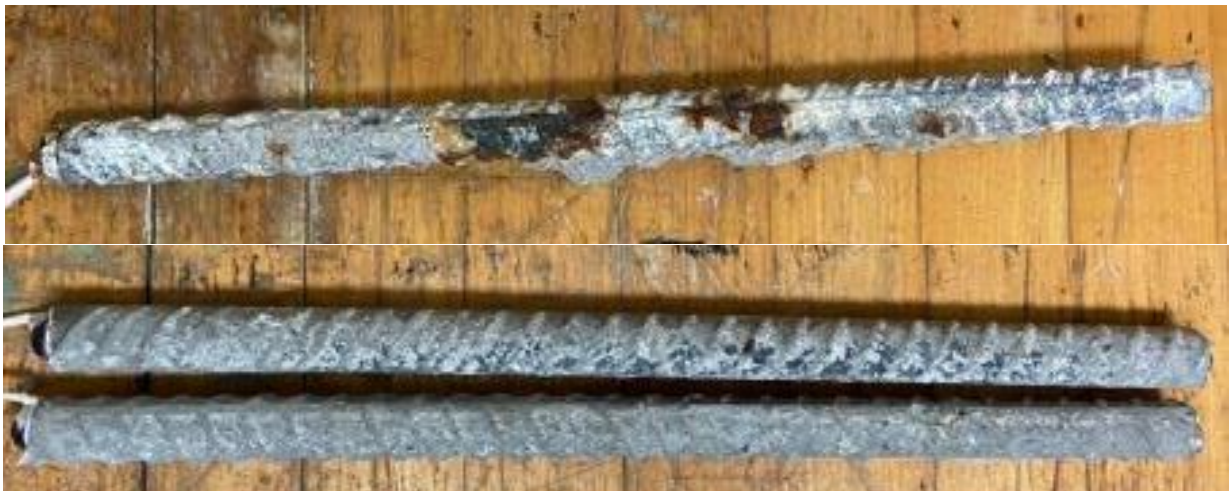
Figure 3.73 shows the bars from specimen CB-A767-3 after 96 weeks of testing, representative of all A767 bars in the cracked beam test. Similar to the Southern Exposure specimens, the top bar exhibited moderate to heavy amounts of corrosion with both zinc corrosion products (white) and steel corrosion products (orange-brown) visible. Fewer white zinc corrosion products were visible on the bottom bars, with isolated areas of steel corrosion products visible.

Figure 3.73: Top bar (top) and bottom bars (bottom) of specimen CB-A767-3 after 96 weeks of testing

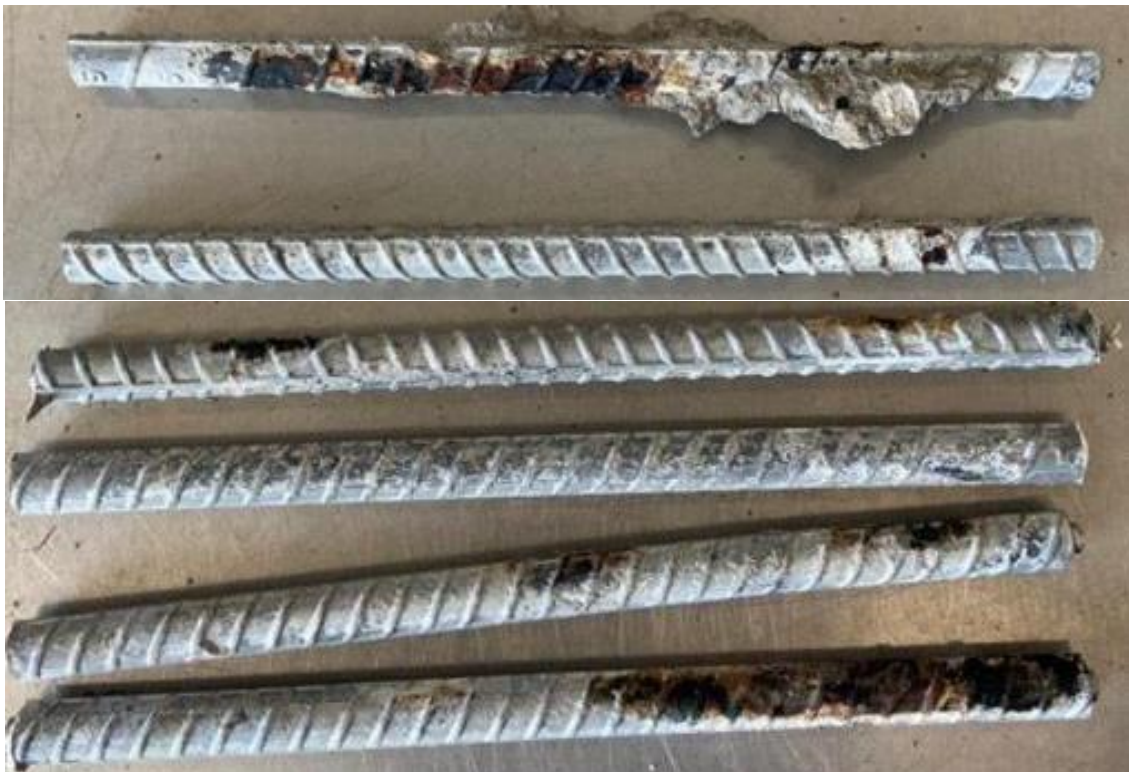
Figure 3.74: Top bars (top) and bottom bars (bottom) of specimen SE-A1094-4 after 96 weeks of testing

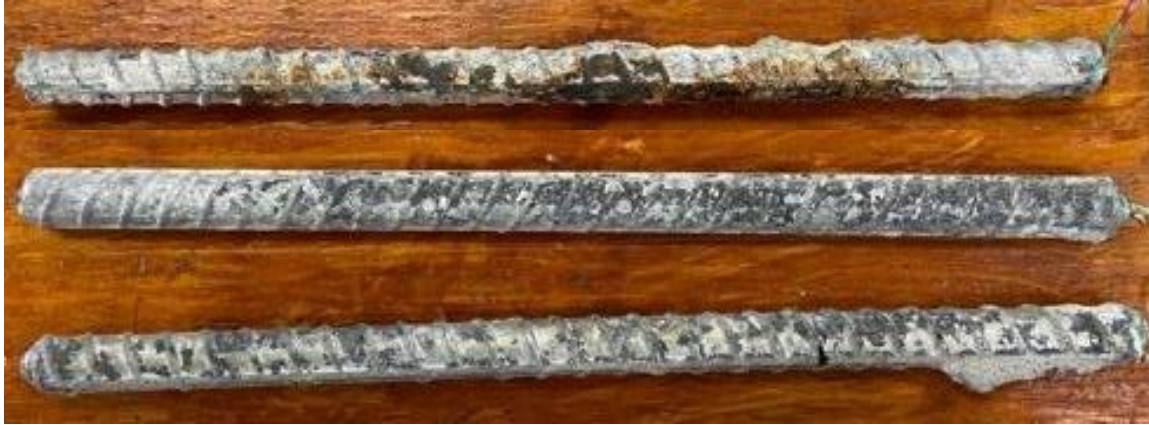
Figure 3.75 shows the bars from specimen CB-A1094-6 after 96 weeks of testing, representative of all A1094 specimens in the cracked beam test. The top bar exhibited a moderate amount of corrosion with both zinc corrosion products (white) and steel corrosion products (orange-brown) visible. Limited amounts of zinc corrosion products were observed on the bottom bars.

Figure 3.75: Top bar (top) and bottom bars (bottom) of specimen CB-A1094-6 after 96 weeks of testing

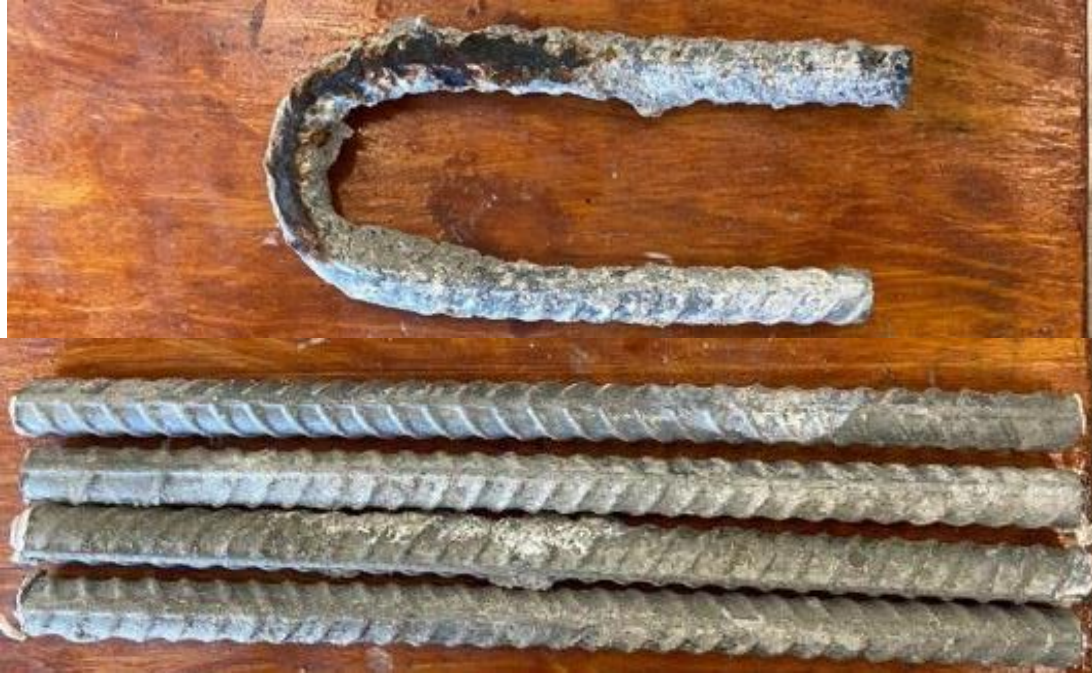
Figures 3.76 and 3.77 show the bars from specimens with bent A767 and A1094 bars, respectively, from the Southern Exposure test and are representative of all specimens with bent galvanized bars. Corrosion products are visible on the top bar both at and away from the bend on both types of bar. As discussed in Section 3.2.4 (total corrosion losses), the presence of the bend resulted in a statistically significant increase in corrosion when compared to straight bars. Limited amounts of zinc corrosion products were observed on the bottom bars of the A767 specimens. A moderate amount of corrosion with both zinc and steel corrosion products were visible on the bottom bars of the A1094 specimens. The greater amounts of steel corrosion products on the bottom A1094 bars are a result of the lower thickness of A1094 compared to A767 steel.

Figure 3.76: Top bar (top) and bottom bars (bottom) of specimen SE-Bent-A767-2 after 96 weeks of testing

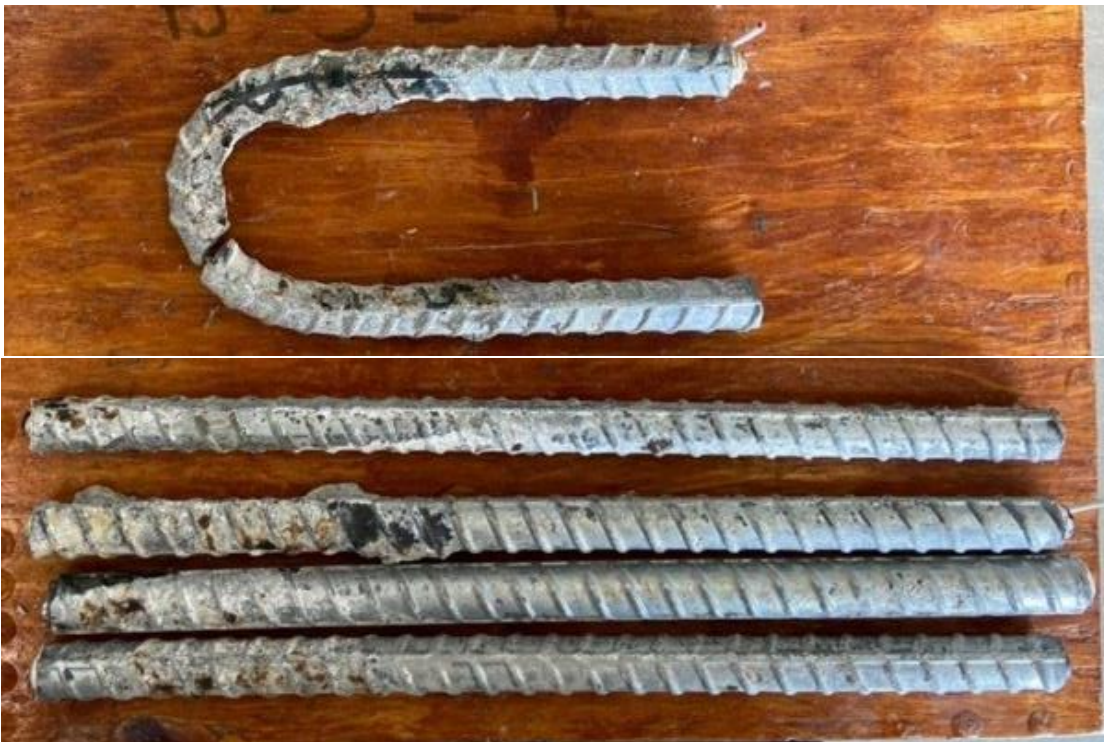
Figure 3.77: Top bar (top) and bottom bars (bottom) of specimen SE-Bent-A1094-2 after 96 weeks of testing

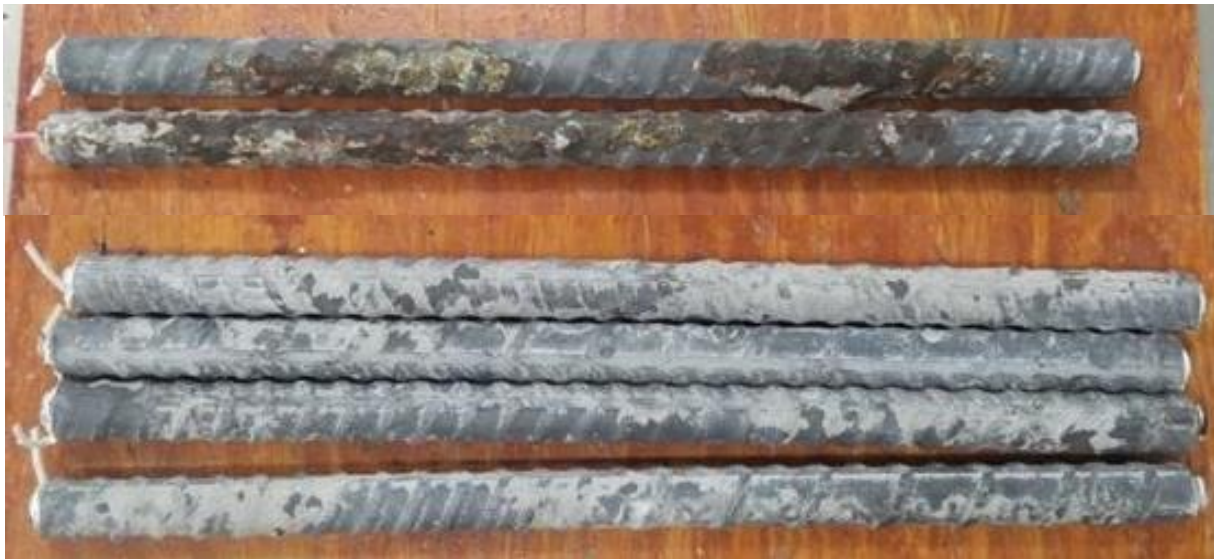
Figure 3.78 shows the bars from specimen SE-ChromX-5 after 96 weeks of testing, representative of all ChromX reinforcement with no admixture in the Southern Exposure Test. Light to moderate amounts of corrosion were visible on portions of both top bars. No corrosion products were visible on the bottom bars. Figures 3.79 and 3.80 show top and bottom bars of specimen SE-ChromX-IPANEX-2 and SE-ChromX-Xypex-1 after 96 weeks of testing, respectively. ChromX bars in concrete with IPANEX, shown in Figure 3.79, and Xypex, shown in Figure 3.80, are representative of all ChromX reinforcement paired with waterproofing admixtures in the Southern Exposure test. ChromX reinforcement with an admixture showed corrosion products similar to ChromX bars without an admixture.

Figure 3.78: Top bars (top) and bottom bars (bottom) of specimen SE-ChromX-5 after 96 weeks of testing
