EVALUATION OF MULTIPLE CORROSION PROTECTION SYSTEMS FOR REINFORCED CONCRETE BRIDGE DECKS

Pooya Vosough Grayli

Submitted to the graduate degree program in Civil, Environmental, & Architectural Engineering
and the Graduate Faculty of the University of Kansas in partial fulfillment of the requirements
for the degree of Doctor of Philosophy.

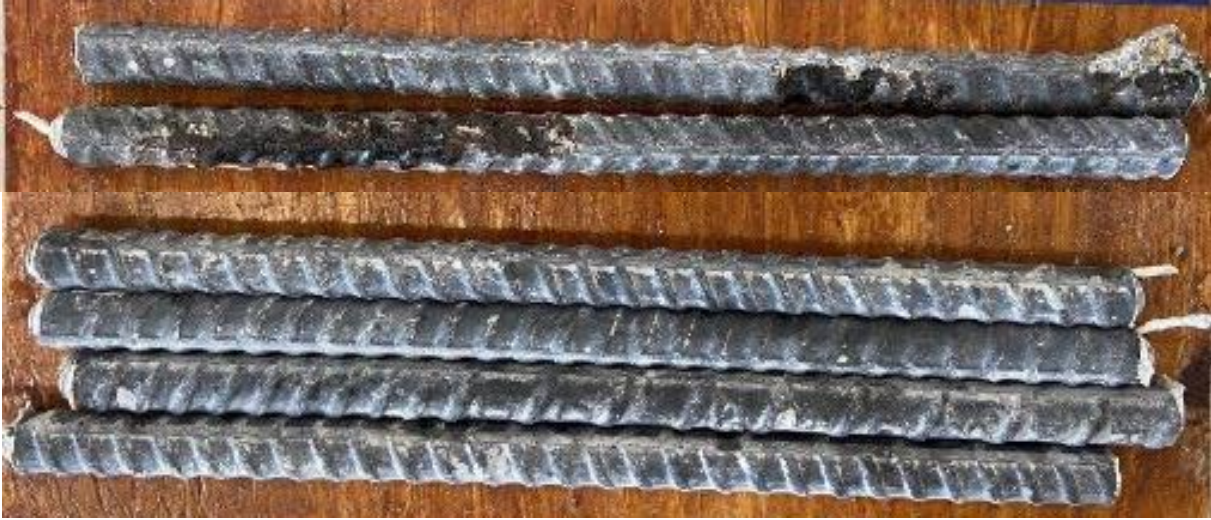
Figure 3.79: Top bars (top) and bottom bars (bottom) of specimen SE-ChromX-IPANEX-2 after 96 weeks of testing

Figure 3.78 shows the bars from specimen SE-ChromX-5 after 96 weeks of testing, representative of all ChromX reinforcement with no admixture in the Southern Exposure Test. Light to moderate amounts of corrosion were visible on portions of both top bars. No corrosion products were visible on the bottom bars. Figures 3.79 and 3.80 show top and bottom bars of specimen SE-ChromX-IPANEX-2 and SE-ChromX-Xypex-1 after 96 weeks of testing, respectively. ChromX bars in concrete with IPANEX, shown in Figure 3.79, and Xypex, shown in Figure 3.80, are representative of all ChromX reinforcement paired with waterproofing admixtures in the Southern Exposure test. ChromX reinforcement with an admixture showed corrosion products similar to ChromX bars without an admixture.

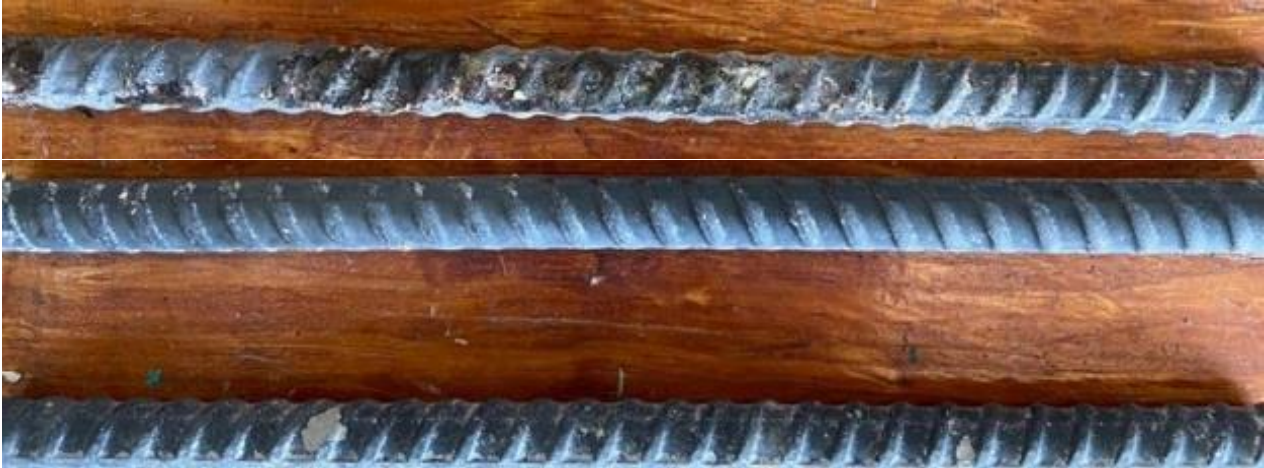
Figure 3.81: Top bar (top) and bottom bars (bottom) of specimen CB-ChromX-1 after 96 weeks of testing

Figure 3.81 shows the bars from specimen CB-ChromX-1 after 96 weeks of testing and is representative of all ChromX reinforcement with no admixtures in the cracked beam test. Light to moderate amounts of corrosion were visible on the steel, less than observed on conventional reinforcement in the cracked beam test. Corrosion was concentrated in the region immediately under the 6-in. simulated crack in the specimen. ChromX bars in concrete with IPANEX (shown in Figure 3.82) and Xypex (shown in Figure 3.83), representative of ChromX reinforcement paired

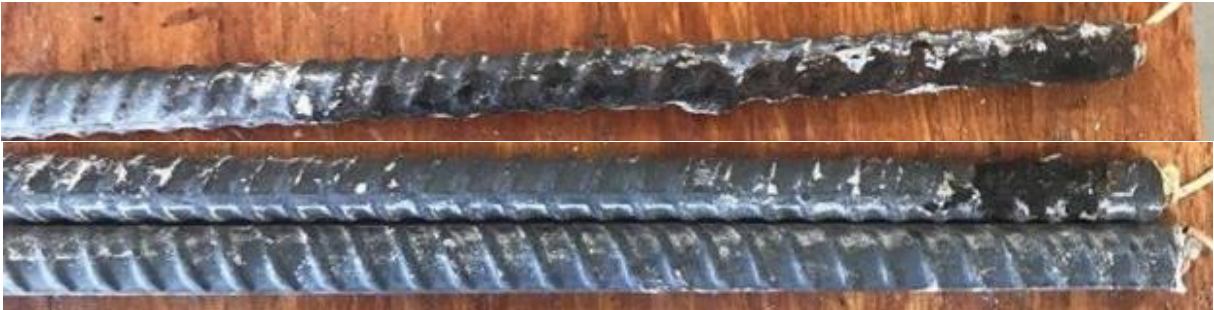
Figure 3.82: Top bar (top) and bottom bars (bottom) of specimen CB-ChromX-IPANEX-6 after 96 weeks of testing

with waterproofing admixtures in the cracked beam test, exhibited similar behavior, with the corrosion products predominantly in the region under the simulated crack.

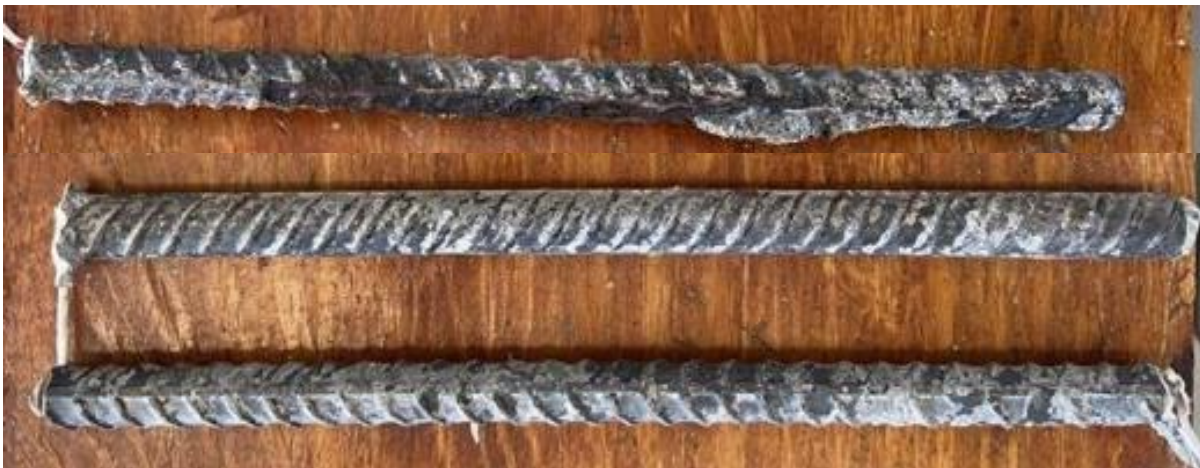
Figure 3.83: Top bar (top) and bottom bars (bottom) of specimen CB-ChromX-Xypex-2 after 96 weeks of testing

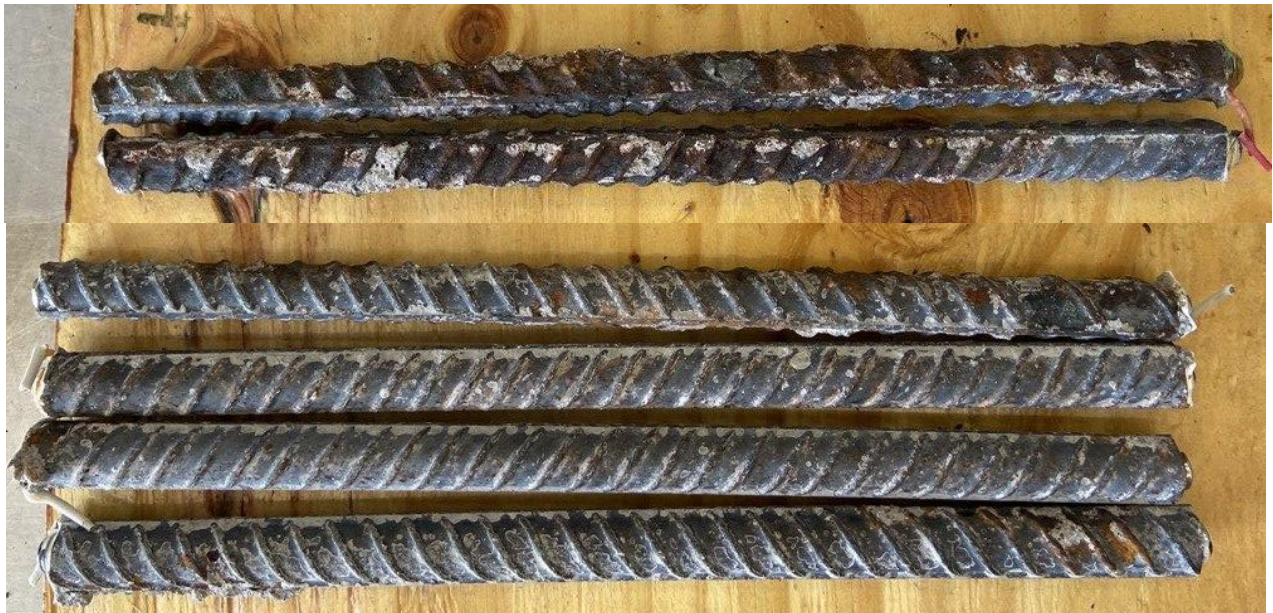
Figure 3.84: Top bar (top) and bottom bars (bottom) of specimen SE-Conv-B-IPANEX-2 after 96 weeks of testing

Figure 3.84 shows the bars from specimen SE-Conv-B-IPANEX-2, and Figure 3.85 the bars from specimen CB-Conv-B-IPANEX-1 after 96 weeks of testing. Moderate to heavy amounts of corrosion were visible on the bars from the top bars, no different than that observed on conventional reinforcement without IPANEX (Figures 3.55 and 3.57). Figure 3.86 shows the bars from specimen SE-Conv-B-Xypex-1, and Figure 3.87 the bars from specimen CB-Conv-B-Xypex-2 after 96 weeks of testing. A moderate amount of corrosion was visible on the bars from the top bar, but less than that observed on conventional reinforcement without Xypex; this is in line with the reduction observed in the corrosion loss in the conventional reinforcement with Xypex admixture. A light amount of corrosion was visible on the bottom conventional bars paired with both IPANEX and Xypex.

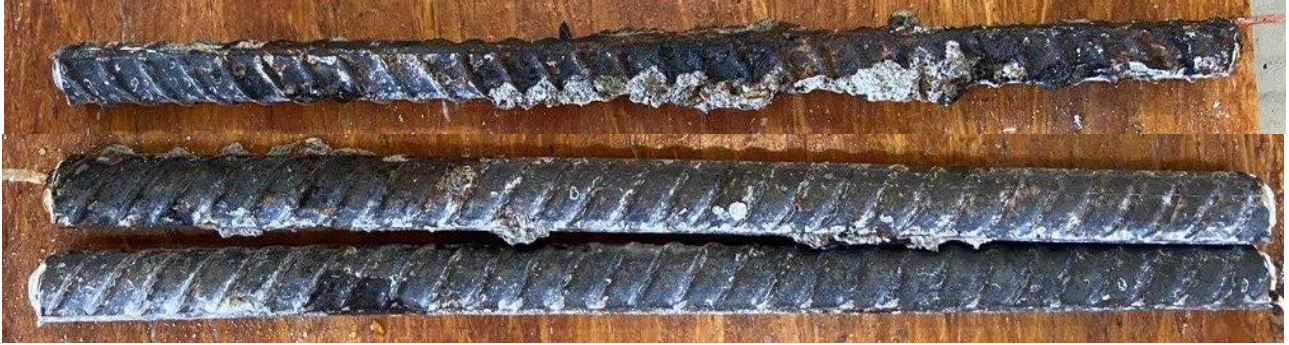
Figure 3.85: Top bar (top) and bottom bars (bottom) of specimen CB-Conv-B-IPANEX-1 after 96 weeks of testing

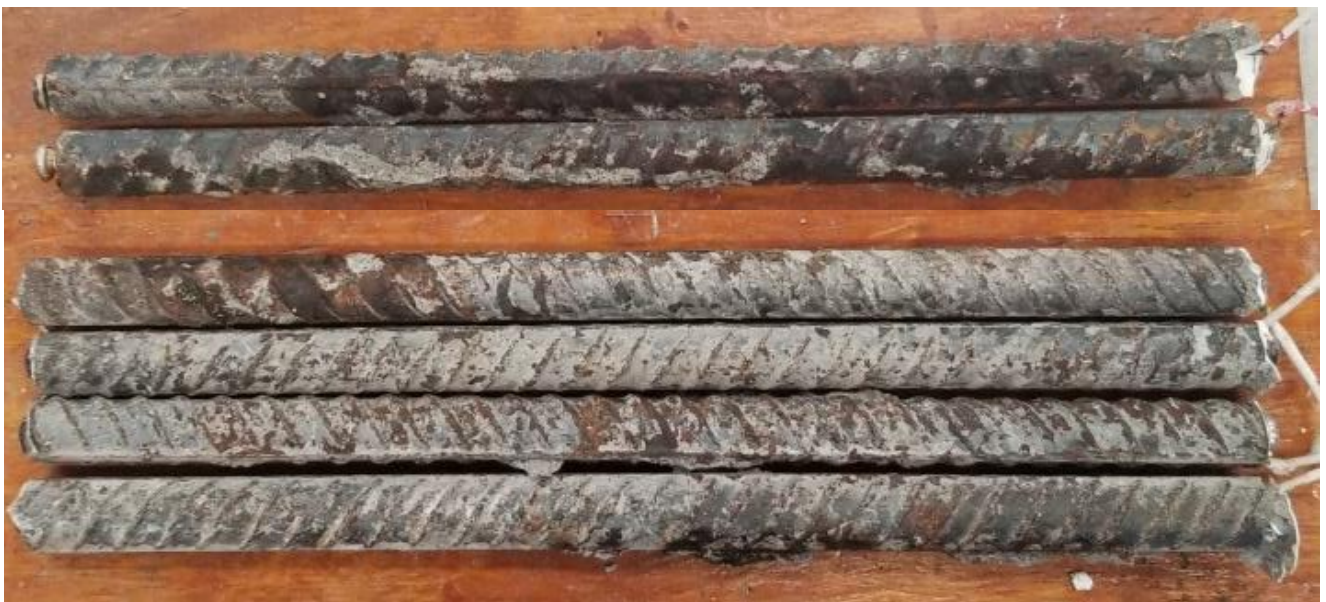
Figure 3.86: Top bars (top) and bottom bars (bottom) of specimen SE-Conv-B-Xypex-1 after 96 weeks of testing

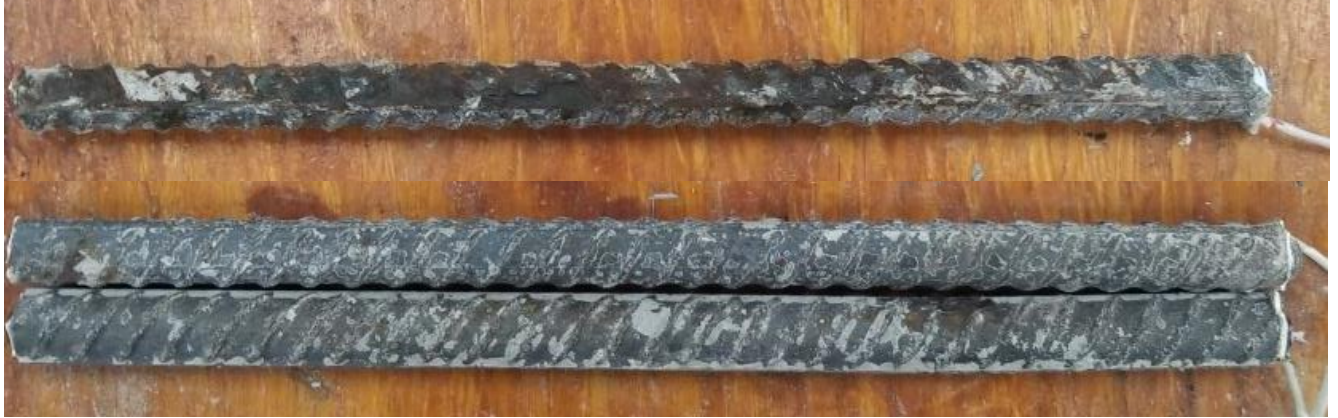
Figure 3.87: Top bar (top) and bottom bars (bottom) of specimen CB-Conv-B-Xypex-2 after 96 weeks of testing
