# Água mole em pedra dura. A água e os materiais pétreos

Fabio Sitzia

Researcher Geologist, Hercules Laboratory

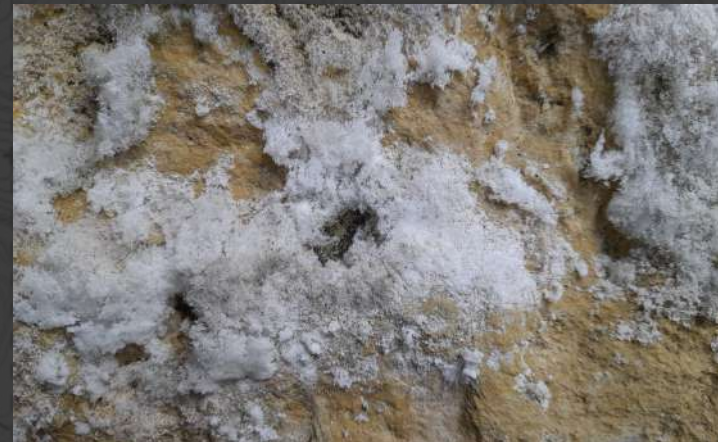
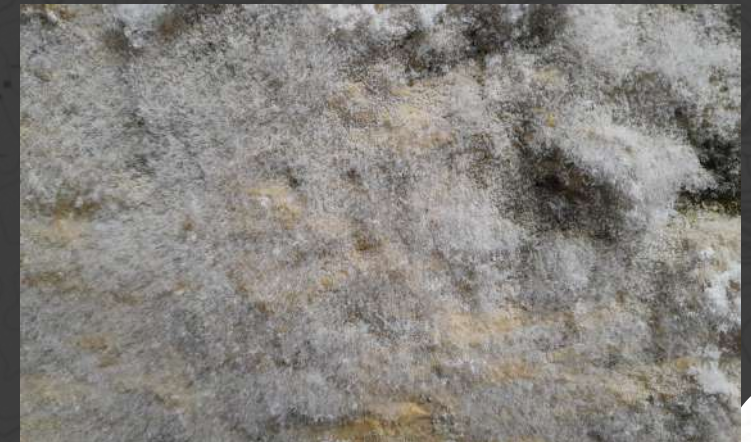
Efflorescences on the walls (elevation 13cm)

During the winter, the water table increases its level, flooding the crypt of the church. The water flows through the foundations made of biomicrite reaching the walls of the inhabited area

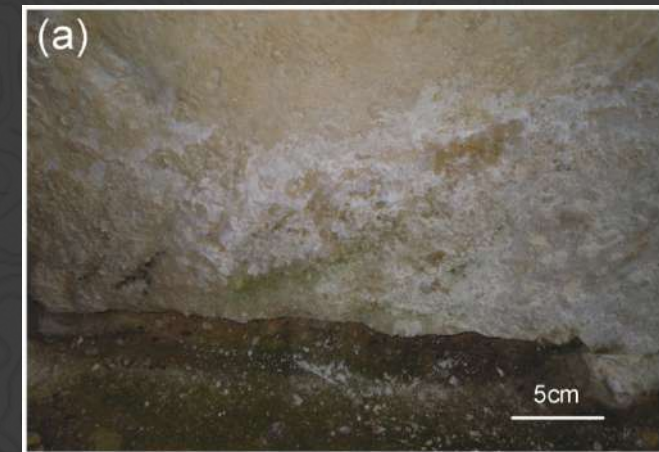
The groundwater shows a high presence of Na<sup>+</sup> and Cl<sup>-</sup> due to a salinization.

The hydrogeological model confirms the presence of marine ingress in the aquifer due to the overexploitation of groundwater for domestic and industrial purposes.

In addition, infiltrations of wastewater from sewerage system and cesspit are present

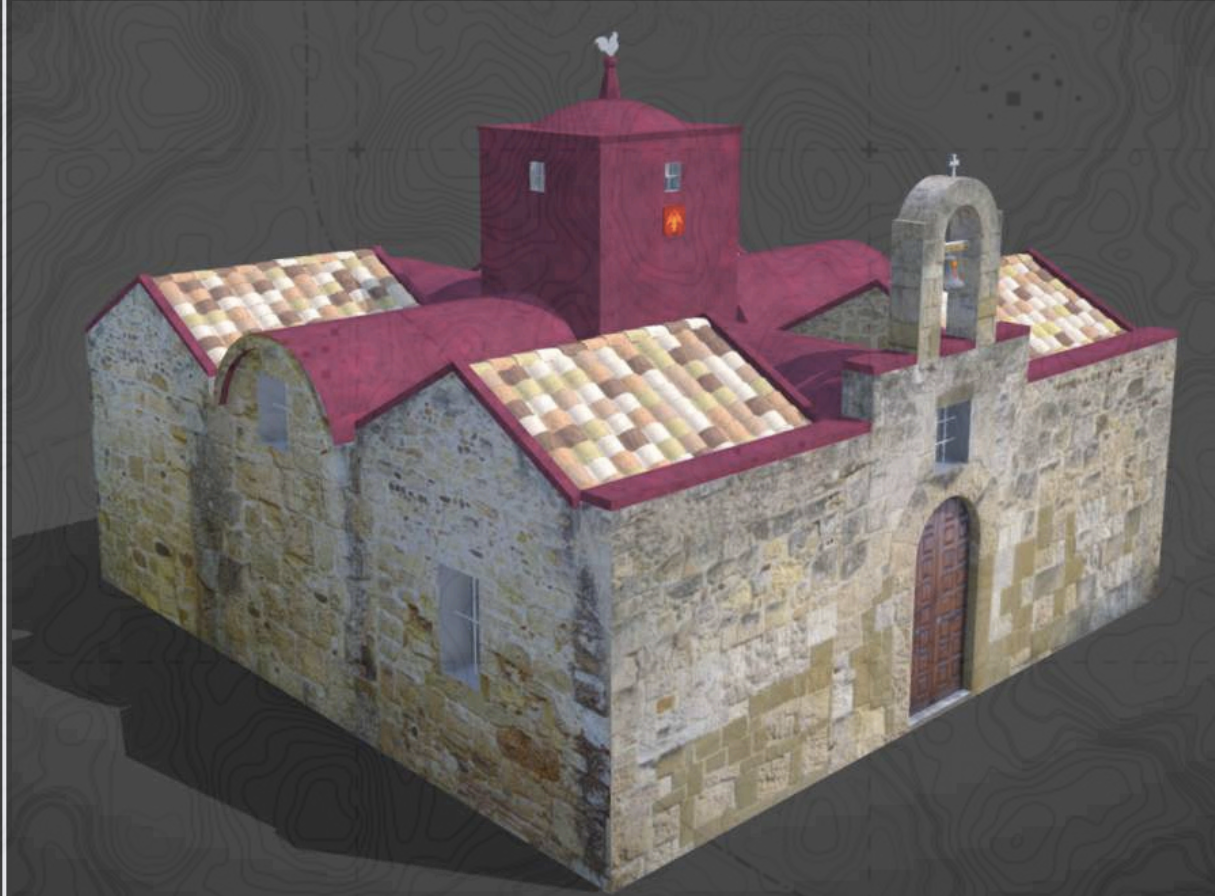
The runoff of water causes the proliferation of biological activities which act as a noble patina. The presence of higher plants, on the other hand, is harmful.

In correspondence with the water dumps, probably with an inadequate maintenance of the gutters, the wall has a surface runoff

This is causing a series of problems for the masonry which is starting to show erosion cavities. Monitoring on a [photogrammetric](#) basis takes place every 5 years to evaluate the erosion degree

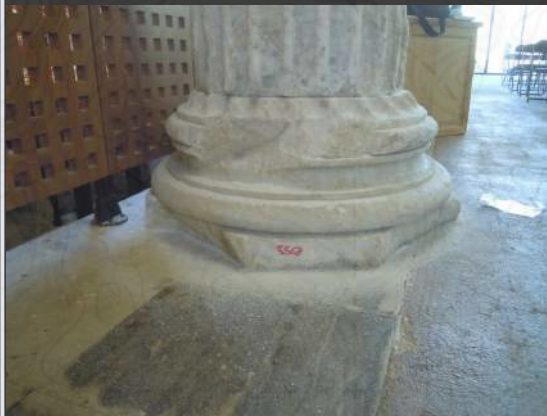
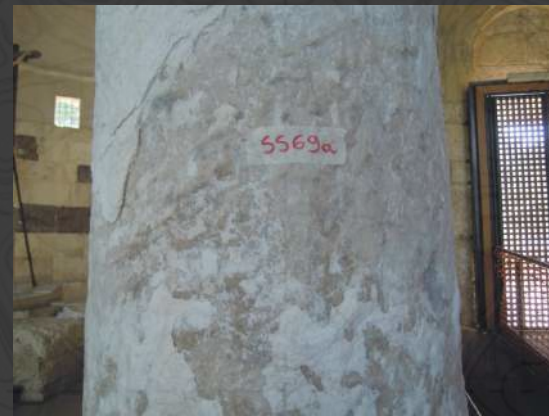
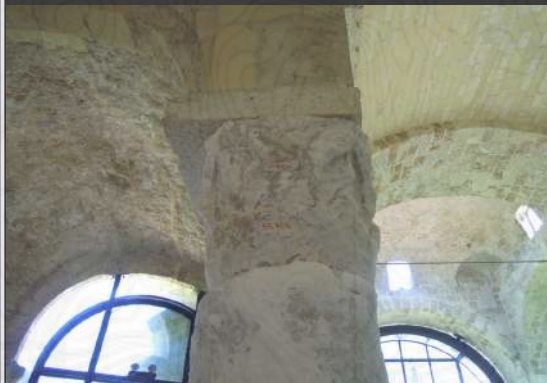
A marble columns inside the basilica of San Saturnino (XII Cent. AD, Cagliari, Italy) are subject to severe degradation due to granular disintegration: The process is also called CSC or Crystal Sugar Corrosion. Marble has a saccharoid structure that disintegrates by crystalline decohesion

Isotopic analysis show that the column is realised with Carrara marble

The analysis are in still in progress but archaeometric hypothesis say that the column was submerged with seawater at the moment of sea transportation

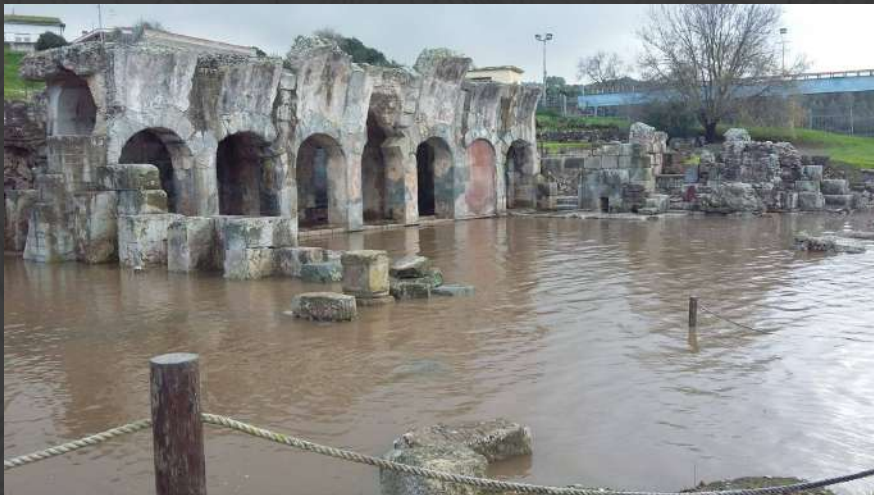
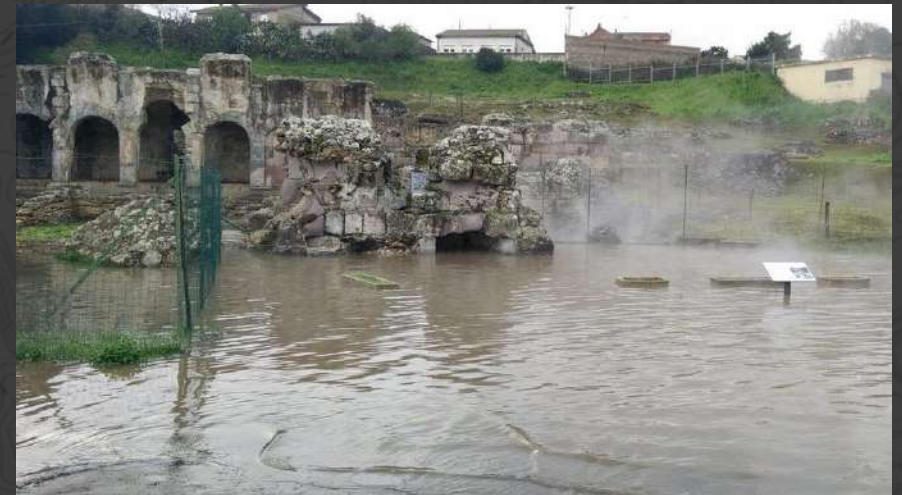
Natural hazard:

Class P4: very high danger for return time  $T = 50$  years

Class P3: highly dangerous, for return time  $T = 200$  years, water height of 0.9m and speed of 2 m/s;

Class P2: medium hazard, ( $T = 200$  years) water height  $< 0.9$  m, and current speed  $< 2$  m/s

Class P1: moderate hazard, in correspondence with flooded areas with  $T = 500$  years.

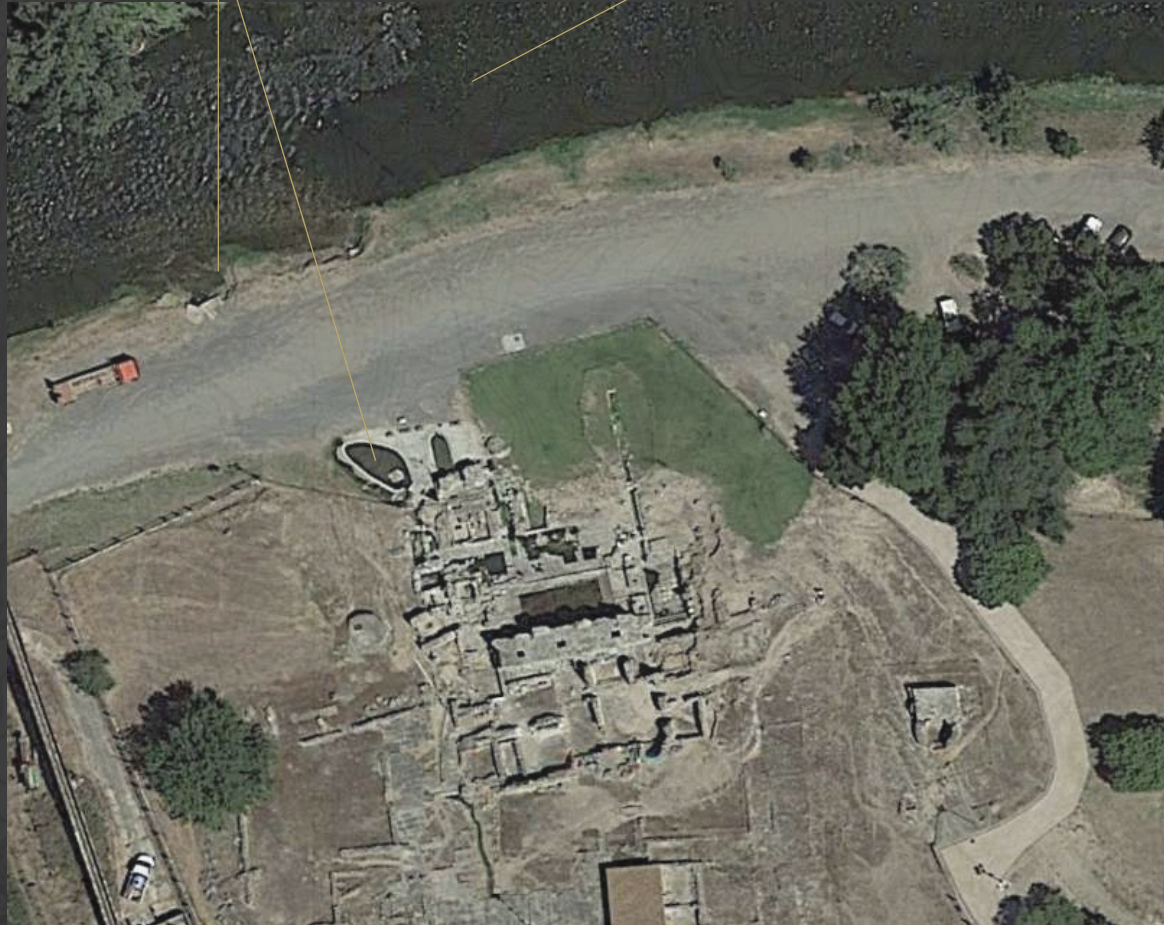
Thermal water source

Tirso river
