## Increasing road network resilience to the impacts of ground movement due to climate change – A case study from Lincolnshire, United Kingdom

A.M. Harrison, M. Heaton & D.C. Entwisle

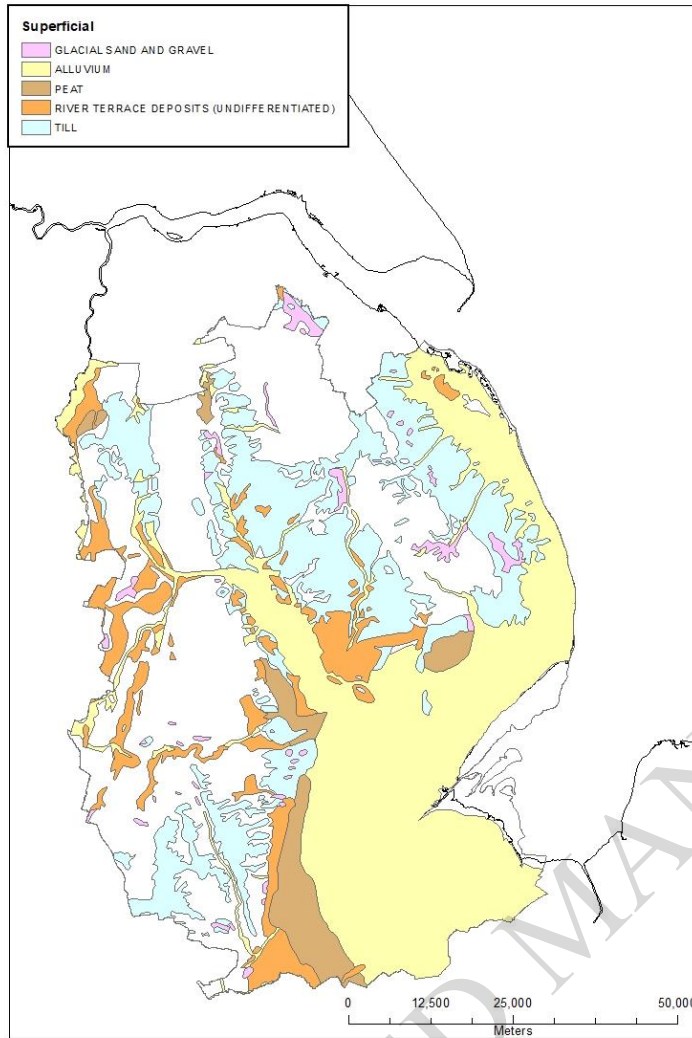
Figure 2 Superficial geology of Lincolnshire (BGS Geology 625K). Contains Ordnance Survey data © Crown copyright and database right [2022]

Quaternary deposits overlie much of the county's bedrock geology (Figure 2 and Table 1), dominating the north as sheets of till, and southeastern areas as unconsolidated Holocene sediments. The Quaternary period began 2.6 M years ago (Head, 2019), and consists of cycles of cold 'glacial' periods, interspersed by warmer 'interglacial' periods. Ice sheets have advanced over parts of Lincolnshire at least three times during these glacial periods. The Anglian glaciation occurred approximately 450,000 years ago. It was by far the largest glaciation and ice covered most of the country reaching as far south as the River Thames. Anglian till deposits would have covered much of Lincolnshire. These have since been eroded by Devensian glacial activity, when ice lobes advanced at least twice into the north of the area, and along the East coast, once around 40,000 years ago, and again during the Last Glacial Maximum, approximately 20,000 years ago (Straw, 2008). Tills are identified by their fine-grained matrix with suspended mixed rock fragments up to boulder size.

In contrast, southeast Lincolnshire is dominated by The Fenlands. These span inland from the Wash with the northern tip reaching into Lincolnshire. The Fens are a low-lying marshy plain, underlain by thick sequences of interbedded peats, silts and clays with coarser-grained old river channels; evidence of variations in sea levels over the last 18,000 years. The cycle of marine inundation and retreat supported the development of mineral- and organic-rich soils. The Fenlands can be clearly identified by the large swathe of alluvium deposits in the 625k scale generalised geological map (Figure 2), with alluvium and tidal flat deposits classified as Alluvium at this scale.

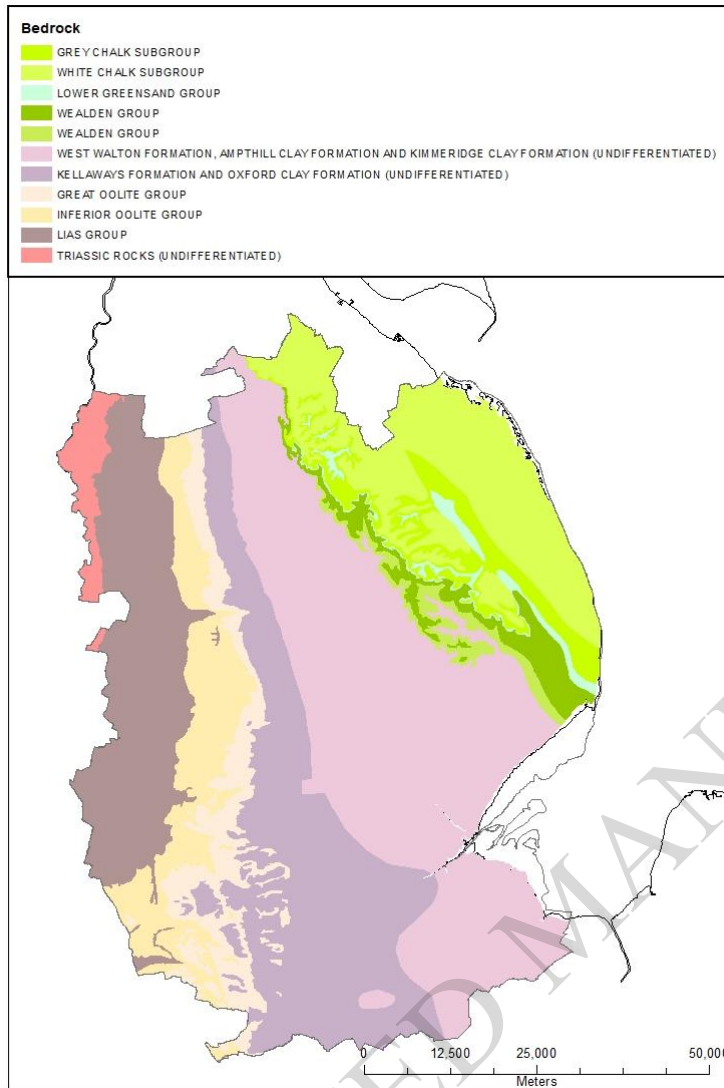
Figure 3 Bedrock geology of Lincolnshire County Council county (BGS Geology 625K). Contains Ordnance Survey data © Crown copyright and database right [2022]

The bedrock of Lincolnshire comprises an easterly dipping succession of Triassic and Jurassic mudstones and clays to the west, with younger Cretaceous chalks to the far east, with a north-north-west to south-south-east sub-crop (Figure 3). The bedrock is largely concealed beneath a thick cover of Quaternary deposits, which control the ground movement susceptibility within the area, with the underlying bedrock having little or no direct impact.

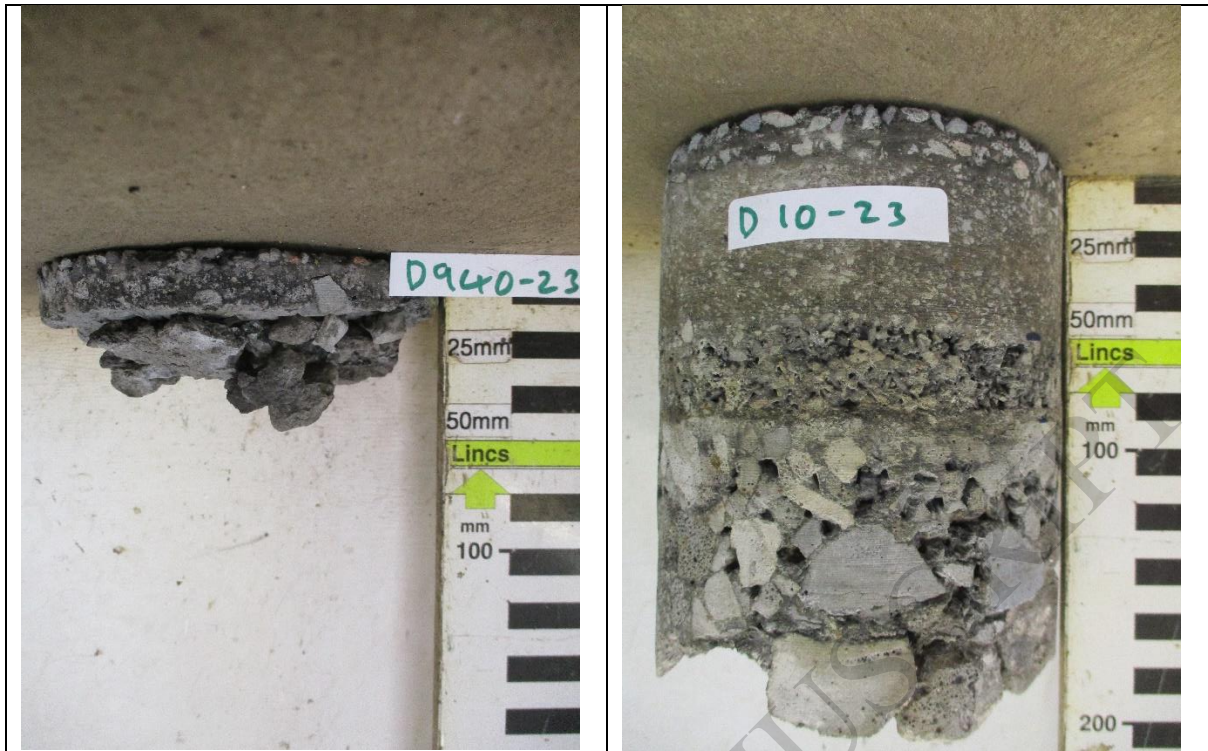
Figure 4: Typical depths of 'evolved' road foundations in the county. Left: Chalk Lane, Withern has a depth of 2.5 to 5 cm, and Church Lane in Friskney has a depth of 20 cm. At least 4 surface courses can be seen to have been added at Friskney.

Lincolnshire's road network is more at risk than other counties, due to a greater exposure to more susceptible geology, and a greater vulnerability due to the shallow foundations of the evolved road network, which originates from old mud tracks. Figure 4 demonstrates common road structure and thickness in the county. At Chalk Lane, Withern (543327, 382202), the thin surface course of 25 mm has no underlying foundations; as seen in Church Road, Friskney (546188, 355195), if repair work is required, these courses have been overlaid and the thickness gradually built up, reaching a depth of 200 mm.

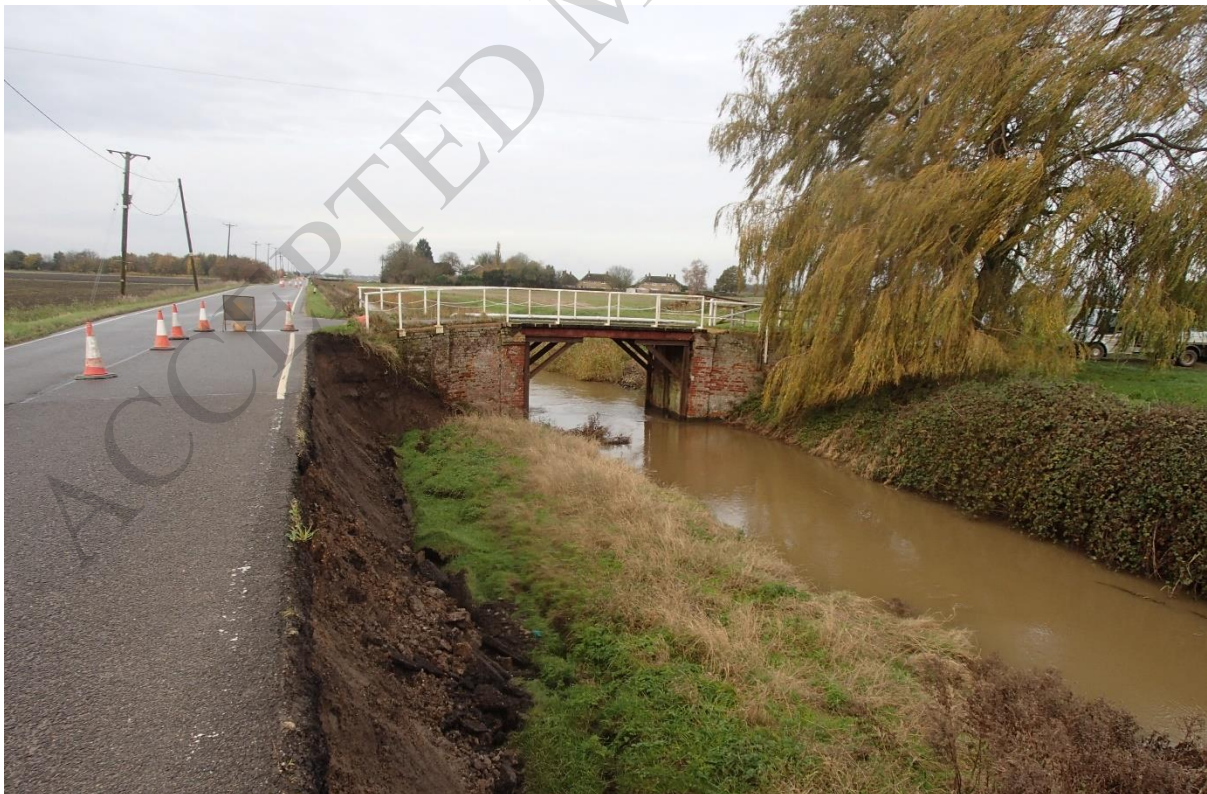
Figure 5 Landslide in large ditch adjacent to road, causing road subsidence and closure for repairs in Autumn 2019. Fodderdyke bank, Midville © Mark Heaton LCC

Flooding resulting in, embankment and ditch slope failures, have recently increased in occurrence due to more frequent high-intensity rainfall events. For example, a bank failure occurred in November 2019 at Fodderdyke Bank, following a high-intensity rainfall event, causing the bank to become quickly saturated. This caused the adjacent highway to become unstable as the minimal subgrade to the carriageway slipped away as part of the bank failure (Figure 5).

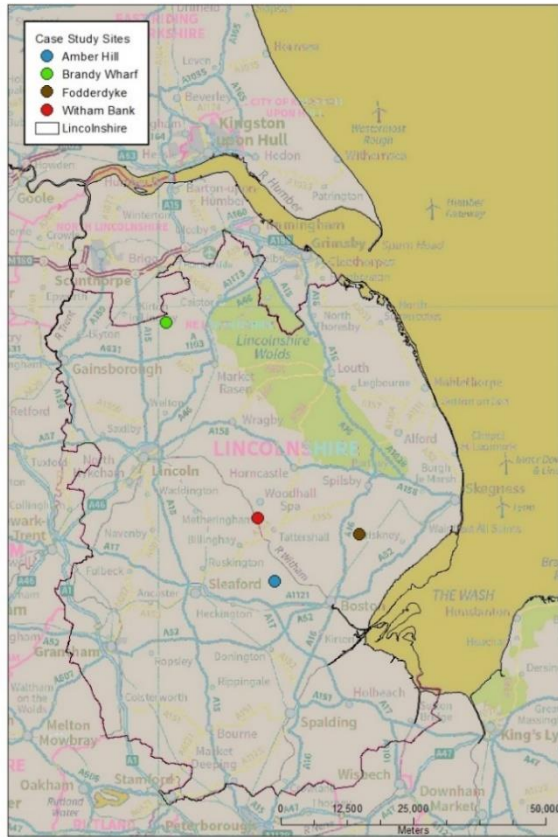
Figure 6 Map of Lincolnshire showing the location of case study sites (OS MiniScale data © Crown copyright and database right 2022)

Four case study sites have been selected to demonstrate the geological, climatic, and anthropogenic controls that affect vulnerability to road damage in Lincolnshire, and the impacts observed on the road network (Table 2 and Figure 6).

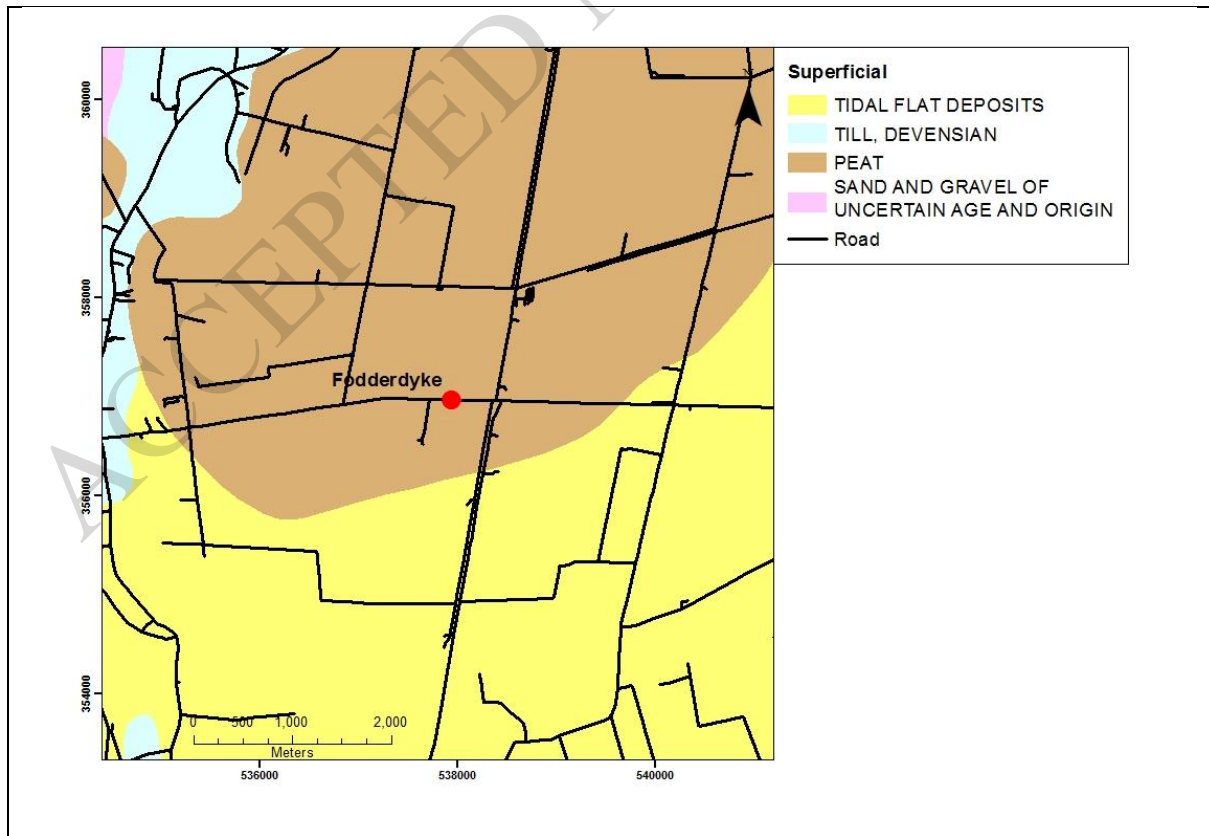
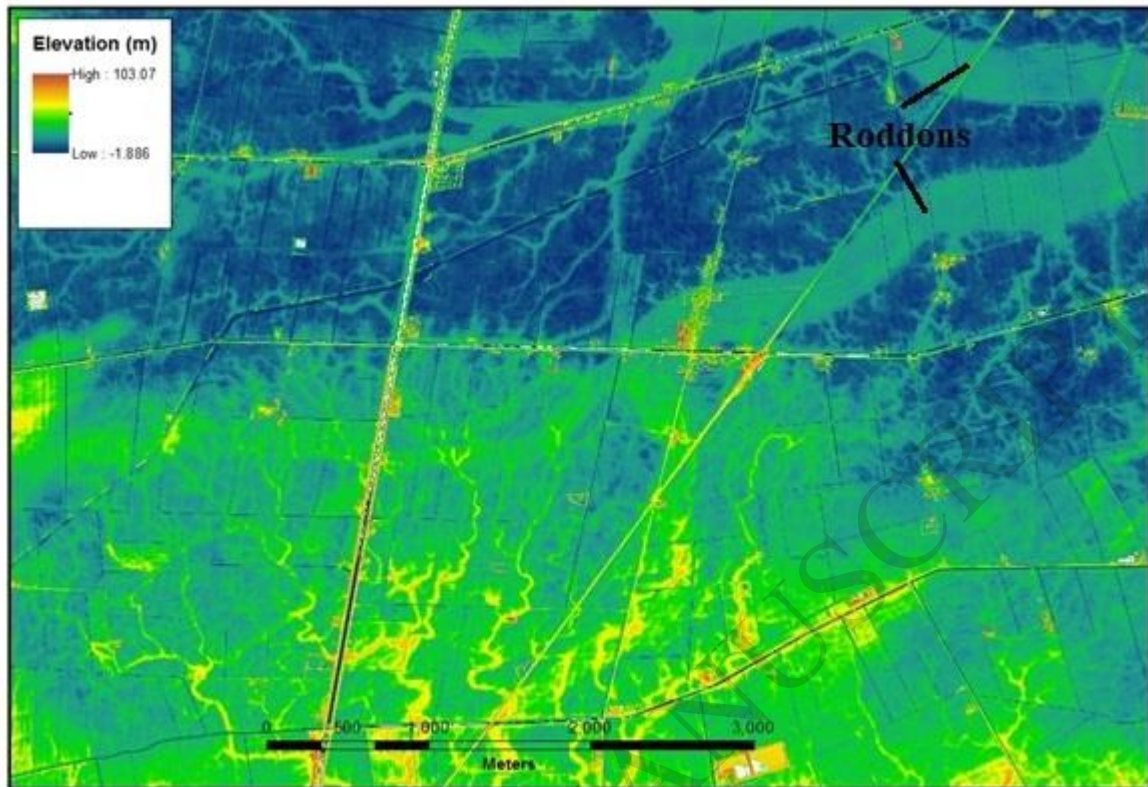
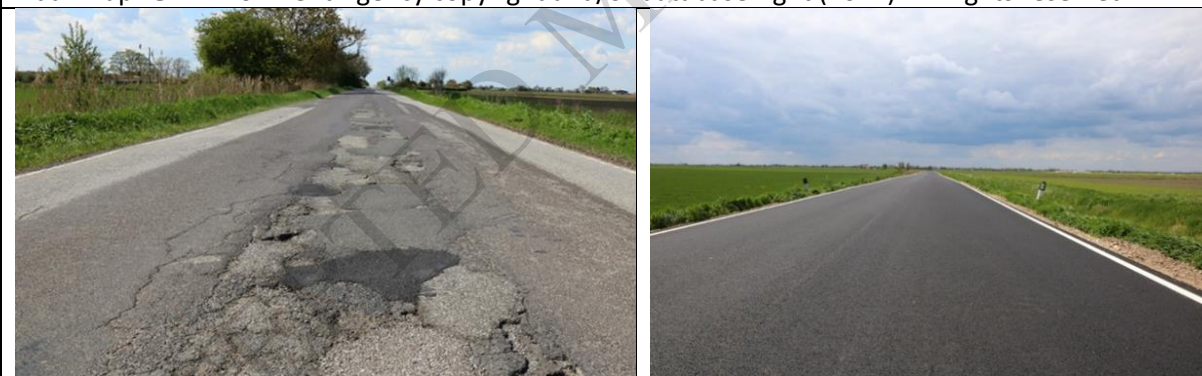
Figure 7 Top: Geological map. Middle: Lidar image. © Environment Agency copyright and/or database right (2022). All rights reserved. Bottom left: Previous road damage and patching work at Fodderdyke western stretch (May, 2018). BGS © UKRI 2018. Bottom right: present day post road repair Fodderdyke eastern stretch (May, 2018) BGS © UKRI 2018

During the last decade, splitting along the longitudinal section (Figure 7), undulations, deformation including localized shears, slope movement and other subsequent highway failures have developed. Due to the worsening state of the road, it became relatively unsafe for travelling on at speed. In 2015 a road traffic incident took place; tragically, this resulted in a fatality, and a lower speed limit was enforced until repair work could be completed. Mitigation work was successfully completed by the local authority during 2018. Although overlays had been the typical repair method, a different approach was used to increase the life of the road and reduce future maintenance requirements. This entailed recycling of the existing road surface, therefore, not introducing additional load. Due to the length of this road this is a rolling programme with works being undertaken each year. It is still ongoing, giving the authority the opportunity to review, monitor and make fine adjustments to the design, whilst continuing its research.

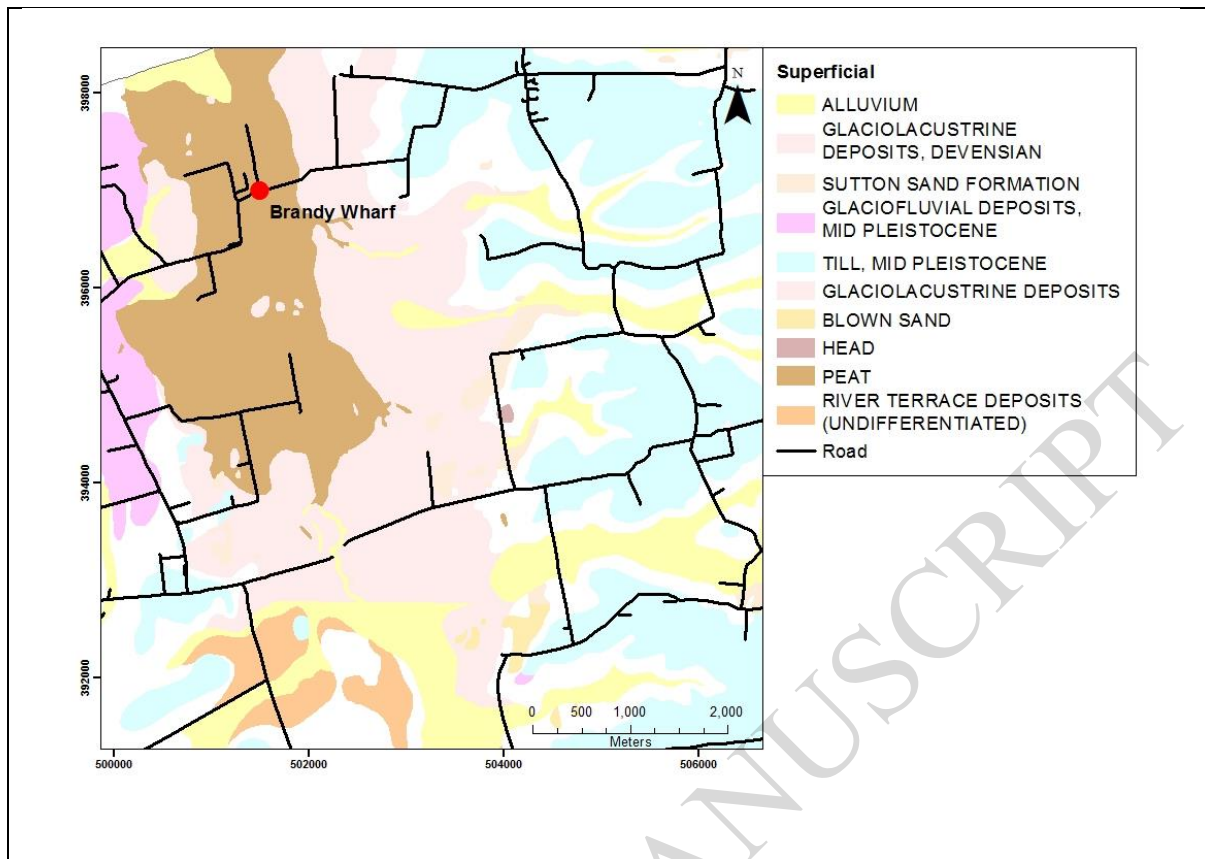
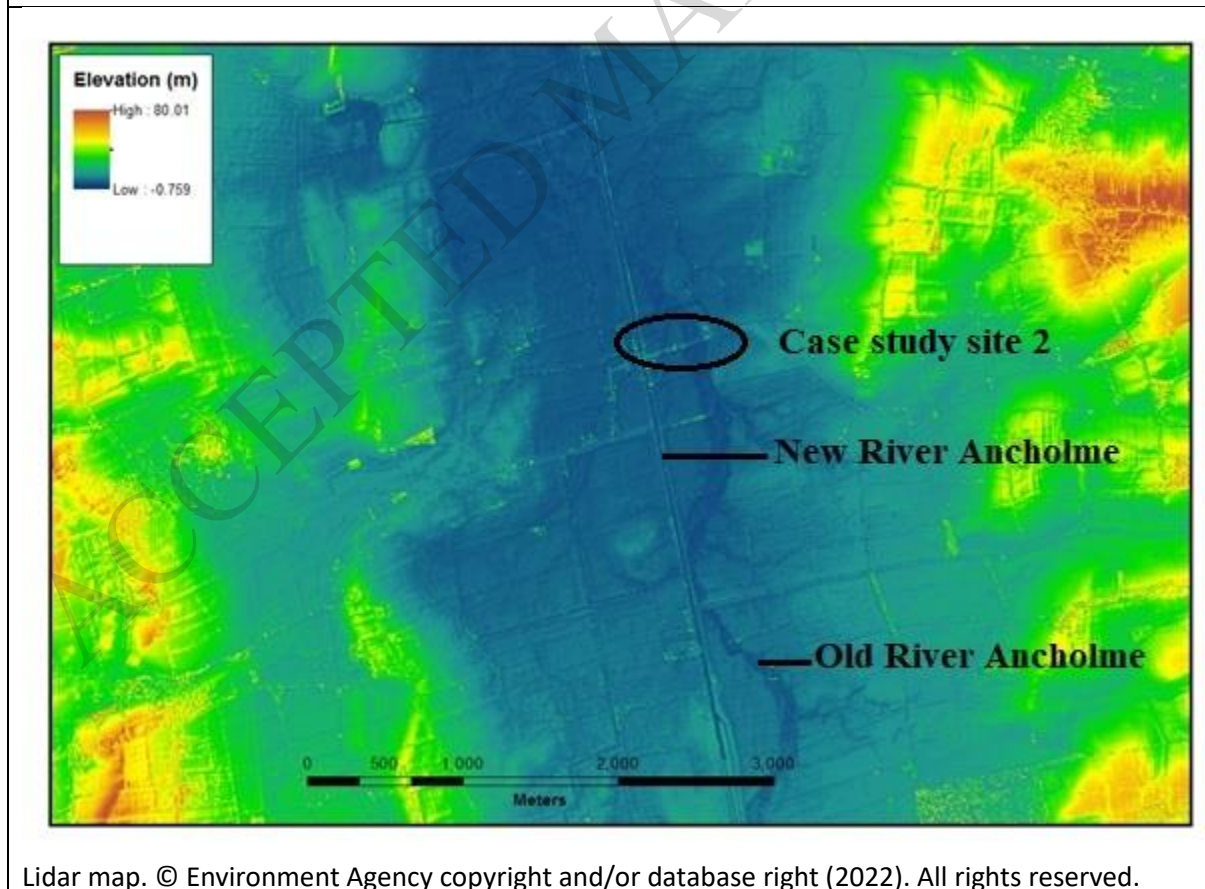
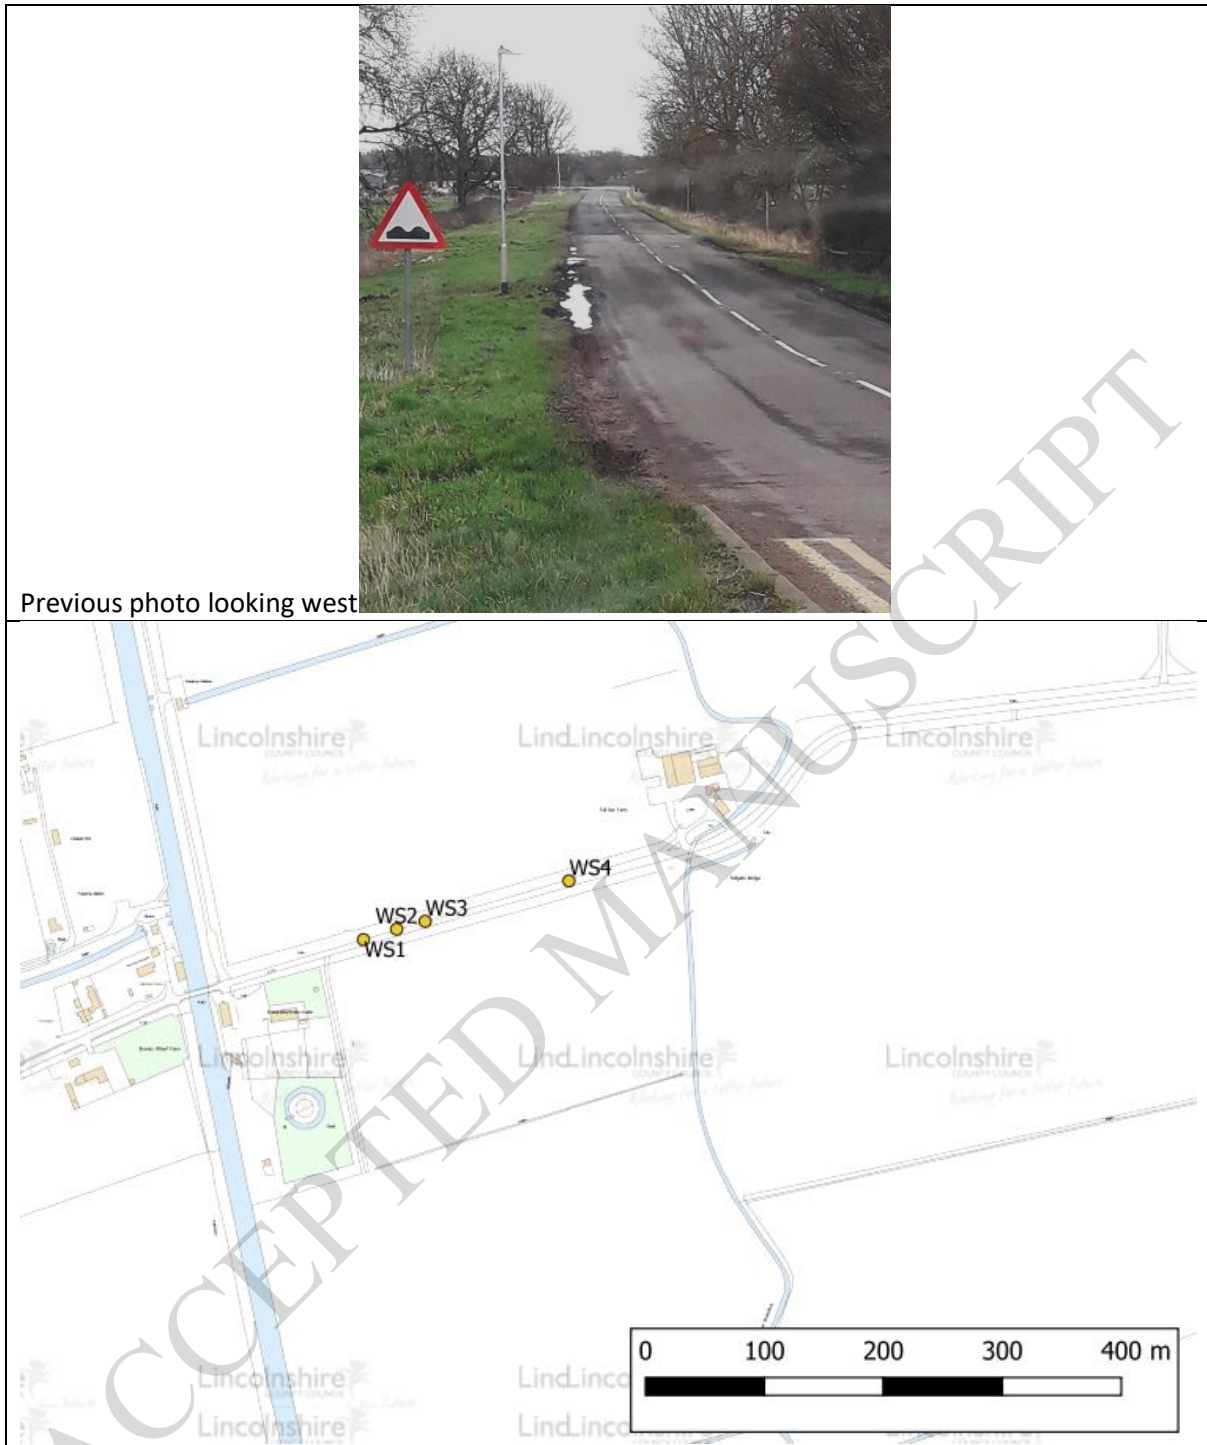
Previous photo looking west

Figure 8 Brandy Wharf. Top: Superficial geology map. Middle: Lidar data. © Environment Agency copyright and/or database right (2022). All rights reserved. Second to bottom: photograph looking west (September, 2020). © Mark Heaton LCC. Bottom right: Sample hole locations ©Lincolnshire County Council

The road has developed large undulations in the surface, as well as edge cracking.

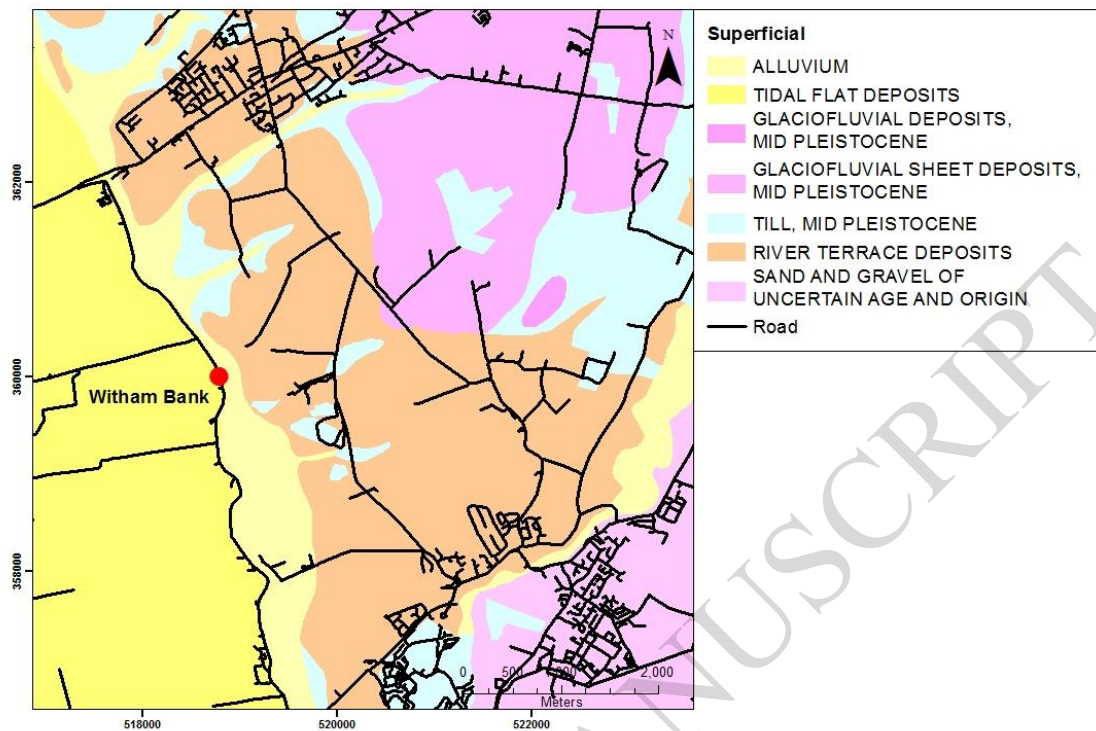
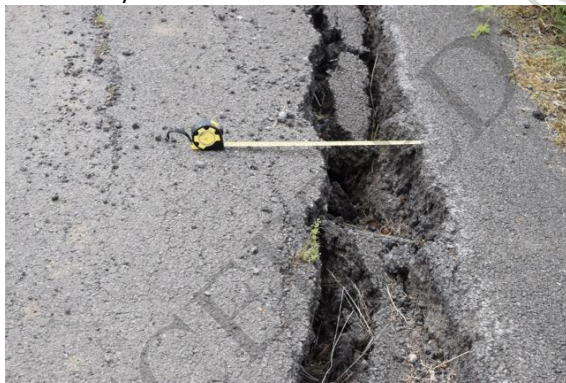
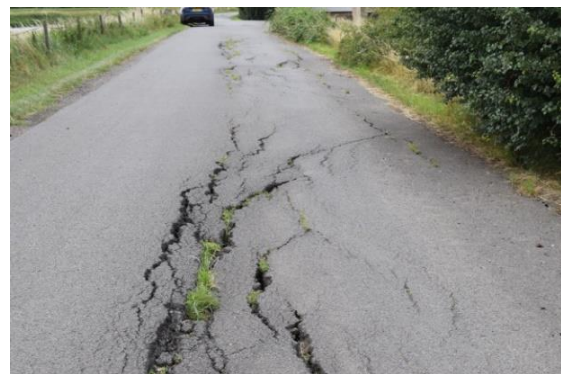
Present day photo  
(June 2020) © Mark Heaton LCC

Road surface damage photo, looking south  
(May, 2018) BGS © UKRI 2018

Figure 13 Longitudinal cracking at Witham Bank. Top: Superficial geology map. Bottom left: present day photograph (June, 2020). © Mark Heaton LCC. Bottom right: Road surface damage, looking south (May 2018) BGS © UKRI 2018

Lateral variation in water content across the carriageway has led to subsidence and the generation of a longitudinal crack in the road surface (Figure 13), commonly up to 20cm wide. A likely cause of this variation is the increase in vegetation along the western edge during the last decade, as seen in Figure 13 (2018), which withdraws water from the ground on the western side. Other potential processes could be compounding changes in water content at the site. These include: the western bank potentially being steeper than the eastern bank; the road having been historically widened on the west rather than the east; the parallel ditch being recently overdug; or the water table dropping due to pumping to the west.

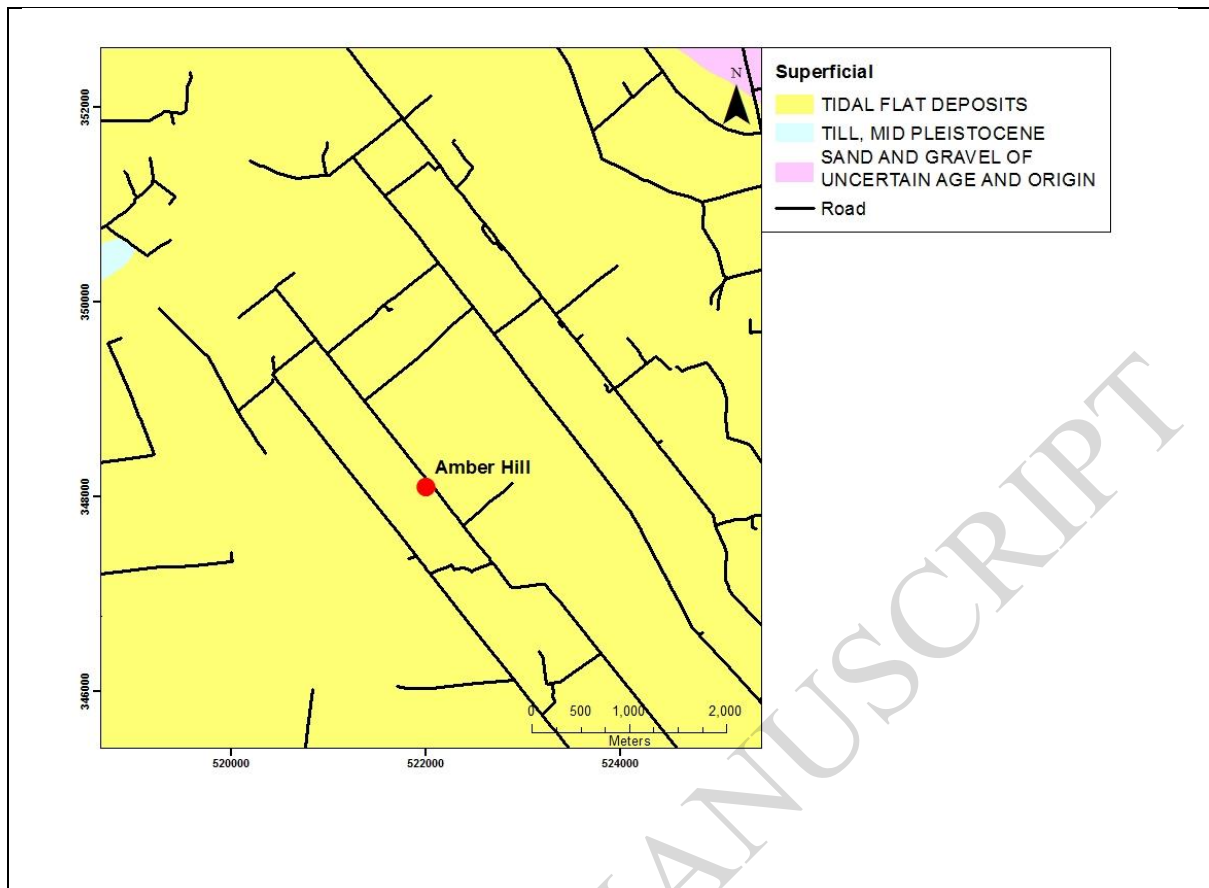
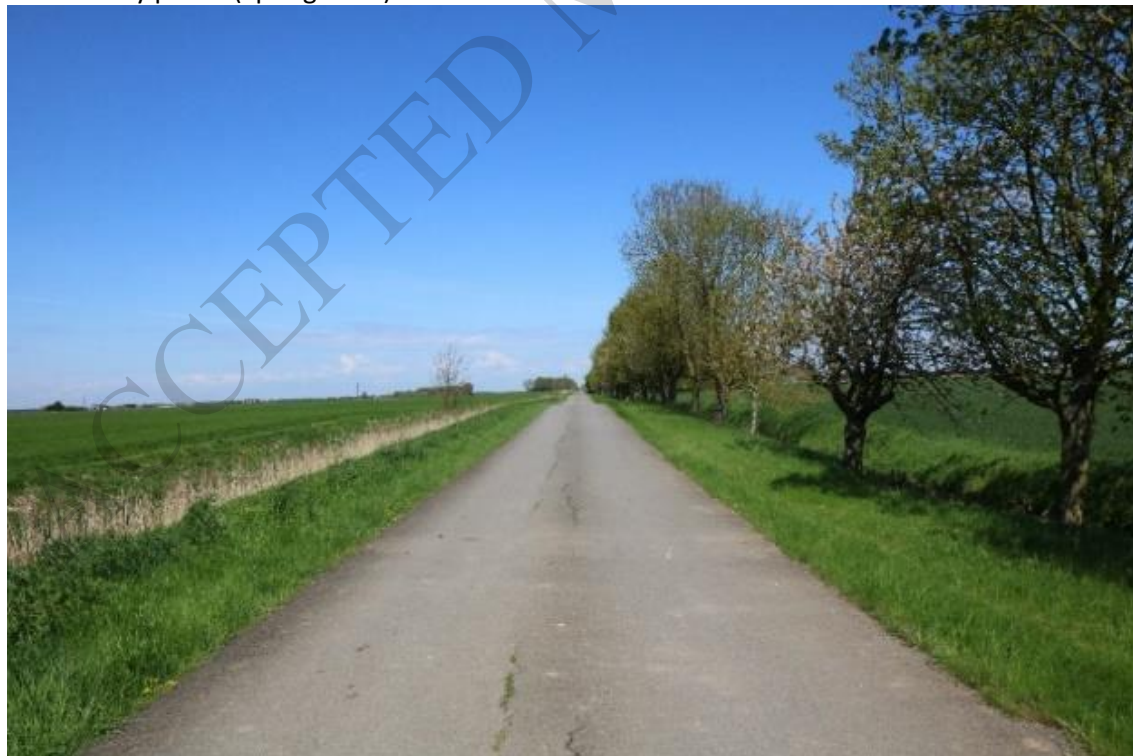
Figure 14 Amber Hill. Top: Geological map. Bottom: Photo taken May 2018 showing longitudinal cracking along the centre of the road. BGS © UKRI 2018

Longitudinal cracking has occurred down the centre of the carriage way, as can be seen in Figure 14.

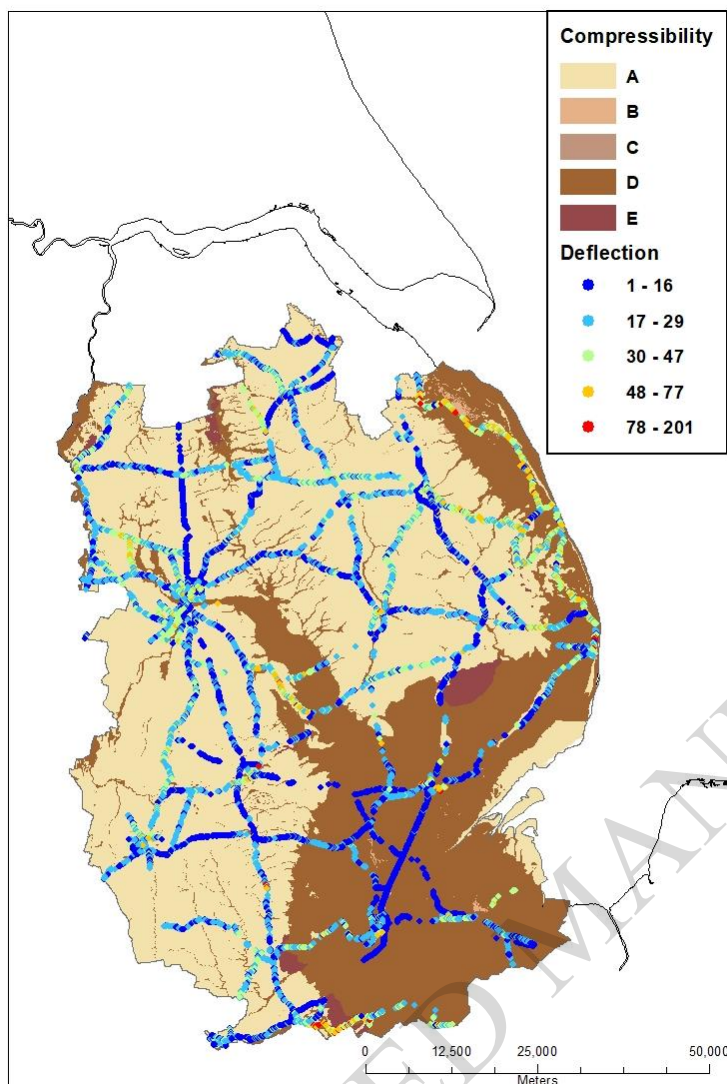
Figure 15 Lincolnshire County Council deflectogram survey residual life data for 2010 to 2013 and the BGS GeoSure compressibility susceptibility map. © Lincolnshire County Council. Contains Ordnance Survey data © Crown copyright and database right [2022]

Deflectogram data for 3 years, which includes a period of drought conditions (2010 to 2012), was analysed against BGS datasets. The data do not correspond with the case study sites due to the deflectogram surveys being limited to the county's principal and strategic road network. The decrease in residual life value was calculated to provide a measure of road deterioration. BGS GeoSure compressibility and clay shrink-swell datasets were used to compare susceptibility to ground movement of the underlying geology with road deterioration (GeoSure Compressibility is shown in Figure 15), to assess whether it is related to the underlying geological units and/or transitions between units with different lithological characteristics.

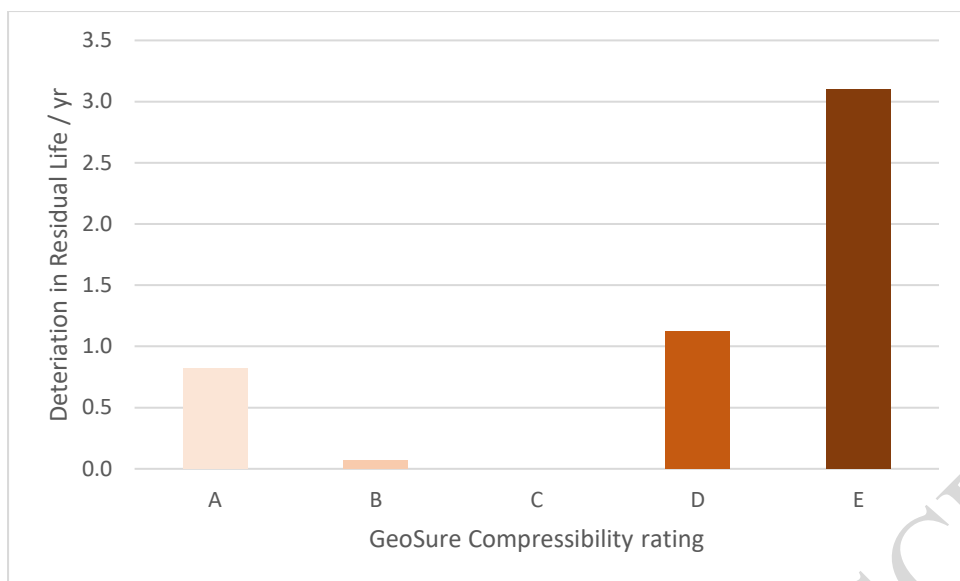
Figure 16 GeoSure Compression values against the Residual Life deterioration rates (all roads)

Table 3 provides an explanation of the GeoSure compressibility and clay shrink-swell values. Table 4 compares the relationship of average annual deterioration, with the shrink-swell and compressibility GeoSure ratings of the underlying geological units. This comparison demonstrates a strong inverse relationship between residual life and the GeoSure compressibility rating (Figure 16). Roads within areas where the compressibility of the underlying strata is classed as high or very high (D and E), experience much more rapid deterioration in residual life than those with lower compression susceptibility. Roads on very significant compressible deposits (E) show an annual deterioration in the residual life of 3.1, in comparison to 0.83 when on non-compressible deposits (A).

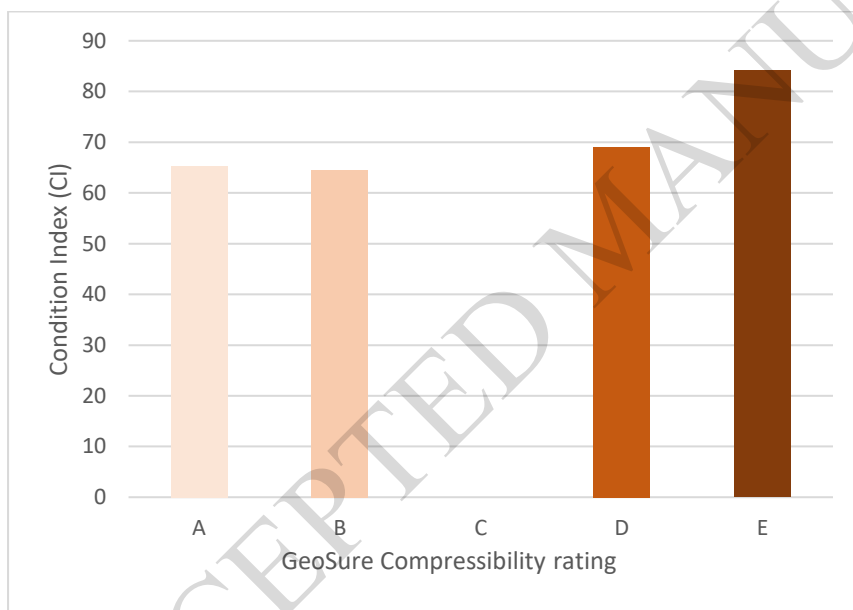
Figure 17 Average Condition Index (CI) between 2010 and 2013 of all surveyed Lincolnshire roads in areas with GeoSure compressibility rating of A to E.

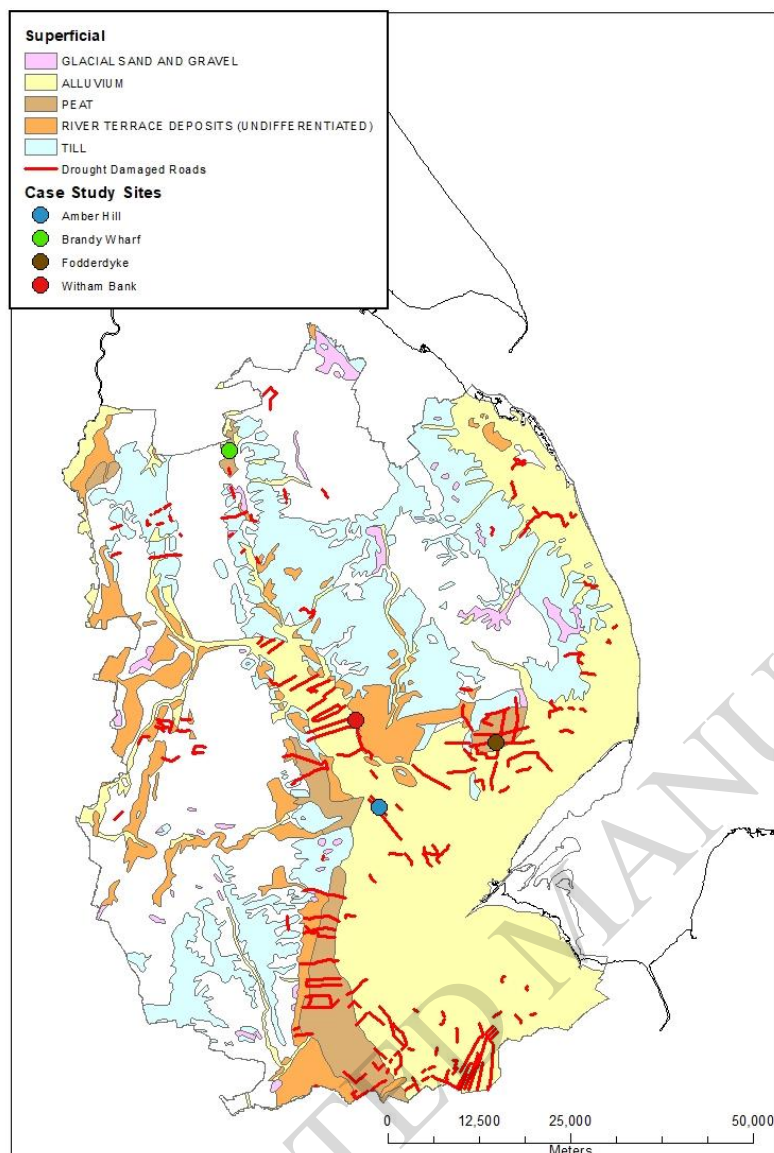
Figure 18 Drought related subsidence claims in Lincolnshire 2011 and the BGS 625k superficial geology map. © Lincolnshire County Council. The four case study sites are highlighted by the coloured dots. N.B. The 625k scale generalised superficial geological map compiles alluvium and tidal flat deposits as Alluvium. Contains Ordnance Survey data © Crown copyright and database right [2022]

In 2003, when the UK experienced one of its hottest summers on record, Lincolnshire reported a greater deterioration in the condition of its highways than in previous, non-drought, years. Since 2003, all ten years recording the highest annual temperature since 1884, when records began, have occurred (Met Office, 2022c). In 2011, the dry period led to Lincolnshire making a bid to central government for road repairs related to what was assumed to be drought related subsidence. The roads affected, mostly unclassified and C roads, are shown in red in Figure 18 and Figure 19. Most of the damaged road are underlain by superficial deposits, primarily high-water content, compressible tidal flat deposits (represented by alluvium in the 625k geological map) and peat. The four case study site locations are highlighted for context.

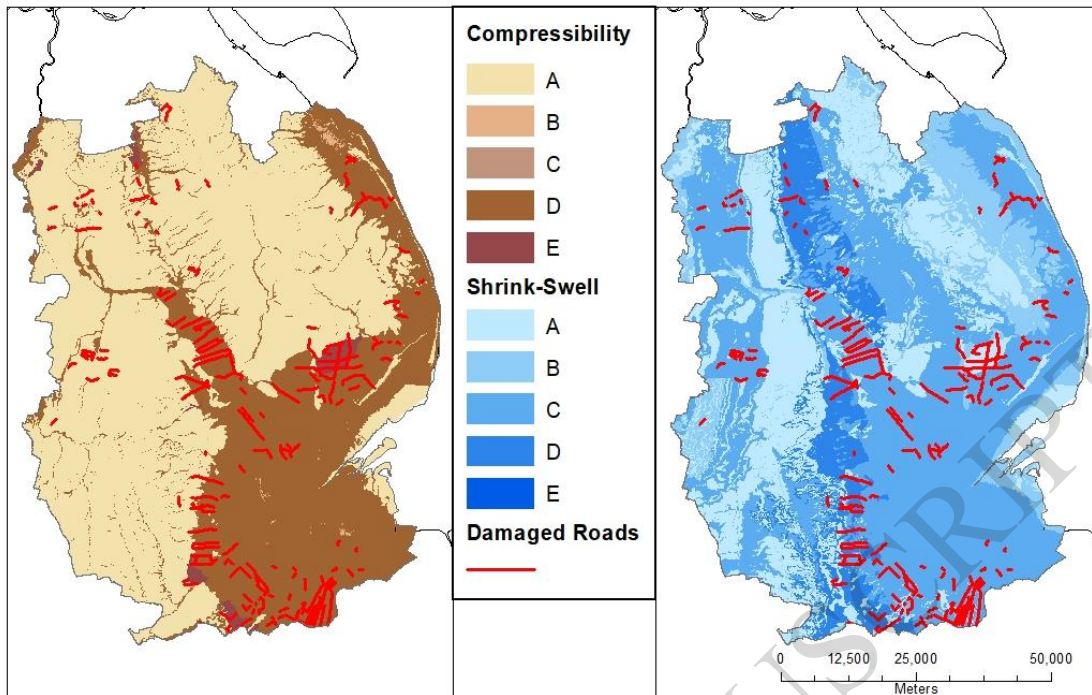
Figure 19 GeoSure Compressibility and clay shrink-swell with sites recorded (red lines) by LCC as requiring remedial work due to drought damage during 2011-2012. © Lincolnshire County Council. Contains Ordnance Survey data © Crown copyright and database right [2022]

The comparison of LCC drought damage data and BGS GeoSure clay shrink-swell compression datasets (Figure 19), showed that clay shrink-swell was not the county's only likely cause of road damage, and that compressible ground had a greater correlation with road damage than was originally considered (Pritchard et al., 2015).

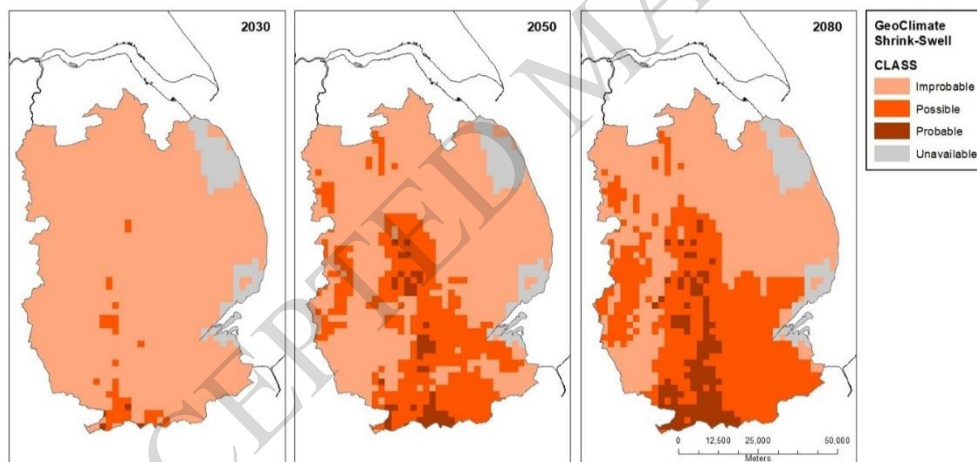
Figure 20 GeoClimate09 Open for Lincolnshire a) 2030s b) 2050s and c) 3080s. Contains Ordnance Survey data © Crown copyright and database right [2022]

The GeoClimate datasets are national datasets showing potential changes in clay shrink-swell subsidence susceptibility due to changes in climate (Harrison et al, 2019; Harrison et al, 2020). They have been developed by considering climate projections and the associated changes in soil moisture deficit, alongside hydrogeological modelling, and the geotechnical properties of the ground to provide long term, modelled analysis for resilience assessments. They provide information on the potential for clay shrink swell to occur at a given location, during a given future time-period. GeoClimate projections for clay shrink-swell susceptibility for Lincolnshire for the coming century are shown in Figure 20.

The GeoClimate projections shown in Figure 20 (Harrison et al. 2019) are partially driven by the Met Office UKCP09 climate projections (Murphy et al. 2009). The soil moisture deficits increase that are projected for the county, are reflected in the values calculated for each case study site (Table 6). These are based on the UKCP18 Met Office climate projections (Murphy et al. 2018) modelled using the UK national scale recharge model (Mansour et al. 2018). The SMD at each site increases from modelled historical values (1979-2000), and projections for the 2060-2080. These indicate an increased likelihood of drier ground conditions at the case study sites and in Lincolnshire in the coming century. The natural change in water content, due to changes in climate over the coming century, will impact shrinkable and compressible deposits across the country, and cause changes in volume over the short, medium and long term. Compressible ground will also be affected due to loading and anthropogenic practises such as surface water management.

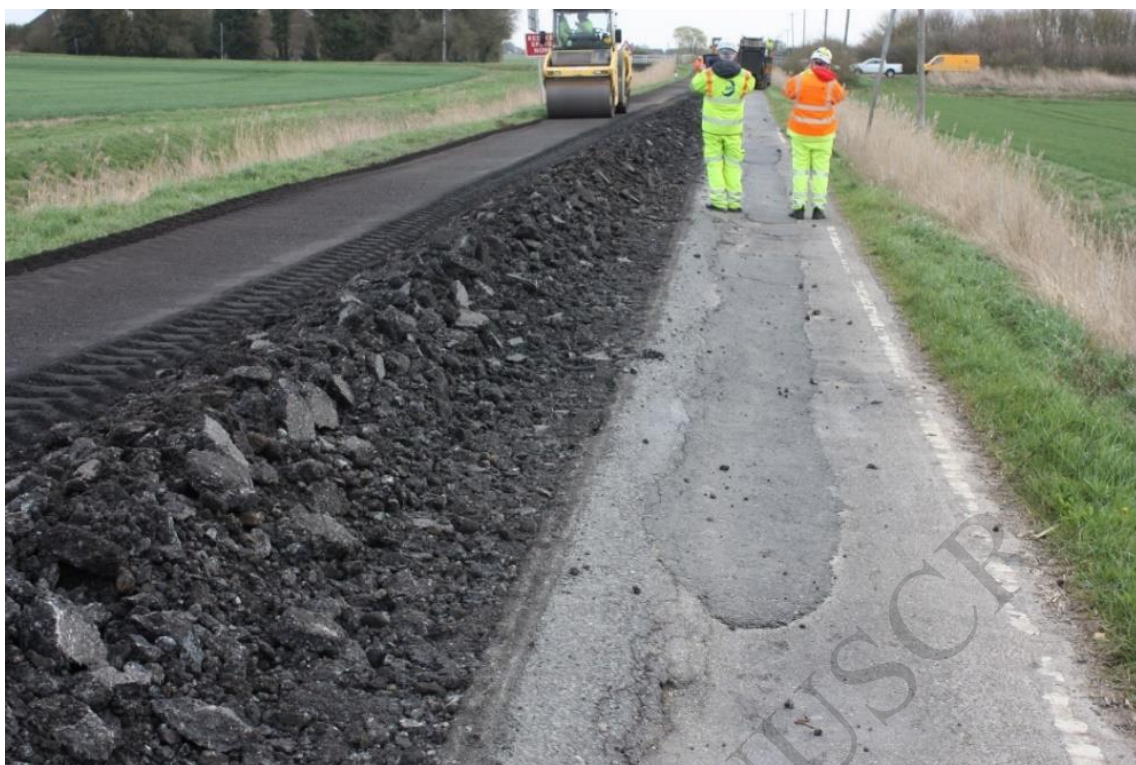
Figure 21 Shaping and compaction of the pulverised existing road surface at Fodderdyke Bank (March, 2018). © Mark Heaton LCC

Remedial work at Fodderdyke was carried out during 2018 (Figure 21 to Figure 23), reflecting the knowledge of the underlying road conditions, their geotechnical properties, and the impact of projected climate scenarios on susceptibility to movement in the future. Recognising the addition of added weight would cause more compression, the existing road surface was recycled. A mesh was included, covering the width of the road, enabling it to move as a single entity and thus experience less differential movement resulting in less surface cracking. Although this initial repair work is costlier and takes longer than the traditional patching, this informed decision making is targeted and defensible. It alleviates the requirement of abundant future repair work, and associated road closures with the resultant economic costs, demonstrating improvements both financially for the
