## Increasing road network resilience to the impacts of ground movement due to climate change – A case study from Lincolnshire, United Kingdom

A.M. Harrison, M. Heaton & D.C. Entwisle

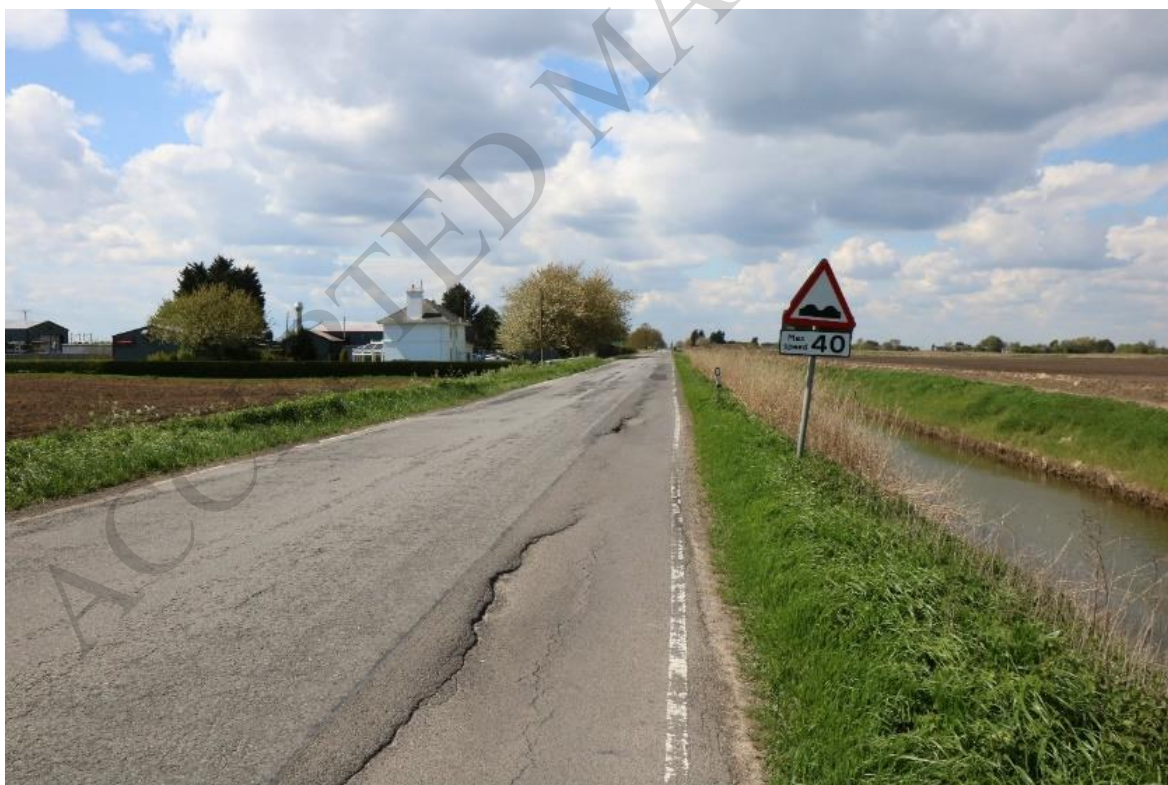
Figure 22 Station Road (Western end of Fodderdyke), Eastville, underlain by Tidal Flat deposits (May, 2018) BGS © UKRI 2018

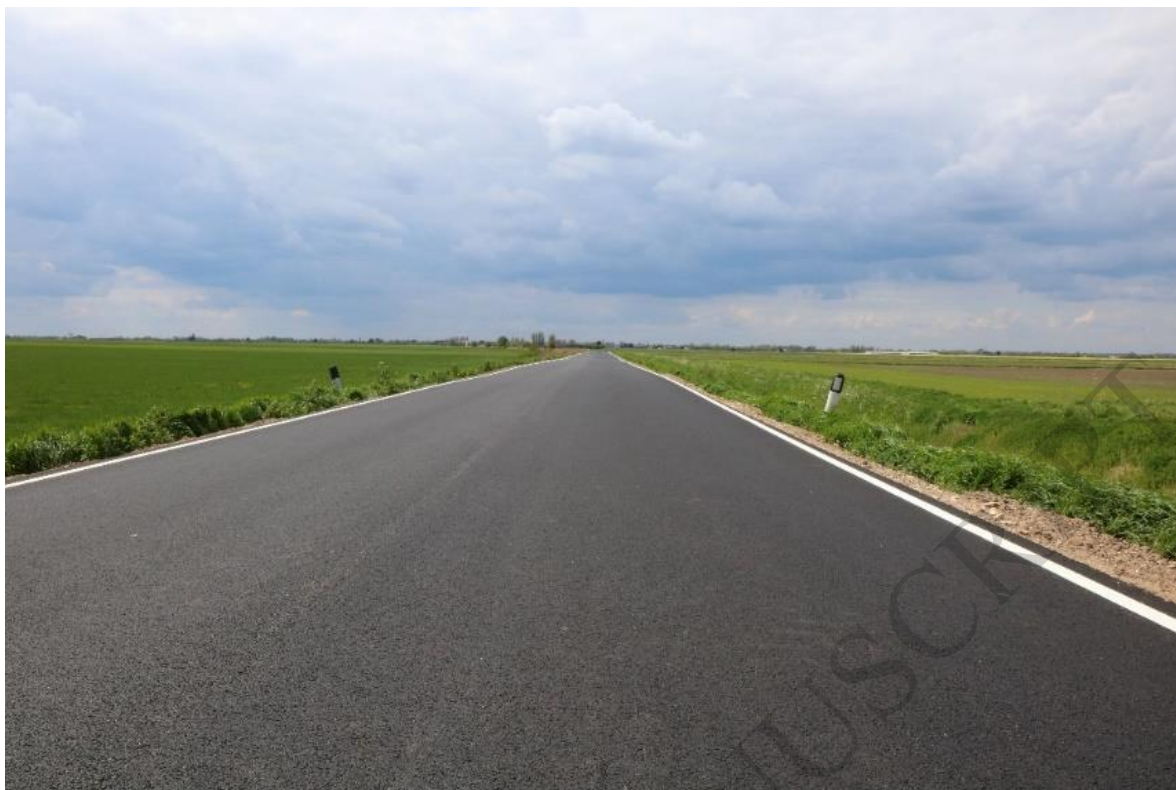
*Figure 23 Fodderdyke (eastern end of Fodderdyke) following resurfacing using the new recycling method (May, 2018) BGS © UKRI 2018*

Remedial work at Fodderdyke was carried out during 2018 (Figure 21 to Figure 23), reflecting the knowledge of the underlying road conditions, their geotechnical properties, and the impact of projected climate scenarios on susceptibility to movement in the future. Recognising the addition of added weight would cause more compression, the existing road surface was recycled. A mesh was included, covering the width of the road, enabling it to move as a single entity and thus experience less differential movement resulting in less surface cracking. Although this initial repair work is costlier and takes longer than the traditional patching, this informed decision making is targeted and defensible. It alleviates the requirement of abundant future repair work, and associated road closures with the resultant economic costs, demonstrating improvements both financially for the
