## THE USE OF POINT CLOUD DATA TO SUPPORT CONCRETE BRIDGE DECK CONDITION ASSESSMENT

A Thesis

Submitted to the  
Civil and Environmental Engineering  
College of Engineering  
In partial fulfillment of the requirement  
For the degree of  
Master of Science in Civil Engineering  
at  
Rowan University  
May 5, 2023

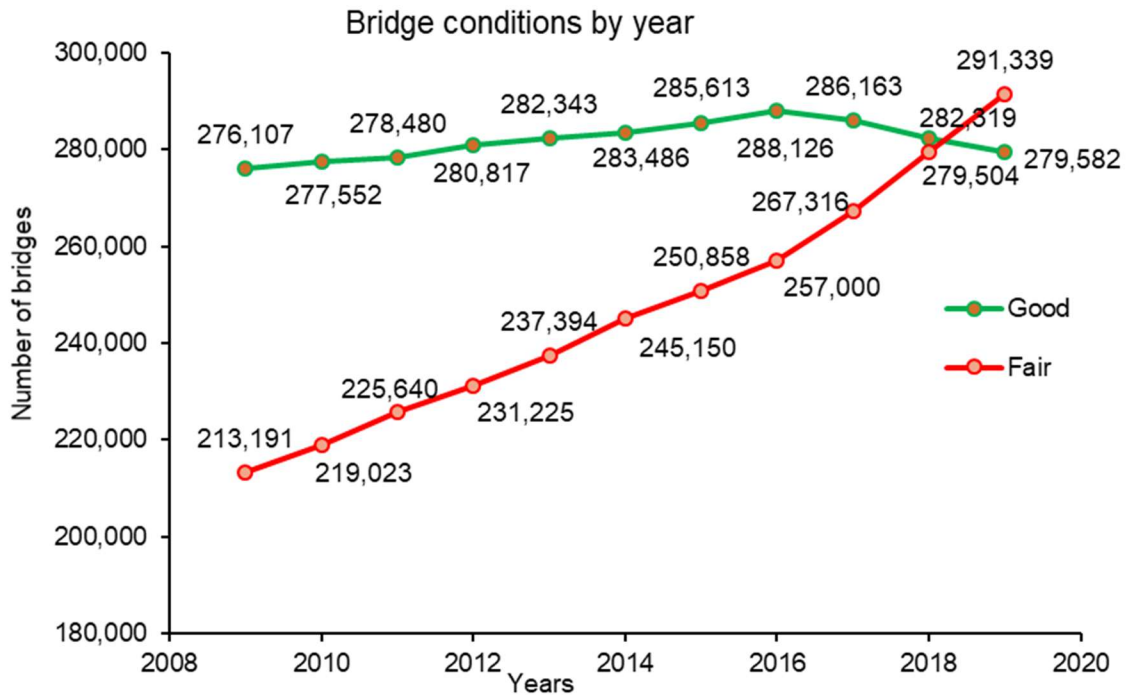
Figure 2. Bridges Condition Rating in the USA from ASCE 2021 infra-structure report.

From the ASCE 2021 infrastructure report. Figure 2, demonstrates the increase in the number of bridges rated as fair over the past years in the USA, which represents about 178 million trips per day each year. The total percentage of bridge deck areas identified as in poor condition was 7.5 percent in 2021 (ASCE, 2021). It is projected, that over the next 50 years, the deterioration trend will continue to increase unless significant work is done to our infrastructure. A systematic program for bridge preservation should be adopted, in which existing degradation is emphasized and preventative maintenance is prioritized.

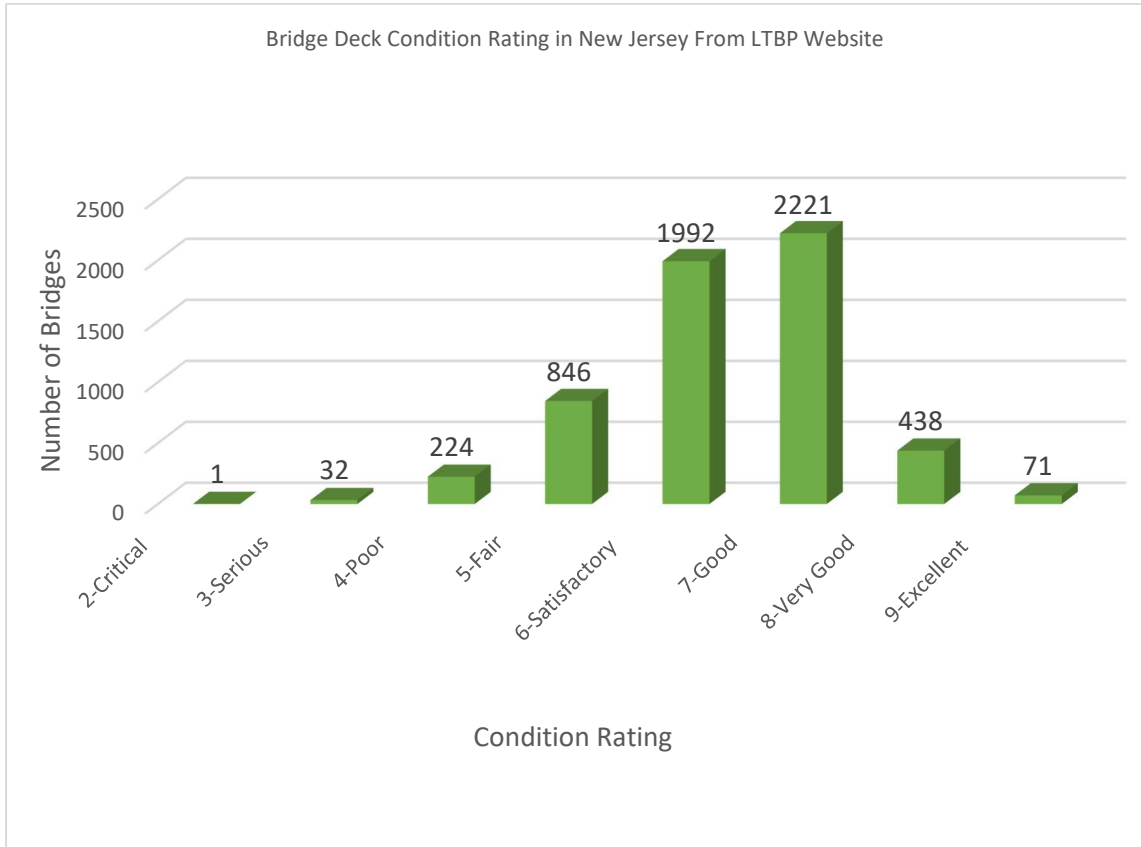
Figure 6. Bridge deck condition ratings for New Jersey from the LTBP website.

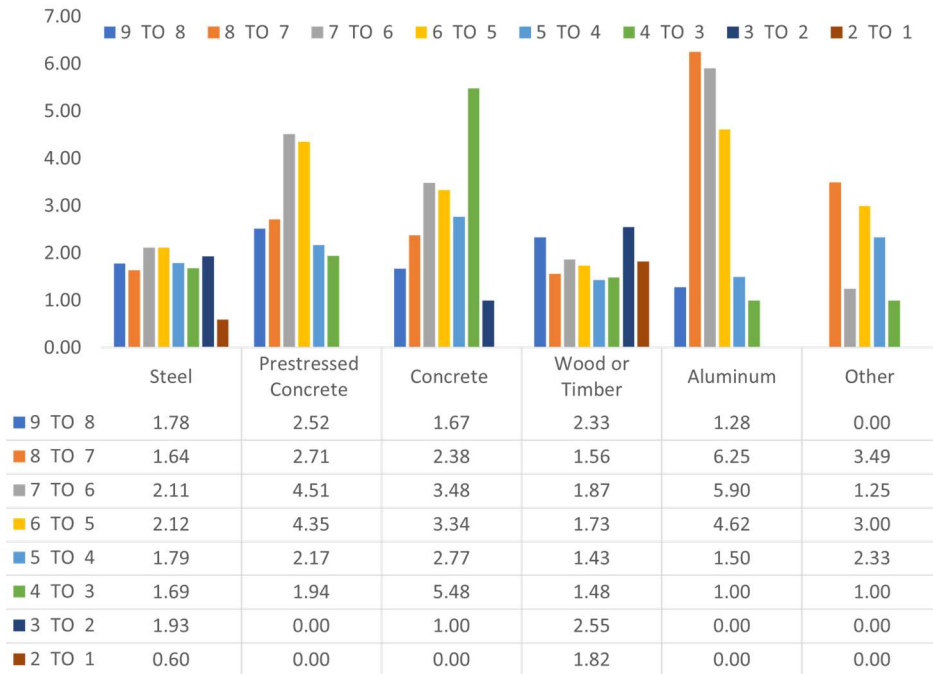
*Figure 8.* Detriment of Condition Rating Pattern for Different Bridge Main Construction Materials.

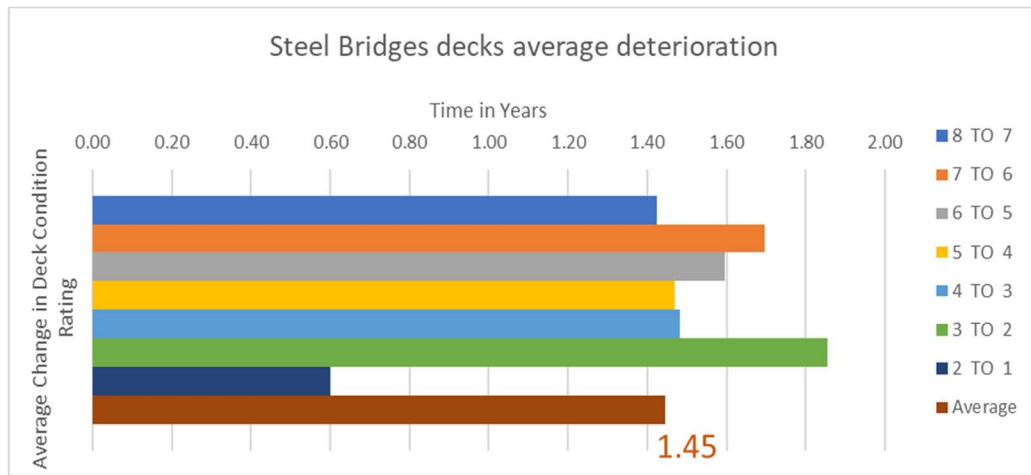
Figure 9. Change in deck condition rating for steel bridges.

every two years, at first glance this inspection should be sufficient. However, by shifting the focus to be on the most representative bridges by main construction material, which would be steel in this case, it can be seen in Figure 9 that, on average, it only takes 1.45 years for the bridge deck condition rating to drop by one grade from its previous rating.

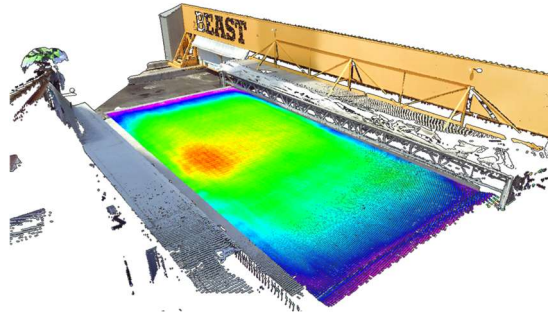
*Figure 10.* The BEAST Bridge Scanned Point Cloud.

LiDAR data was collected: (a) during the construction of the bridge, recording the as-built dimensions, (b) during an intermediate deterioration stage, and (c) at the end of the first phase of the BEAST specimen project.

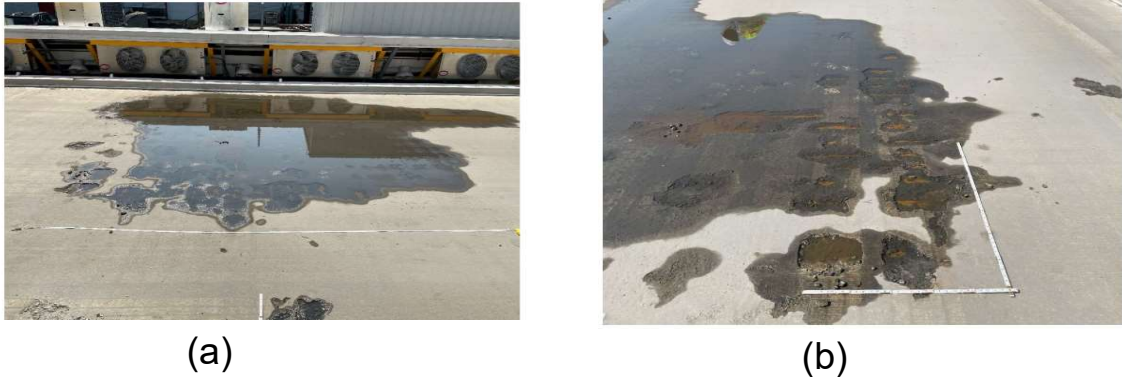
*Figure 11.* Images from visual inspection reports of the BEAST (a) Small to large spalls (35 SF total) looking east (b) 25 SF large spalls looking south.

correlated to the damaged area, which had 35 square feet of spalls equal to or deeper than 1” or 6” in diameter. The images from the visual inspection report captured in July 2021 can be seen in Figure 11.

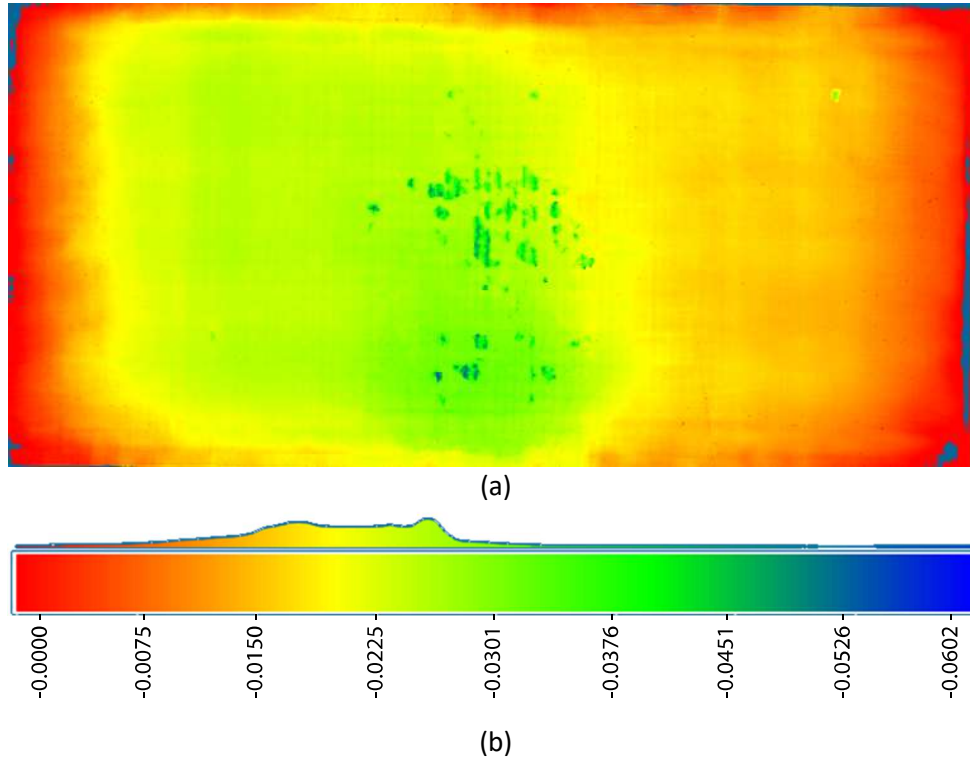
*Figure 15.* Heat Map of The BEAST Bridge Deck: (a) Plan view of deck's heat map by elevation; (b) Elevation scale from 0.00 to -0.06 in.

closer look to the area of study, where the figure on the top (a), encloses the area that was selected to perform the percent damage evaluation, and the image on the bottom (c), is the points that correspond to the points classified as actual damage.

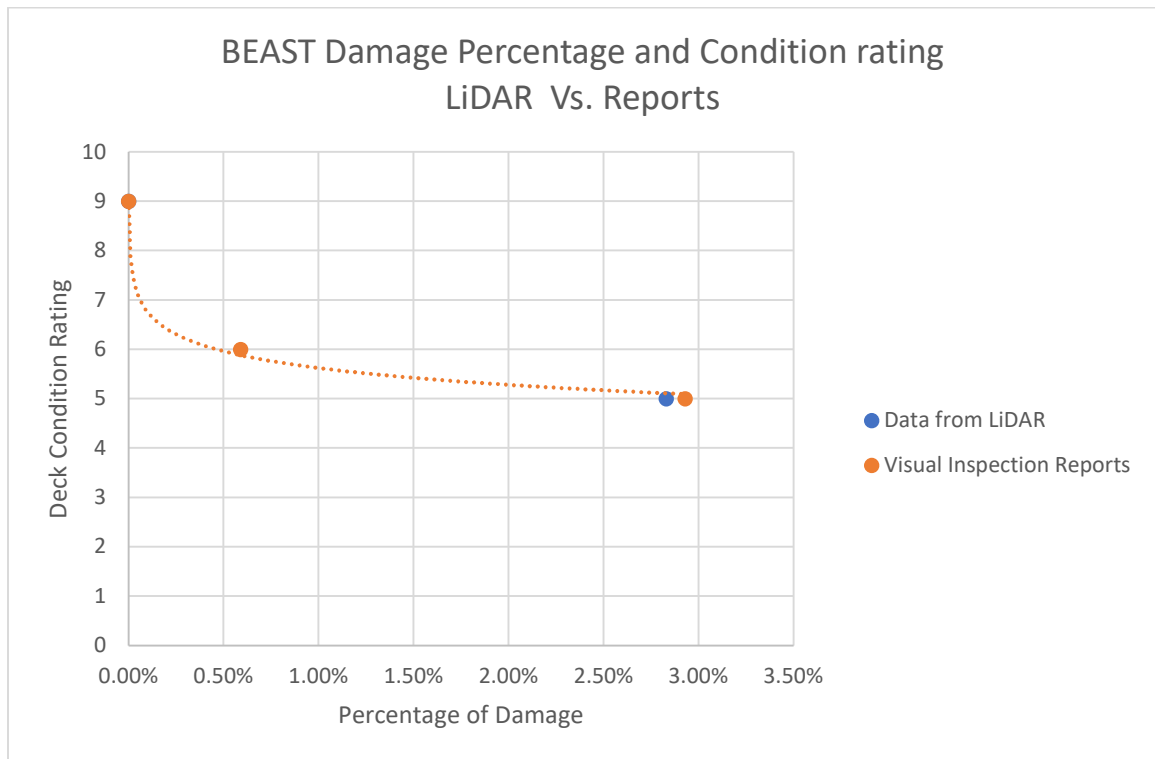
*Figure 17. BEAST Damage Percentage and Condition rating LiDAR Vs. Reports*

The results of comparing the damage detected by the LiDAR at a similar time to the inspection report show a compelling pattern of deterioration. These findings are displayed in a clear and concise manner in Figure 17. This comparison highlights the efficacy of the LiDAR technology in detecting and monitoring damage over time, and demonstrates its potential as a valuable tool in infrastructure maintenance and management.

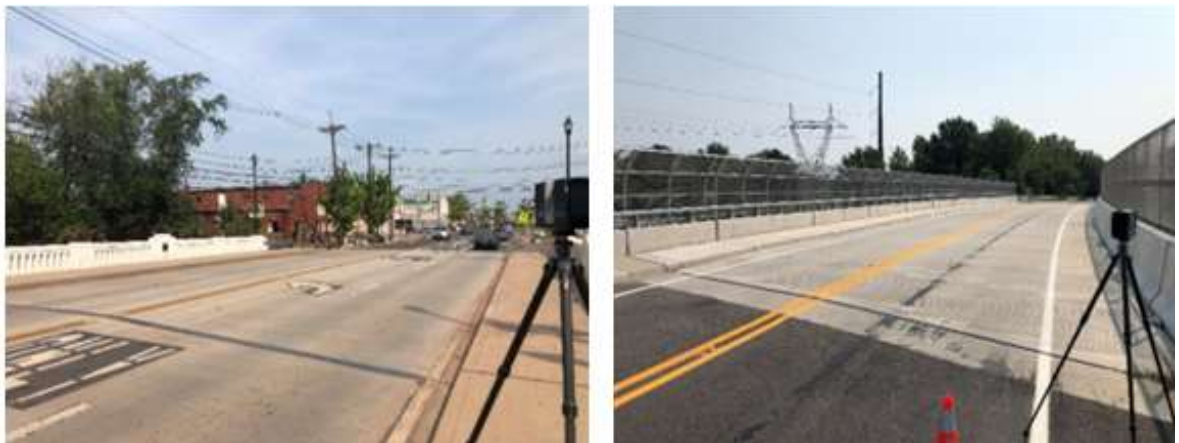
*Figure 20.* Typical location of scanner: (a) Scanner located on deck's shoulder; (b) Scanner located on the sidewalk.

The researchers utilized a Faro Focus terrestrial laser scanner to gather information on the bridge decks. They visited each bridge and determined the scanner's position and scans based on its characteristics, such as span length, curb-to-curb dimension, obstructions, and traffic flow during scanning. The scanner was placed on the side of the road (shoulder or sidewalk) to prevent traffic disturbances, as depicted in *Figure 20*.

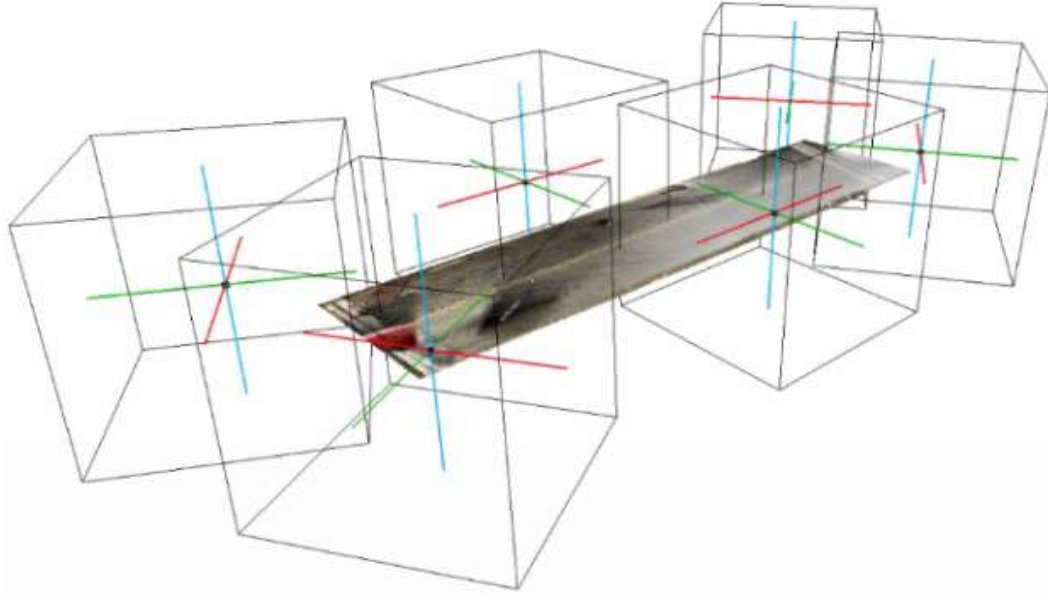
*Figure 21.* Processed point cloud of a bridge deck.

To increase the precision of the registration, it is recommended to pre-process each scan by removing potential noise and unnecessary points that can affect the final registration. The goal of point cloud processing methods in bridge engineering is to recognize structural features in the point cloud and then apply the algorithm that best meets the project demands (e.g., geometry capturing, condition assessment, structural evaluation) (Trias-Blanco, A., (2020).). An example of one set of registered point cloud containing a bridge deck analyzed in this research is shown in *Figure 21*.

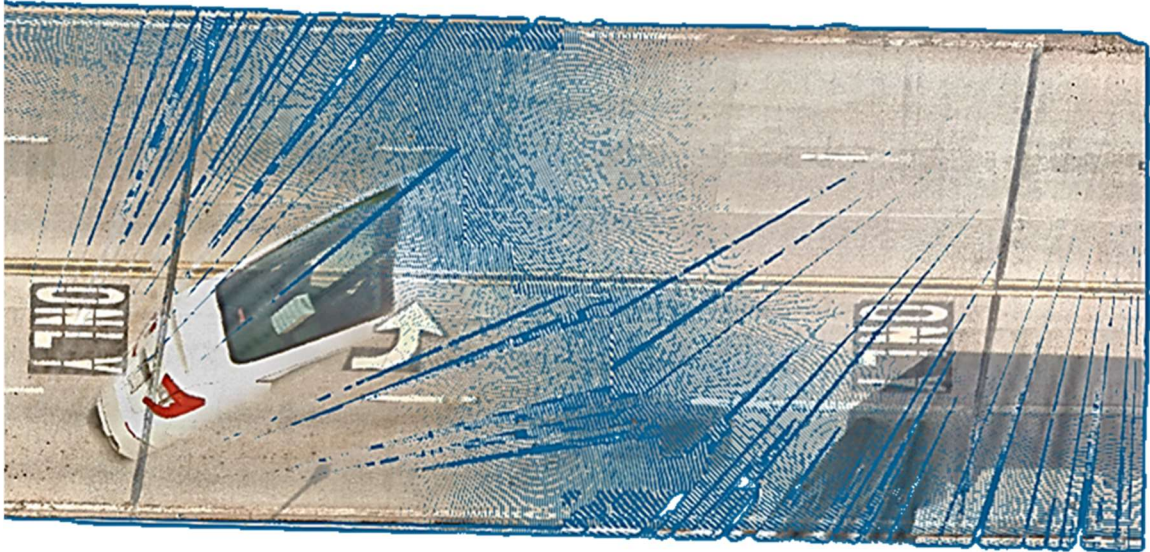
*Figure 22.* RGB Of Structure 18G0701.

Cross sections along the transverse and longitudinal directions were generated by creating slices of the point cloud of the deck. *Figure 22*, represents an RGB image of a sample of the bridge decks used in our research structure number 18G0701.

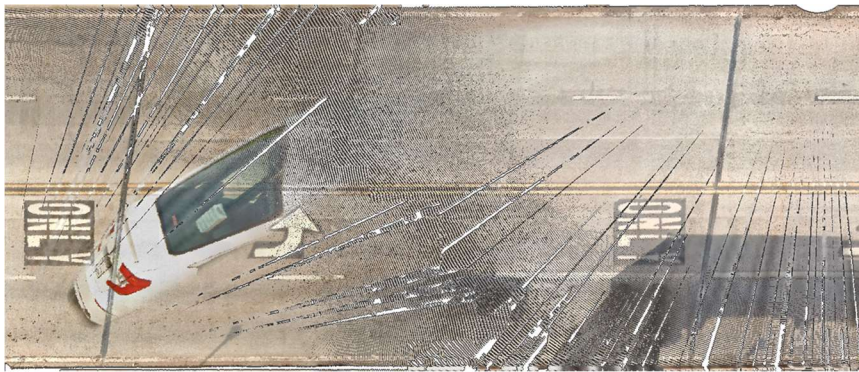
*Figure 25. RGB of Structure 18G0701/*

Structure 18G0701 has a recently reconstructed Deck. Based on the visuals provided in Figure 26, Figure 28 and Figure 29, it has been constructed with appropriate slopes to facilitate drainage in both the longitudinal and transverse directions. However, it should be noted that there are a few depressions or low points on the deck, as can be observed in Figure 28 that shows Longitudinal sections and Figure 29 for Transverse sections, which could pose potential problems in the future.

Figure 27 displays a blueprint of the deck, indicating the locations of the longitudinal and transverse sections. Additionally, Figure 25 provides a colored view of the top surface of the deck. And

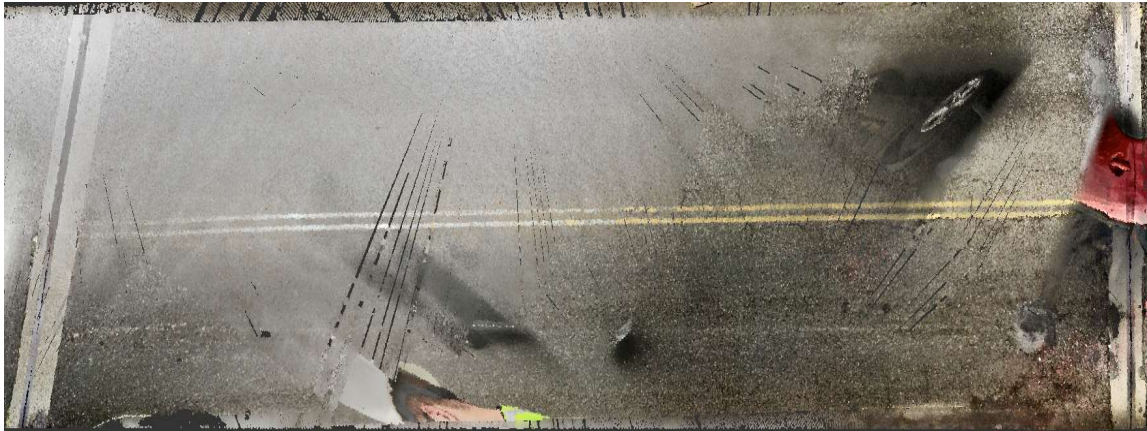
*Figure 30.* RGB of Structure 0954163

The longitudinal cross-sections produced for this structure illustrate multiple areas with depressions, as displayed in Figure 32. These low points are prone to accumulating water for extended periods, speeding up the reinforcing steel's deterioration. Furthermore, the longitudinal slope was approximately 0.5%, which hinders water drainage, based on Figure 32. The transverse cross-section slope ranges from 0 to 0.8%, falling below the recommended 2% as seen in Figure 33. Figure 31 presents a plan view that pinpoints the placement of the longitudinal and transverse sections within the deck.

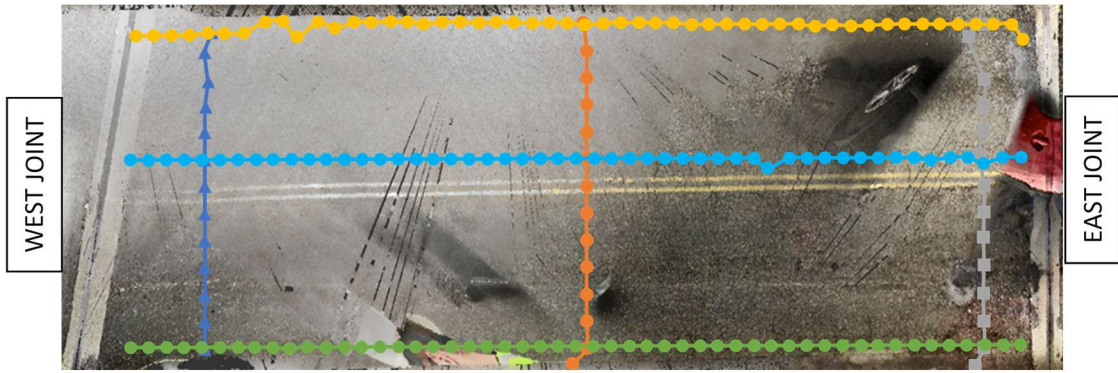
Figure 31. Approximate Cross Sections Locations on the Deck Surface

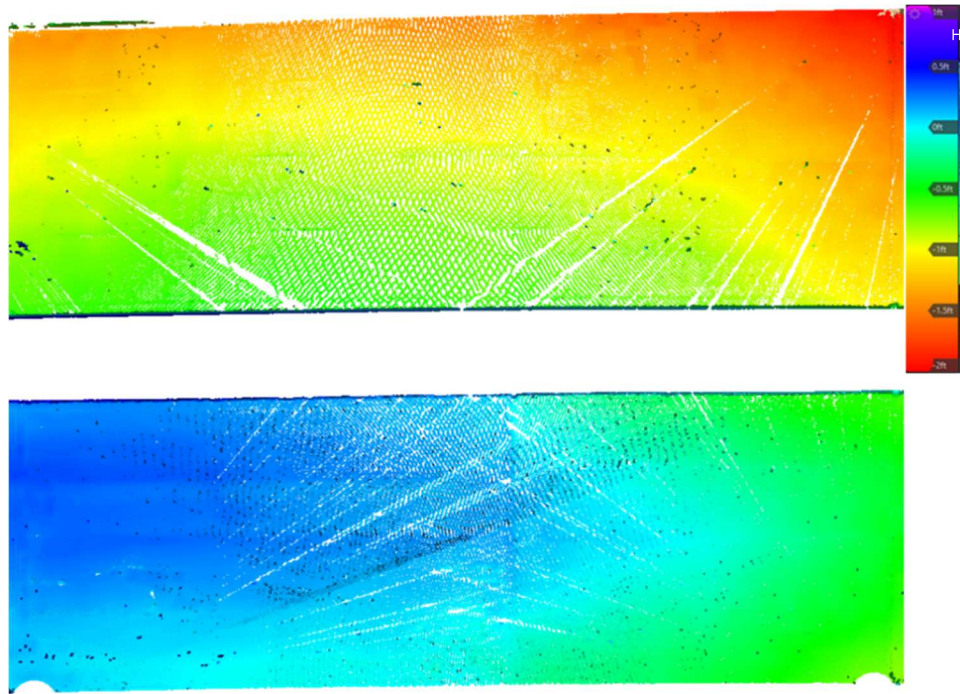
*Figure 35.* Heat Map of structure 0416151

Bridge 0416151 was observed to have significant flat regions, as depicted in Figure 35 and Figure 36. Figure 35 portrays the differences in height on the top surface of the deck, while Figure 36 points out the areas that are level and devoid of changes in elevation or slope. Figure 34 shows an RGB view of the deck's top surface. These flat regions have an impact on the way water flows off the bridge. The flat areas are prone to accumulating water, which can seep into the deck and heighten the risk of corrosion on the reinforcing steel.

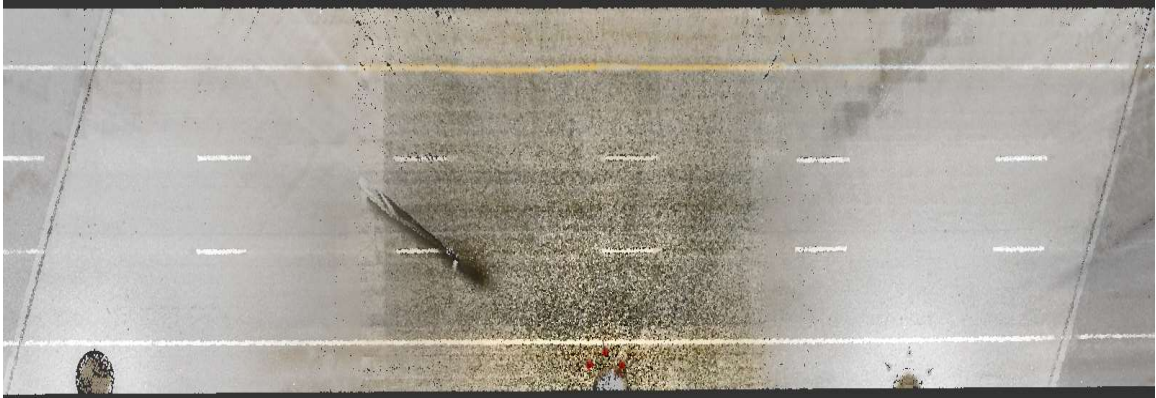
Figure 40. RGB of Structure 361632N

Figure 41 shows an elevation map, and Figure 43 estimates a 1 to 1.5% longitudinal slope. These indicate that the surface conditions allow water to run off the deck efficiently. Additionally, Figure 44 estimates a transverse slope of approximately 2%. There is no clear evidence of areas on Structure 361632N prone to early deterioration. However, it is worth noting that the first half of the deck (upstream) has a lower slope than the second half. This could affect performance by causing water to sit longer on flatter areas and accelerating deterioration. Figure 40 provides an RGB view of the top surface of the deck.

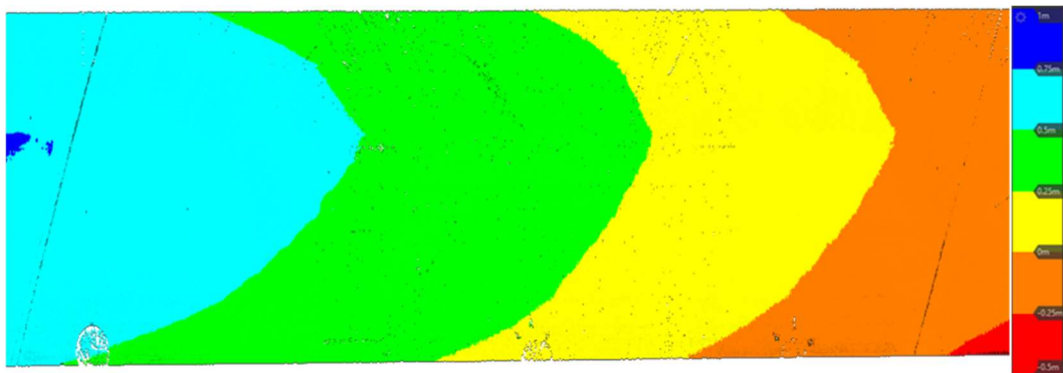
Figure 41. Structure 361632N Heat Map

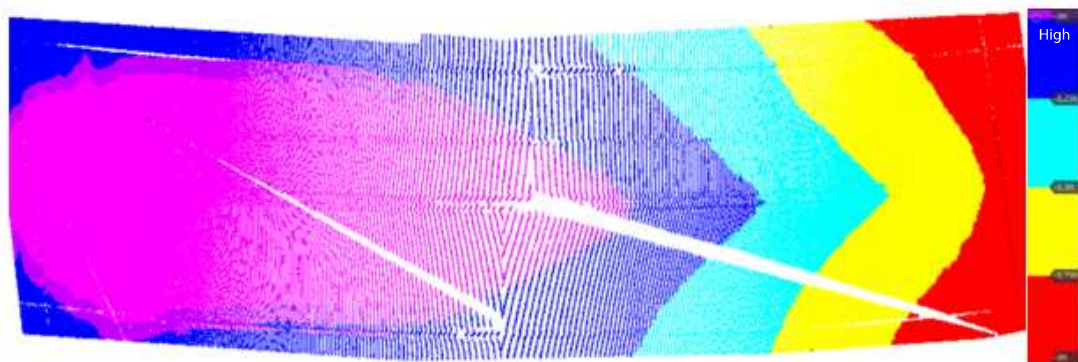
Figure 46. Structure 0821155 Heat map

Structure 0821155 is recently built. Figure 46 and Figure 48 show a flatter area on the left side that may cause problems in the long run. The transverse cross-section slope of the deck is around 1.4%, which is slightly lower than the recommended 2%, as estimated from the data in Figure 49. Figure 45 shows an RGB view of the top surface of the deck.

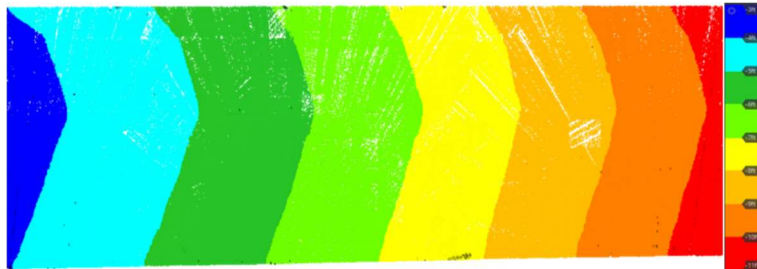
Figure 51. Structure 1317154 Heat Map

The slope of Structure 1317154 is uniformly inclined at about 3% longitudinally, according to Figure 51 and Figure 53. As estimated in Figure 54, the transverse slope is slightly below the recommended 2%, at approximately 1.6%. There is no particular area of concern where the structure might deteriorate prematurely. However, the transverse slope observed in this deck is worth noting; Figure 52 provides an approximate location of each cross-section in Structure 0821155. Long A, B, C, and D refer to cross sections in the longitudinal direction. Trans Top, Trans Mid, and Trans Bottom denote cross sections in the transverse direction.

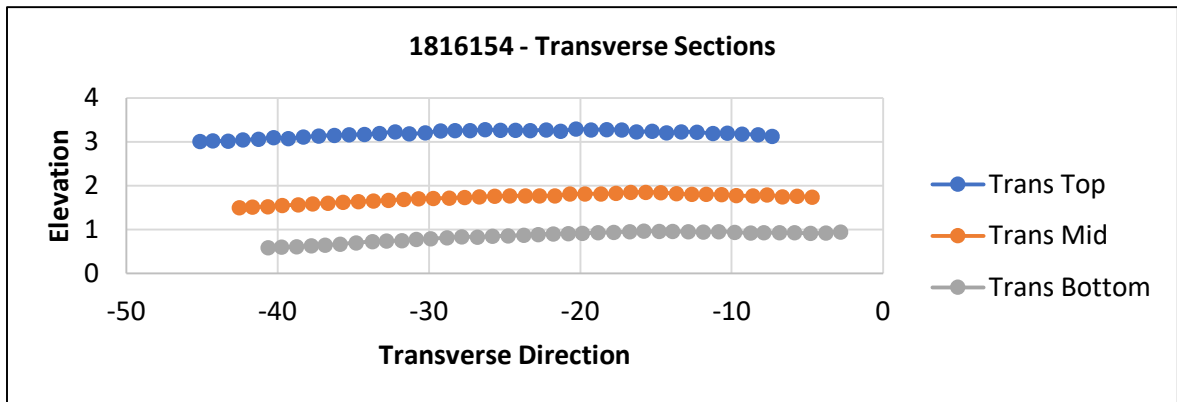
Figure 64. Structure 1816154 - Transverse Sections

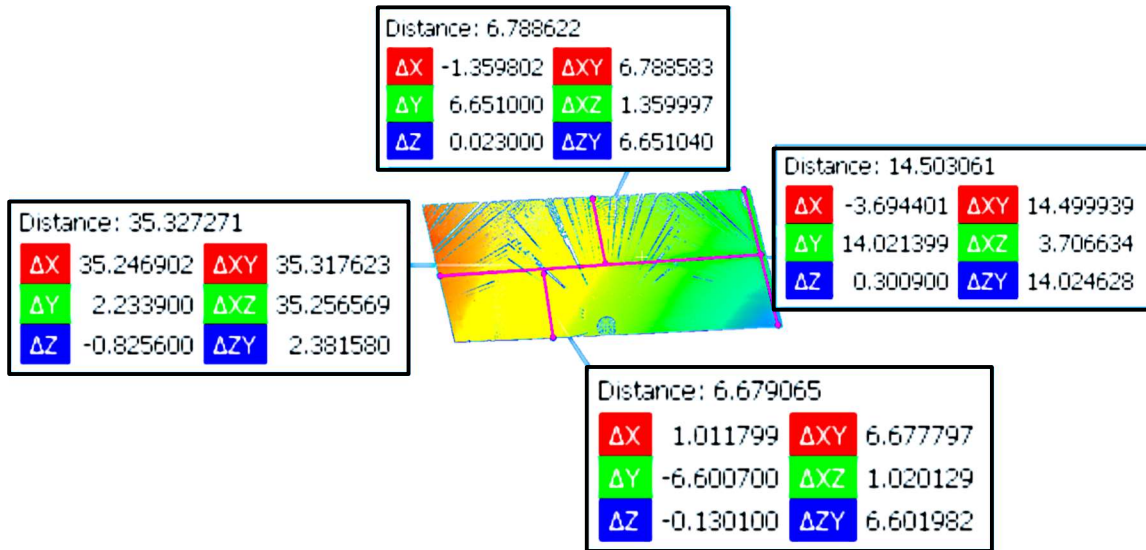
Figure 65. Points Coordinates and slopes Variation along the Deck

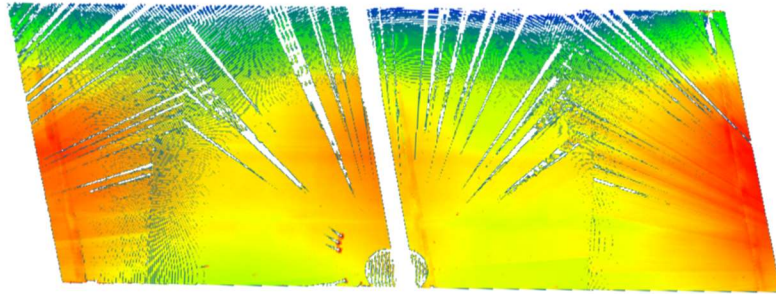
*Figure 69.* Sectioning the Bridge Deck based on Slopes variation.

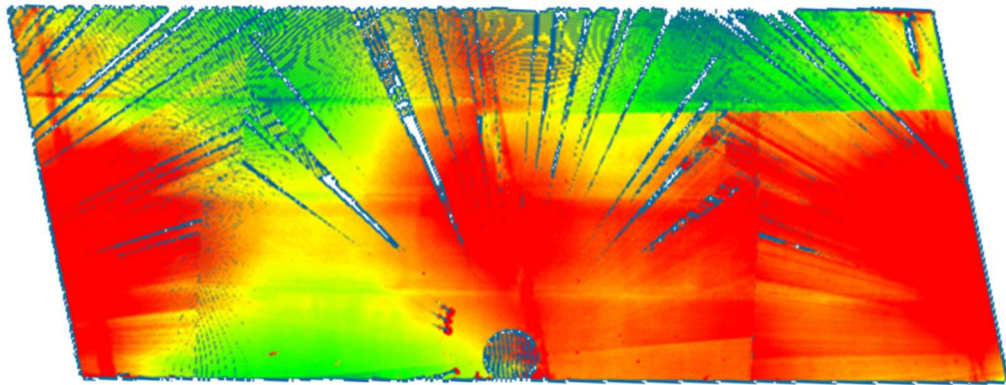
*Figure 73. Fitted Planes Heat Map*

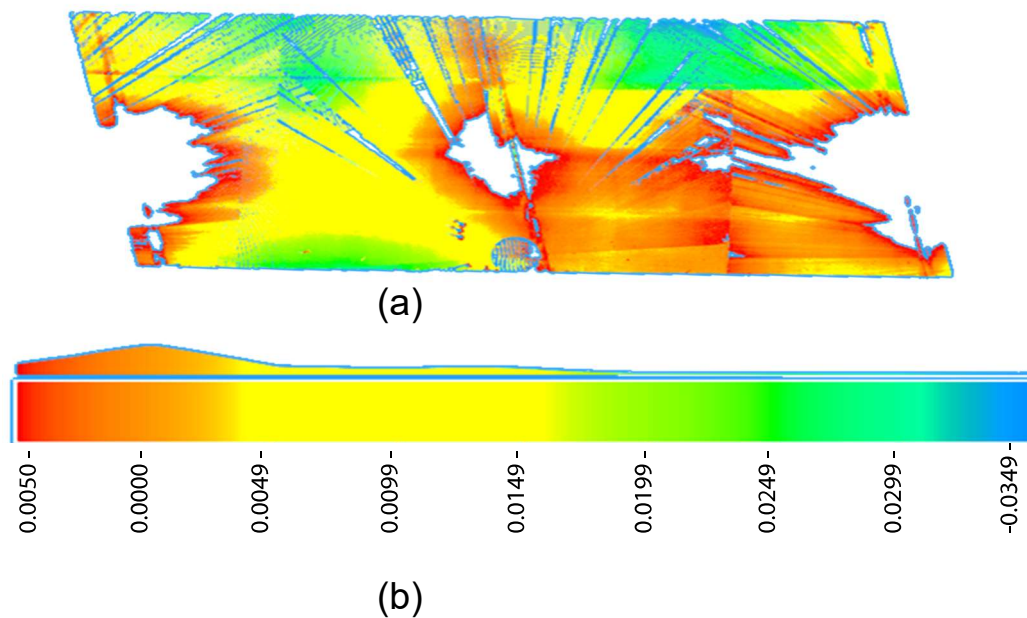
Figure 74. (a) Plane Fitted Bridge Deck of Structure 1816154, (b) Elevation scale after choosing the representative Elevation ranging from 0.005 to -0.035

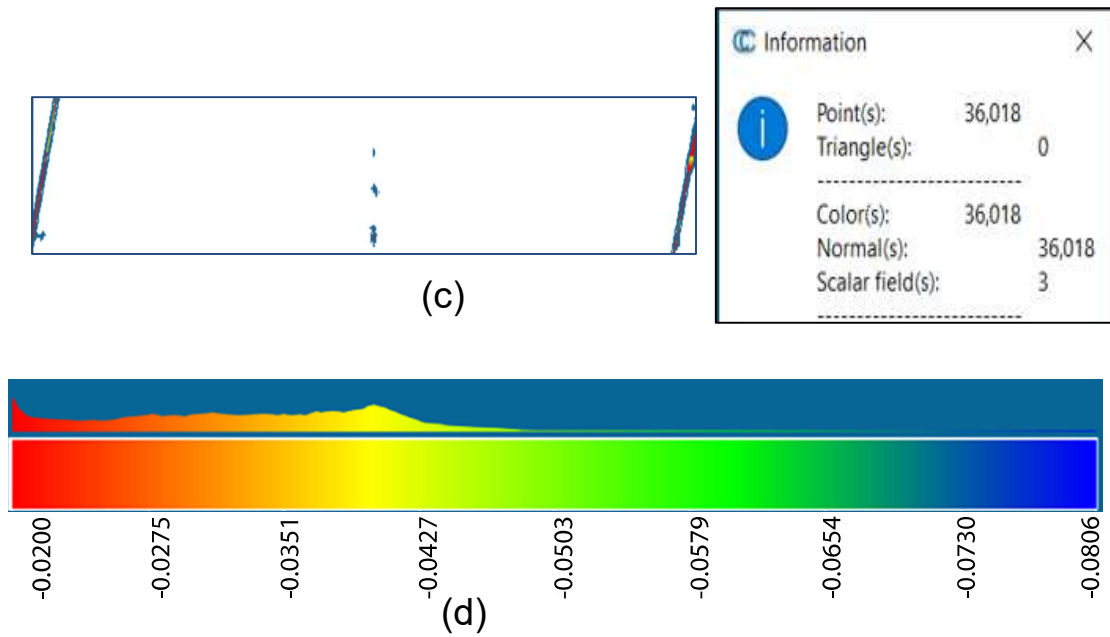
Figure 77. Analysis of Structure 0821155 Bridge Deck (a) Heat map of the plane fitted bridge deck (b) Elevation scale showing Elevations from 10 to - 80 mm(c) Isolated damaged points along with the number of points in the isolated cloud that represent damage,(d) Elevation scale showing elevations from -20 to – 80 mm.

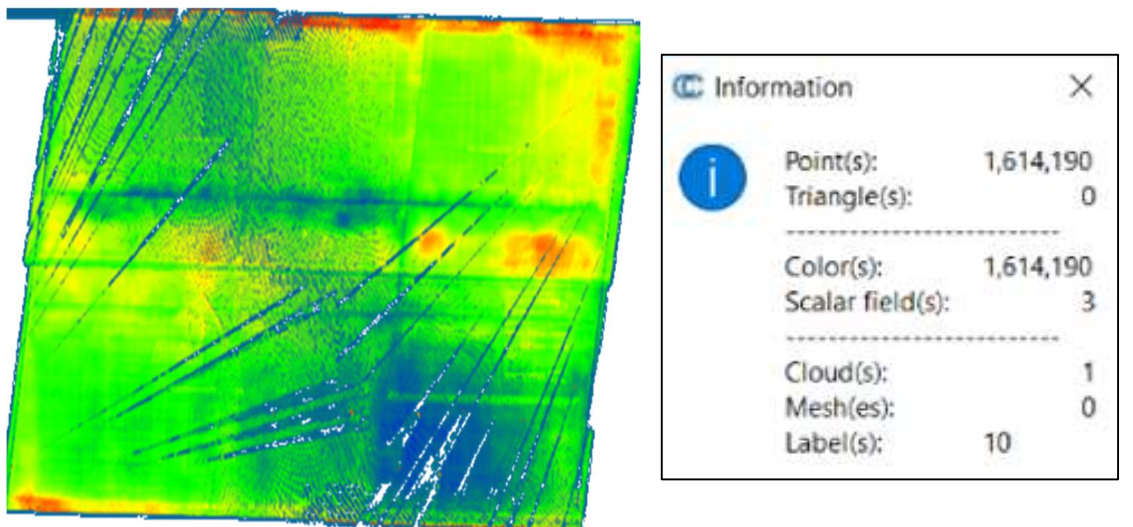
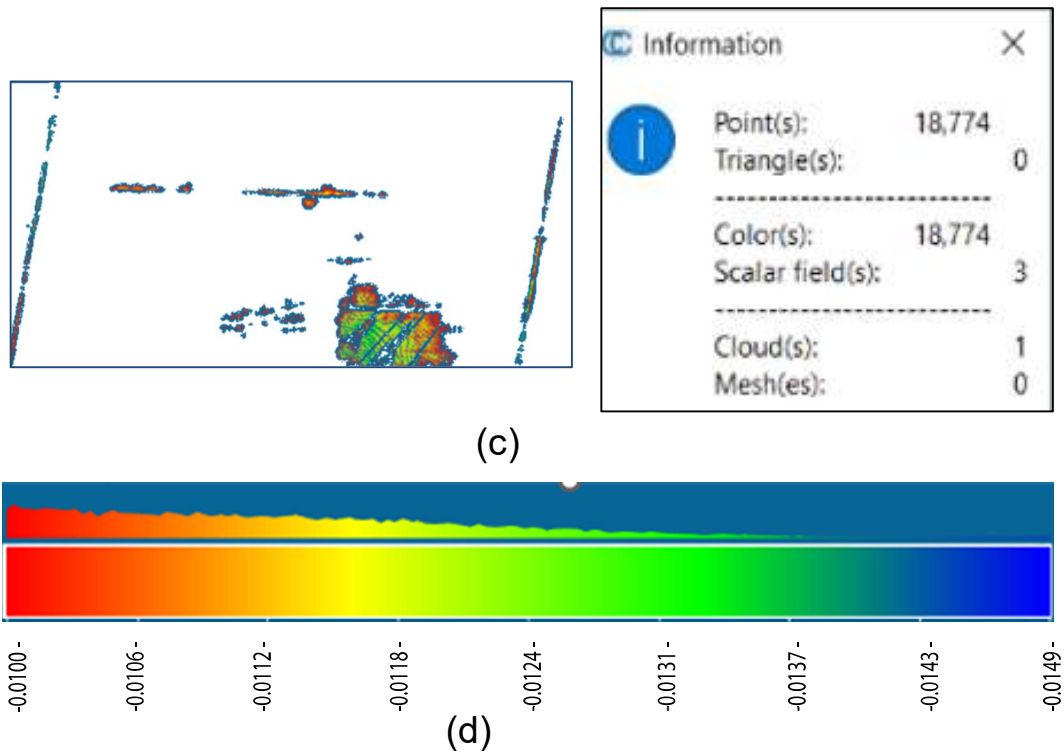
Figure 78. Analysis of Structure 18G0701 Bridge Deck (a) Heat map of the plane fitted bridge deck (b) Elevation scale showing Elevations from 15 to - 15 mm (c) Isolated damaged points along with the number of points in the isolated cloud that represent damage,(d) Elevation scale showing elevations from -10 to -15 mm

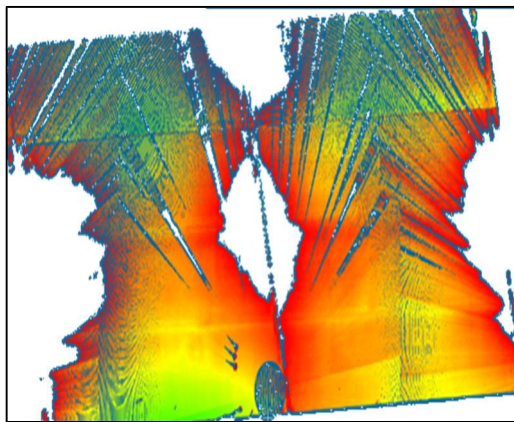
Figure 81. Analysis of Structure 1816154 Bridge Deck. (a) Heat map of the plane fitted bridge deck (b) Elevation scale showing Elevations from 0.0 to – 60 mm (c) Isolated damaged points along with the number of points in the isolated cloud that represent damage,(d) Elevation scale showing elevations from -26 to – 60 mm.

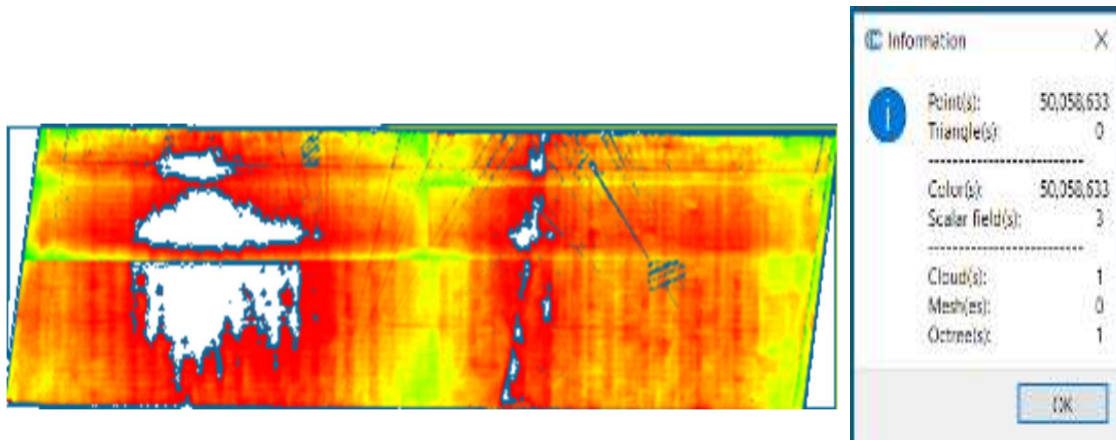
Figure 83. Analysis of Structure 1317154 Bridge Deck. (a) Heat map of the plane fitted bridge deck (b) Elevation scale showing Elevations from 17.4 to – 41 mm (c) Isolated damaged points along with the number of points in the isolated cloud that represent damage,(d) Elevation scale showing elevations from -8 to – 41 mm.

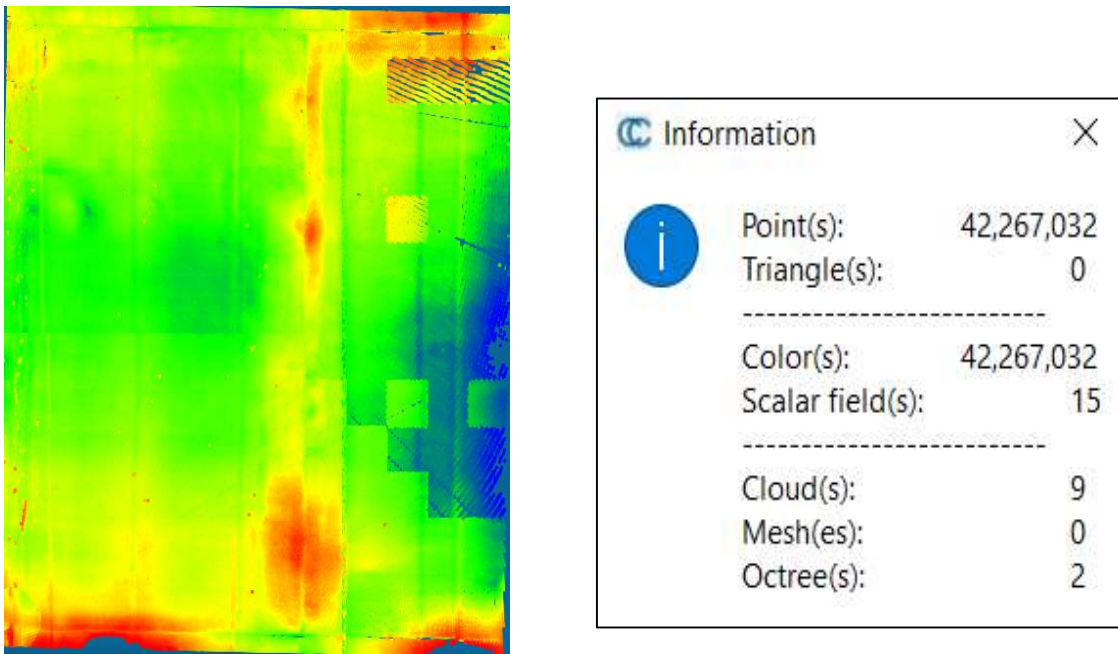
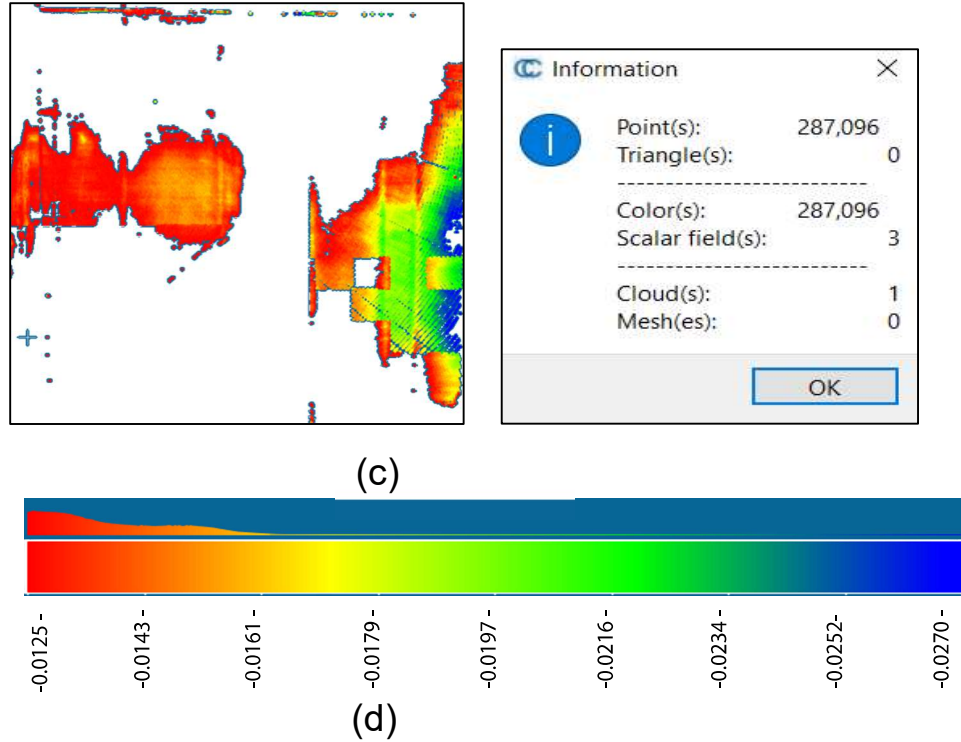
Figure 84. Analysis of Structure 0411163 Bridge Deck. (a) Heat map of the plane fitted bridge deck (b) Elevation scale showing Elevations from 12.9 to – 27 mm (c) Isolated damaged points along with the number of points in the isolated cloud that represent damage,(d) Elevation scale showing elevations from -12.5 to – 27 mm.

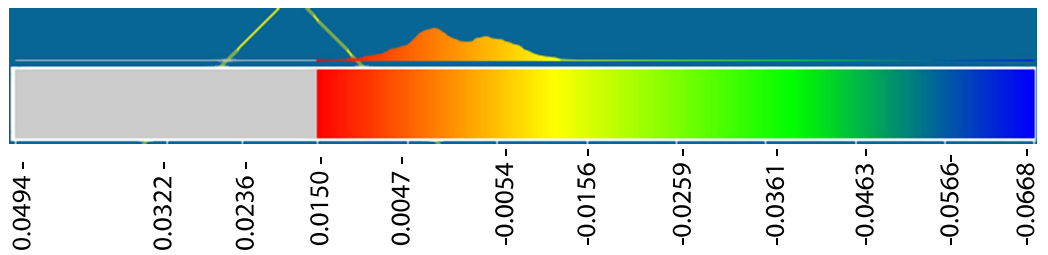
Figure 85. Analysis of Structure 0411164 Bridge Deck. (a) Heat map of the plane fitted bridge deck (b) Elevation scale showing Elevations from 15 to – 67 mm (c) Isolated damaged points along with the number of points in the isolated cloud that represent damage,(d) Elevation scale showing elevations from -10 to – 67 mm.

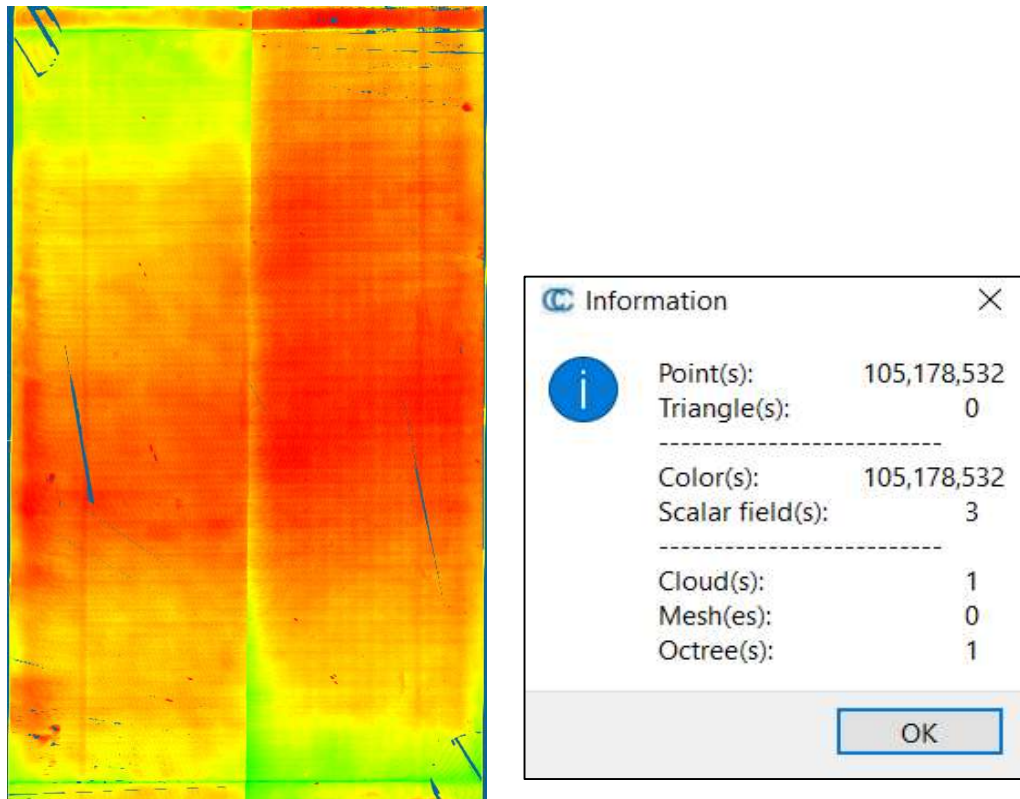
Figure 86. Analysis of Structure 0805F03 Bridge Deck. (a) Heat map of the plane fitted bridge deck (b) Elevation scale showing Elevations from 15 to – 42 mm (c) Isolated damaged points along with the number of points in the isolated cloud that represent damage,(d) Elevation scale showing elevations from -13.5vt to – 42 mm.

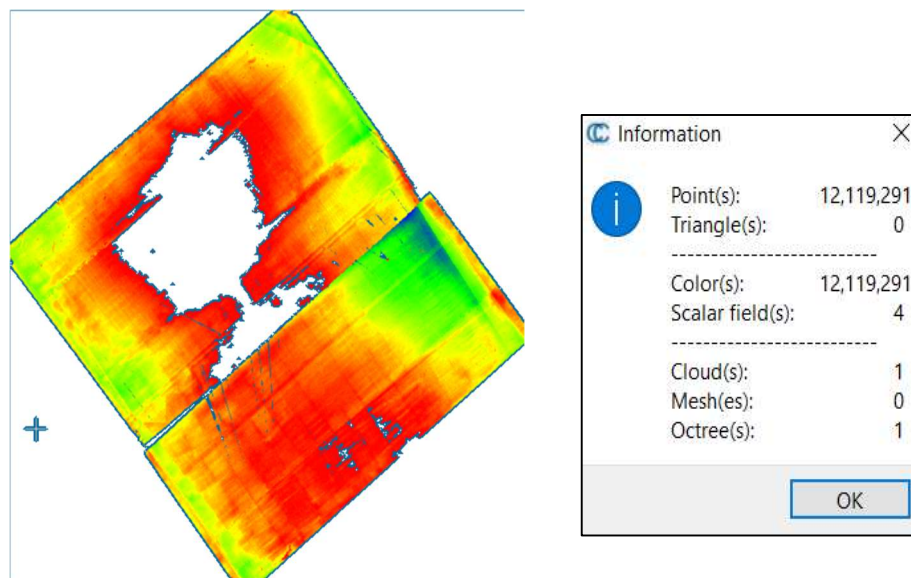
Figure 88. Analysis of Structure 0807P01 Bridge Deck. (a) Heat map of the plane fitted bridge deck (b) Elevation scale showing Elevations from 8 to –36 mm (c) Isolated damaged points along with the number of points in the isolated cloud that represent damage,(d) Elevation scale showing elevations from -15.5 to – 36 mm.
