## THE USE OF POINT CLOUD DATA TO SUPPORT CONCRETE BRIDGE DECK CONDITION ASSESSMENT

A Thesis

Submitted to the  
Civil and Environmental Engineering  
College of Engineering  
In partial fulfillment of the requirement  
For the degree of  
Master of Science in Civil Engineering  
at  
Rowan University  
May 5, 2023

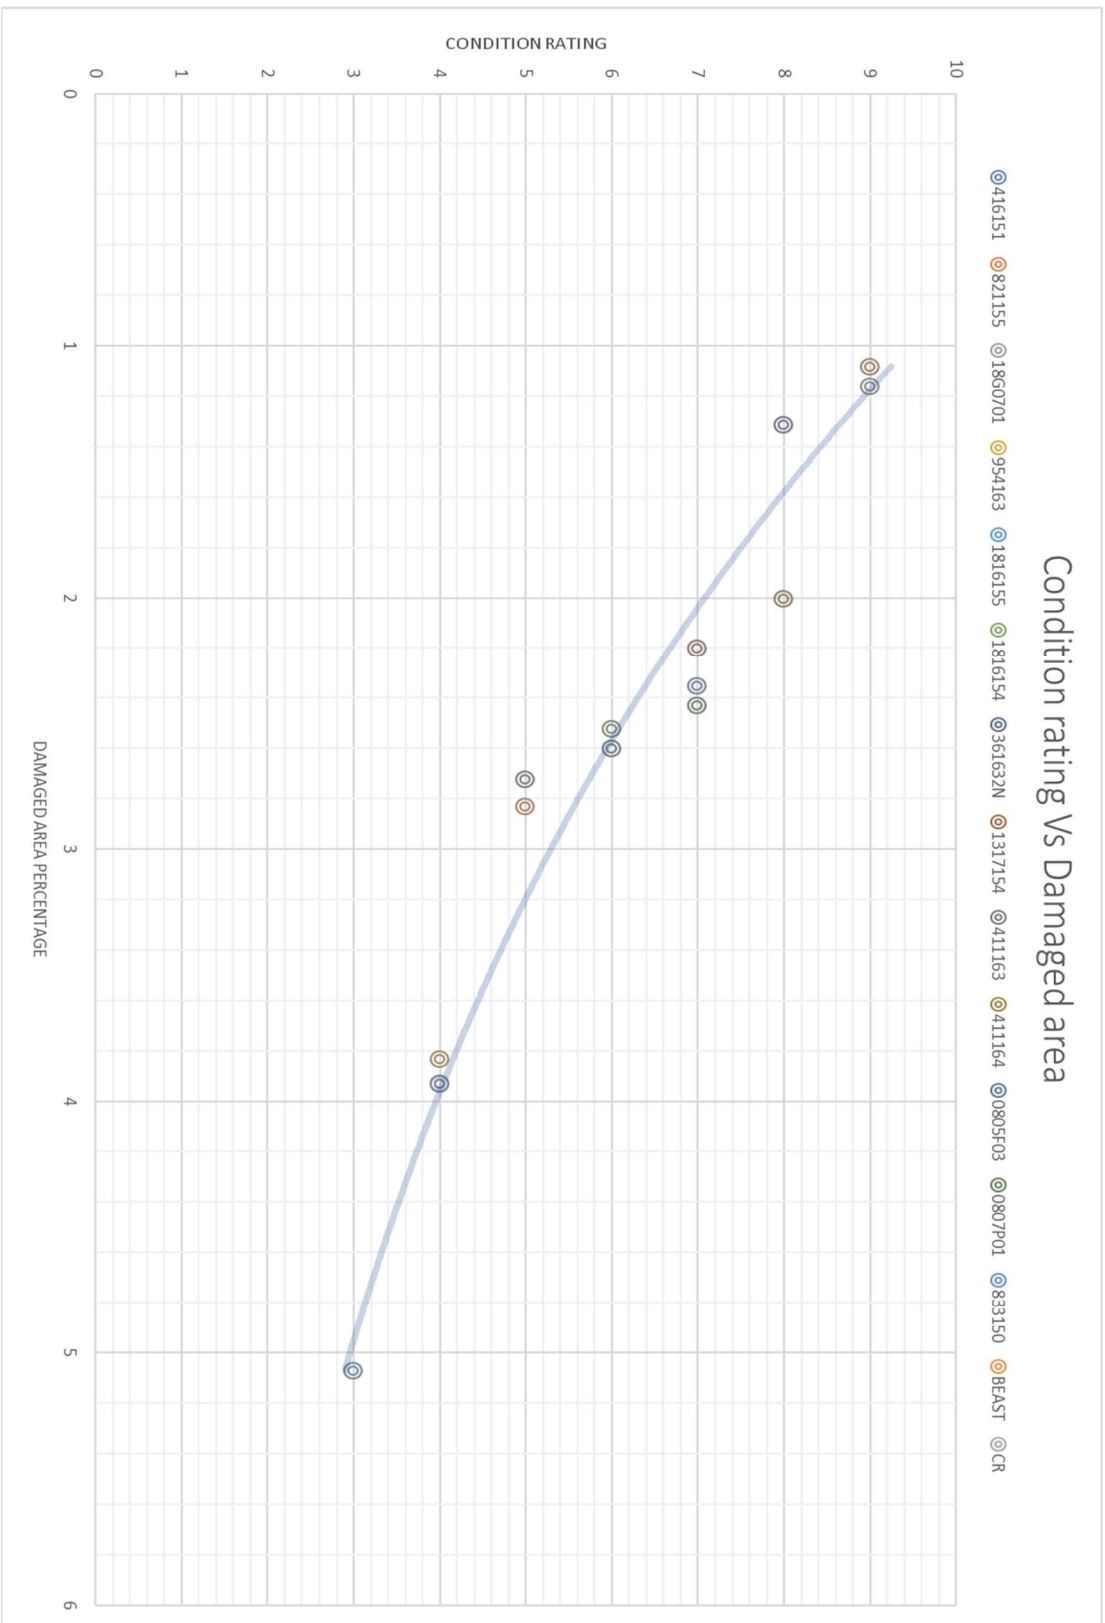
Figure 89. Condition Rating Vs Damaged area Analysis Trend
