# Multi-vulnerability analysis for seismic risk management in historic city centres: an application to the historic city centre of La Serena, Chile

Pilar Baquedano-Juliá<sup>1</sup> · Tiago Miguel Ferreira<sup>2</sup> · Camilo Arriagada-Luco<sup>3</sup> · Cristián Sandoval<sup>4</sup> · Nuria Chiara Palazzi<sup>5,6,7</sup> · Daniel V. Oliveira<sup>1</sup>

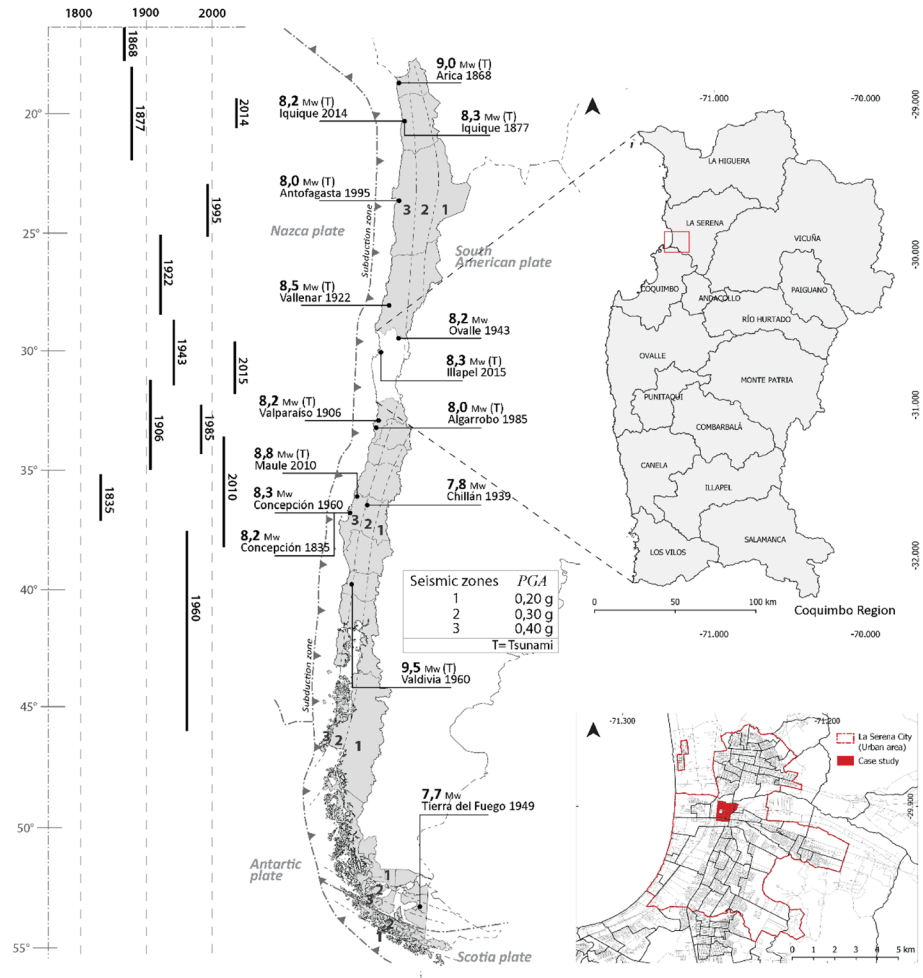
**Fig. 1** Seismicity in Chile (Processed from [www.csn.uchile.cl](http://www.csn.uchile.cl)), Coquimbo region (IV Region) and case study

The coastal zone of Chile concentrates more than 25% of the energy released in seismic form worldwide (Cisternas 2011). Figure 1 shows the 15 largest earthquakes that occurred in Chile over the last 200 years. They correspond to earthquakes with a magnitude equal to or greater than 7.7  $M_w$ . The size of the earthquake (magnitude) is proportional to the area of the zone that was able to move and how much it moved (CSN 2013).

On September 16, 2015, the Mw 8.3 Illapel earthquake occurred in the Coquimbo region (Fig. 1). The earthquake occurred on thrust faults along the boundary of the Nazca and South American plates, at a depth of 22.4 km. It was immediately followed by tsunami waves which caused severe damage to Coquimbo’s seafront. The run-up depth in the bay was over 4.5 m and extended over a distance of ~500 m from the coast in some areas. The

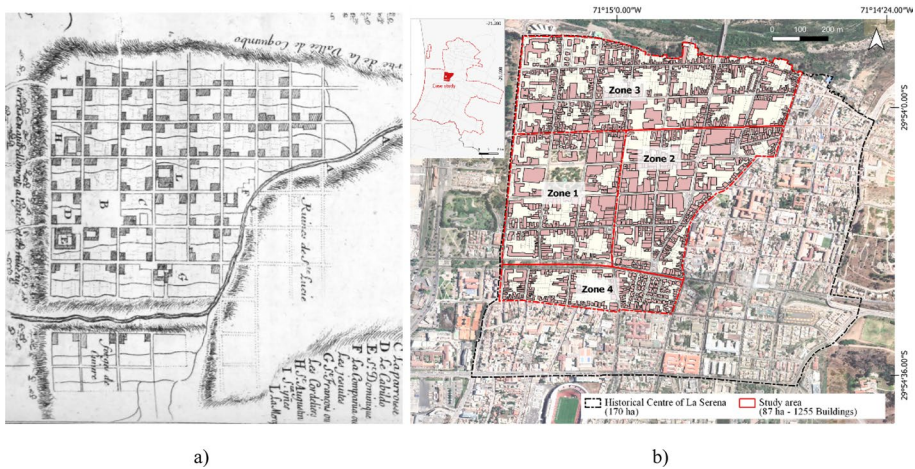
**Fig. 3** **a** Map of La Serena 1713, Frezier Frezier (Marqu ez de la Plata 1979); **b** Historic centre of La Serena and study area

The selected study area has a surface area of 87 hectares, which for simplicity of analysis and data collection, was subdivided into four zones (Fig. 3b). It corresponds to the first limits of territorial occupation and has the oldest and most representative buildings of the various architectural typologies of the historic centre. Originally, about 80% of the

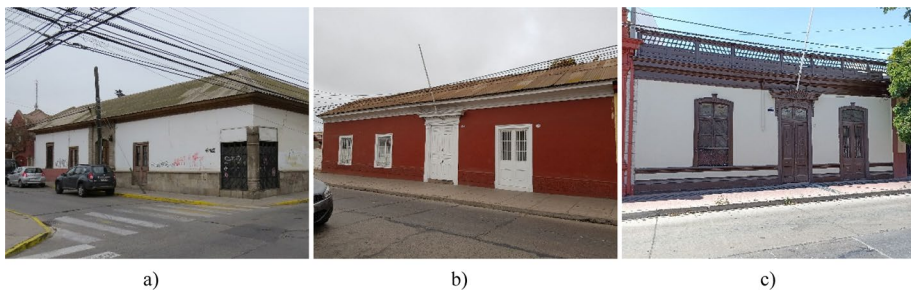
**Fig. 5** **a** Colonial Typology (Photo: Daniel Contreras); **b** Classical derivation typology: Classical (Photo: Marta Carvajal Alvarez); **c** Classical derivation typology: Classical Serenense

In the group of traditional buildings in the study area, two highly representative architectural typologies can be recognized, which are related to a specific building period and social context. These are i) Colonial derivation typology (until 1840) and ii) Classical derivation typology, which is divided into two styles, Classical (1830–1860) and Classical *Serenense* (1850–1880) (Fig. 5).

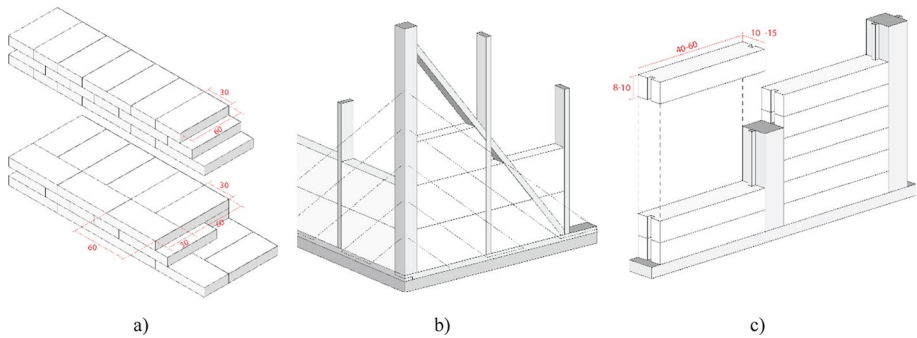
**Fig. 6** **a** Different thicknesses of the walls with  $60 \times 30 \times 10$  cm block size; **b** Mixed timber structure filled with adobe laid on rowlock stretcher bond; **c** Adobillo

C-shaped floors, with the rooms aligned around 1 or 2 courtyards, the main volume has a gable roof aligned toward the street, and the dwellings are in aggregation, forming a continuous façade that originally completed the block. Like most traditional buildings in Chile, the buildings under study have load-bearing adobe masonry façade walls. The most used adobe block measures  $60 \times 30 \times 10$  cm and is laid in the header bond. In order to reach greater heights and keep a slenderness ratio between 1:8 and 1:7, the walls increase up to 90 cm in thickness (Fig. 6a), measurements that arise from the modulation

of the block (Rivera 2017). The buildings increased in height using timber framing filled with adobe laid on rowlock stretcher bond (Fig. 6b) or *adobillo* (Fig. 6c).

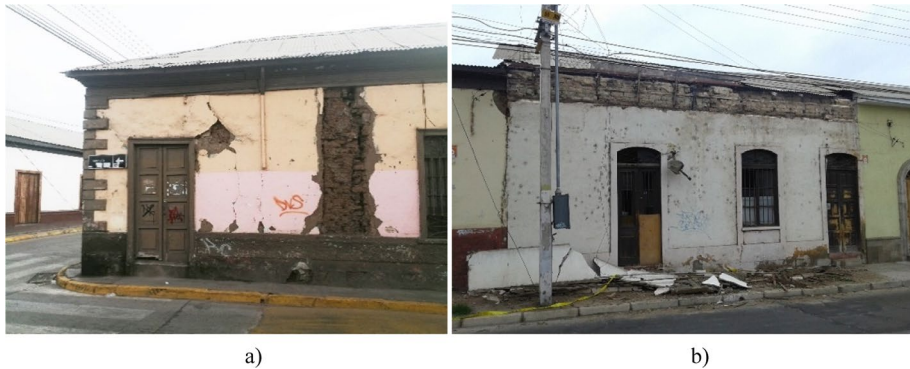
**Fig. 7** **a** Poor interlocking connection of the adobe bricks at intersections; **b** impulsive nature of the roofing structure

Correspond to one-storey structures with adobe load-bearing walls without embedded timber reinforcement. The colonial settlement was a homogeneous set of constructions contiguously arranged and mutually interconnected. The connection between the façade and the orthogonal walls is made through the interlocking of adobe bricks in the intersections. For this reason, original masonry structures presented good connections between the main-adjacent façades and the façade-orthogonal wall. Nevertheless, the urban growth process resulting from the real estate boost installed over the last 30 years has led to heavy changes in the internal spaces of these structures, which, in turn, have resulted in structural discontinuities on the original buildings and urban blocks. These alterations, with inadequate or null repair interventions after past earthquakes, have direct implications on the seismic performance of modified URM buildings, leading to a larger risk of local collapses due to the activation of out-of-plane failures in the case of poor connections between walls and parts of them (Fig. 7a).

correct distribution (Fig. 7b); the lack of adequate gables-top of walls connections; and the presence of large and heavy masonry spandrel which overloads timber lintels.

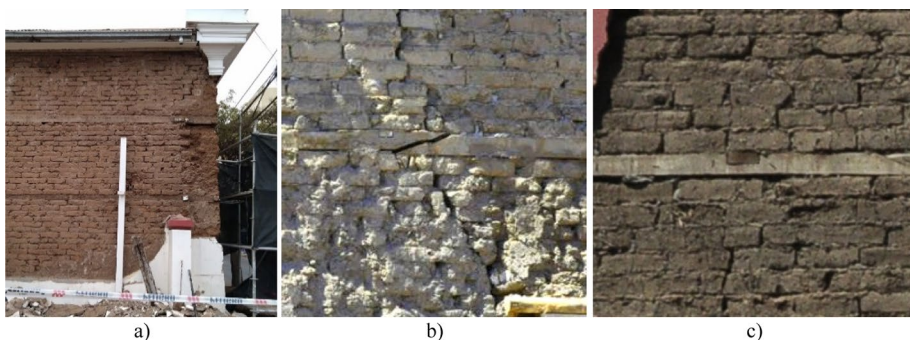
**Fig. 8** CLD typology: **a** corner wall; Traditional timber joints: **b** hooked scarf and **c** halved joint (Photos: Nuria Chiara Palazzi)

members end-to-end in Fig. 8b and halved (joining two orthogonal members by removing material from each at the point of insertion so that they overlap in Fig. 8c joints—are one of the main seismic weakness of this mixed wooden-earth system when subjected to the seismic motion (Misseri et al. 2020; N.C. Palazzi et al. 2021). In fact, the link failure determines the propagation of vertical and diagonal cracks along the entire height of the wall and the activation of out-of-plane mechanisms.

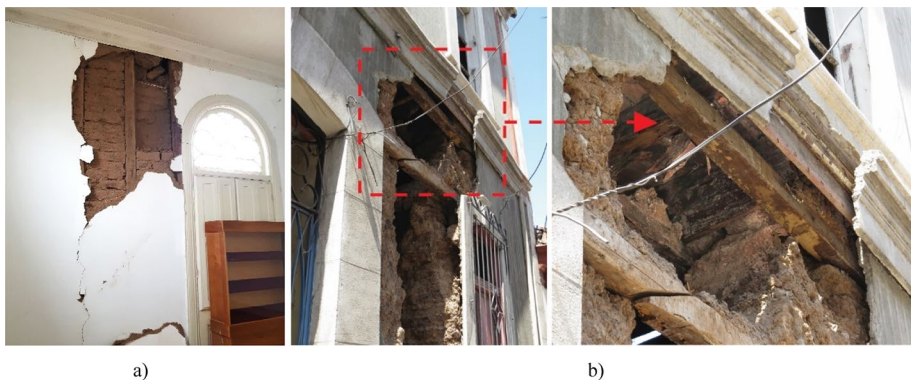
**Fig. 9** **a** Timber frame infill with Adobillo; **b** Timber floor structure. Images captured after the 2019 earthquake

The load-bearing system of the upper floors is typically made of a mixed structure of masonry and timber. The timber structure is composed of pillars (cross-section piers with  $0.15 \times 0.15 \text{ m}^2$ ) spaced between 40 and 60 cm braced with diagonals filled with earth bricks. Post-earthquake crack patterns have generally shown that mixed timber and earth structures triggered local mechanisms and partial collapse of adobe or *adobillo* due to poor links with wooden piers and masonry blocks (Fig. 9a).

The horizontal diaphragms observed are made of timber. The floor structure is composed of beams placed over a primary ring beam of the first-floor adobe walls (Fig. 9b). No metal connectors were identified between timber pieces and the adobe to improve their connection, so it is assumed that the buildings have flexible diaphragms with a weak connection to the wall.

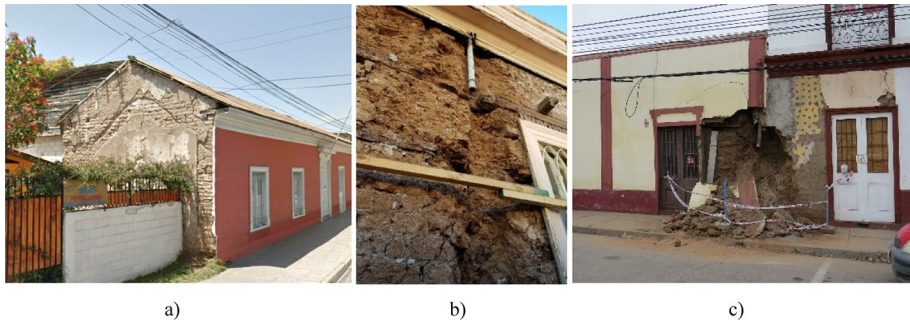
**Fig. 10** a Impulsive nature of the roof; b Eroded adobe façade of CL Serenense style; c Adobe erosion in a refurbished building (Photo: Daniel Contreras)

In this study, the roof structure is considered to have an impulsive nature, as most of them have a slope of more than 30%, and despite the existence of beams at the top of the adobe wall, it is not always possible to ensure the existence of the collar beam, as the continuity of these is usually interrupted by the lateral adobe gables (Fig. 10a).

the roof. Figure 10c displays the partial collapse of two façades that occurred after a heavy rainfall event in July 2022.

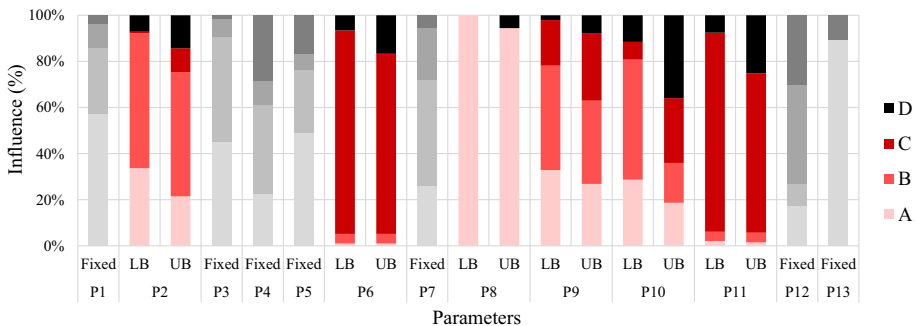
Fig. 11 Vulnerability index distribution of the building stock: Histogram and normal distribution

Figure 11 shows that, for Parameter P4, Misalignment of openings, about 29% (205) of the façades are inside class D. The majority of those (179) are due to the presence of openings greater than 1.5 m wide, of which approximately half are extensions in width, due to conversion from residential to commercial use. In P6, Masonry quality, 88% (634) of the façades are assigned a class C at the lower boundary, corresponding to adobe masonry laid on header bond and good quality mortar and 7% (47) class D. At the upper bound, buildings with art deco style updates with signs of deterioration are considered as class D, increasing the number of class D buildings to 17% (120). The nature of the roof, P11, is one of the parameters classified according to architectural typology. At a lower limit, 86% (620) of the buildings are class C, corresponding to rehabilitated Colonial or Classical derivation buildings, with a roof of impulsive nature and the presence of a perimeter beam at the top of the wall. As a conservative measure, buildings without a clear architectural typology are assigned to class D. As for P12, which measures the presence of non-structural elements, 30% (218) have heavy elements on the façade, mainly parapets and balustrades, and are classified as Class D. Finally, in P13, Improvement elements, only 11% of the façades present structural strengthening actions, these correspond to integral structural consolidation projects approved by the CMN, following the recommendations of NCh 3332 (2013).

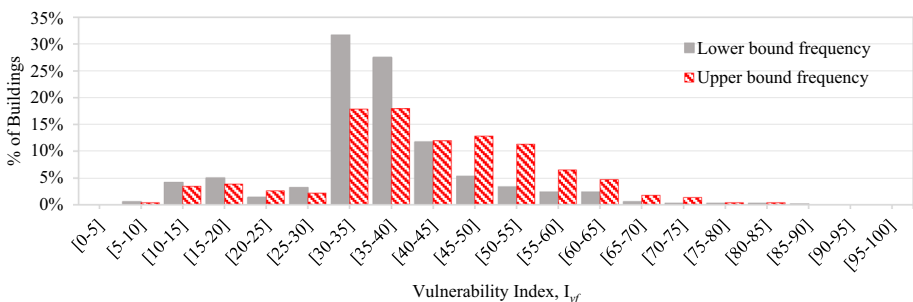
Fig. 12 Histograms with the distribution of the vulnerability index values

The histogram resulting from the analysis for the lower (LB) and upper (UB) bounds are given in Fig. 12. A mean LB seismic vulnerability index,  $I_{vf,mean}$ , of 36.28 was obtained. The minimum value of the vulnerability index is 9.07, and the maximum value is 85.19. The associated standard deviation value,  $\sigma_{I_{vf}}$ , is 11.11. About 15% (107) of the façades have a vulnerability index over 45. With respect to the upper bound, the mean UB seismic vulnerability index is  $I_{vf,mean}$ , is of 41.64, the minimum value is 9.07, and the maximum is 88.52. The standard deviation value  $\sigma_{I_{vf}}$ , obtained for this distribution is 13.55, with about 40% (284) of the façades having a vulnerability index value greater than 45.

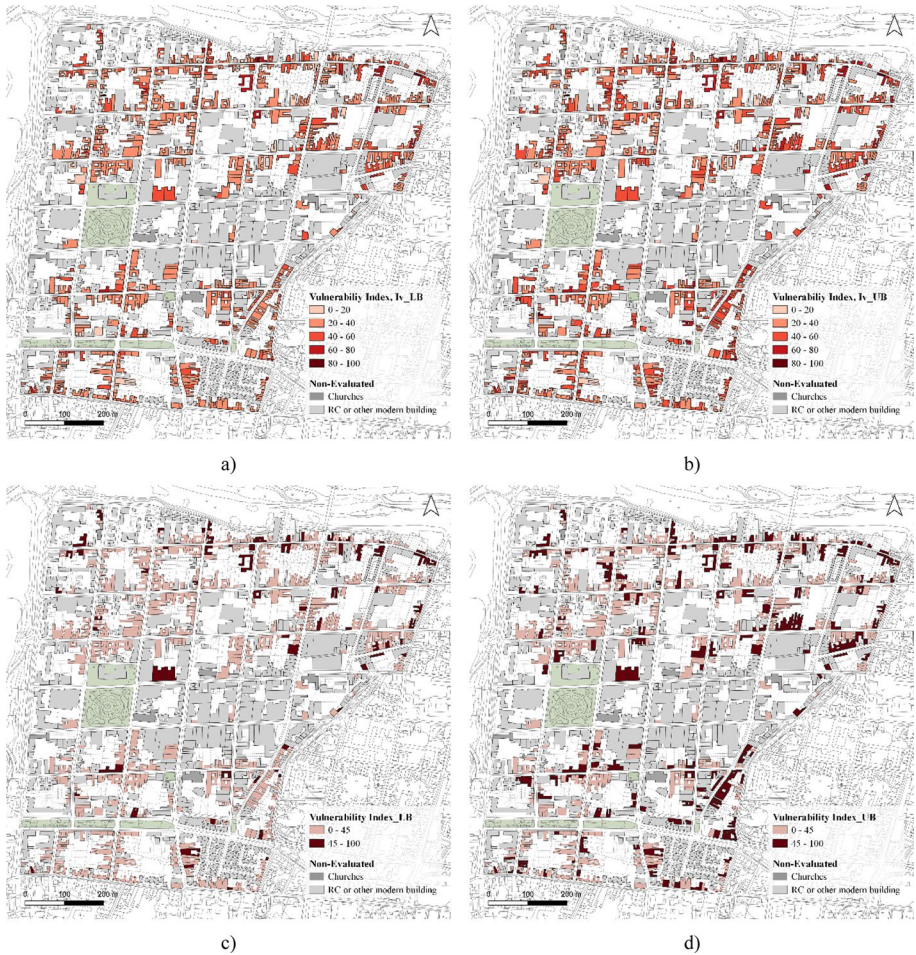
**Fig. 13** Global vulnerability distribution: **a** LB; **b** UB. Façade walls with  $I_{vf}$  values over 45; **c** LB; **d** UB

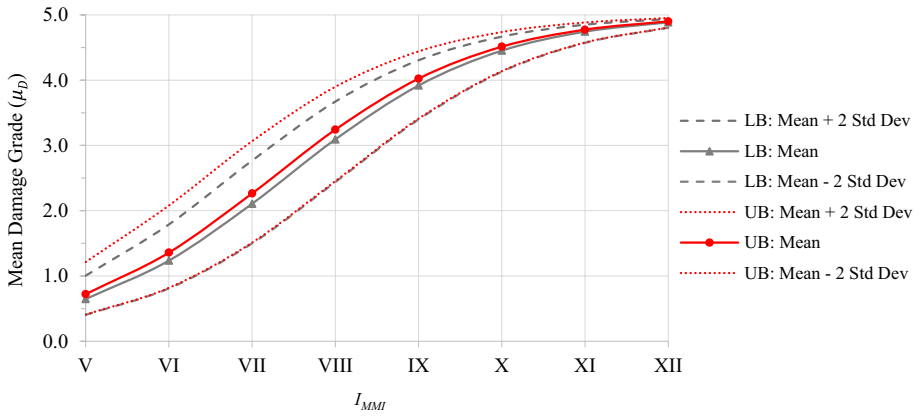
Fig. 14 Vulnerability curves for the LB and the UB seismic vulnerability index

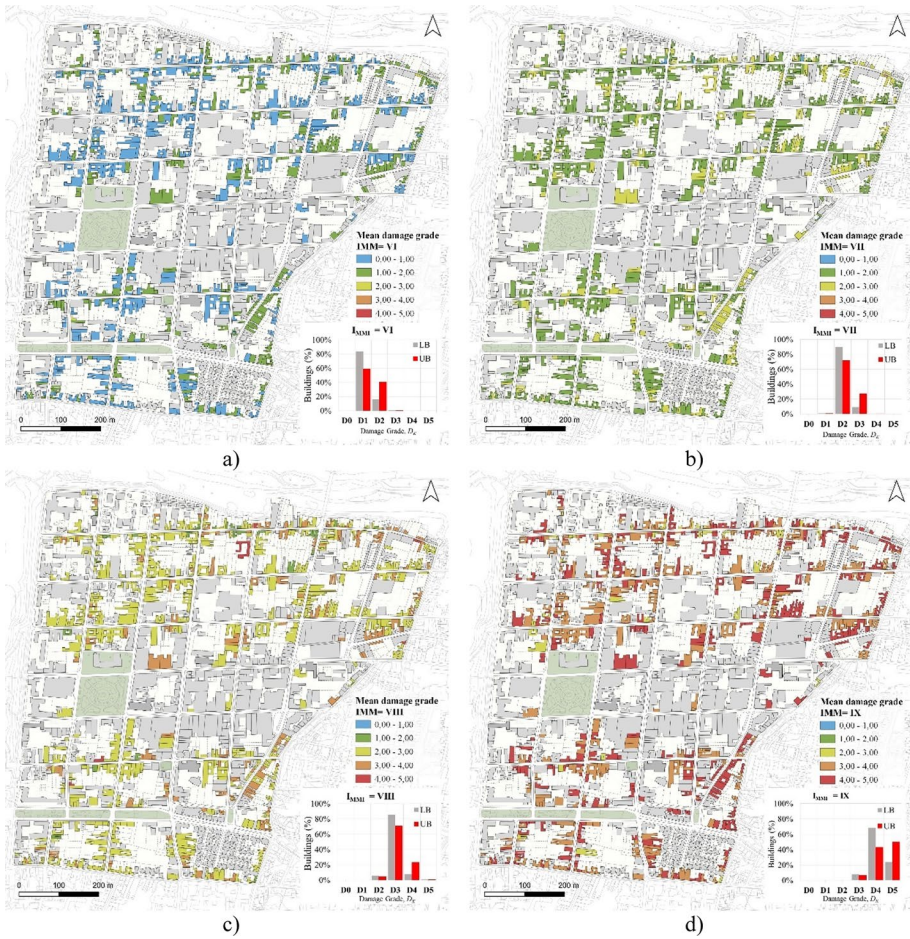
Fig. 15 Damage distributions for seismic scenarios and UB maps: a  $I_{MMI} = VI$ ; b  $I_{MMI} = VII$ ; c  $I_{MMI} = VIII$ ; d  $I_{MMI} = IX$

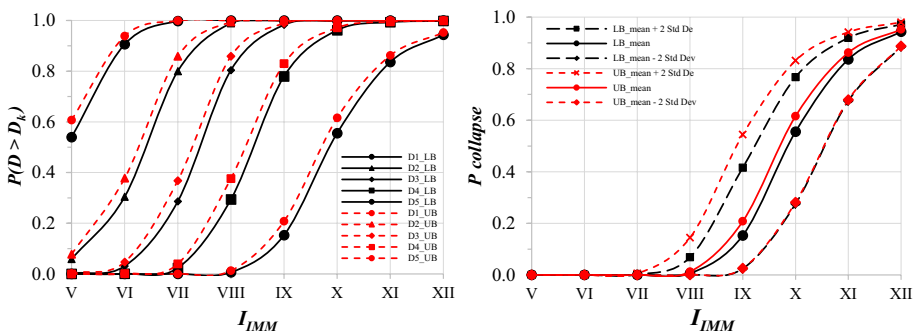
**Fig. 16** **a** Fragility curves obtained for  $I_{vf,meanLB}$  and  $I_{vf,meanUB}$ ; **b** Probabilities of collapse for different vulnerability index values

Figure 16b depicts the collapse probability curves for three vulnerability distribution values ( $I_{vf,mean} - 2\sigma_{I_{vf}}; I_{vf,mean}; I_{vf,mean} + 2\sigma_{I_{vf}}$ ) for the LB and the UB seismic vulnerability index. It shows that at macroseismic intensity  $I_{IMM} = VIII$ , the maximum probability of collapse is around 15% of the façades. If the mean vulnerability values are considered, the probability of total collapse is very low, showing less than 2% for both limits (LB and UP). For proper emergency disaster management, it is important to consider the high probability of façades that could present severe ( $D_3$ ) and very severe ( $D_4$ ) structural damage (see Fig. 16a), which represent the risk of a partial collapse of elements with the possibility of harming people at the assessment stage. At intensity  $I_{IMM} = IX$ , the values increase, showing a probability of collapse of 15–20% between the LB and UB. And for intensity  $I_{IMM} = X$ , the probability increases considerably, showing a probability of collapse of between 55 and 61% of the façades.

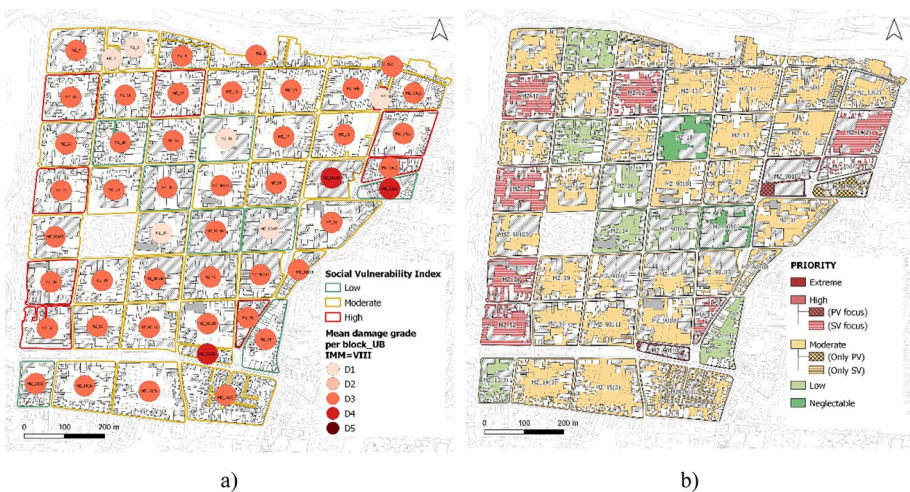
**Fig. 17** a Social vulnerability index map crossed with the mean degree of damage per block in an earthquake scenario of intensity VIII; b Priority map in case of an earthquake

- **Extreme priority** (High PV + High SV): these are blocks that combine buildings whose façades can potentially suffer partial or total collapse and high social vulner-
