Design of an Anti Head Check profile based on stress relief

Design of an Anti Head Check profile based on stress relief
PhD Thesis, University of Twente, Enschede, The Netherlands
Ir. R.P.B.J. Dollevoet

Keywords: RCF, Head Checks, Profile, Wheel, Rail Contact, Cracks, Track, Friction.

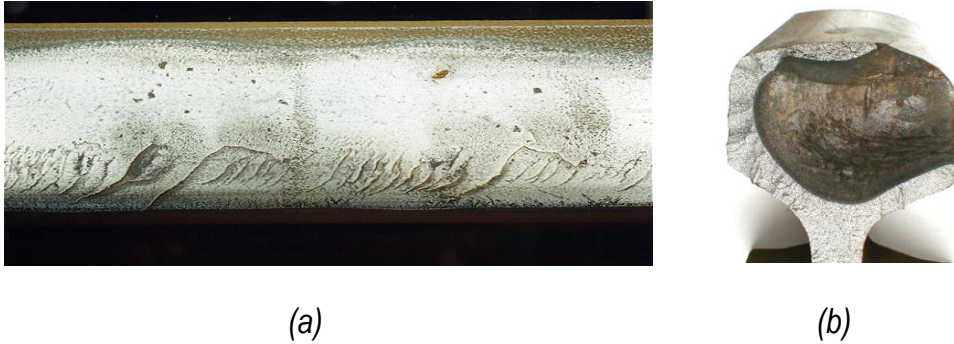
Figure 1.1 Severe Head Checks (a) and cross section of a severe single Head Check (b).

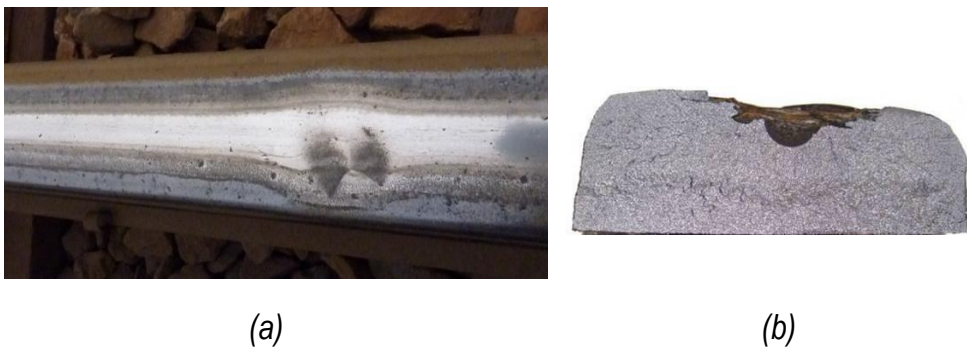
Figure 1.2 A typical severe Squat (a) and cross section of a Squat after four point bending (b).

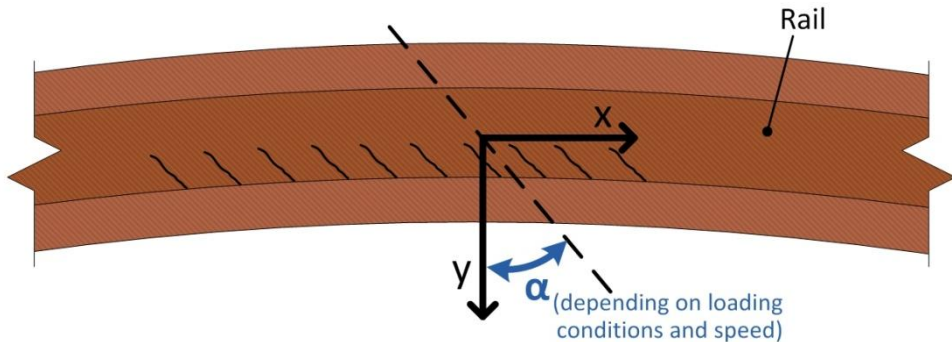
Figure 1.3 Head Checks in gauge corner of high rail. The traffic is in the x direction.

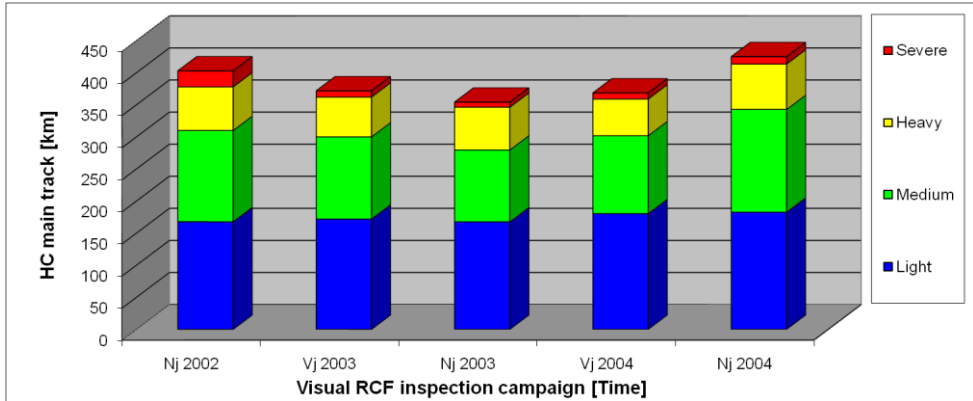
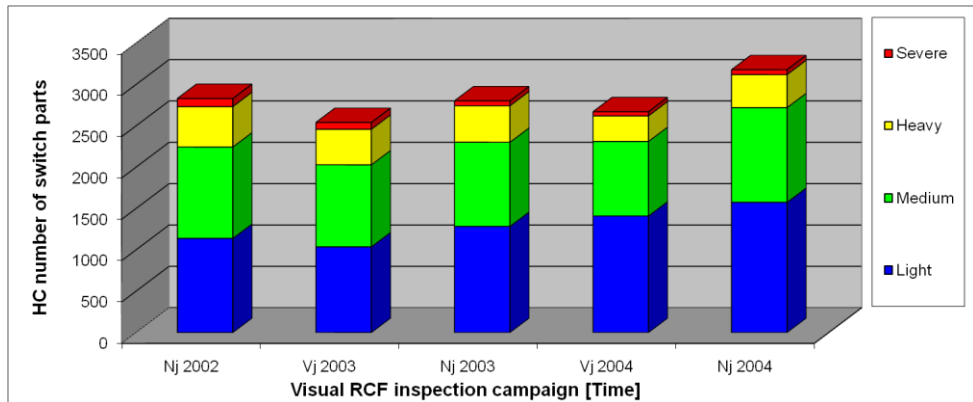
Figure 1.4 HC defects in (a) straight track in kilometres and (b) switch parts in numbers for 2002-2004 in the Netherlands. Visual inspection is carried out twice a year (nj and vj) parallel to Ultrasonic measurements by train.

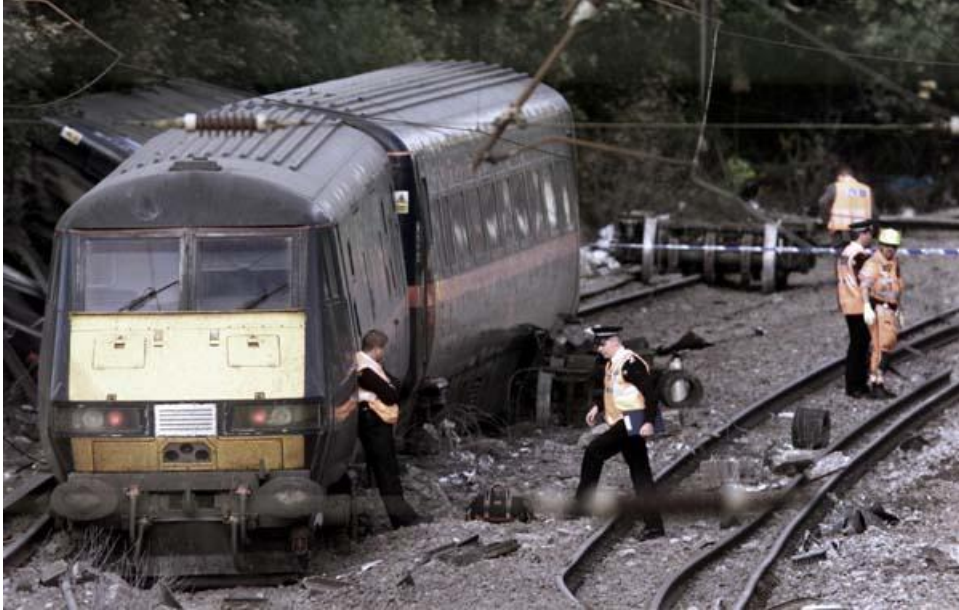
Figure 1.5 Hatfield derailment on 17th of October 2000 because of broken rail due to Head Checks (photo Network Rail).

HC has a severe consequence on safety. The well-known disaster with casualties was Hatfield (October 2000) where the rail was fractured over 35 m with around 300 critical HC cracks, Cannon et al. (2003), and Smith (2003), see Figure 1.5.

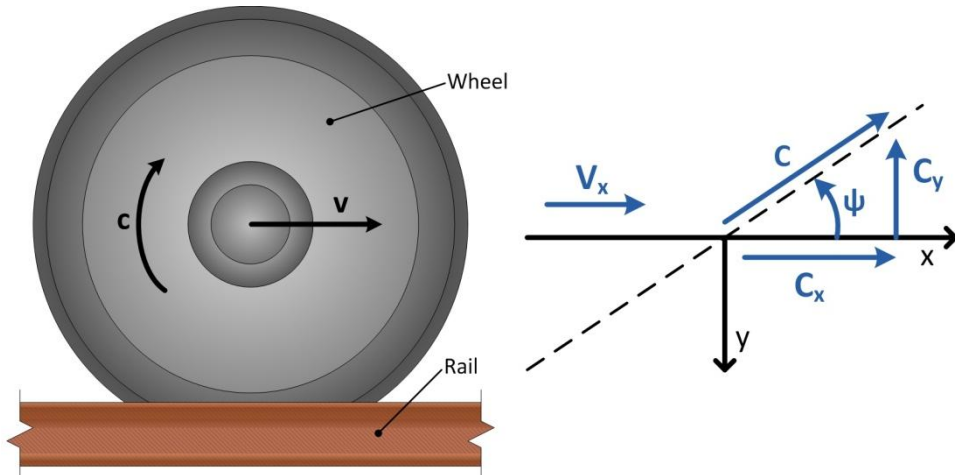
Figure 2.4 Creepage and velocity directions.

Where c is the circumferential velocity of a wheel as a rigid body. Its projection to the rolling direction is c_x , while the actual forward speed is v_x .

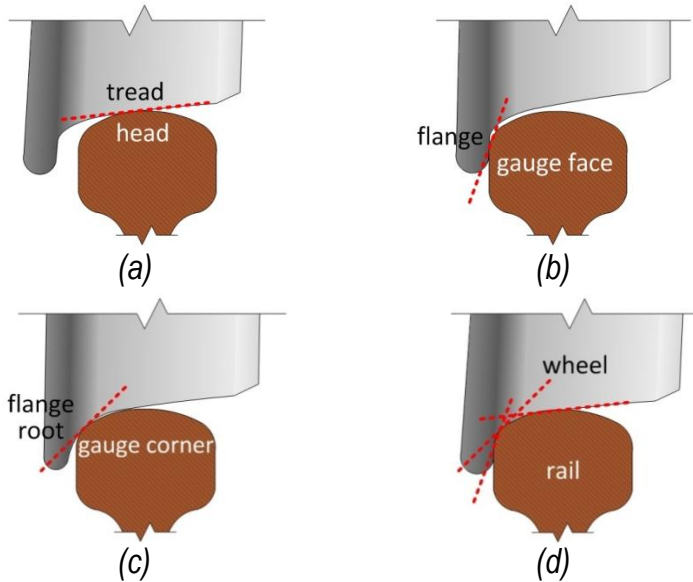
Figure 2.7 Various wheel-rail contact types.

A wheel, depending on its motion and the profiles of the wheel and rail, can take various positions relative to the contacting rail, see Figure 2.7. They are (a) wheel tread – rail head contact, (b) wheel flange – gauge face contact, (c) flange root – gauge corner/shoulder contact. The aforementioned three types of contact can also combine to form multiple-point contact. Figure 2.7(d) shows a two-point contact. In the cases of Figure 2.7(b to d), large spin will occur. And in the cases of Figure 2.7(c to d) the geometrical spin varies across the contact area.

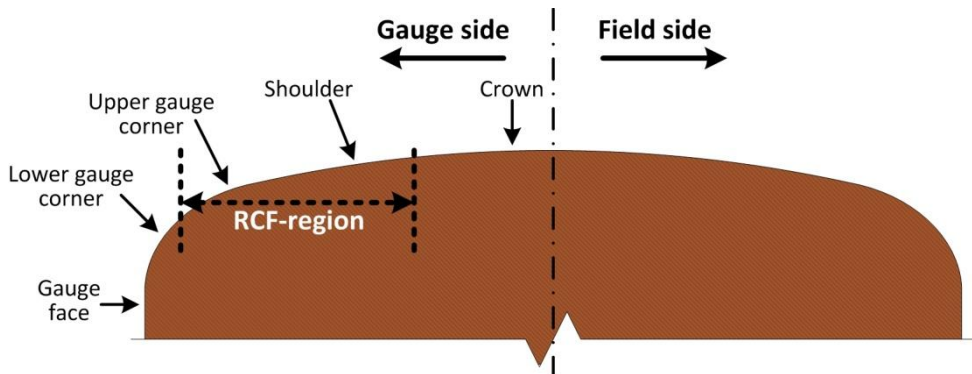
Figure 2.8 Names of rail profile parts.

Figure 2.8 shows the names of the various parts of a rail profile. They are used for later discussions.

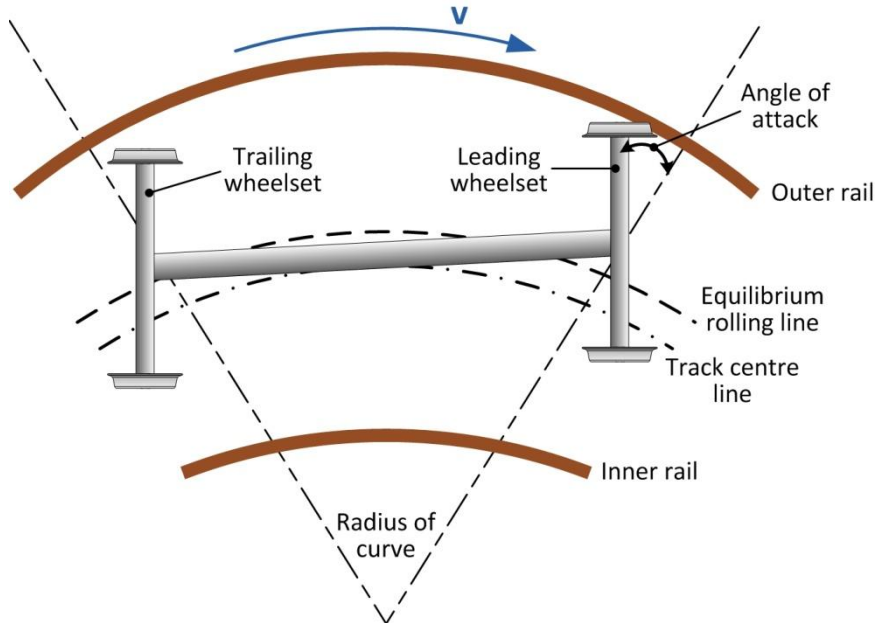
Figure 2.9 Wheel positions in curves.

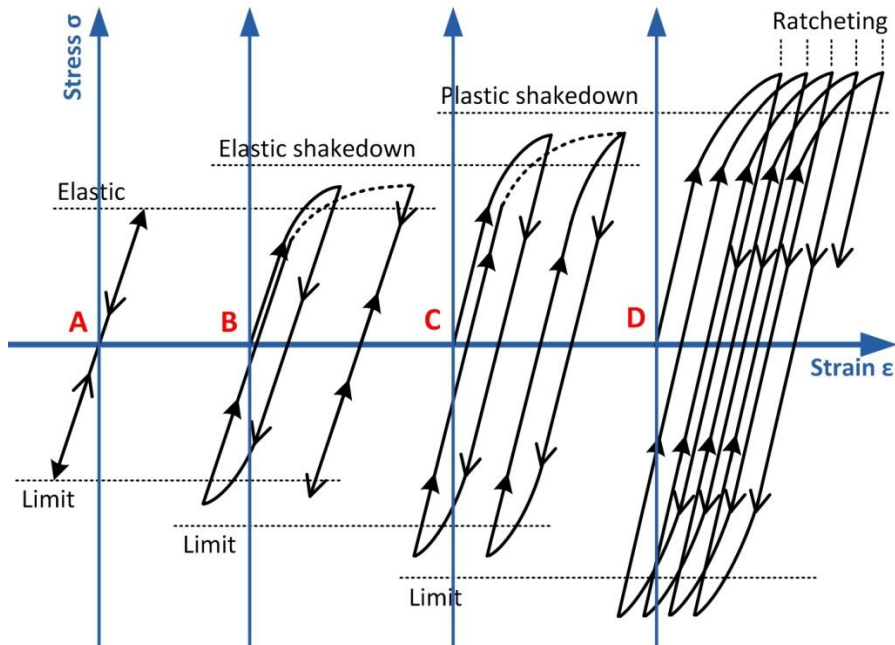
Figure 2.10 Different types of loading cycles related to fatigue: perfectly elastic (A), elastic shakedown (B), cyclic plasticity (plastic shakedown) (C) and incremental (ratcheting) (D). After Bower and Johnson (1989).

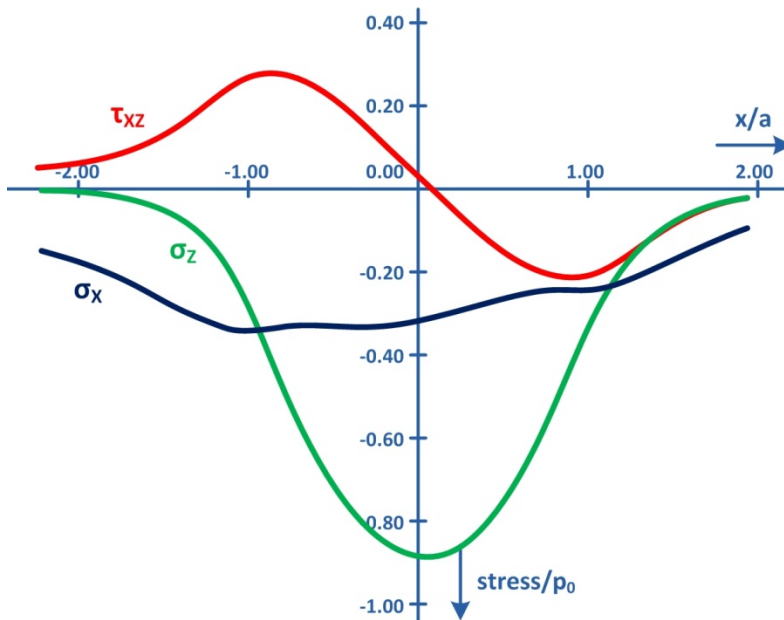
Figure 2.11 *Non-proportional stresses evolution at a point of $z = a/2$ under the surface when a line contact rolls over it. The shear stress τ_{xz} is reversed while the direct stress rises from zero to its maximum. a is half the width of the contact area, x is the distance along the rolling direction between the observation point and the contact, p_0 is the maximum pressure. After Bower and Johnson (1989).*

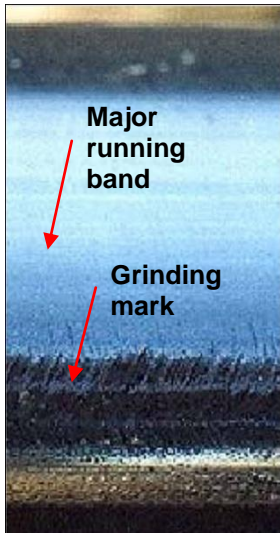
(a)

Figure 2.12 Change of contact topography of a rail due to wear. HC occurred at location where initially there was no contact. In (d) and (e) the brown and red lines correspond to the profiles of (b) and (c) respectively. The unit of the abscissa and ordinate in (d) and (e) is in millimetres.

Rolling contact changes its contact geometry by plastic deformation, wear and crack formation. This is particularly of great importance in unlubricated situations where wear of material is significant. Because of the high stiffness of the steel-steel contact, small alternation in the topology can result in a large change in the magnitude and distribution of the stress and strain, influencing the initiation and growth of cracks. Figure 2.12 shows how a rail profile was changed by wear, and that HC occurred at a location where initially there was no contact. Figure 2.12(a) shows a rail shortly after grinding. The grinding marks which were not yet worn away were dark, while locations where wheels rolled over were run in, hence smooth and shining. Figure 2.12(b) shows an intermediate status. The area with grinding marks had shrunk due to wear; contact started to take place at the gauge corner which corresponds to the lowest shining strip (arrowed). It is noticed that the major running band, which is the broadest shining part in Figures 2.12(a), (b) and (c), and which bears the wheel load, had shifted downwards towards the gauge side. Figure 2.12(c) shows that HC had already occurred at a location which in Figure

2.12(a) was an area of dark grinding mark. It is also observed that the running band had further shifted towards the gauge side, compared to Figure 2.12(b).

Figure 2.12(d) and (e) show the profiles corresponding to Figure (b) and (c). The difference in the profiles seems small, the difference in contact is large: For the profile of Figure 2.12(b), the contact would be at two locations, in the form of the so-called two-point contact: the major contact would be on the upper broad running band which bears the vertical load, and a second contact would take place at the lower shining band, where the lateral force would be counteracted. It will later in sections 3.2 and 4.2 be shown that a small change in the rail profile can result in significant change in the location of contact, and the associated stress, strain and micro-slip.

Micro-pitting occurs most frequently in hard steels that have been ground and in situations where the lubricant film is thin compared to the height of the roughness of the surfaces. It is usually thought to be a form of RCF associated with the asperity stress field, Berthe et al. (1980), Olver (2004). On the other hand asperities on the softer rail steel seem not to cause any fatigue, even if the most common rail roughness which is caused by grinding, is in the order of 0.1 mm (Figure 2.12), 2 orders higher than the magnitude of asperities of bearings and gears. This may be attributed to the lower yield stress, high ductility and higher wear rate, such that the roughness can be easily smoothed by plastic deformation and/or wear, without causing significant stress and strain concentration. Figure 2.12(a-c) gives a clear example, where the grinding marks were worn away.

Without lubrication, the rail profile, compared to that of the rolling bearings and gears, will be quickly modified by wear. The wear may bring the HC-vulnerable part of the profile into contact so that HC takes place, like what happened in Figure 2.12. The wear may also suppress HC initiation and propagation, as is shown in Figure 2.16. Further, the rail profile may be

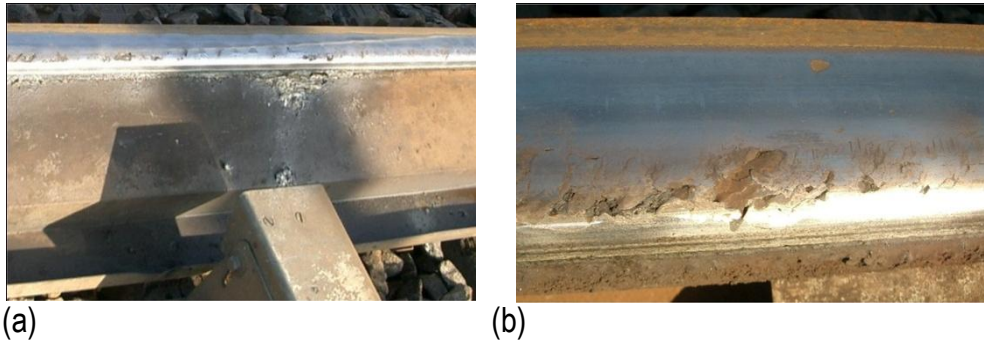
Figure 2.13 HC growth promoted by liquid pressurization.

In Figure 2.13(a) a track lubrication installation is seen. It should provide lubrication to the gauge corner of the rail upon wheel passages to reduce the coefficient of friction, so that the surface shear stress of the contact can be reduced to prevent HC from initiation. This should work if everything functions well. But actually severe HC can be seen in the two pictures. This situation happened, probably because the installation stopped providing the rail with lubricants, at a certain moment for one reason or another, so that HC initiated. When lubricant was again supplied to the rail later, the grease, and more probably a mixture of grease and water, came into the cracks (Figure 2.14(a)) and became entrapped and pressurized when a wheel rolled over, causing high pressure on the crack faces, resulting in tensile stress at the crack tip, which tore the crack open. Further, the lubricant accelerated the HC propagation in the sense that it prevented rain water from drying, so that the pressurization of the crack faces happened for a much longer time than without lubrication.

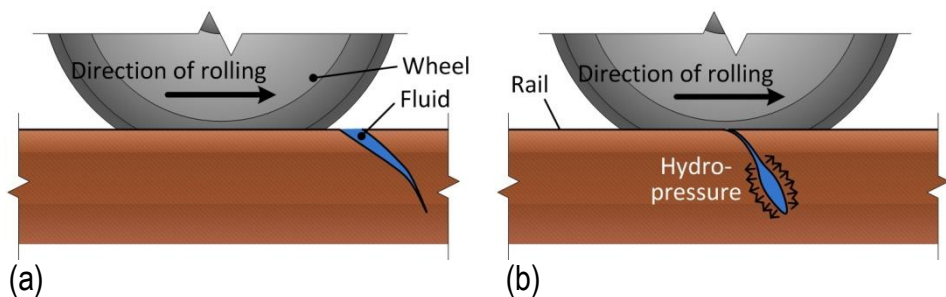
Figure 2.14 Crack propagation due to liquid entrapment and pressurization.

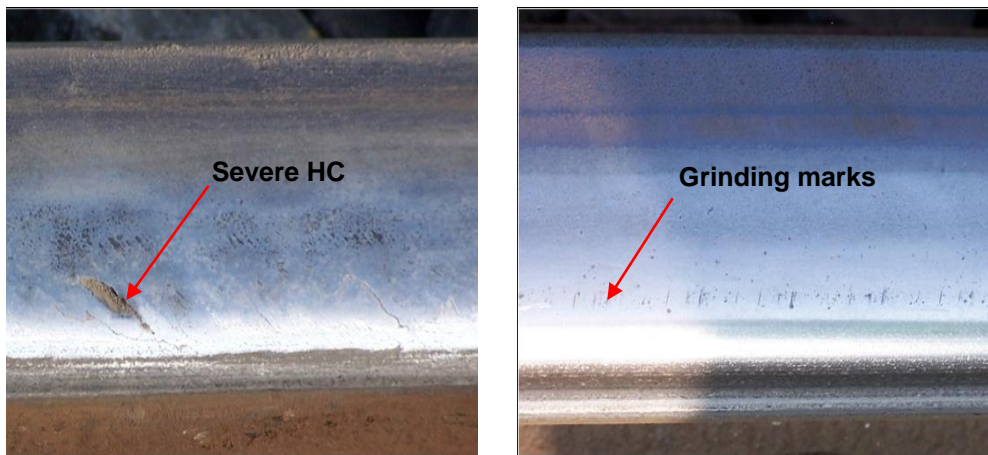
(a) R350HT rail in service since 1998. (b) R260 rail in service since 1984.

Figure 2.16 HC versus wear. Photos taken on 24th of April, 2005.

Nevertheless the results were totally different. Severe HC had developed in the stronger rail in shorter time (Figure 2.16(a)), while there was no HC at all in the soft one (Figure 2.16(b)). Notice in Figure 2.16(b) that there should have been significant natural wear, evidenced by the very much worn gauge face. The rail had also been ground; see the grinding marks (arrowed). On the contrary there was no wear at the gauge face in Figure 2.16(a), the wear at the gauge corner was insignificant, and there was also no evidence of grinding. In theory cracks should have initiated earlier in the soft rail. The natural wear and the artificial wear by the grinding appear, however, to have suppressed the crack growth.

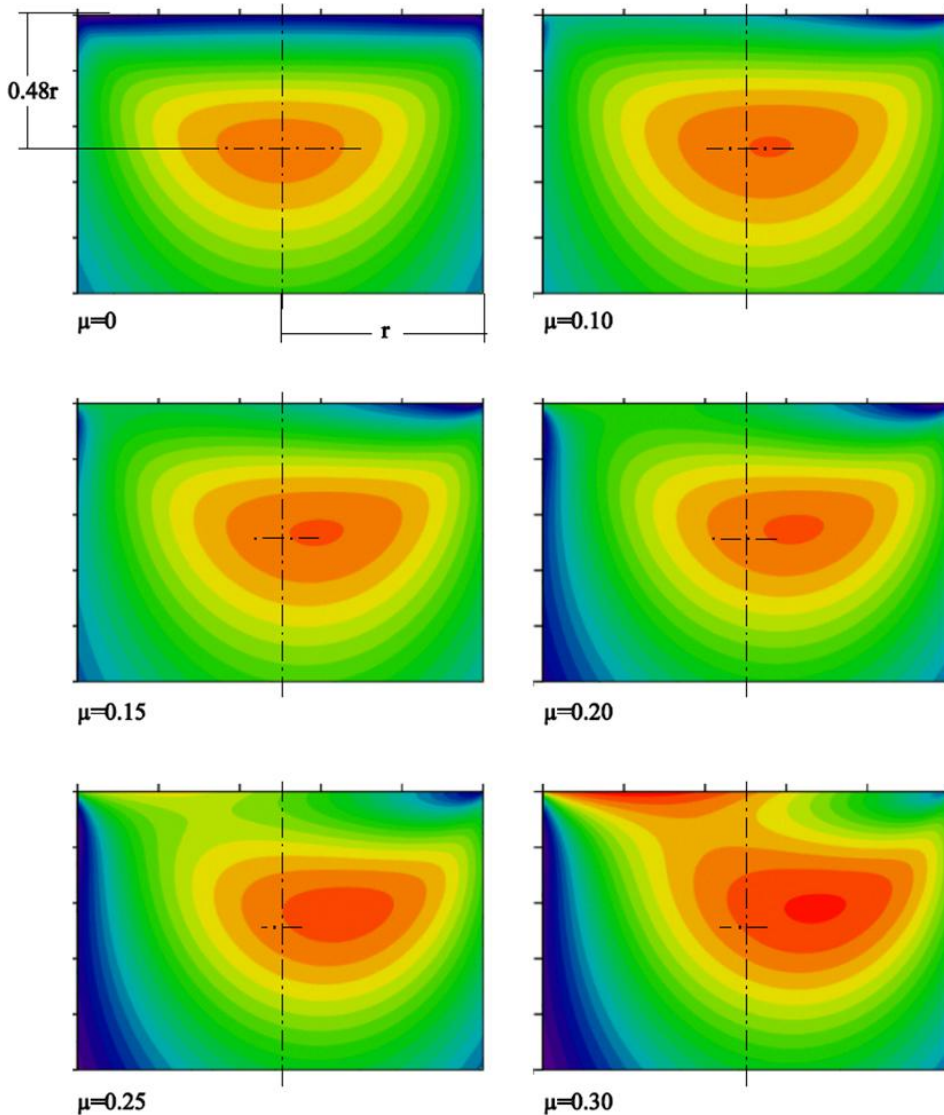
Figure 2.17 Contours of shear stress beneath a nominal point contact with $\mu = 0.3$.

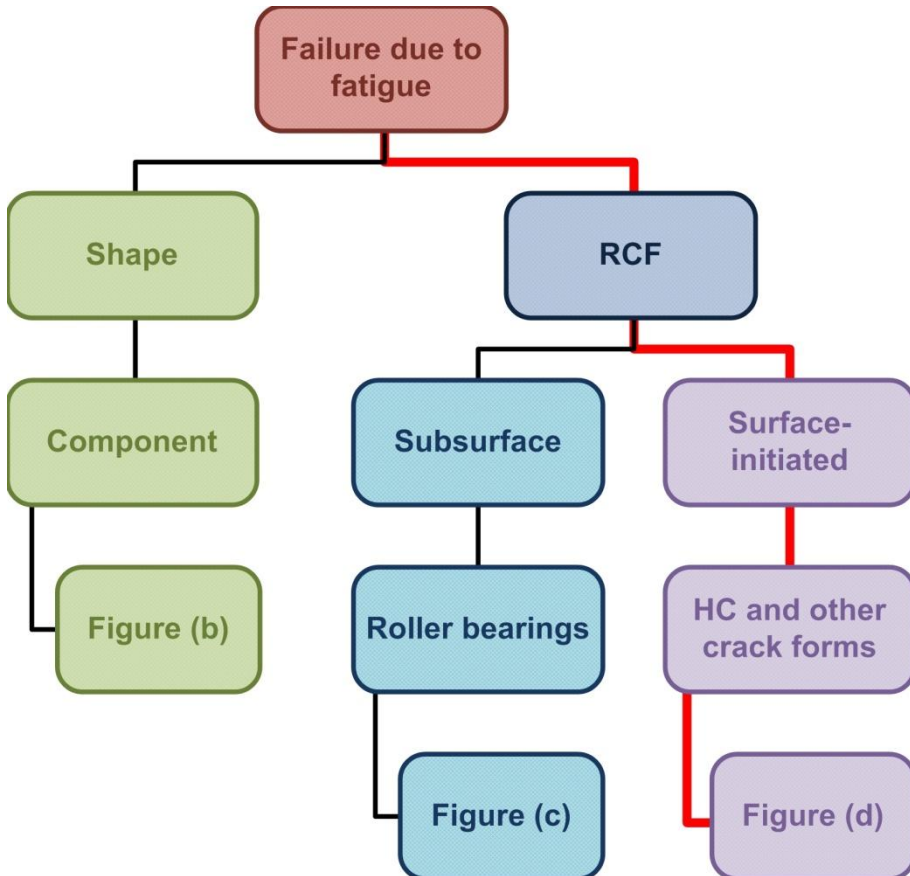
(a) Comparison of fatigue mechanisms.

Figure 2.18 gives a comparison of the three categories of fatigue mechanisms. HC belongs to the surface-initiated category. Its differences from the surface-initiated fatigue of the roller shown in Figure 2.18(d) are that HC is featured by the strong ratcheting texture, see Figure 2.15, and is almost insensitive to surface asperities, see Figure 2.16(a).

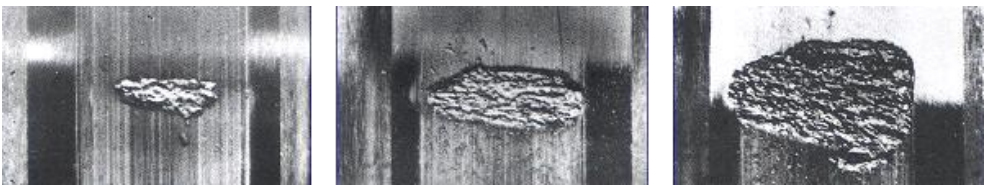
(d) Surface-initiated fatigue, Neale (1973).

Figure 2.18 Comparison of fatigue mechanisms.

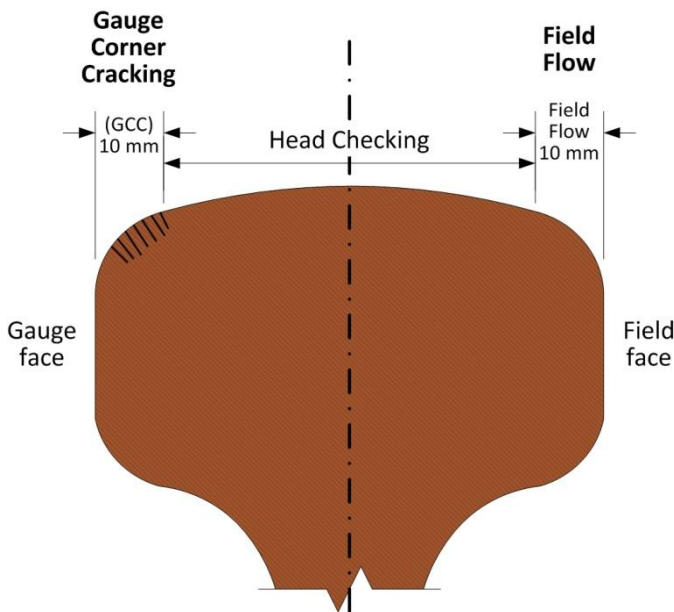
Figure 2.19 Head Checking and gauge corner cracking classified according to position on the railhead (see Sawley et al. (2000)).

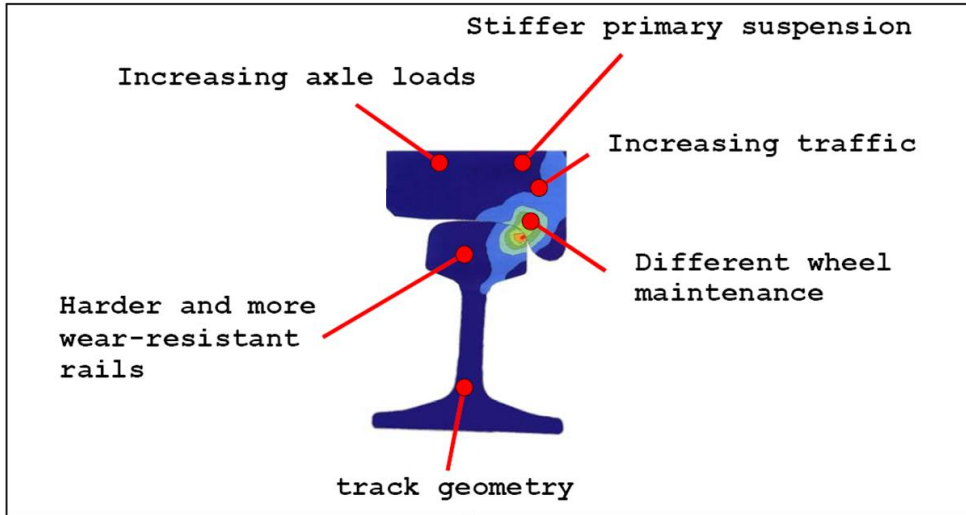
Figure 2.20 An overview of some possible causes of HC.

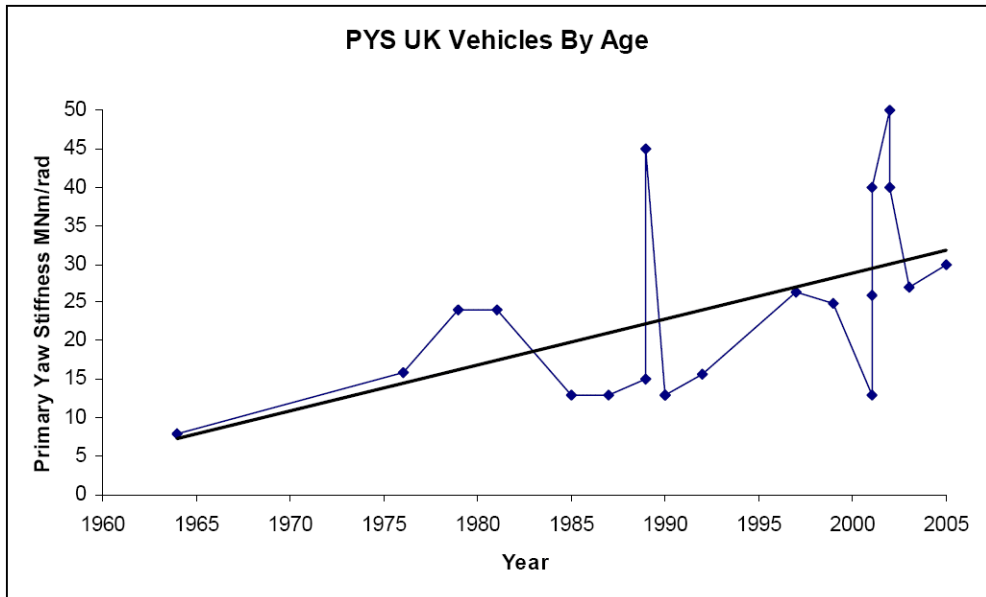
Figure 2.21 Increase of primary yaw stiffness over time (Amoore (2007)).

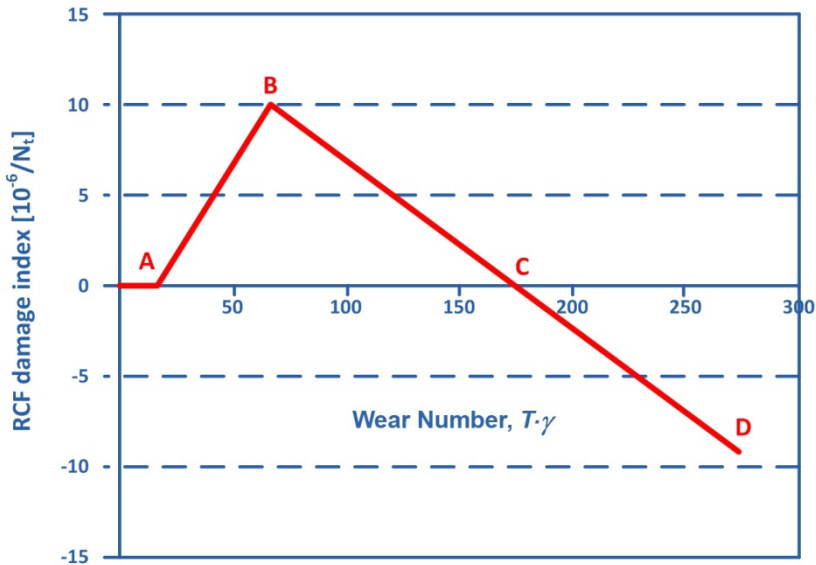
Figure 2.22 The Whole Life Rail Damage (WLRM) according to Zacher (2009), i.e. RCF damage index as a function of the wear number $T \cdot \gamma$.

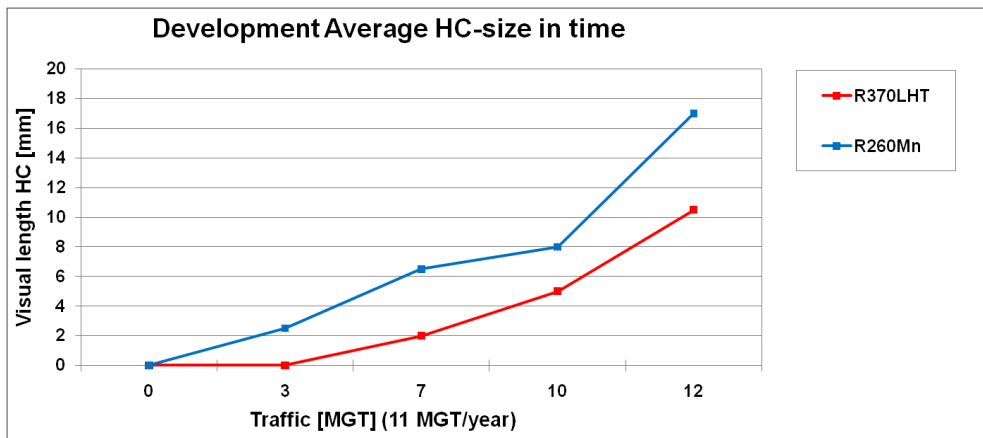
Figure 2.23 HC development in grades R260Mn and R370LHT rails.

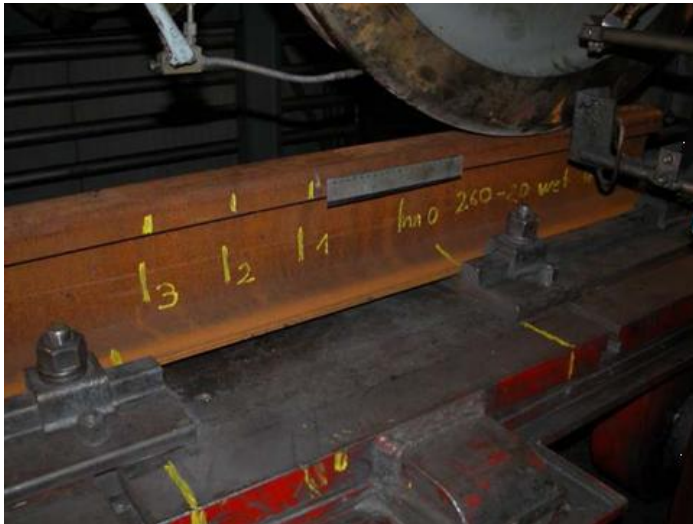
(b) The rail and wheel test rig.

Figure 3.1 The VAS test rig. (a) Schematic representation and (b) photograph of the test rig.

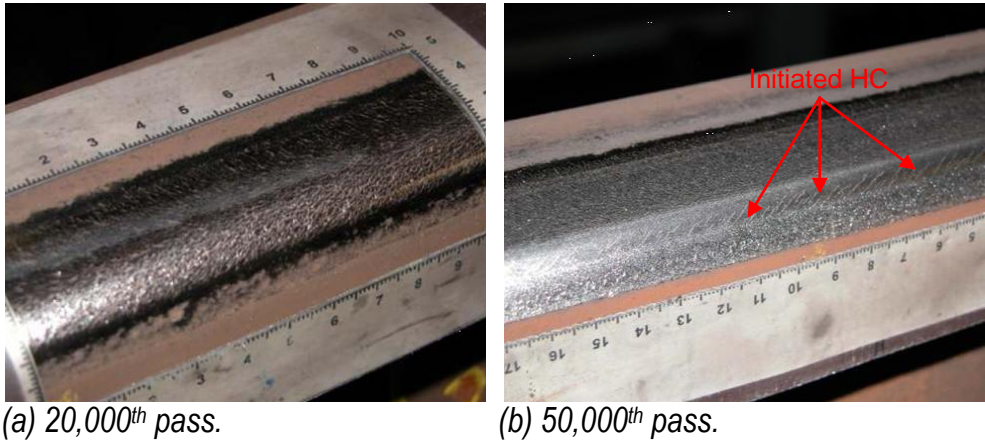
Figure 3.2 Rail surface at 20,000th and 50,000th pass. No crack can be found at 20,000th pass. Initiating cracks are visible at 50,000th pass.

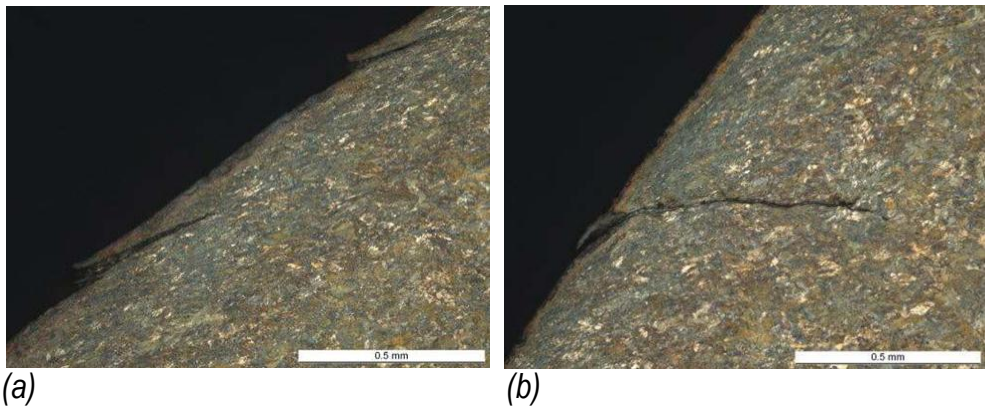
Figure 3.3 Rail sections with Head Check cracks after 100,000 wheel passes.

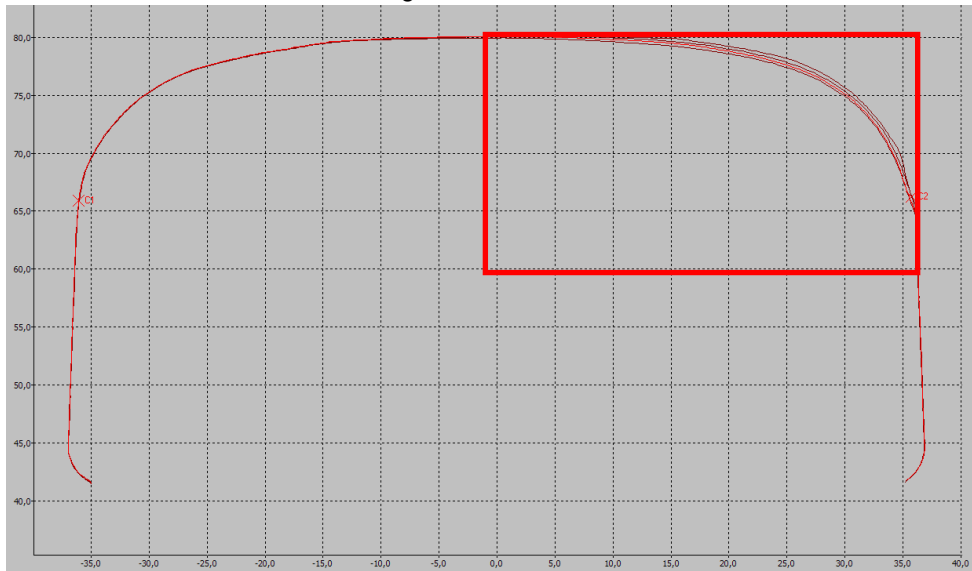
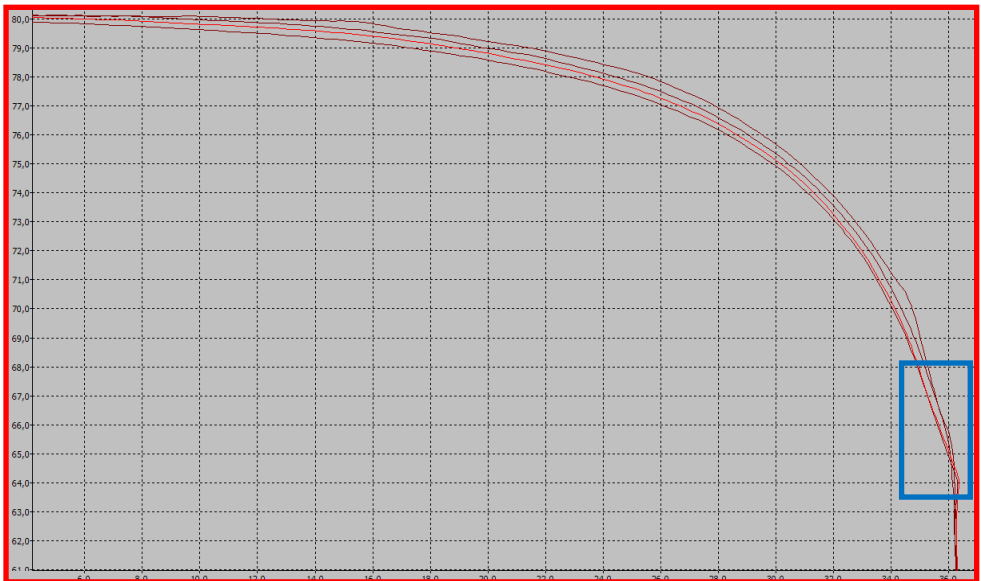
(a) Overall view of the measured profiles. Red line was measured at 50,000th passes.

(b) Profile measurement of the rail in the gauge corner. From top down are profiles at 0th, 20,000th, 50,000th and 100,000th wheel passes. Red line was measured at 50,000th passes.

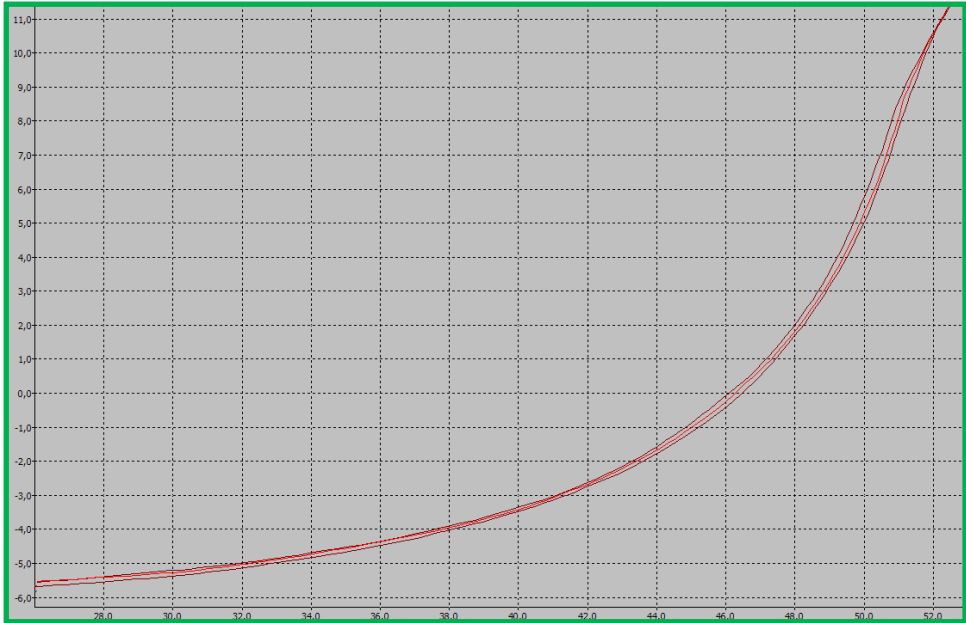
(b) Zoom-in of flange throat. From top down are profiles at 0^{th} , $20,000^{\text{th}}$ (in red) and $50,000^{\text{th}}$ wheel passes.

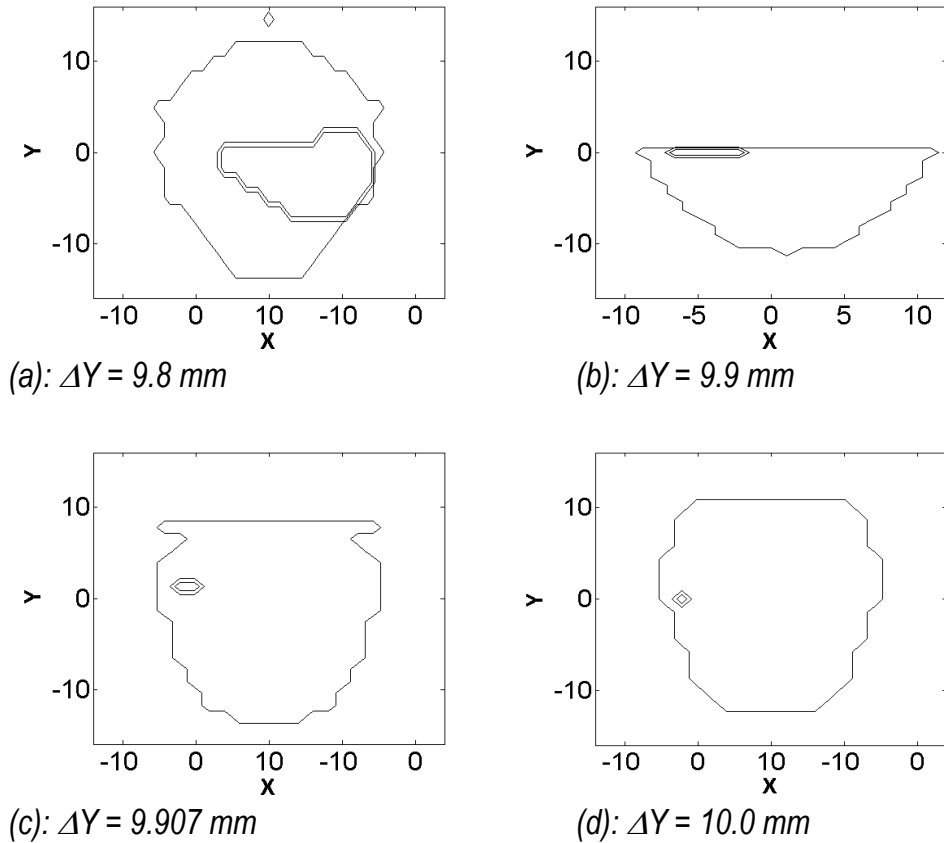
Figure 3.7 Contact area change with lateral displacement of the wheel ΔY for profile measured at 20,000th pass. Rail inclination = 0. Single line represents the contact area and the double lines depicts the adhesion area. Outside the adhesion area but inside the contact area is the area where micro-slip occurs. Positive X-axis is in rolling direction, and Y-axis is in lateral direction. Positive Y-axis points laterally from field side to gauge side. Dimension in mm. See table 3.1 for other parameters.

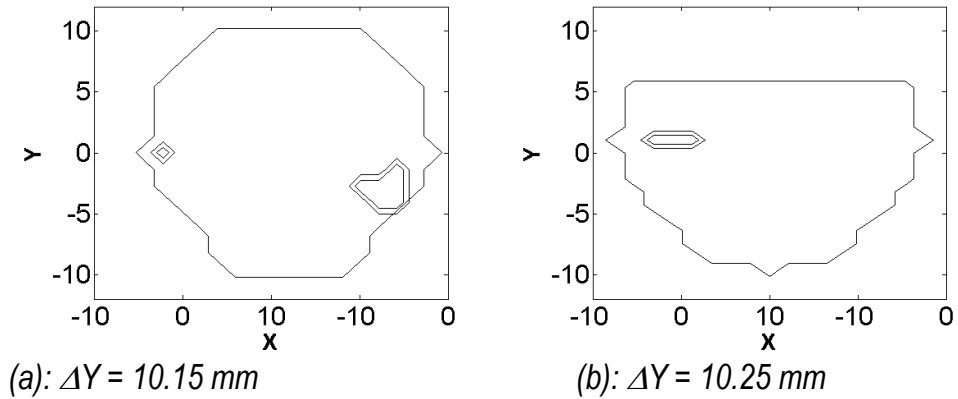
Figure 3.9 Contact area change with lateral displacement of the wheel ΔY for the profile measured at 50,000th pass. Rail inclination = 0. The single line represents the contact area and the double lines the adhesion area. Outside the adhesion area but inside the contact area is the area where micro-slip occurs. Positive X-axis is in rolling direction. Positive Y-axis points laterally from field side to gauge side. Dimension in mm. See table 3.1 for other parameters.

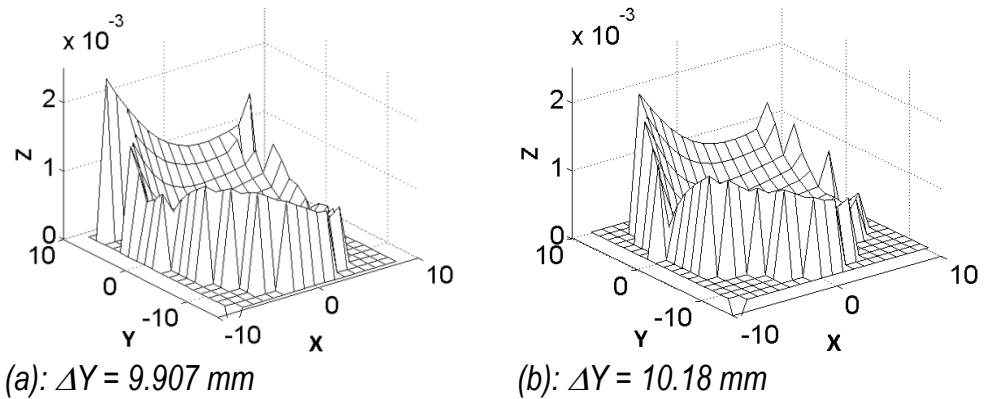
Figure 3.12 Magnitude of micro-slip of the cases shown in Figure 3.11. The micro-slip is dimensionless. (a) For the case of 20,000th pass, $\Delta Y = 9.907 \text{ mm}$ with $Y_{\text{cnt}} = 31.1 \text{ mm}$, $\delta_0 = 42.2^\circ$. (b) for the case of 50,000th pass, $\Delta Y = 10.18 \text{ mm}$ with $Y_{\text{cnt}} = 31.2 \text{ mm}$, $\delta_0 = 44.1^\circ$.

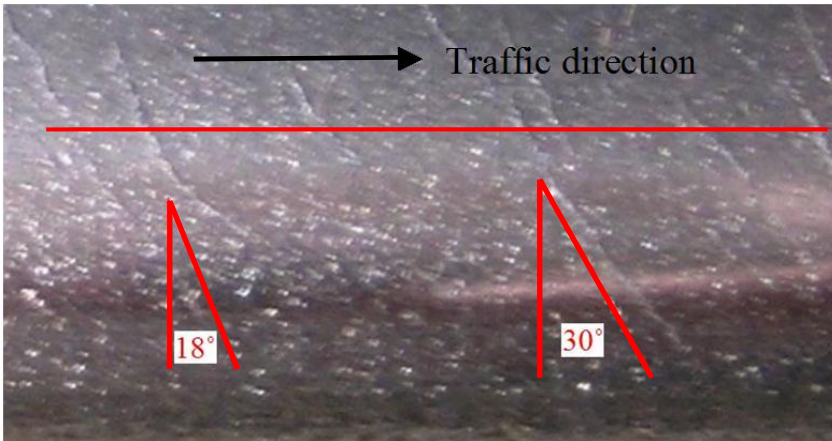
Figure 3.15 Head Checking on the monitored rail. The horizontal red line indicates the average location of the HC initiation (above the red line it is the mean wheel contact area on top of the rail). The angles are those of the cracks at the initiation location.

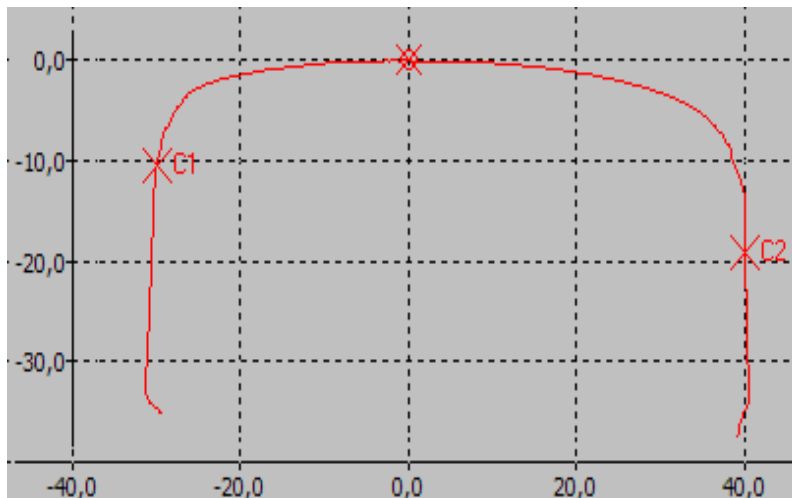
(a) The rail profile measured at the time of the HC initiation. The gauge side is on the right side.

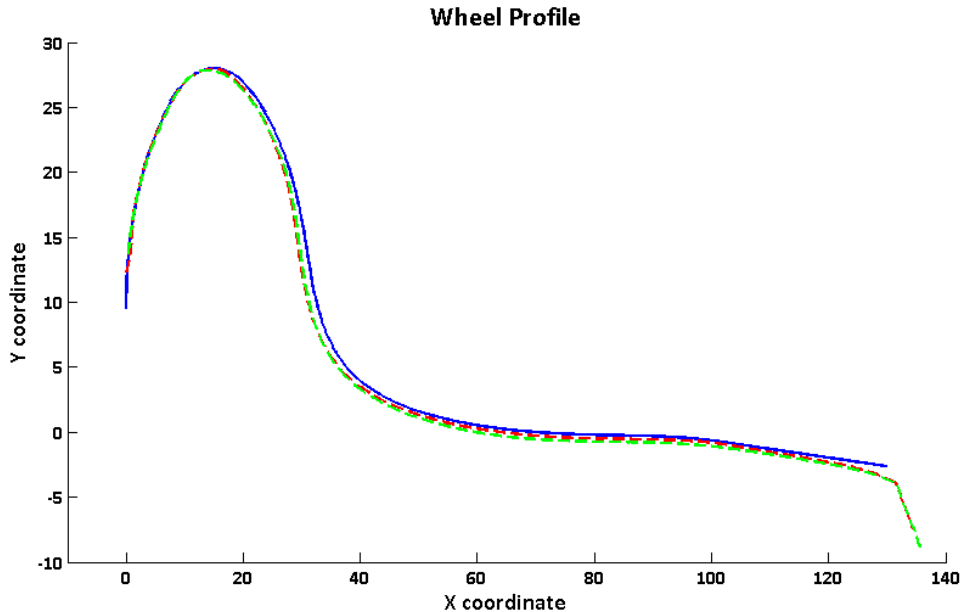
(b) Wheel profiles: The solid blue line is S1002, the broken lines are worn profiles.

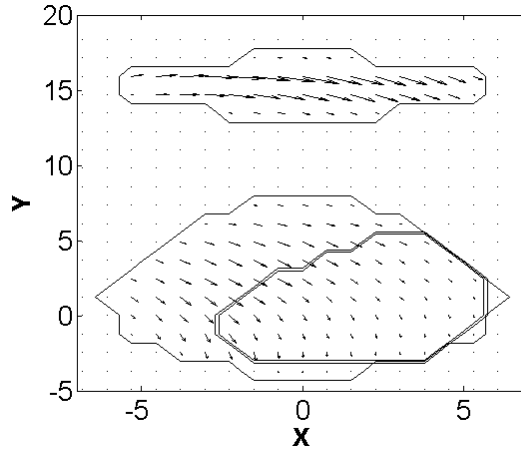
Figure 3.17 The contact area and the distribution of the tangential traction (i.e. surface shear stress). Positive y direction points from the field side to the track centre. The arrows point in the direction of the stress on the wheel. The length of the arrows is proportional to the magnitude of the local tangential traction. Enclosed by the single lines is the contact area. Enclosed by the double lines is the adhesion (stick) area. The area of slip is in the contact area, but outside the adhesion area. The dimensions of the abscissa and ordinate are mm.

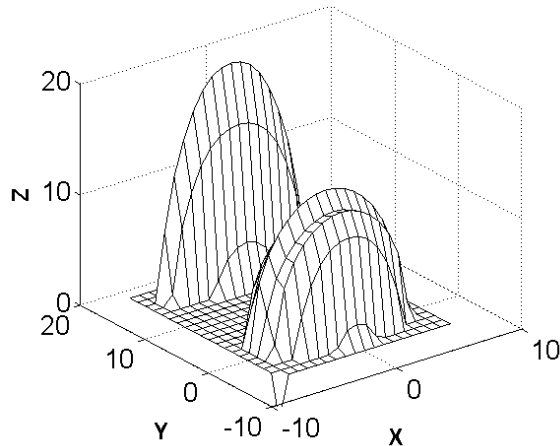
Figure 3.18 Normal pressure at the wheel-rail contact where the HC initiated. It is normalized by the shear stiffness $G = 82 \text{ GPa}$ and it is, therefore, dimensionless. Positive x direction is in the rolling direction, and positive y direction points to the track centre. Dimension of x and y axes is mm.

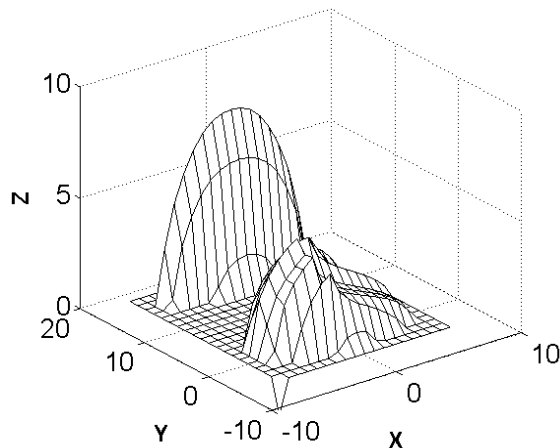
Figure 3.19 Tangential stress at the wheel-rail contact where the HC initiated. It is normalized by the shear stiffness $G = 0.82 \text{ GPa}$ and it is, therefore, dimensionless. Positive x is in rolling direction, and positive y points to the track centre. Dimension of x and y axes is mm.

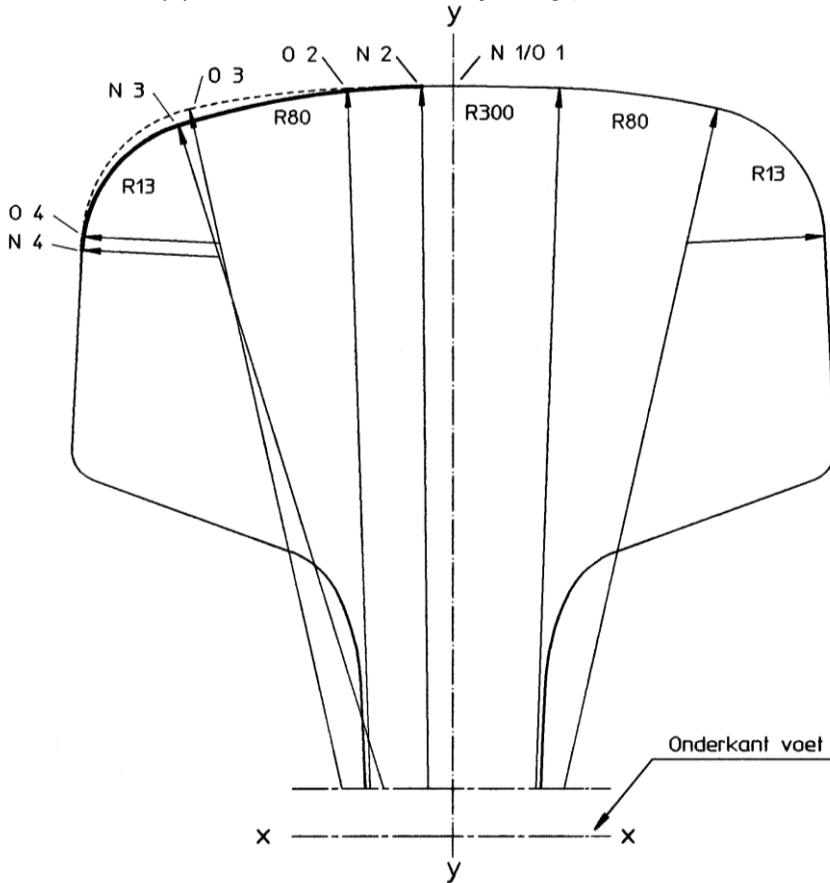
(a) The AHC profile (solid line) in comparison with its origin – 54E1 (Dashed line at the left). The two profiles coincide for the half on the right side (the field side). O_i designate points on 54E1, and N_i for points on the AHC 54E1, $i = 1, 2, 3$ and 4.

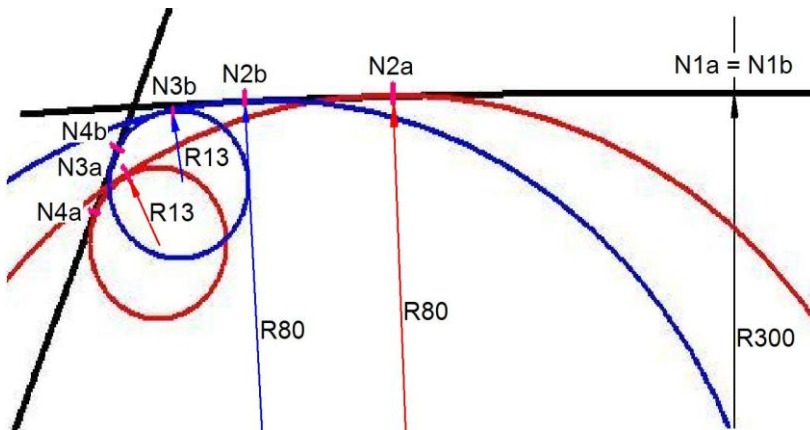
Figure 4.4 Relation between N2, N3 and N4. The slanting straight black line represents the gauge face. The curved black line is a R300 mm arc. Two design scenarios are shown. Scenario a is in red, designated with N1a, N2a, Scenario b is in blue. In either scenario, a profile is constructed according to constraint D of section 4.1.3, i.e. the arcs and the straight line meet with and are tangent to each other at N2a, N3a, N4a or N2b, N3b or N4b.

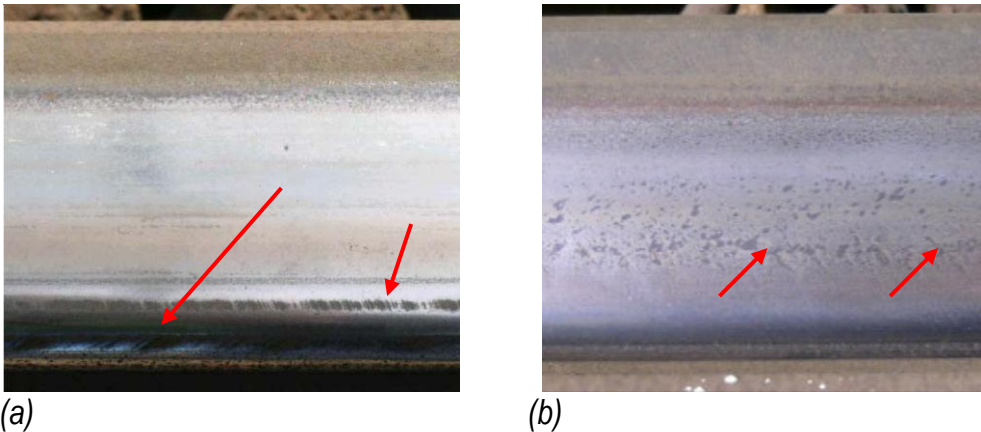
Figure 4.7 The AHC 54E1 rail at monitoring location M0 of the Bunnik monitoring site. (a) The rail at the 3rd monitoring. Remaining marks from the grinding is visible (arrowed). No HC crack was present. (b) The rail at the 4th monitoring. The grinding marks were worn away and HC cracks were present (some arrowed).
