Design of an Anti Head Check profile based on stress relief

Design of an Anti Head Check profile based on stress relief
PhD Thesis, University of Twente, Enschede, The Netherlands
Ir. R.P.B.J. Dollevoet

Keywords: RCF, Head Checks, Profile, Wheel, Rail Contact, Cracks, Track, Friction.

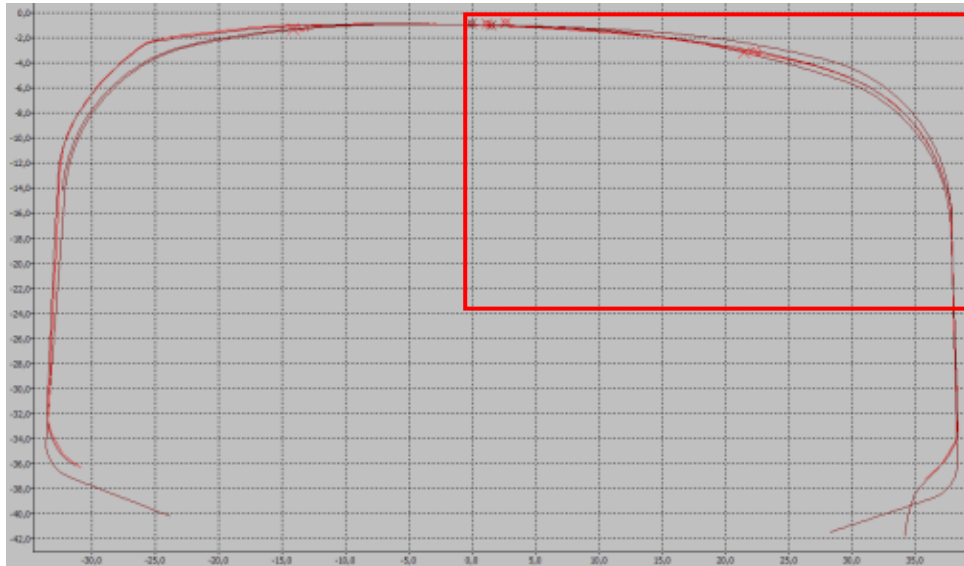
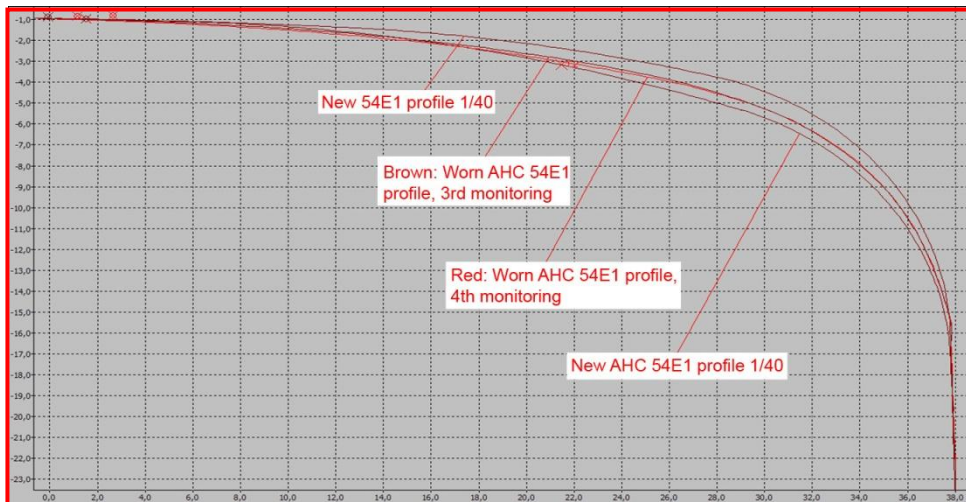
(a) Global view.

(b) Zoom-in of gauge side.

Figure 4.8 Worn AHC 54E1 profile measured at M0 in comparison with new 54E1 and new AHC 54E1 (i.e. 54E5) profiles. Units of abscissa and ordinate are mm. For comparison the profiles are aligned in such a way that they coincide in the middle of the rail top and at the gauge face.

Keeping in mind that the HC has initiated between the 3rd and 4th monitoring, the relation between HC initiation, wear rate and surface shear stress is examined. It can be seen from Figure 4.8(b) that between the 3rd and 4th monitoring, the least material was worn away between abscissa 28 – 32 mm, i.e. $Y_g = 6 - 10$ mm: in this range the two worn profiles coincide, while on both sides of this, the profile of the 4th monitoring (the red curve) is different from that of the 3rd monitoring. On the other hand it must be noted that in table 4.3 the calculated τ_{\max} of the worn AHC 54E1 is for the new and worn S1002 at $Y_g = 7.1$ mm and 11 mm. Since these two S1002 profiles represent the two extremes of S1002 wheels, as discussed above, it may be considered that for all new and worn S1002 wheels passing over this worn AHC 54E1 rail, the τ_{\max} should occur in the range of $Y_g = 7.1 - 11$ mm. Taking into account possible error in the measurement of the profiles etc, this location of $Y_g = 7.1$

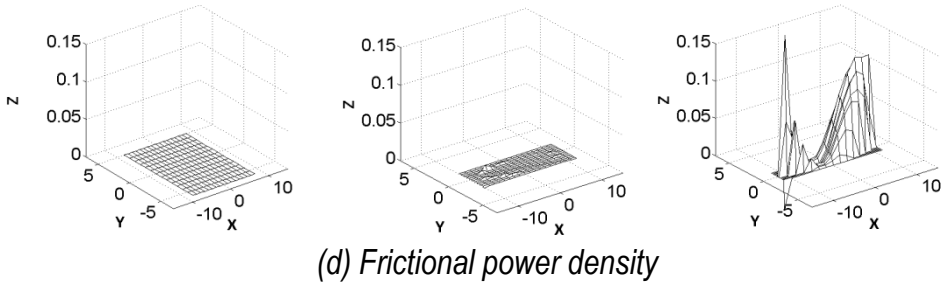
Figure 4.12 Contact conditions of new 54E1 with worn S1002. The left, central and right columns correspond to rigid-body contact points at 25.00, 9.3 and 0.93 mm respectively measured from the gauge face. Other convention is the same as Figure 4.11.

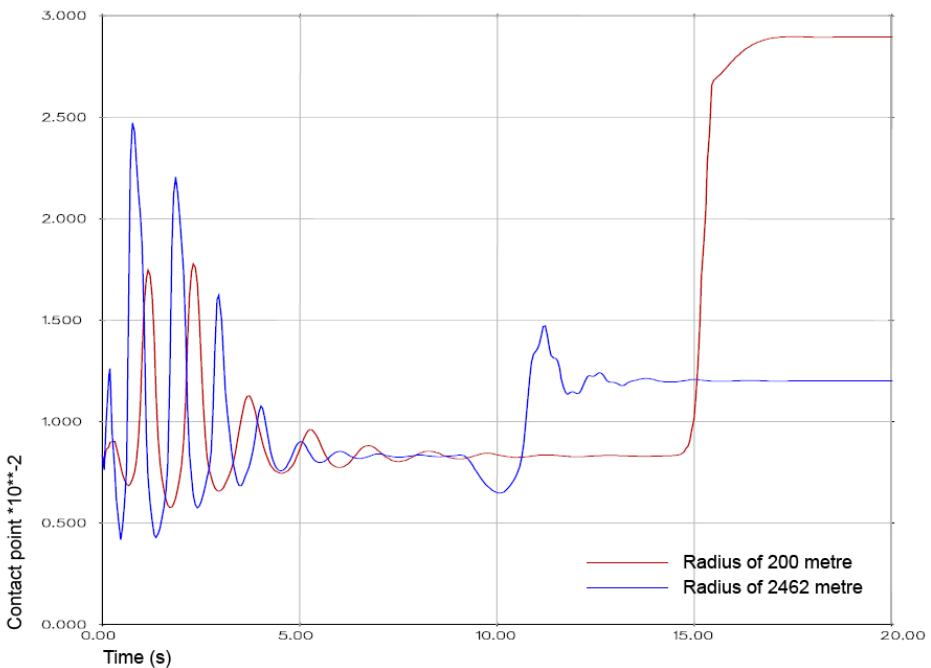
Figure 4.13 Running stability of the AHC 54E1 profile on straight and curved tracks of small and large radii.

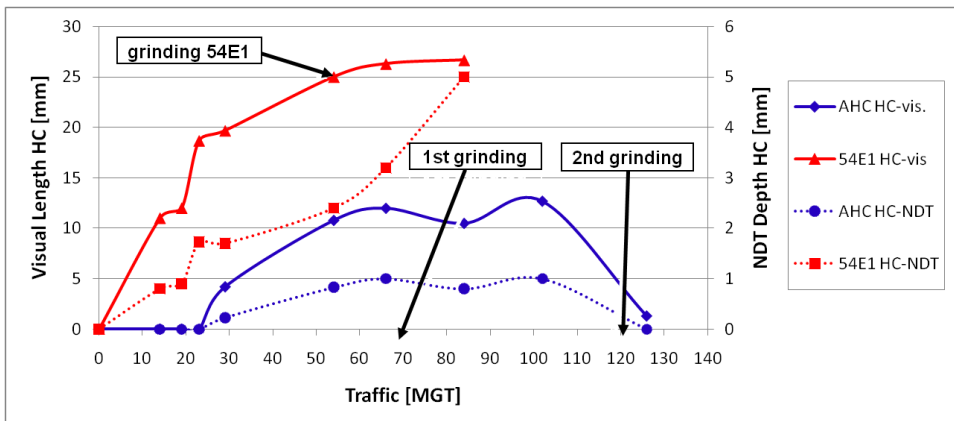
Figure 4.14 Comparison of the HC development in the R260Mn rail with AHC 54E1 profile at track A, against the R260Mn rail with 54E1 profile at the opposite track B. Abscissa is the accumulative MGT. Ordinates are visual length of the HC HC-vis and the depth of HC detected by non-destructive testing HC-NDT.

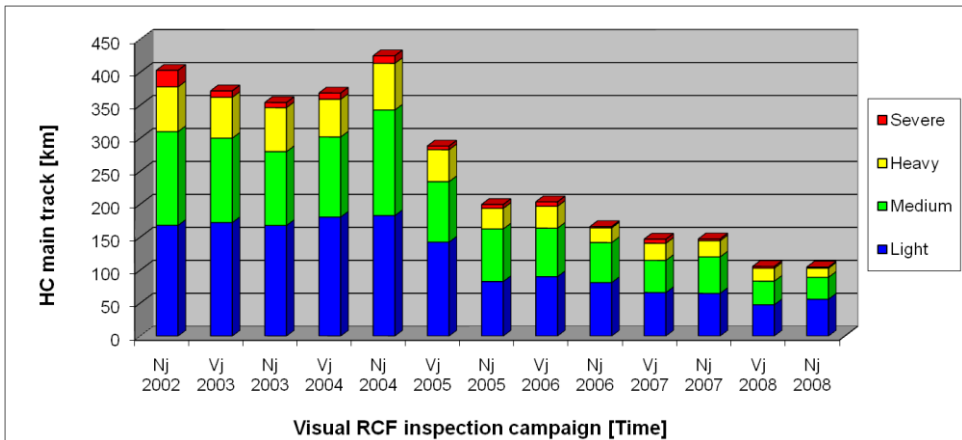
Figure 4.15 HC defects in plain track (i.e. excluding switches and crossings) in 2002-2008 in the Netherlands. See RCF Monthly Report, January, 2009, ProRail.

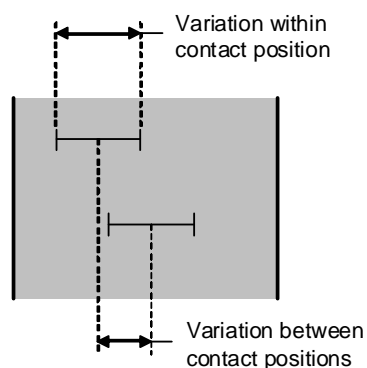
Figure A.2 Variations of contact position.

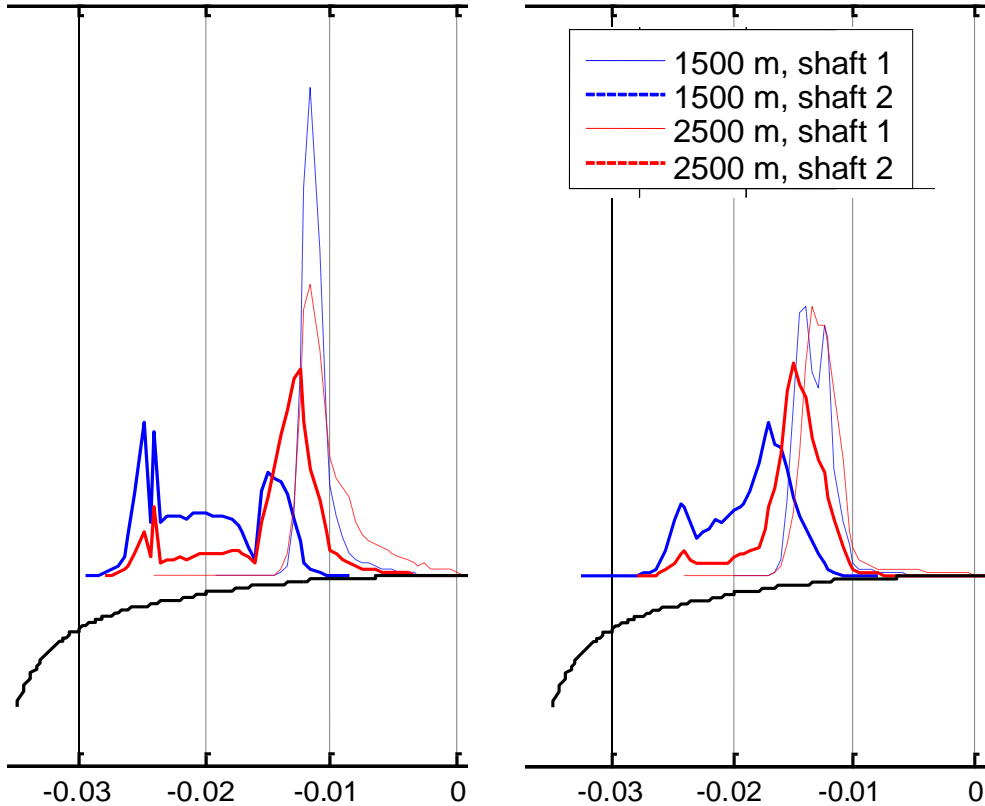
Figure A.3 Weighed distribution of contact position for S1002 (left) and worn profiles (right).
