STATE OF BANDA ACEH BEACH BEFORE AND AFTER THE TSUNAMI

C. Marjolein Dohmen-Janssen¹, Ella Meilianda², Ben H.P. Maathuis³
and Poh Poh Wong⁴

The Great Sumatra Earthquake of December 26, 2004 and resulting tsunami largely devastated the coastal zone of Banda Aceh, Sumatra, Indonesia, because it was located so close to the epicenter. Sustainable management of the coastal zone of Banda Aceh in future requires knowledge about the impact of the tsunami on the coast of Banda Aceh and knowledge on the morphological development of the coastal zone since the tsunami. Therefore, the aim of this paper is to quantify the changes in coastline due to the tsunami and to determine the sediment composition before and after the tsunami. Changes in coastline were derived from satellite images and revealed that the coastline retreat is in the order of several hundred meters. Grain sizes of tsunami deposits, determined from samples taken five months after the tsunami, varied from 90 – 210 μm . This is within the range of grain sizes observed in the nearshore zone before the tsunami, indicating that the sediment composition did not change significantly due to the tsunami and that the source of tsunami d

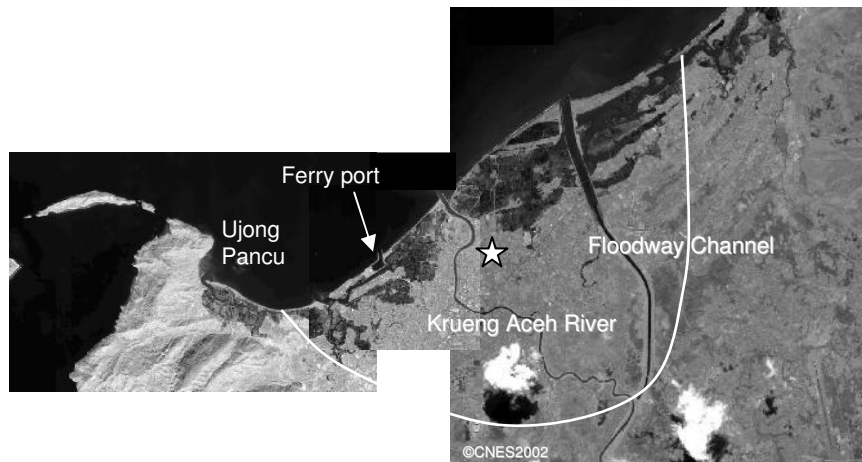
Figure 2. SPOT satellite image of Banda Aceh beach, showing Ujong Pancu headland, Krueng Aceh River and the artificial Floodway Channel. The white line indicates the location of the urban area of Banda Aceh and the white star the location of the city center.

Banda Aceh, the capital of Nangroe Aceh Darussalam, is a city of about 300,000 inhabitants, located at the northern tip of Sumatra Island. Banda Aceh beach is about 25 km long and stretches between the headlands Ujong Pancu and Ujong Batee. It is surrounded by the Indian Ocean on the west, the Andaman Sea on the north, and the Straits of Malacca on the east. Clear landmarks in the coastal area are a ferry port (partly submerged after the tsunami), and two branches of Krueng Aceh River. One of the branches is an artificial floodway channel (see Fig. 2).

Before the tsunami, the coastal area of Banda Aceh was intensively used for human activities, such as housing, fish ponds, shrimp ponds, tourism and small industries. The fish and shrimp ponds are visible in Fig.2 as the dark-colored areas to the sides of the floodway channel.

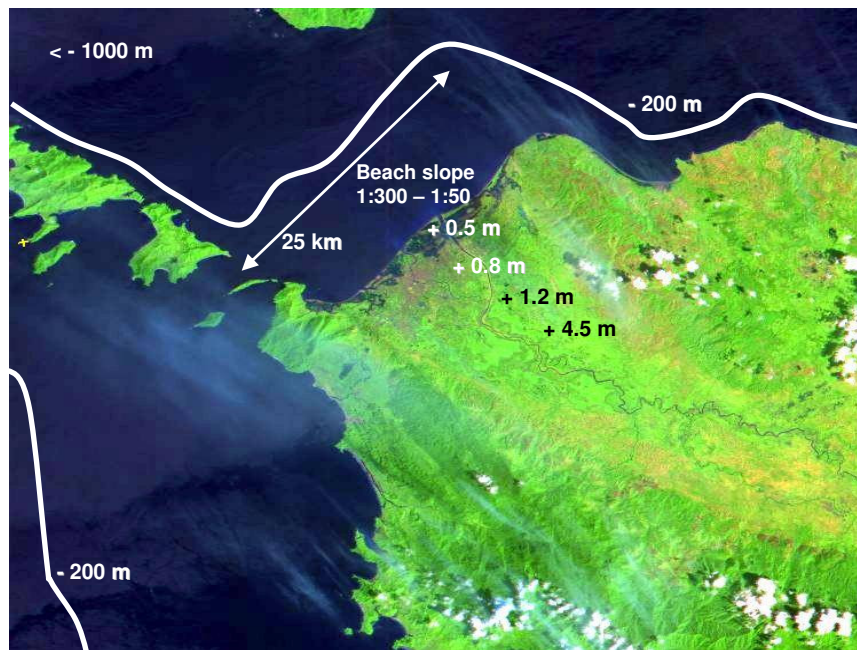
Figure 3. Summary of findings on coastline, bathymetry and topography of Banda Aceh beach before the tsunami, overlaid on a satellite image of the area.

The presented findings about the coastline, and global bathymetry and topography of Banda Aceh beach before the tsunami are summarized in Fig. 3

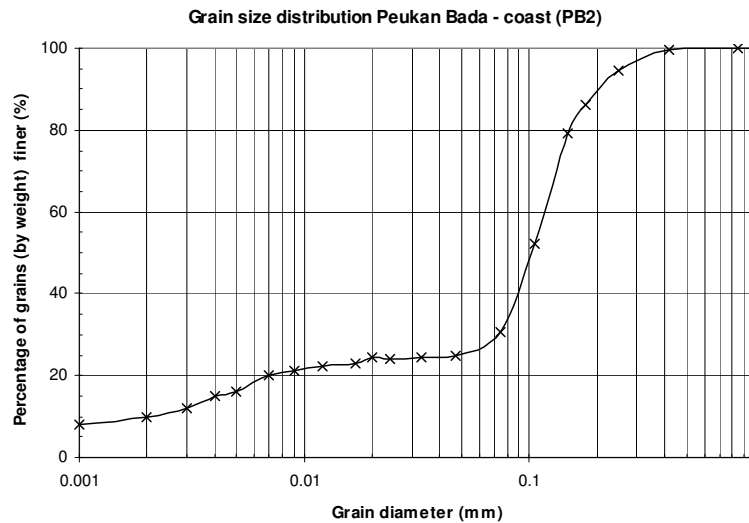
Figure 8. Grain size distribution of samples at PB2 (Peukan Bada, coast)

The deposit at PB2 (coast) consisted of a single sandy layer (with a thickness of 5.1 cm) above the existing ground material. The sediment in this layer had a median grain size of $D_{50} = 90 \mu\text{m}$. The grain size distribution (see Figure 8) shows that this layer contained even more silt and clay than the top layer of PB1, i.e. 31 % finer than $74 \mu\text{m}$ and a D_{10} of only $20 \mu\text{m}$ ($D_{50}/D_{10} = 4.5$). Again, on the coarse end of the distribution, the variation is much smaller with a D_{90} of about $200 \mu\text{m}$ ($D_{90}/D_{50} = 2.2$)
