The corrosion and mechanical behaviours of aluminide, FeCrAlY and CoCrAlY coatings in aggressive environments

V. A. C. Haanappel, B. Geerdink, T. Fransen* and P. J. Gellings

Department of Chemical Technology, University of Twente, PO Box 217, NL-7500 AE Enschede (The Netherlands)

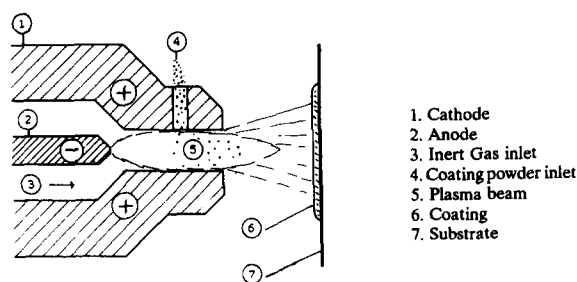
Fig. 1. Schematic illustration of plasma spraying.

The FeCrAlY coatings were applied at Eindhoven on HP40Nb by atmospheric pressure (Ar-H₂) plasma spraying. Figure 1 shows an illustration of plasma spraying. The maximum substrate temperature of HP40Nb was kept below 423 K. Below the FeCrAlY coating an intermediate layer of Ni-5Al (Metco 450) with a thickness of about 50 µm was applied. The top coating of FeCrAlY, type Amdry 970, consisted of Fe-24Cr-8Al-0.2Y. Its thickness was about 200 µm. The final heat treatment was done in an argon atmosphere for 0.5 h at 1373 K in order to improve the adhesion and structural homogeneity via diffusion of the elements into the substrate to some extent.

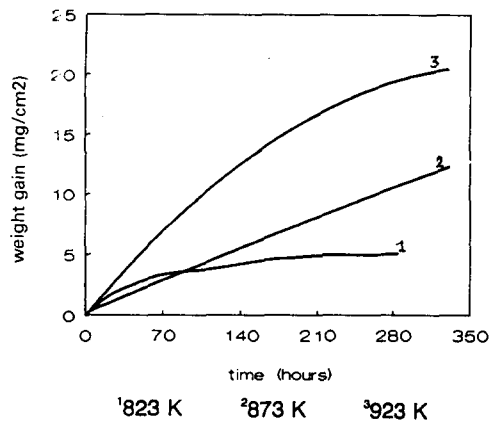
Fig. 10. TGA results for FeCrAlY-coated specimens in sulphidizing atmosphere at different temperatures.

In Fig. 10 the thermogravimetric results are shown for HP40Nb coated with FeCrAlY. The specimens suspended in the oxidizing-sulphidizing environment described showed corrosion attack at 823, 873 and 923 K.

Exposure of the FeCrAlY coupons to oxidizing-sulphidizing environments at 823 K revealed a relatively rapid initial weight increase followed by a very slow attack of the coating. Owing to the low mass loss (millimetres per year) of the specimen and since the coating thickness is about $250 \mu\text{m}$, protection for at least 1 or 2 years is ensured. The sulphidation rate at 873 K is much higher, which means that the protective behaviour of the coating is less pronounced. However, this coating-substrate combination fails at temperatures of 923 K and above. The coating showed breakaway at this temperature.

FeCrAlY-coated specimens do not give sufficient protection against aggressive atmospheres, as seen in Fig. 10. The incubation time of these

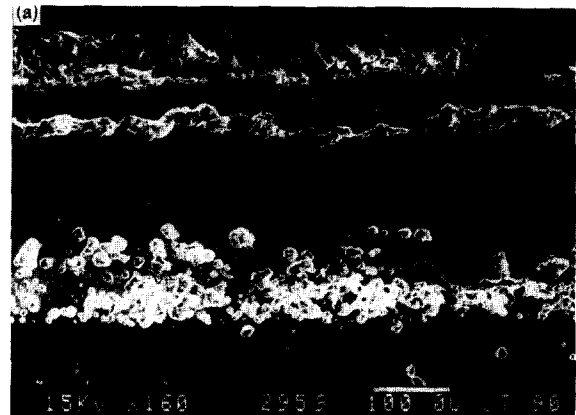
Fig. 11. (a) SEM image (cross-section) of FeCrAlY-coated HP40Nb specimen after sulphidation for 320 h at 873 K and X-ray maps showing distributions of (b) nickel, (c) iron, (d) chromium, (e) aluminium and (f) sulphur.

Figure 11 presents an SEM image (cross-section) and X-ray maps showing the distribution of the elements nickel, iron, chromium, aluminium and sulphur for an FeCrAlY-coated specimen exposed to the oxidizing-sulphidizing atmosphere for 320 h at 873 K. Examination of the sulphidized specimen after exposure to the aggressive environment indicated that a sulphide scale had formed with a thickness of more than 100 μm . Energy-dispersive X-ray (EDX) investigations revealed that this sulphide scale had formed only at the outer part of the coating, consisting of an outer iron-rich zone (mole ratio Fe:S \approx 1) and a chromium-rich inner zone (mole ratio Cr:S \approx 1) adhering to the coating. In this zone iron depletion has also been observed, probably due to the outward diffusion of iron. Between the sulphide scale and the coating, separation has been detected.

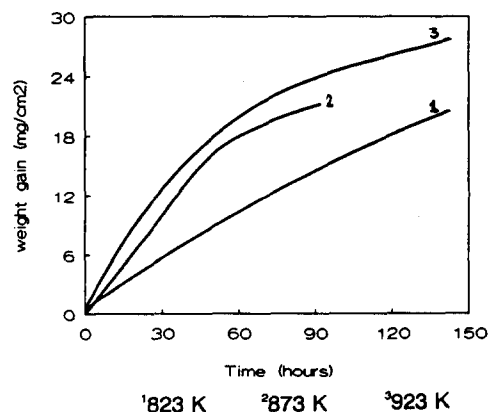
Fig. 12. TGA results for CoCrAlY-coated specimens in sulphidizing atmosphere at different temperatures.

Figure 12 shows the thermogravimetric results for CoCrAlY on Incoloy 800H. From this figure it can be deduced that the weight gain in an oxidizing-sulphidizing environment is higher than for FeCrAlY coatings. In an $\text{H}_2\text{O}-\text{H}_2-\text{H}_2\text{S}-\text{Ar}$ gas mixture after 150 h a weight gain of at least 20 mg cm^{-2} is observed at 823 K.
