# Community-Based Flood Risk Assessment Using GIS for the Town of San Sebastián, Guatemala

**G. Peters Guarín**  
**C.J. van Westen**  
**L. Montoya**

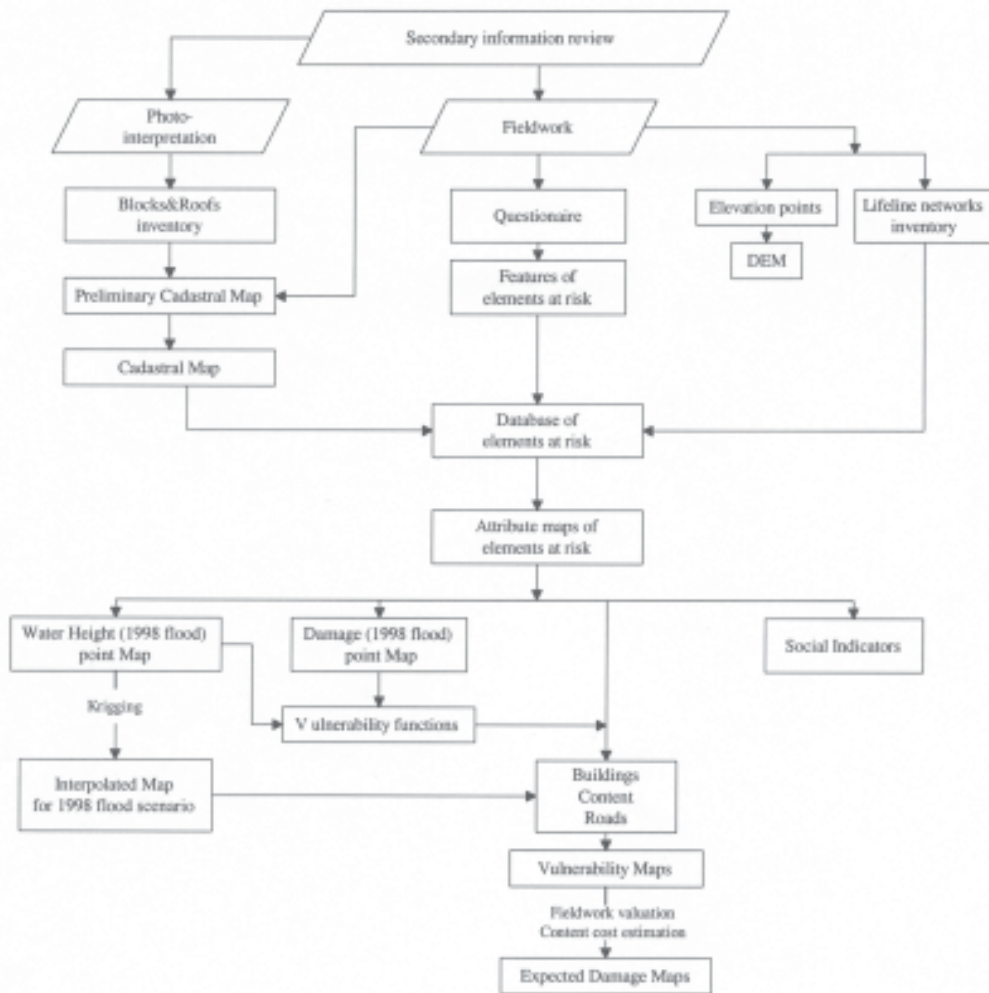
*Figure 1 - Schematic overview of the flood risk assessment.*

Within the framework of the UNESCO program on “Capacity Building for Natural Disaster Reduction” (UNESCO-CBNDR), a Regional Action Program for Central America was initiated which focused on training and the development of case studies in most Central American countries. One of these case studies was conducted in the town of San Sebastián, Guatemala, located in an area exposed to a range of natural hazards. Over the last 50 years, the town has been affected several times by floods from some of the tributaries of the Samalá River. The most recent event occurred in October 1998 and was caused by extreme precipitation related to Hurricane Mitch. The 1998 flood scenario was reconstructed through interviews with local people. The data were then used to conduct a vulnerability assessment and a loss estimate calculation. An overview of the methodology used is presented in Figure 1.

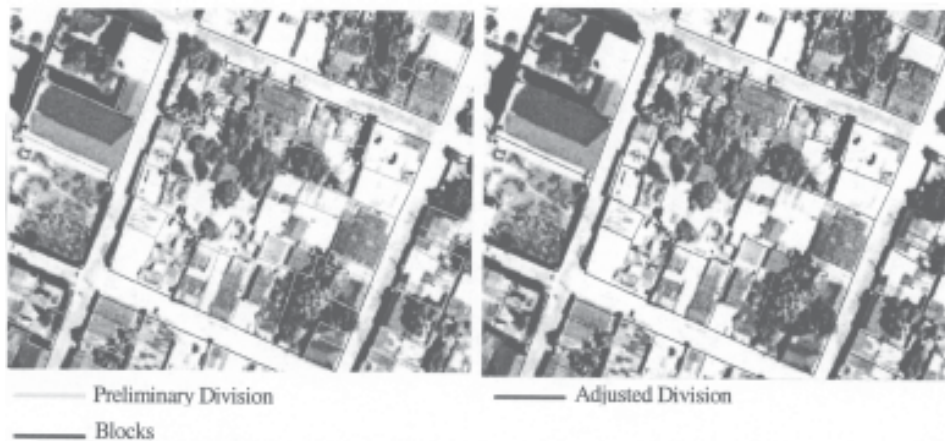
**Figure 3 - Comparison of digitized plots before (preliminary roof inventory - left) and after field inspection (right), for a section of San Sebastián.**

The orthophoto from 2000 was used to generate a cadastral base map containing information on individual plots and buildings, with attached attribute information related to ownership, building features and land use. Preliminary delineation of building blocks (or 'manzanas') and roof inventory was made by means of detailed digital image interpretation and 'on-screen' digitizing. Plot boundaries were later checked during fieldwork and significant discrepancies were identified mainly in areas near the main square. Most were due to the complex densification

pattern that significantly increases the number of individual dwellings inside a building plot. For example, a single roof may cover more than one home or a given plot may have more than one type of roof (see Figure 3). The preliminary interpretation map was then verified and adjusted during inspection transects along the streets and inside the blocks.

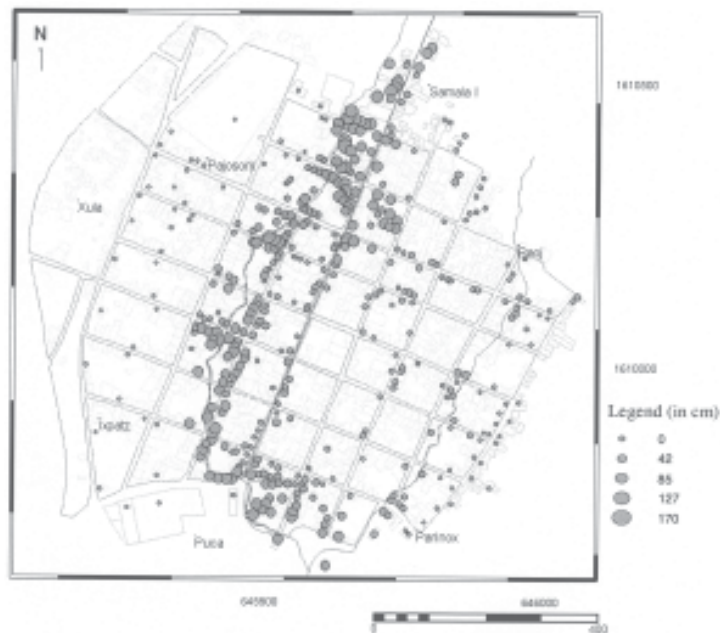
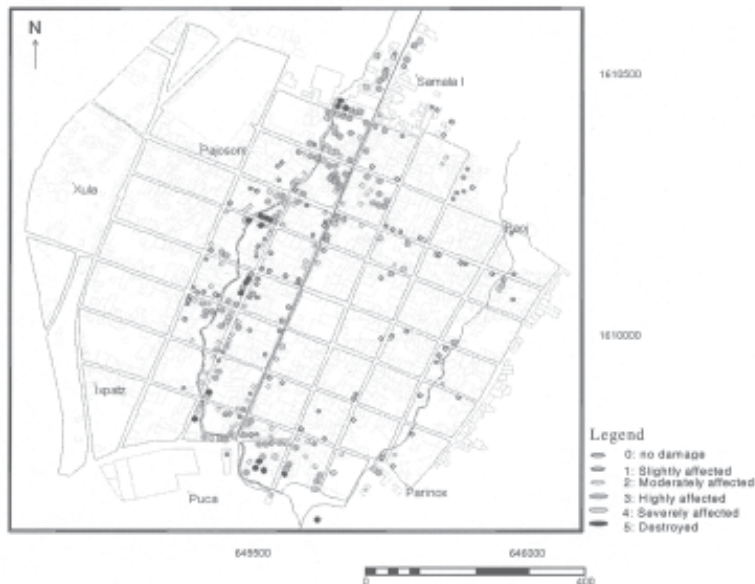
**Figure 4 - Plots from which information on 1998 floodwater height was collected (top); Plots with damage information from 1998 flood (bottom).**

Based on the information collected during the survey, it was possible to develop two maps representing the flood scenario for 1998: one for the water height and one for the damages. Figure 4 shows the cadastral plots from which information on water heights and damage levels was obtained. It should be noted that greater focus and more detailed survey data were collected in those areas affected by flooding in 1998.

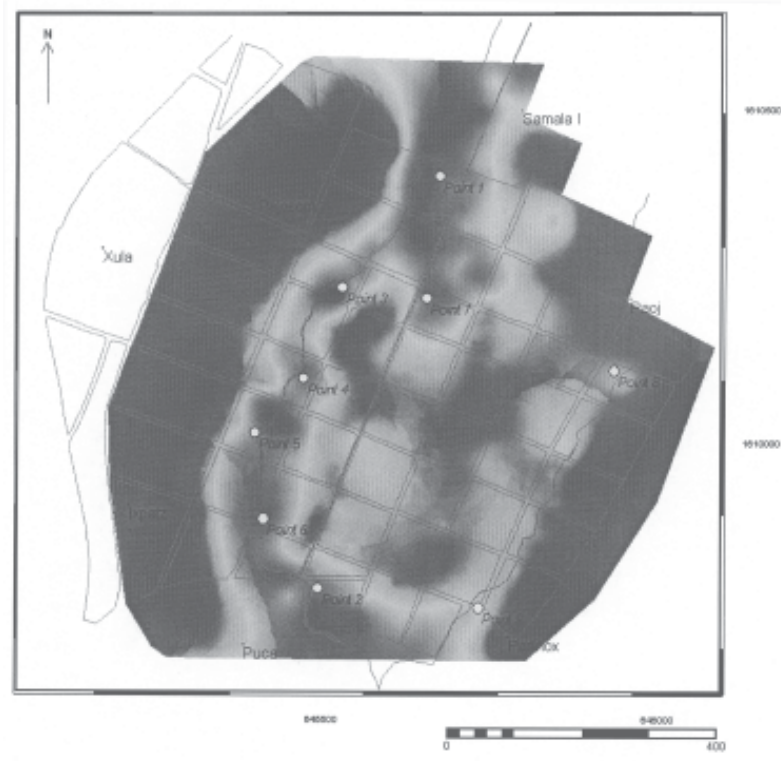
*Figure 5 - Interpolated map for water height and main bottlenecks (indicated as points) during the 1998 flood event in San Sebastián.*

A GIS point interpolation method (ordinary Kriging) was performed from plots containing water height data (see Figure 5). Regarding damage, descriptive information on both the buildings and their contents was compiled during the survey. This qualitative report was subsequently converted into numerical values for every specific level of damage (see Table 2).

The water height map shows that the 1998 flood spread across all four urban “cantons” in San Sebastián. Building blocks near the watercourses of the Ixpatz and Cachel and along the Avenida Central were particularly affected. By analyzing the most severely damaged areas, it

was noticed that the water height reached 130 centimeters at some point during the flood (points 1 and 2 in Figure 5). In those zones, 6 houses were destroyed, 3 were severely damaged and 16 were highly damaged (see Table 2). Moreover, the water removed most of the bricks covering the streets, which people later used to rebuild their houses or piled them up as temporary flood protection. Severe damage was also caused to roads connecting San Sebastián with the National Pacific Highway. At some points the asphalt surface was completely removed. Flood heights also exceeded 1 meter in four spots identified as bottlenecks along the Ixpatz River (points 3 to 6 in Figure 5). In most cases, bridges built above the street level behaved as source points for overflowing at higher velocities resulting in 9 houses destroyed, 14 severely damaged and 48 highly damaged.

At point 7 in Figure 5 the flooding heights were above 1 meter. In this sector water coming from the Ixpatz watercourse covered Avenida Central spreading out in all directions, particularly towards the southeast due to topographical features. In this zone, many houses are built on the flat tops of the Ixpatz and Cachel watersheds. This leveled topography is conducive to water accumulation. The pattern of flooding seemed to be related to the existence of empty spaces, passages and inner constructions. In this sector, 2 houses were reported as severely damaged and 16 as highly affected.

The critical flooding spots located along the Cachel River (points 8 and 9 in Figure 5) were caused by buildings that confine the watercourse, channels that have progressively been in-filled with sediment and garbage, and deficiencies in sewerage and run-off collection systems whose capacity has been further reduced by dumped rubbish and garbage. Dwellings built be-

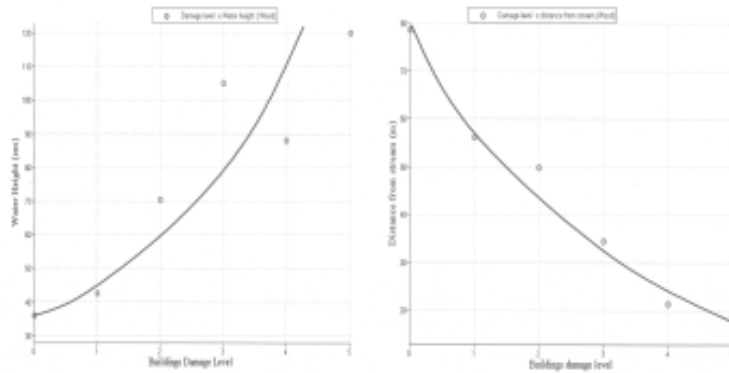
**Figure 6 - Stage-damage curves relating Damage versus Water Height (left) and Damage versus Distance from the street (right) for wooden buildings. Dots represent the averaged value for all plots with equal damage level (see Table 2).**

In order to establish relationships between damage and floodwater height, two graphs were plotted for each construction type: damage level (assessed from the building damage report) against averaged flood, and damage level against distance from the streams (see Figure 6).

These graphs were converted into stage-damage curves by assessing vulnerability values from 0 to 1 for each qualitative damage class and construction type (see Table 2). Based on these functions a building vulnerability map was generated for the 1998 scenario. Consistency was checked afterwards through comparison with plots reported as damaged during fieldwork (see Figure 7a and 7b).

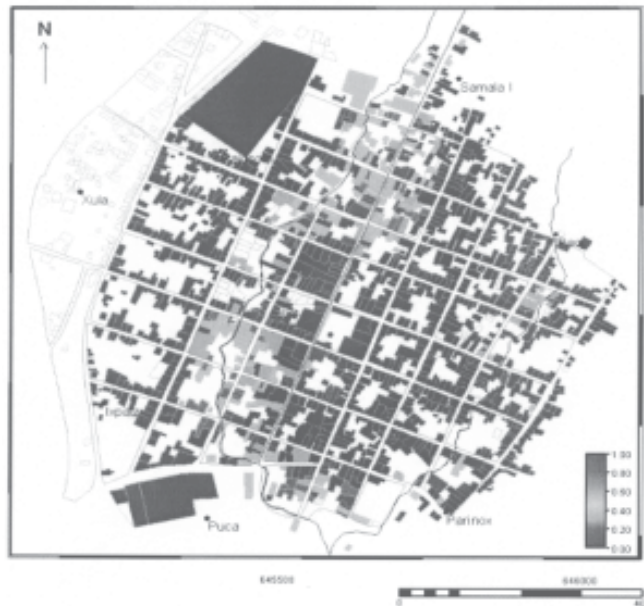
**Figure 7a - Building vulnerability map.**

- For buildings: building vulnerability (see Figure 7) was multiplied by the market value of each parcel;
- For contents: building contents vulnerability (see Figure 7) was multiplied by an attribute map displaying the building contents' costs. This map was obtained by classifying all houses according to socio-economic class. Non-residential buildings were classified according to land use type. This map was later reclassified by linking the costs of the list according to the socio-economic class. In mixed-use cases (e.g., housing and commercial), the values of both lists, residential and non-residential, were combined;
- For roads: area covered by each type of surface was multiplied by its respective price per square meter, and then multiplied by the flood vulnerability value.

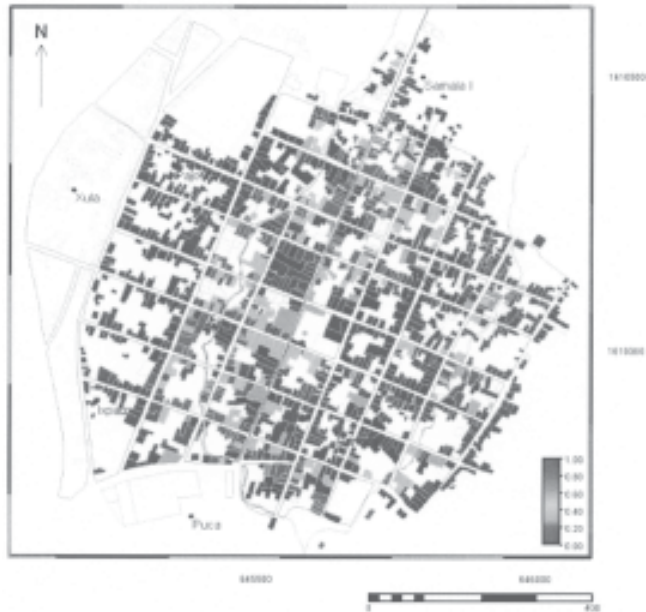
*Figure 7b - Building content vulnerability map.*

Figure 7 illustrates the vulnerability map for building contents. The map indicates in terms of flooding contents vulnerability was higher and more widespread than building vulnerability. The procedure also evidenced how damage is influenced by socio-economic class as buildings having more assets inside will show greater expected damage.

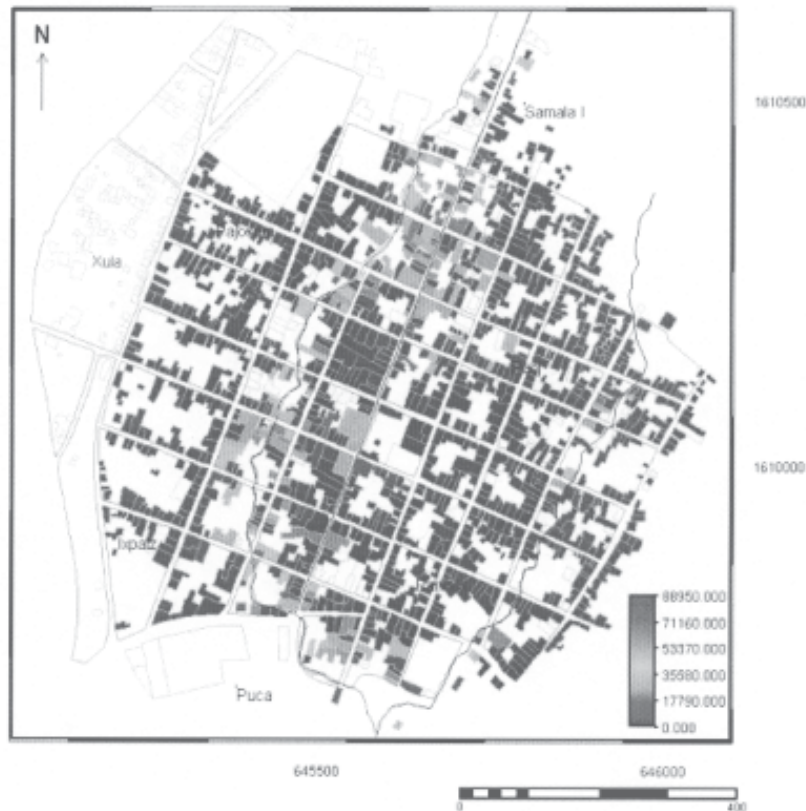
*Figure 8 - Map of Total Expected Damage for elements at risk (combined building and content loss). Prices are given in Quetzals (1 USD = approx. 8 Quetzals at the time of this research - October 2002).*

Finally, a total loss value was calculated by adding up the damage for buildings and their contents and displaying the expected losses for roads in the areas surrounding the plots (see Figure 8).
