# A Methodology Based on Pulse-Velocity Measurements to Quantify the Chemical Degradation Levels in Thin Mortar Specimens

In this research, ultrasonic pulse echo measurements are used to quantify through thickness chemical degradation in thin mortar specimens. The degradation level is predicted using the time of travel of the acoustic wave through the thickness of the structure. The front and back wall interaction reflections are used to obtain additional information from very early stage degradation. The pulse-velocity of sound waves as a function of the thickness of the layers within the structure is described. With knowledge of the pulse-velocity in pristine and fully degraded conditions, it is possible to determine the complete range of degradation length over the layer thickness. The method is applicable for leaching of calcium and acidic attack. The acoustic measurements were verified with destructive testing. The correlation between the acoustic and non-acoustic experiments agree with the described pulse-velocity and degraded depth function. The method based on ultrasonic measurements can be implemented in other thin-layered structures.

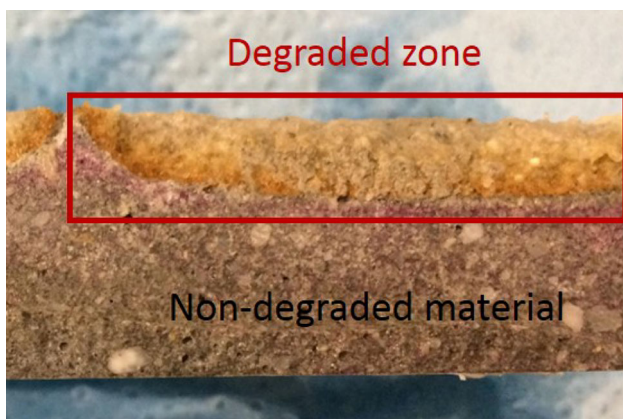
**Fig. 1** Acidic deterioration in cementitious material. Cross-section of specimen subjected to degradation from only one side. Sharp transition between pristine and degraded material

A visual change in the structure can be seen between degraded and non-degraded material (see Fig. 1). Further, in the degraded zone, a thin brownish coloured layer can be seen at the edge of the degraded zone. This ferric hydroxide layer accumulates the salts that are being removed from the binder. The later was reported by Chandra [25] where she concluded that just after the brown ring, the calcium content completely drops due to dissolution. The ferric hydroxide layer remains with a constant thickness. In the degraded zone there is no binder anymore and the remaining compounds and aggregates easily crumble.

The case of calcium leaching has a different story. This is mostly because the degraded zone is not as sharp as in the acidic deterioration (see Fig. 1). In Fig. 14, the transition between degraded and non-degraded is not very clear. The purple indicator gradually changes. In the experimental part, the degraded layer was considered until where the blue arrow in Fig. 14 is pointing. However, the identification from the purple coloration of the complete degraded zone was not possible to achieve. Thus, the results from the calcium leaching should have a higher degraded depth for the measured pulse velocity.

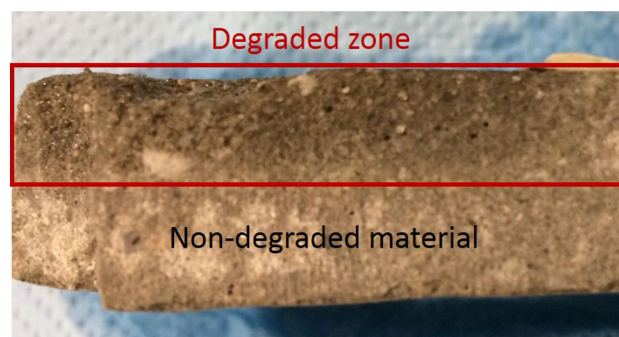
**Fig. 2** Leaching of calcium in cementitious material. Transition between pristine and degraded material is composed of gradual layers of calcium content (Color figure online)

Figure 2 depicts the degradation profile of a specimen's cross-section. The part in the red box shows the material that was subjected to leaching. Leaching in this case originated from the top surface. There is no clear sharp transition nor difference in the material structure. The degraded material in this case has much higher remaining strength capacity than compared to a material deteriorated by acid.

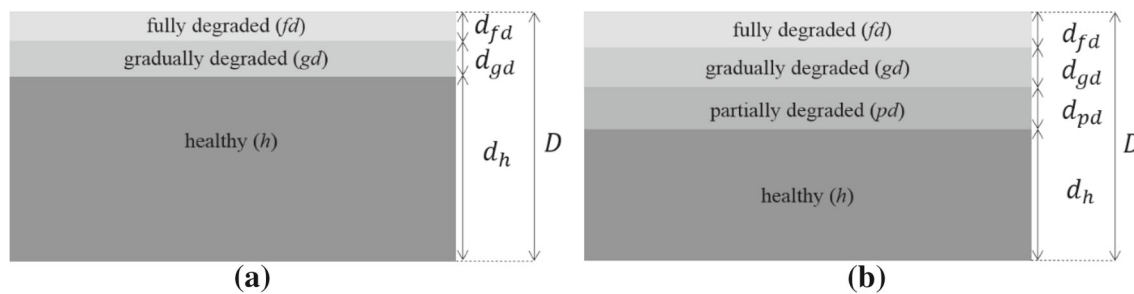
**Fig. 3** Leached cementitious structure **a** with low permeability and degradation resistant and **b** with high permeability and non-degradation resistant admixtures

The layered structure defined in Fig. 3 is a function of the calcium content, thus Fig. 3a and b are two different cases of calcium leaching. For acidic attack only Fig. 3a represents the calcium content distribution. Experimental evidence of the calcium distribution along the thickness, the mechanical strength and the porosity can be found in the literature [24–27, 30–35]. This corroborates the distribution of the layers shown in Fig. 3a and b.

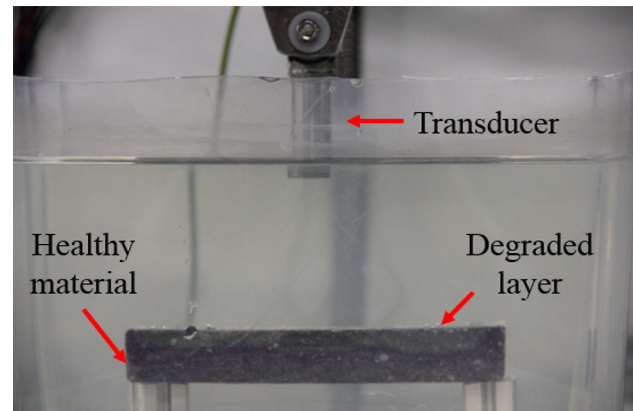
**Fig. 4** Immersion ultrasonic test set up with a degraded cementitious specimen

The specimens were placed in an immersion tank (free of degradation agents) as shown in Fig. 4. A uniform coupling between the transducer's surface and the specimen was achieved. In an inline inspection, it is possible to access to the internal which is one of the main constraints. Therefore, pulse-echo is the most suitable technique to measure the speed of sound in the structure. The tests were performed on the deteriorated side (for the one-sided degradation). Two flat non-focused transducers with 0.5 MHz and 1 MHz central frequencies were used with 0.75" and 0.5" diameters respectively. The data was recorded with a 16 bits resolution digitizer at a 62.5 MS/s sample rate.

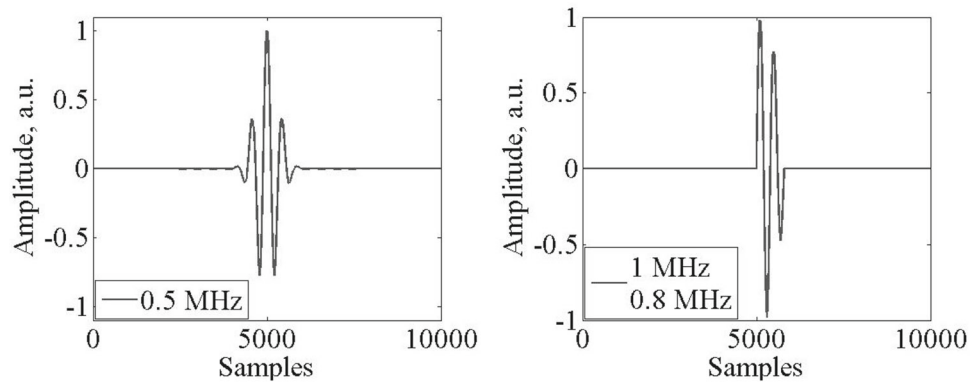
**Fig. 5** Input signals with **a** Windowed sine; **b** exponential decrease sine

The input voltage used is shown in Fig. 5. A windowed sinusoidal signal was applied to the 0.5 MHz transducer and

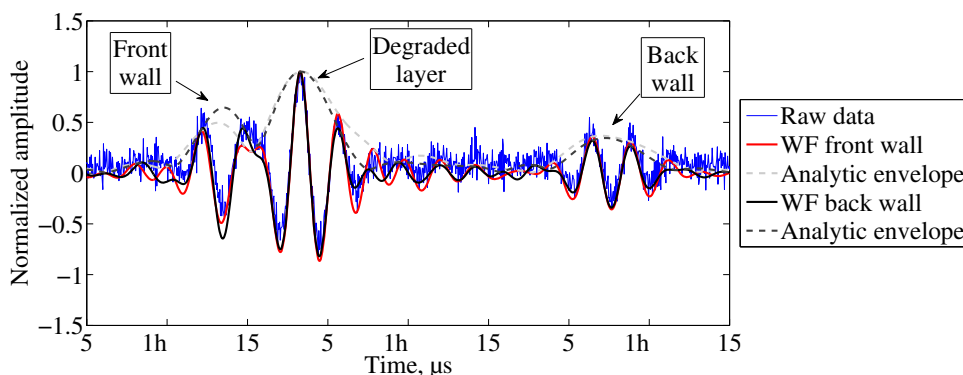
**Fig. 6** Typical data for acidic deterioration obtained after 3 days in one-sided acidic solution. The signal processing steps are shown as the Wiener filter and analytic envelope (Color figure online)

The processing steps for the experiments performed in the mortar under acidic attack are depicted in Fig. 6. The blue line represents the raw signal, while the red and black lines represent the data after Wiener filter for the front wall reflection and back wall reflection respectively. The dotted line represents the analytical envelope of the filtered data. As mentioned in the previous section, the change in the material properties is sharp in an acidic deterioration environment. For this reason it is possible to see a reflection from the deteriorated layer. In the literature, the detection mechanism is based on such reflection [8]. Nevertheless, it was found that such reflection cannot be found in a calcium leaching scenario (see Fig. 7). Furthermore, Fig. 7 depicts the typical signal recorded from the experiments of a mortar degraded

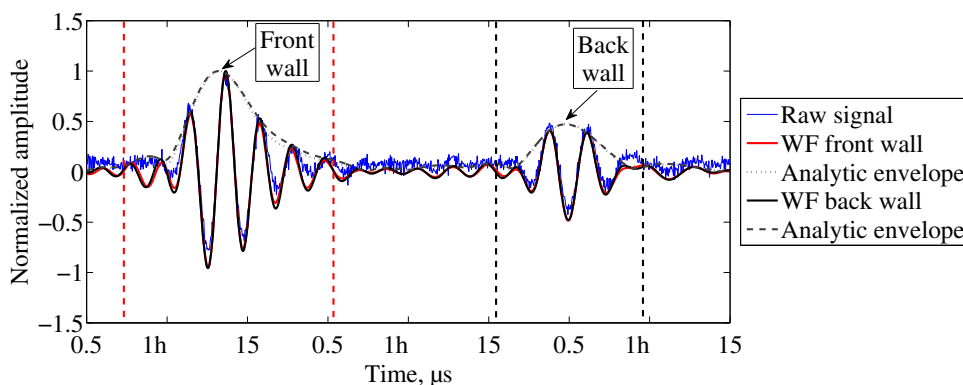
**Fig. 7** Typical data for calcium leaching obtained after 4 days in one-sided deterioration configuration. The signal processing steps are shown as the Wiener filter (WF) and analytic envelope (Color figure online)

by contact with ammonium nitrate solution. The red lines and the black lines enclose the part of the signal that is used to obtain the frequency components and perform the Wiener filter. The signal-to-noise ratio clearly improves the detection of the reflection of interest.

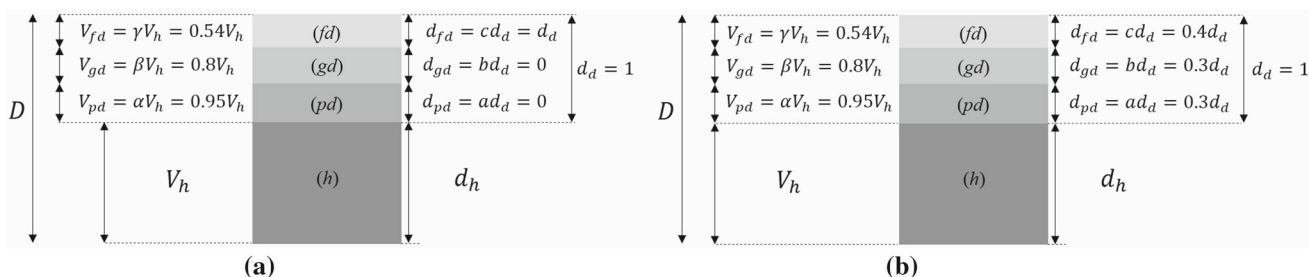
**Fig. 8** **a** Healthy and fully degraded configuration are present in the structure. **b** Degraded zone dominated by gradually and partially degraded regions. This is considered as a “worst” case where the leaching process is not as sharp and the properties of the material gradually extend from healthy to fully leached

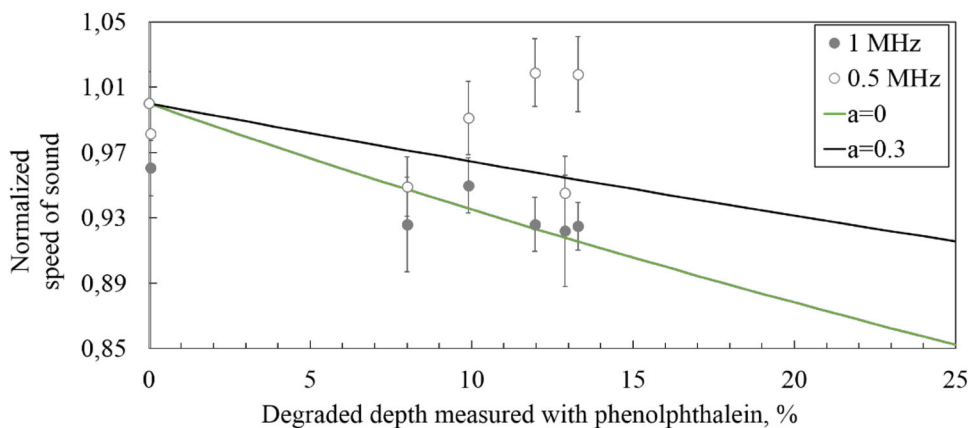
**Fig. 9** Speed of sound change from early stage degradation. Solid lines: model from Eq. 10 evaluated with  $b = a$  and  $c = 1 - a - b$ ;  $\gamma = (V_{fd}/V_h)$

The change in the acoustic velocity of various degraded levels can be seen in Figs. 9 and 10 for early stage and long deterioration respectively. Only after testing with frequencies in between 0.5 and 1 MHz it was found that the standard measurement deviation for the pristine state is higher for tests performed with lower frequency compared to higher frequency. Additionally, for the lower frequency signals, an increase in the speed of sound in early degraded material was found (see Fig. 9). Both the high scatter and the increase in speed of sound are due to the resolution problem with low frequency signals. For higher frequency waves this problem does not exist.

In Figs. 9 and 10 these two cases are shown as  $a = 0$  and  $a = 0.3$ . In this research these two conditions are considered as the boundaries of the possible leaching events that can happen in a cementitious structure.

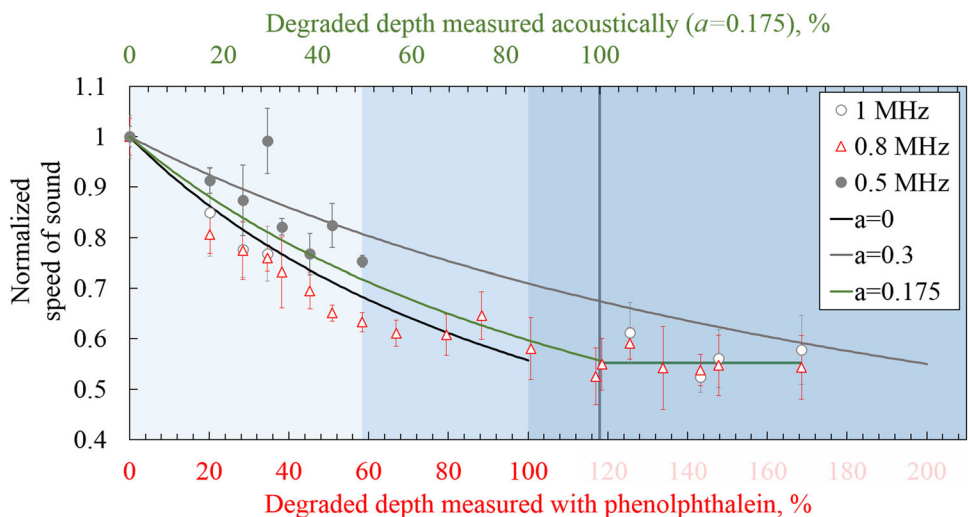
**Fig. 10** Speed of sound profile with 0.5, 0.8 and 1 MHz central frequency excitation signals (markers). Solid lines: model from Eq. 10. Light blue region: measurements with unmodified thickness. Middle blue zone: measurements with reduced thickness up to largest degraded depth. Dark blue zone: measurements from reduced thickness greater than the measured degraded depth (phenolphthalein tests) (Color figure online)

Figure 10 shows the results for long term degradation with 0.5, 0.8 MHz and 1 MHz. The back wall reflection from the 1 MHz central frequency tests were heavily damped after 45% of degradation depth. The back wall reflection from the two other frequencies were heavily attenuated after 60% of degradation depth. In order to characterize larger degradation depths, the specimen's thickness was gradually reduced from the healthy side towards the degraded side by dicing. Thus, instead of inducing further degradation the material is made thinner, resulting in an overall higher degradation. These results are shown in the two darker blue zones in Fig. 10. The degradation degree was obtained by dividing the measured degraded depth ( $d_d$ , from phenolphthalein tests) with the thickness of the specimen,  $D$ ;  $(d_d/D) * 100\%$ . The results from the ultrasonic tests were correlated with the phenolphthalein tests as shown in Fig. 10 bottom axis.

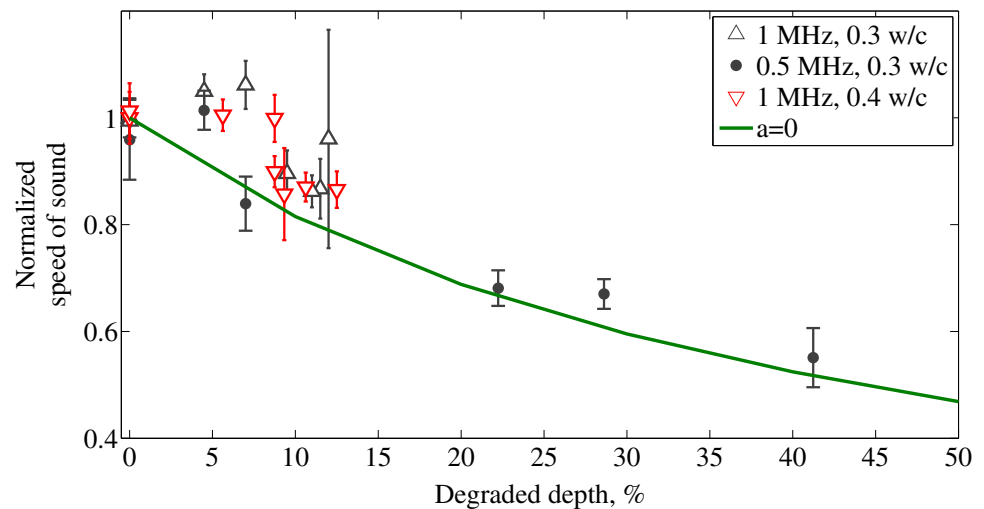
**Fig. 11** Speed of sound profile for the different degraded depths measured with 0.5 MHz and 1 MHz central frequency transducer. Solid line: model from Eq. 10

Figure 11 depicts the speed of sound profile for the different degradation depths. The measured speed of sound in fully degraded material due to acidic attack is found to be 1400 (m/s) with a 0.5 MHz central frequency actuation signal. This is corroborated with the literature [8, 10]. Due to the heavy attenuation of the waves, new batch of specimens with a lower water-to-cement ratio (0.3) were manufactured and degraded.

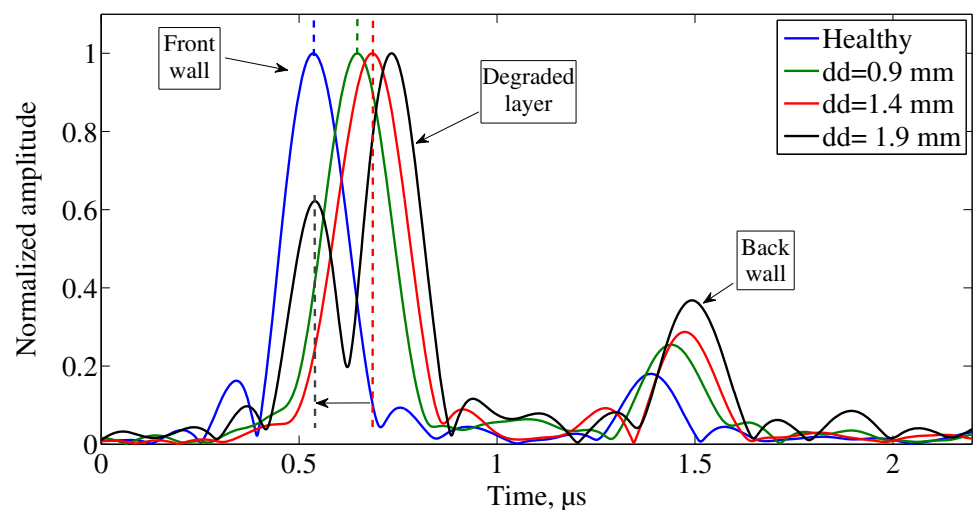
**Fig. 12** Early stage degradation signals from acidic deterioration. Dotted lines represent the location in time of the front wall reflection. The data was normalized to the maximum of each signal. Thus it is not possible to see the reduction in amplitude from the front wall. In the legend,  $dd$  is degraded depth

The increase in the speed of sound in the early stage degradation is due to the proximity between the front wall reflection and the reflection from the degraded layer. In Fig. 12, the process where the front wall is shifted in time to the right as the degraded layer increases. Once the degraded layer is far enough from the front wall reflection, it is shifted back to the initial position as depicted by the dotted lines in the front wall reflection. Furthermore, the back wall reflection

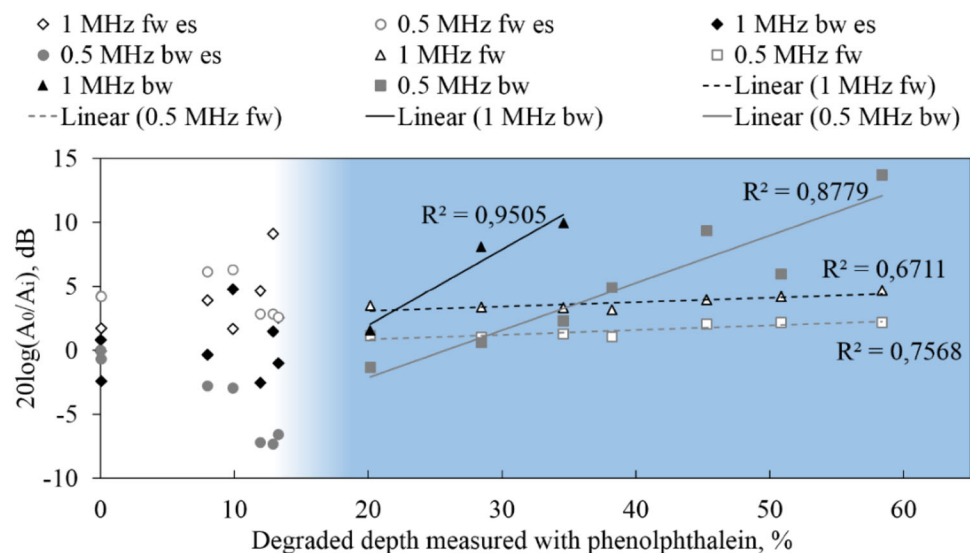
**Fig. 13** Front wall and back wall amplitude change (in dB). Trendlines are shown for the long term degradation. Gradual colour shows the change from early degradation (white) to long term degradation (blue). In the legend, early stage is abbreviated as (es), back wall is abbreviated as (bw) and front wall is abbreviated as (fw) (Color figure online)

means that more energy is transmitted to the material (see Fig. 13). This effect is frequency dependent. The higher the excitation frequency the higher the reduction in front wall and back wall amplitudes. In Fig. 13, a gradual transition between early degradation and long degradation is seen from the white zone to the blue zone. The amplitude of the pristine state for both front wall and back wall was considered as the reference for calculating the dB change shown in Fig. 13.

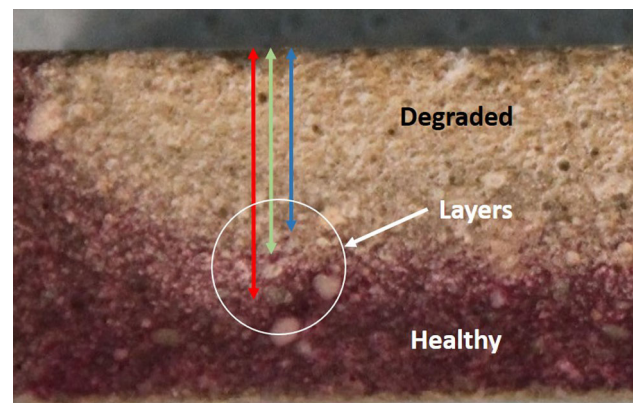
**Fig. 14** Cross-section view of a mortar degraded from contact with ammonium nitrate solution. Purple colour represents high pH (pristine). Grey zone represents low pH (degraded) (Color figure online)
