UAV-BASED STRUCTURAL DAMAGE MAPPING – RESULTS FROM 6 YEARS OF RESEARCH IN TWO EUROPEAN PROJECTS

N. Kerle ^{a,*}, F. Nex ^a, D. Duarte ^a, A. Vetrivel ^b

^a Faculty of Geo-Information Science and Earth Observation (ITC), University of Twente, 7500 AE Enschede, The Netherlands - (n.kerle, f.nex, d.duarte)@utwente.nl

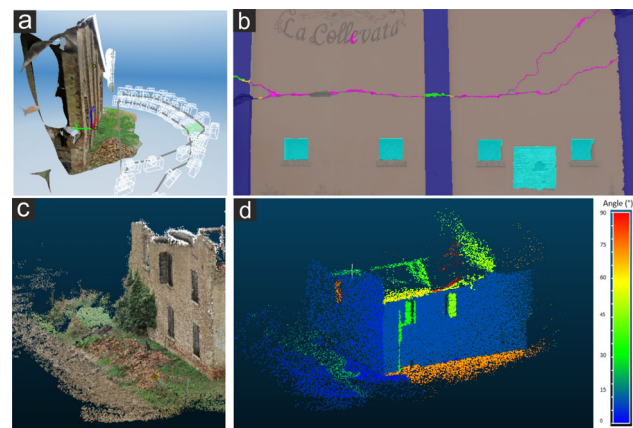
Figure 1. Damages identified from UAV-derived point clouds and from OBIA processing. (a) inclination in walls, (b) openings (turquoise), cracks (magenta) and damage crossing beams, (c) and (d) detailed point cloud and segment orientation angles (adapted from Fernandez Galarreta et al. 2015)

The earliest attempts to use UAV data in RECONASS were based on segmentation- and texture-based analysis of mono-temporal imagery. Fernandez Galarreta et al. (2015) processed multi-perspective UAV imagery of an 2012 Emilia Romagna (Italy) earthquake site into detailed 3D models. Those were analysed for geometric damage indicators such as slanted walls or deformed roofs, as well as presence of debris piles (Figure 1). In addition object-based image analysis (OBIA) was carried out on the images to extract damage features such as cracks or holes, but also identification of those damages intersecting with apparent load-carrying structural elements. In recognition of the diversity and ambiguity of the observed damage patterns the work did not aim at automatic damage classification, except in cases where the 3D model clearly showed complete collapse (D5 on the European Macroseismic Scale 1998, EMS-98; Grünthal 1998). For all other cases the geometric and image-derived information was combined to produce a detailed damage score per façade, and in turn per building.

The work of Fernandez Galarreta et al. demonstrated the significance of geometric information, in particular of openings. Vetrivel et al. (2015a) advanced the work by developing a method to isolate individual buildings from a detailed image-derived point cloud covering a neighbourhood of Mirabello (Italy) comprising nearly 100 buildings. Each of those was then subjected to a search for openings attributable to seismic damage, such as partial roof collapses or holes in the façades. The gaps were identified based on the Gabor wavelets as well as a histogram of gradient (HoG) orientation features. Two basic machine learning algorithms, Support Vector Machine (SVM) and Random Forest, were used to identify damaged regions based on the radiometric descriptors, with a success rate of approximately 95%. However, in particular the segmentation of point clouds is frequently hindered by artefacts and data gaps. Therefore, we also developed an approach to project initial point cloud-derived 3D segments into image space, with a segmentation using both geometric and radiometric features yielding more accurate and complete building segments (Vetrivel et al. 2015b). Given that video-data are often the first acquired dataset of a disaster scene, be it by the police or news media, we also showed how also lower-quality video data can be analysed for damage with computer vision and segmentation methods (Cusicanqui et al. 2018).

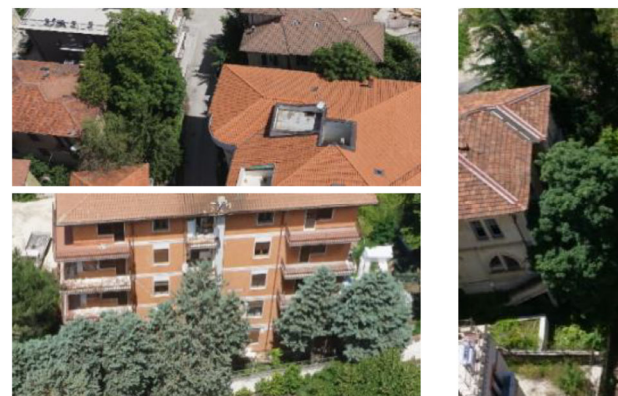
Figure 2. Problems for image processing posed by shadow and occlusion (Duarte et al. 2017).

Our contribution to RECONASS and INACHUS was centred on the use of highly detailed UAV images that provide views on all exterior parts of the surveyed buildings. Earlier work had shown how highly variable the expression of structural damage is in vertical and oblique data (Kerle and Hoffman 2013). The former essentially only considers the damage expressed in the roof, and in addition makes use of proxies such as debris piles for specific shadow configurations (for a recent review of those proxies see Ghaffarian et al. 2018). Significant additional information is also encoded in the façade information, as already explained in section 2.1. However, the OBIA-based approach tends towards overfitting and lacks the efficiency and transferability of deep learning. While a focus on façades is appealing, their actual delineation in imagery poses its own challenges, especially when considering aspects such as occlusion or environmental effects such as shadows (Figure 2).

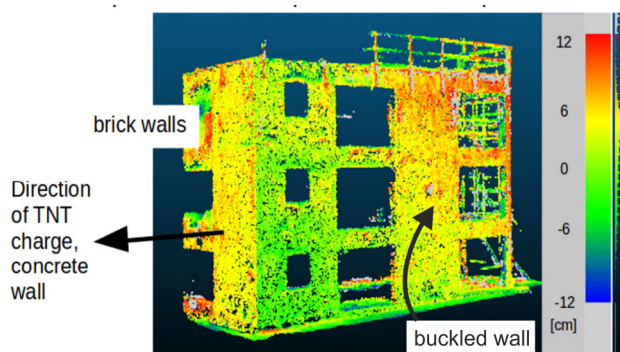
Figure 3. UAV-derived point clouds of reinforced concrete structure with brick in-fill walls subjected to exterior and interior detonations. Openings, cracks and debris piles were automatically detected, and also subtle deformation in the façades were detected.

Both RECONASS and INACHUS included a number of pilot experiments, where first individual components or sets thereof, and later the entire systems were tested under relatively realistic conditions. For the already mentioned explosion experiments in Sweden we acquired data using a Aibot X6 Hexacopter carrying a Canon D600 camera with a Voigtlander 20 mm lens. In addition to reference data images were acquired after both the exterior and the interior blasts, with a ground sampling distance (GSD) of approximately 1.5 cm. From those images detailed 3D point clouds were calculated and analysed. The data proved suitable to identify damage-related openings, such as infill walls damaged or blown-out by the blasts, as well as cracks and debris. Additionally, subtle façade deformations could be detected and quantified (Figure 3). It was also shown how a BIM model of the structure in 3D CityGML format could be automatically updated, both to visualise and catalogue detailed damage information. THW deployed a LEICA TM30 total station to survey the structure from 4 reference points, using 16 prisms mounted on the structure. While the total station has the advantage that a structure can be continuously monitored for minute deformations – critical when rescue personnel operates near or within weakened structure – the UAV-derived data provided damage data of comparable quality, with greater flexibility and lower cost, including the roof that ground-based surveys cannot see, and potentially operated from a safer distance. The building was further surveyed by a Riegl VZ400 terrestrial laser scanner, which also confirmed the high quality of the UAV-derived 3D models.

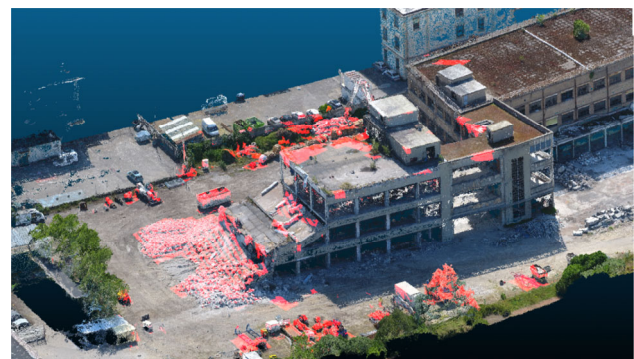
Figure 4. Point cloud representation of an INACHUS pilot structure in Lyon, France, calculated from optical imagery acquired with a low-cost commercial drone (Phantom 4, DJI), showing damage detected through machine learning (red).

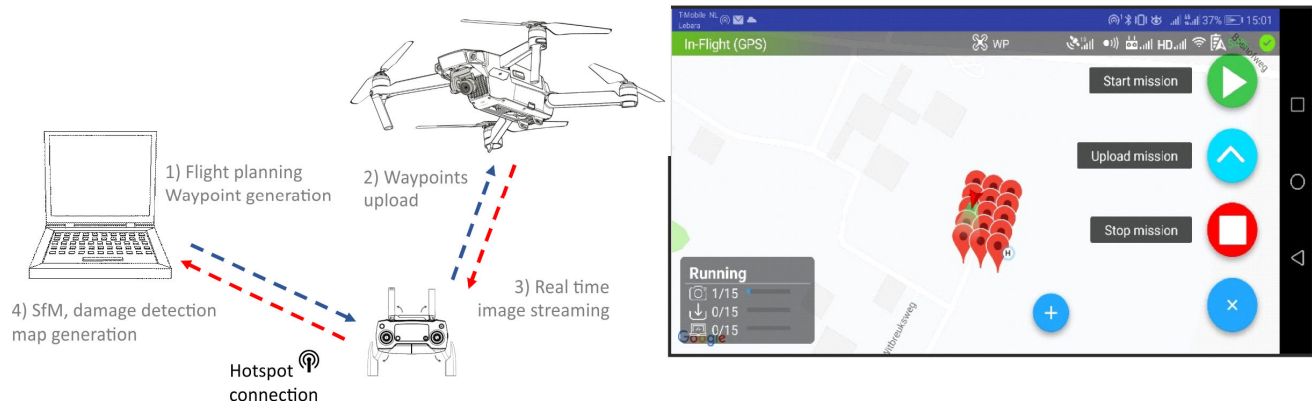
Figure 5. Work flow of the app developed for real-time damage mapping. Images are streamed to a laptop computer and processed immediately after acquisition. A CNN-based damage detection algorithm is applied, and a progressively built 3D model is used to orthorectify them. By the time the UAV lands an orthomosaic displaying the damage is finished.

While commercial UAV by DJI and other makers have clearly reached high levels of cost-benefit, stability and reliability, most are also not designed to be survey-grade instruments working in real time. For rapid search & rescue support it is vital to provide usable information quickly. For that reason we also developed a procedure to process the data with minimal delay. The Mavic Pro allows images to be streamed during flight, which means that we built a procedure that (i) downloads images right after acquisition, (ii) builds a progressively extended 3D model of the scene using established structure from motion (SfM) methods, (iii) applies the machine learning algorithm to detect damage, and (iv) orthorectified the images using the 3D model. By the time the UAV lands after a maximum flight duration of about 25 minutes all processing is done and the damage map available. We built a smart phone app that allows this procedure to be executed together with a standard laptop (Figure 5). Details about the app and data processing workflow can be found in Nex et al., (2019).
