The Vulnerability of Damaged River and Lake Dikes for Wave Overtopping

Vera M. van Bergeijk^{1,a}, Vincent A. Verdonk^{1,2}, Jord J. Warmink¹ and Suzanne J.M.H. Hulscher¹

Abstract. Wave overtopping results in erosion of grass-covered flood defenses which can result in a dike breach. Damages to the dike cover decrease the cover strength and simultaneously increase the hydraulic load on the dike cover. Therefore, damages on the dike cover are vulnerable locations for wave overtopping failure. In this study, the failure probabilities of different types of damages are calculated and compared to the failure probability of a regular dike profile to determine the vulnerability of damages for wave overtopping. The method is applied to a river and lake dike where the model results show that the total failure probability is smaller on the crest and upper slope for the lake dike and higher on the lower slope and at the inner toe. The failure probability increases between a factor 4 and 14 for damaged location where the cover still contains grass vegetation. However, lake dikes are more vulnerable for damages compared to lake dikes in cases where only a bare clay cover is left. In that case,

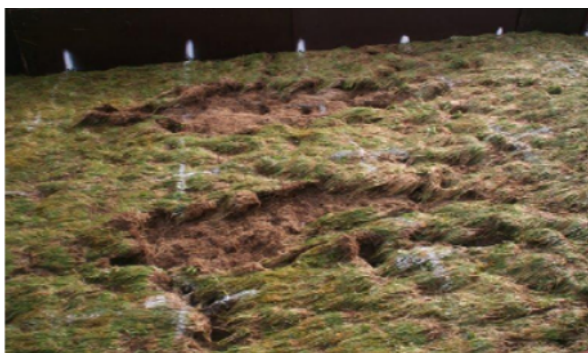
Figure 1. Example of a damage of the dike cover as the result of wave overtopping (Van der Meer et al., 2010).

up or bulging (Le et al., 2017; Van der Meer et al., 2010). Animal burrows decrease the dike cover strength while the grass vegetation is often removed near erosion holes so only the clay cover remains to protect the dike for a breach (Figure 1).

Damages affect the wave overtopping failure probability due to two processes. Firstly, the damage to the dike cover results in (partial) removal of the grass vegetation reducing the cover quality and therefore the critical velocity (Figures 1 and 3). Secondly, a vertical cliff forms at the damage resulting in the formation of a jet that impacts in the impact zone (Figures 1 and 3). The jet increases the hydraulic load on the dike cover in the impact zone. Both processes can result in more erosion and thereby increase the vulnerability of damages for wave overtopping failure.

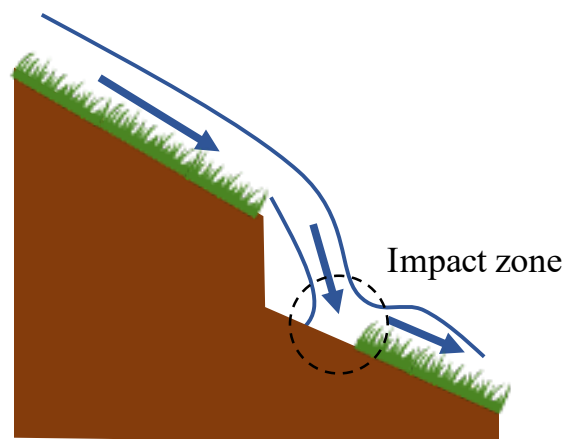
Figure 3. Damages on the inner slope lead to (partial) removal of the grass cover and a vertical cliff. Flow over the vertical cliff results in the formation of a jet that impacts in the impact zone indicated by the black dashed circle.

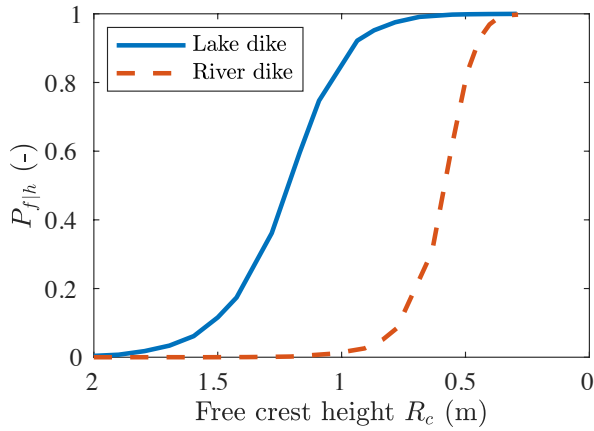
Figure 4. The conditional failure probability $P_{f,h}$ at the inner toe as function of the free crest height R_c for the lake and river dike.

The fragility curves show the failure probability conditional to the water level $P_{f|h}$ as function of the free crest height R_c , defined as the height difference between the water level and the dike height. A steep fragility curve means that the failure probability has a high predictability (Marijnissen et al., 2019). In this study, the steepness is related to the amount of wave overtopping. Since the waves on a river are relatively small, overtopping only occurs when the water level is sufficiently high. The waves on a lake are higher and wave overtopping is also possible for smaller water levels.

The conditional failure probability of the lake dike is higher compared to the river dike for a free crest height. The average overtopping discharge at a specific free crest height is larger for a lake dike compared to the river dike, because the waves are higher on the lake due to a larger fetch length. The higher overtopping discharge leads to

more and large overtopping waves which increases the load on the dike cover and thereby the dike is more likely to fail.

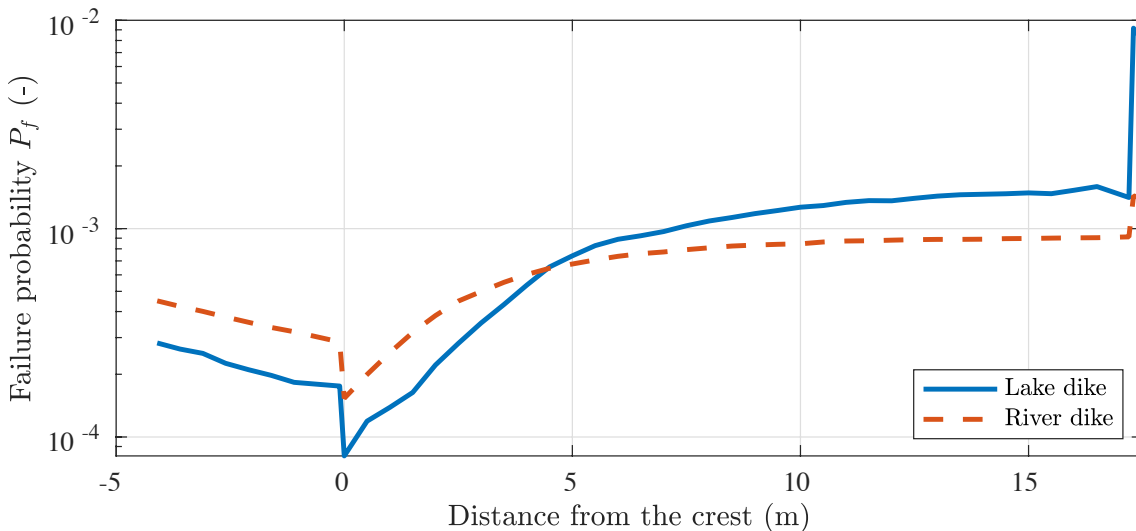
Figure 5. The cross-dike failure probabilities for the lake and river dike for an average grass quality.

The cross-dike failure probability decrease on the crest because of friction and increase on the inner slope due to gravitational acceleration (Van Bergeijk et al., 2019) (Figure 5). The sudden jumps in the failure probability at the end of the crest and the end of the inner slope are related to the variation in the turbulence parameter, which is smaller for the slope compared to the crest and inner toe (Section 2.2). Although the conditional failure probabilities are higher for the lake dike, the total failure probability is smaller on the crest and upper slope compared to the river dike. This is related to the probability distribution of the water level, the high water levels corresponding to small free crest heights have a lower probability of occurrence for the lake dike compared to the river dike.

The lake and river dike are both most likely to fail at the inner toe with a failure probability of $9.2 \cdot 10^{-3}$ and $91.4 \cdot 10^{-3}$, respectively. The increase in the failure probability on the slope is larger for the lake dike, because

the larger overtopping waves accelerate more on the inner slope. This is related to the bottom friction, which has a relatively larger effect on smaller waves compared to larger waves (Van Bergeijk et al., 2019).

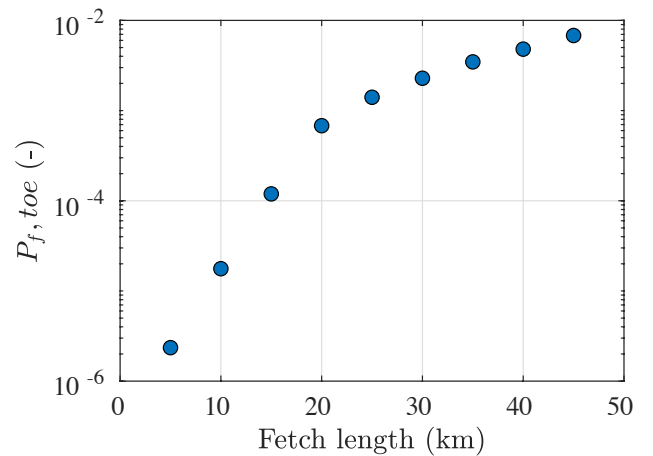
Figure 6. The effect of the fetch length on the failure probability at the inner toe $P_{f,toe}$ for the lake dike with an average grass quality.

The failure probability increases with the fetch length from $2.4 \cdot 10^{-6}$ for a fetch length of 5 km to $6.8 \cdot 10^{-3}$ for a fetch length of 45 km (Figure 6). This shows that the fetch length has a large influence on the failure probability. The failure probability is especially sensitive for the fetch length for small fetch lengths. The failure probability increases with almost a factor 10 when the fetch length increases from 5 to 10 km, but increase only 30% from a fetch length 40 km to 45 km which is usually within the error range of the failure probability.

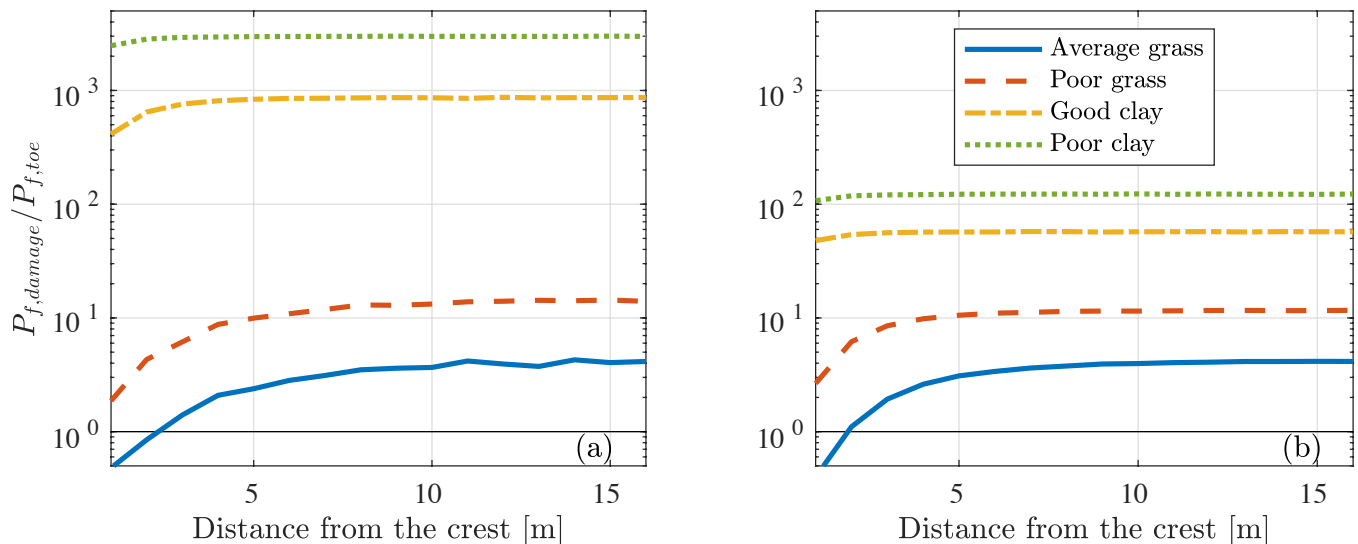
Figure 7. The ratio $P_{f,damage}/P_{f,toe}$ along the inner slope with $P_{f,damage}$ the failure probability of a damaged location for the four cover qualities and $P_{f,toe}$ the failure probability at the inner toe for a good grass cover for (a) the lake dike and (b) the river dike.

The ratio between the failure probability of a damage and the inner toe shows that a damage is more likely to fail except for a damage on the upper slope with an average grass quality (Figure 7). The failure probability is higher for a damage on the lower slope compared to a damage on the upper slope due to the higher flow velocity at the lower slope.

The vulnerability of damages with a poor and average grass quality is similar for a river and lake dike where the ratio is of the same magnitude (Table 3). However, damages with a solely a clay cover are more vulnerable on a lake dike compared to a river dike where the ratio is much higher for the lake dike. Small overtopping waves are already able to erode clay due to the low critical velocity (Table 2) and the erosion rate of clay is larger compared to grass, which means that the erosion depth of 20 cm for clay is reached with a small number of overtopping waves (Verheij et al., 1995). The fragility curve shows that significant wave overtopping start for the lake dike at already around a free crest height of 2 m compare to a free crest height of 1 m for the river dike. Therefore, the clay covers are likely to fail for a wide range of free crest heights ($R_c < 2$ m) resulting in a high failure probability.
