17 **Abstract**

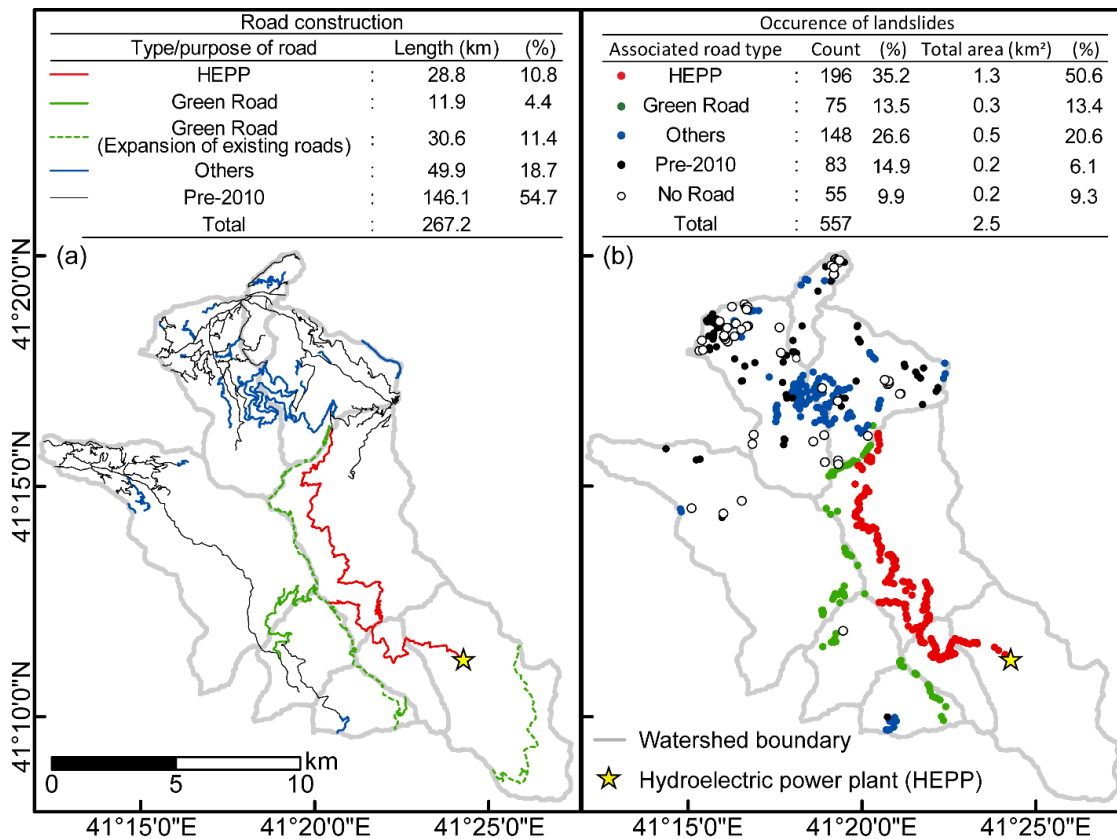
203
 204 **Figure 3.** Maps showing the distribution of (a) the roads constructed for different purposes and
 205 (b) the associated landslides.

196 We identified the roads associated with “HEPP” and “Green Road” projects (Fig. 3a) based on
 197 information from our local contacts and interviewees. They informed us about other expansion
 198 work conducted along the route of the Green Road project. We could not identify the time of
 199 these expansions, but we know the sections where the engineering work was carried out. We
 200 labelled the roads that already exist as of January 2010 as “Pre-2010” based on our analyses of
 201 satellite scenes. We labelled the rest of the roads constructed after 2010 as “Others”. Based on
 202 the identified roads, we also labelled corresponding mass movements (Fig. 3b).

206 To create these road and landslide inventories, first, we mapped both roads and landslides
 207 associated with HEPP (Fig. 3). Mapping landslides was particularly challenging because of the
 208 short-term interactions between mass movements and engineering activities. Specifically, local
 209 people indicated that the excavated hillslope materials were mostly dumped into the river
 210 channels during the construction, and also down the slope of the road cut. This may have also
 211 induced some landslides further down the hillslope because of the additional load. Notably, this

294 We mapped 557 mass movements and a 267.2 km long road network. Overall, 33.9% of the
 295 roads were developed during the last 10 years, for various purposes (see Fig. 3a). Among them,
 296 10.8% is associated with the *HEPP* project and 4.4% is related to the *Green Road* project. Also,
 297 some of the existing roads have been extended in relation to the *Green Road* project and this
 298 contribution refers to 11.4% of all roads in the study area. Moreover, 18.7% of the roads
 299 constructed after 2010 are not directly associated with the *HEPP* nor the *Green Road* projects,
 300 but some indirect connections could exist (*Others*).

301 We also examined mass movements in relation to road work. Our findings show that 90.1% of
 302 them occurred after 2010 while being in immediate proximity to the roads (Fig. 3b). As for the
 303 cumulative area of mass movements, the anthropogenic influence is also significant: 90.7% of
 304 total size is associated with road constructions. Roads constructed as part of the *HEPP* project
 305 has the most substantial contribution to mass movements occurrences. In the study area, 1.3 km²
 306 of mass movements were solely caused by the *HEPP* project, which refers to 50.6% of the total
 307 size identified in the study area. During the last 10 years, 9.9% of landslide occurred with no
 308 direct relationship with roads. In terms of total size, the influence of these landslides constitutes
 309 9.3% of the total area of mass movements. This static summary is complemented below by
 310 examining the variation in both road construction and landslide occurrence on a temporal basis

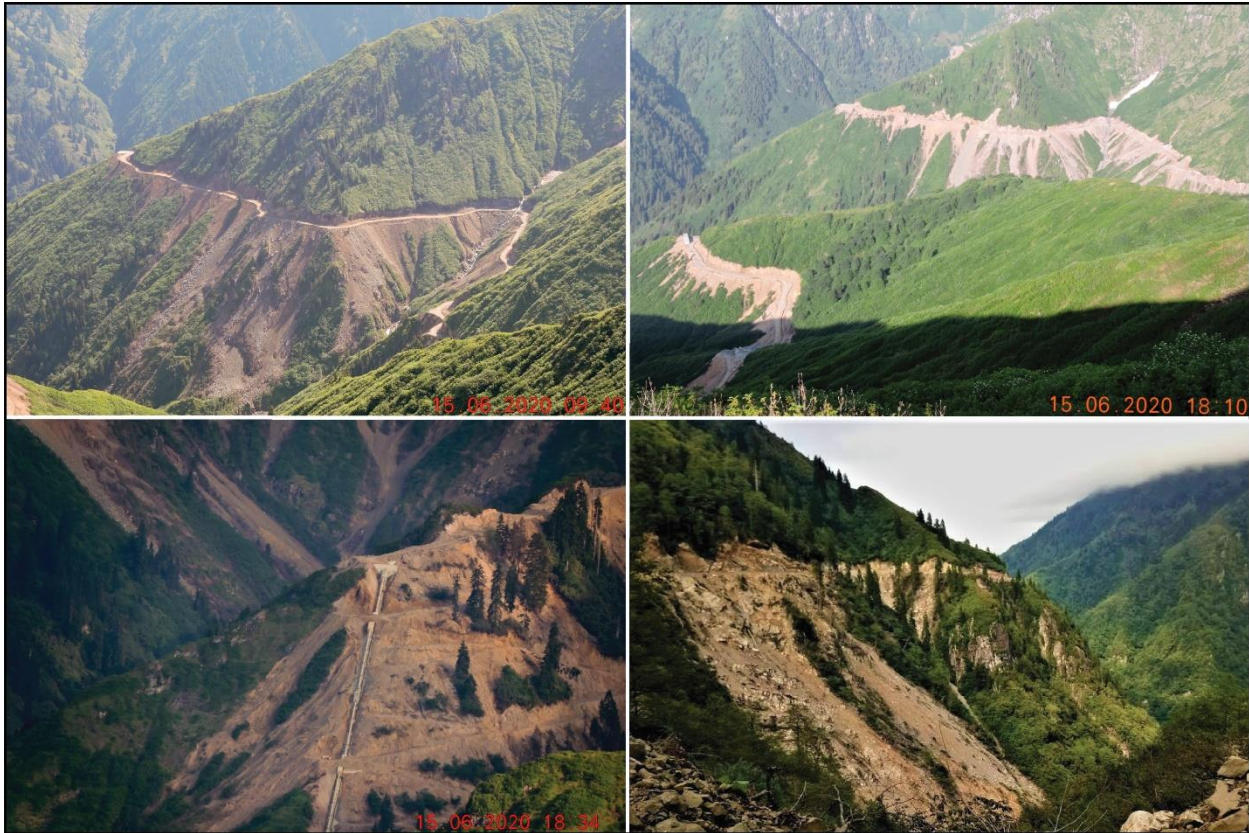
233
 234 **Figure 5.** Photos showing the mass movements on hillslopes associated with road constructions
 235 of *HEPP*. The photos were taken on 15th June 2020 (Photographs courtesy of Hasan Sıtkı
 236 Özkazanç).

228 Local interviews also emphasized that the road construction carried out for the *HEPP* project has
 229 dramatically affected the natural course of erosional processes since 2016 (Fig. 5). They argue
 230 that explosives were used in some parts of the road construction to facilitate the progress of the
 231 project. This most likely weakened the shear strength of hillslope material, increasing the
 232 landslide susceptibility of the given site and promoting the failures we noted.

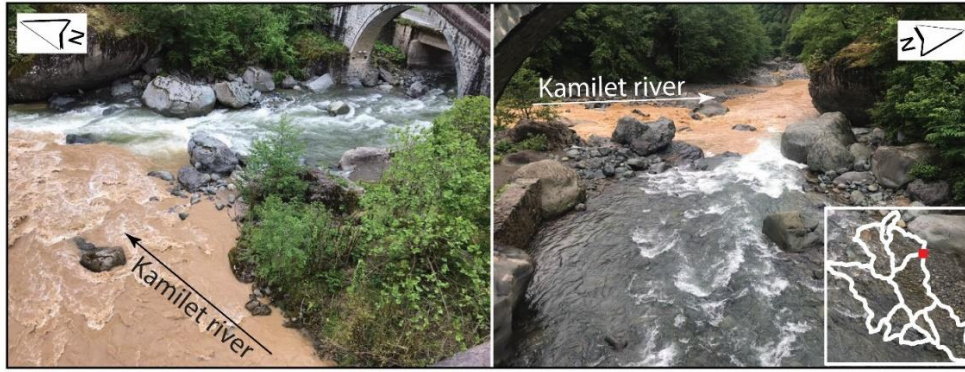
245 **Figure 6.** Photos showing the intersection of Kamilet and Durguna Rivers ($41^{\circ} 16' 34''$ N and 41°
 246 $22' 32''$ E) where increased sediment content in Kamilet River caused by the *HEPP* construction
 247 is evident. The pictures were taken in May 2020. Location of this spot is given in the lower right
 248 of the panel (b) (Photos by Hasan Sıtkı Özkazanç).

237 Overall, the differentiation between dumped materials and human-induced landslides is
 238 challenging. Regardless, these processes initiate additional anthropogenic sediment loads to
 239 river channels. The local environmental organizations (*Arhavi Doğa Koruma Platformu*)
 240 provided evidence to this claim in an early 2020 report where an increased sediment content was
 241 noted in the Kamilet River (Fig. 6). Therefore, in this study, we did not differentiate the dumped
 242 hillslope materials and landslides; instead, we considered them all as human-induced mass
 243 movements.

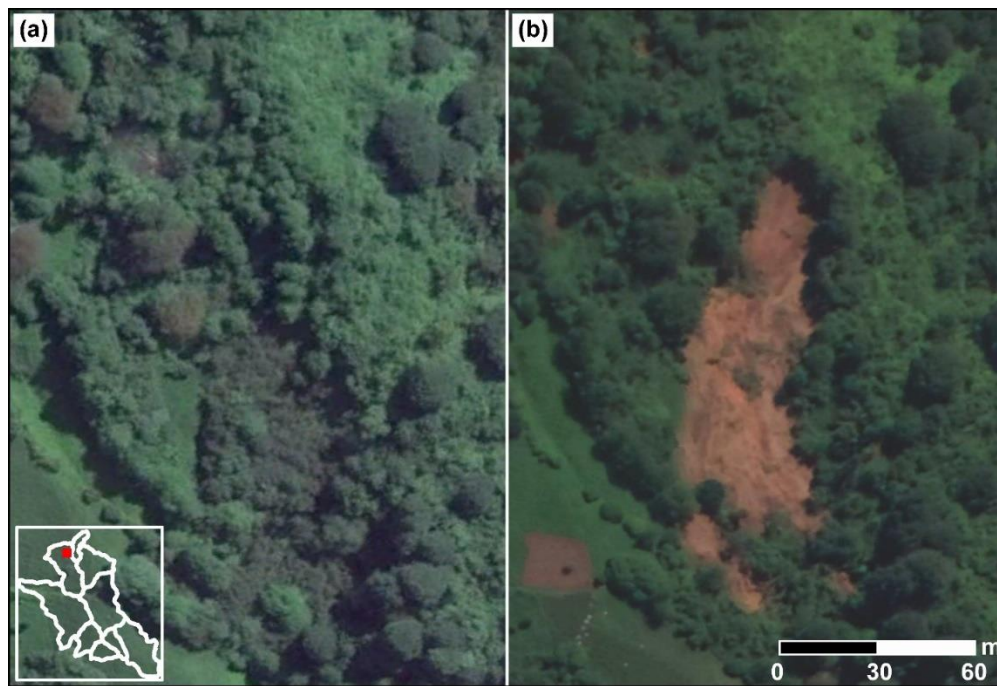
288
 289 **Figure 10.** Google Earth scenes showing the pre- and post- landslide landscape at a selected site
 290 ($41^{\circ} 18' 20''$ N and $41^{\circ} 17' 58''$ E) representing the mass movements triggered by natural agents

291 (i.e., *No Road*). The landslide occurred between 17th July 2016 – 9th September 2016. The
 292 location of the landslide is given in the lower left of the panel (a).

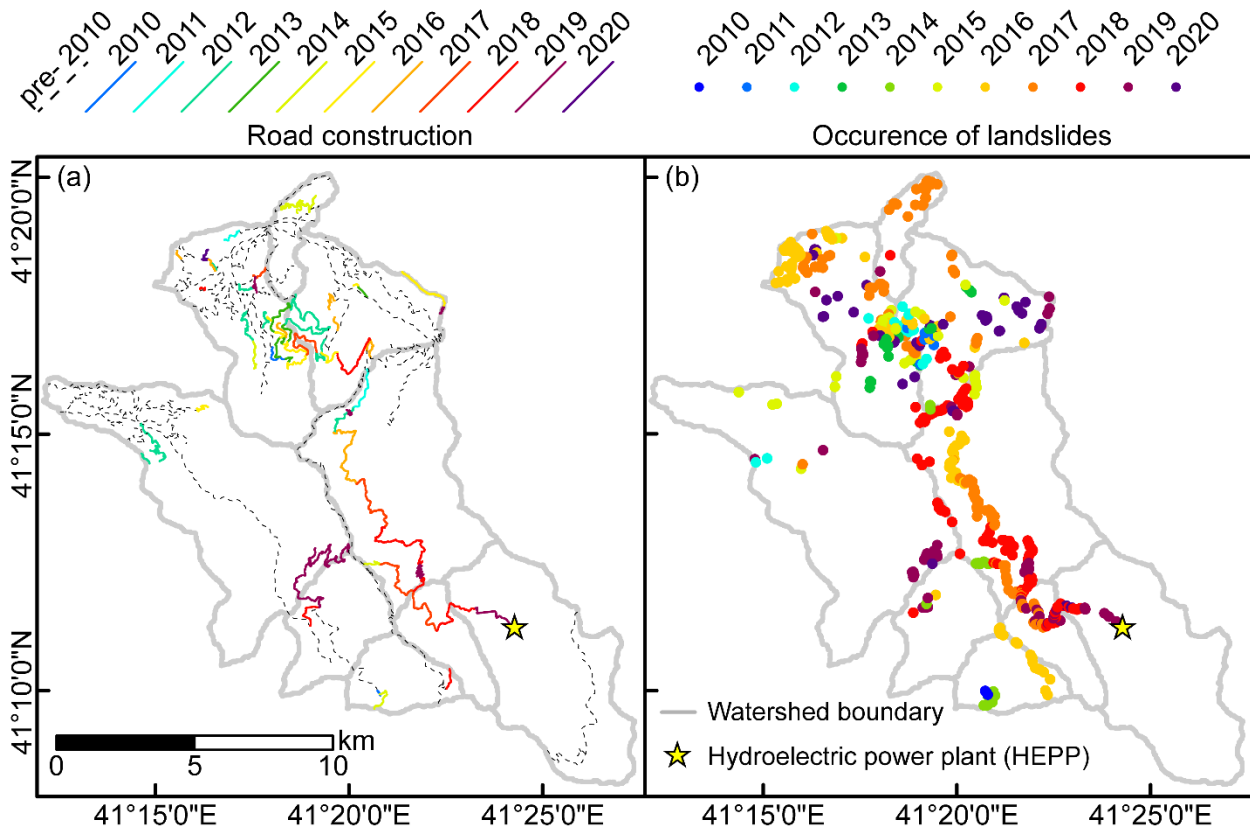
323
 324 **Figure 11.** Maps showing the temporal evolution of (a) the roads and (b) the associated
 325 landslides.

311 (Fig. 11 and 12). We noticed a peak value in road construction in 2012. However, the peak in the
 312 constructions does not correspond to a significant number of landslides. This is mainly because
 313 of the morphologic conditions encountered through the route. In fact, most of the roads we
 314 mapped between 2011 and 2012 are associated with roads categorized as *Others*. The mean slope
 315 steepness observed through these roads is 23°, which is lower than mean steepness encountered,
 316 for instance, through the roads associated with the *HEPP* project (33°) (Fig. 12). This is also the
 317 case for two other categories (i.e., *Pre-2010* and *Green Road*). They both cross relatively smooth
 318 topography compared to the *HEPP* project. Specifically, the *Green Road* project mainly follows
 319 the existing old road path, which passes through ridges (Fig. 3a). Therefore, a predominant part

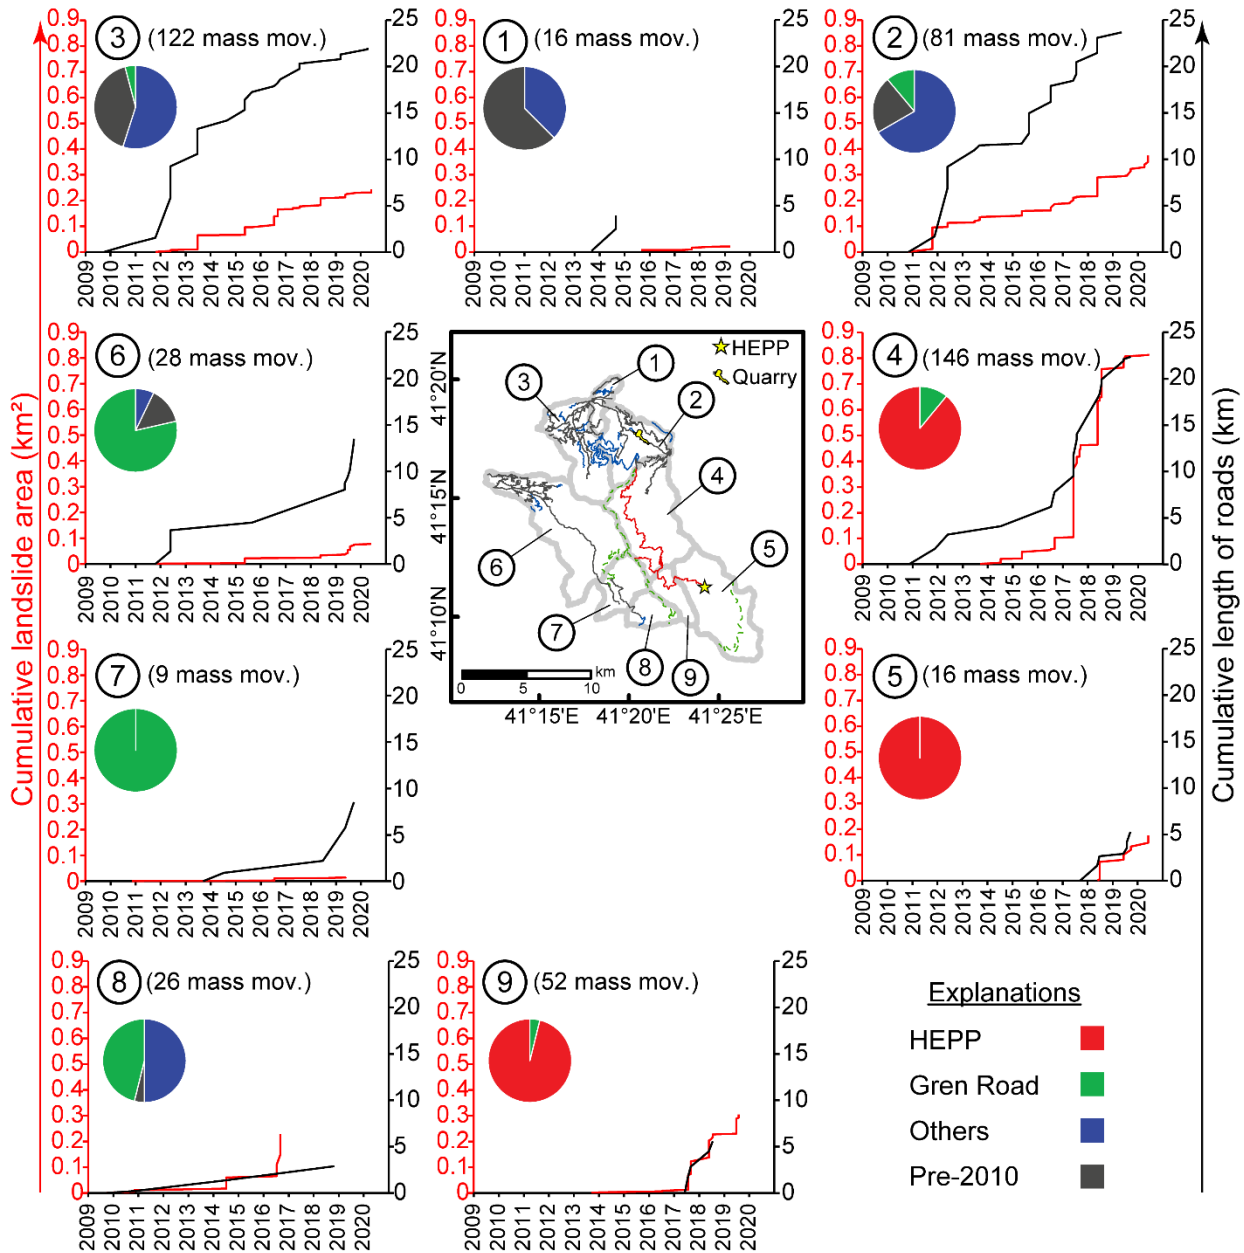
362 **Figure 14.** Figure showing the temporal evolution of both roads and landslides within each
 363 catchment from 2010 to June 2020. Catchments 2, 3 and 4 appear as hydrological units exposed
 364 to the highest road construction and consequently, the largest number of mass movements.

345 We also examined how the road constructions evolved after 2010 in each catchment and,
 346 consequently, how this affected the occurrences of mass movements per hydrological unit.
 347 Figure 14 shows the summary of this temporal evolutions. For this analysis, we excluded the
 348 naturally occurring landslides. Our findings show that if there is no significant road construction,
 349 the number of mass movements is relatively low. For instance, catchments 1, 2, 3 and 4 are
 350 adjacent catchments. Among them, catchment 1 is the only hydrological unit where the total
 351 length of constructed roads in the last 10 years is less than 5 km. The associated total landslide
 352 size in catchment 1 is 0.02 km², whereas, in the three other catchments (2,3 and 4), it ranges
 353 from 0.24 km² to 0.82 km². We observed a similar situation in catchments 5, 8 and 9, where we
 354 identified a relatively low amount of road constructions (<~5 km) associated with a limited

355 number of landslides (Fig. 14). In catchments 6 and 7, the total length of the road (~10 km) is in
 356 between two other sets we mentioned above, but we identified 28 and 9 landslides in these
 357 catchments. These roads are mostly associated with the *Green Road* project and thus the limited
 358 number of landslides is most likely because of the steepness of the route followed during the
 359 construction (Fig. 13).

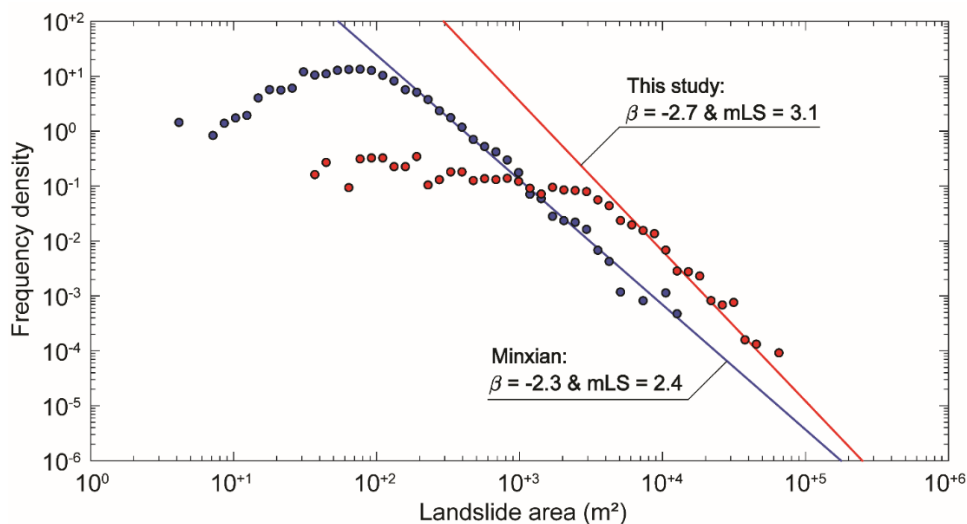
508
 509 **Figure 19.** Frequency-density curves plotted for the landslides associated with roads in our study
 510 area (red) and landslide triggered by the 2013 Minxian earthquake (blue). Power-law exponents

511 (β) were calculated based on the method proposed by Clauset et al. (2009), whereas power-law
512 fits and landslide-event magnitudes were identified based on Tanyaş et al. (2018).

490 The comparison between the frequency-density distributions of the human-induced landslides we
 491 mapped and those naturally triggered by the 2013 Minxian earthquake shows that larger
 492 landslides were triggered in our Turkish site (Fig. 19). The power-law exponents calculated for
 493 both our inventory ($\beta=-2.7$) and the Minxian inventory ($\beta=-2.3$) are close to each other and align
 494 well with distributions documented in the literature. In fact, power-law exponents of naturally
 495 occurred landslide inventories fall in the range 1.4–3.4, with a central tendency 2.3–2.5 (Stark &
 496 Guzzetti, 2009; Tanyaş et al., 2018; Van Den Eeckhaut, Poesen, Govers, Verstraeten, &
 497 Demoulin, 2007).

498 We also calculated the landslide-event magnitudes of our human-induced landslide inventory
 499 ($mLS=3.1$) and the Minxian inventory ($mLS=2.4$). The difference between the two cases are
 500 consistent with our initial assumption that if a similar earthquake occurred in our study area, it
 501 would be more disastrous. In fact, based on the empirical relation between earthquake magnitude
 502 (M) and landslide-event magnitude scale proposed by Malamud et al. (2004), the earthquake
 503 magnitude for an equivalent earthquake-induced landslide inventory would be 6.8. This shows
 504 how destructive the anthropogenic effect on geomorphological processes could be compared to
 505 natural processes. The destruction produced by the road constructions conducted in the last 10
 506 years is compatible with the possible effect of a theoretical earthquake with a magnitude greater
 507 than 6.0.
