# Quaternary International

## 8th century coastal uplift in Peninsular India – The Shore Temple at Mahabalipuram, Tamil Nadu

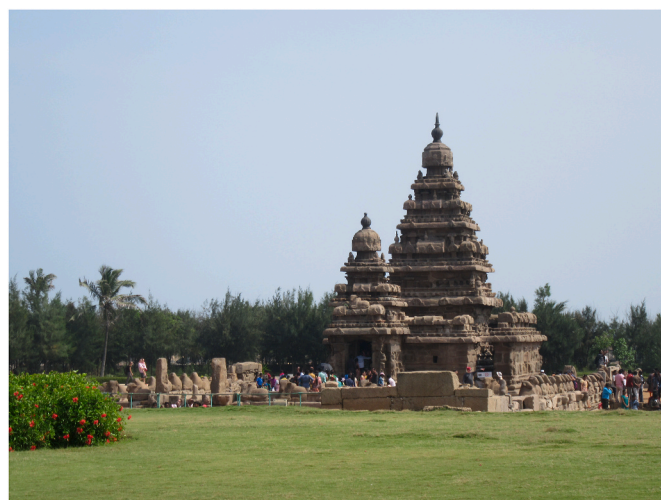
Fig. 2. The shore temple of Mahabalipuram, as seen from the southeast. View towards the Indian Ocean. The canal on Fig. 3 is between the lawn and the wall made of simple masonry. Archaeological DataBase photo #2155.

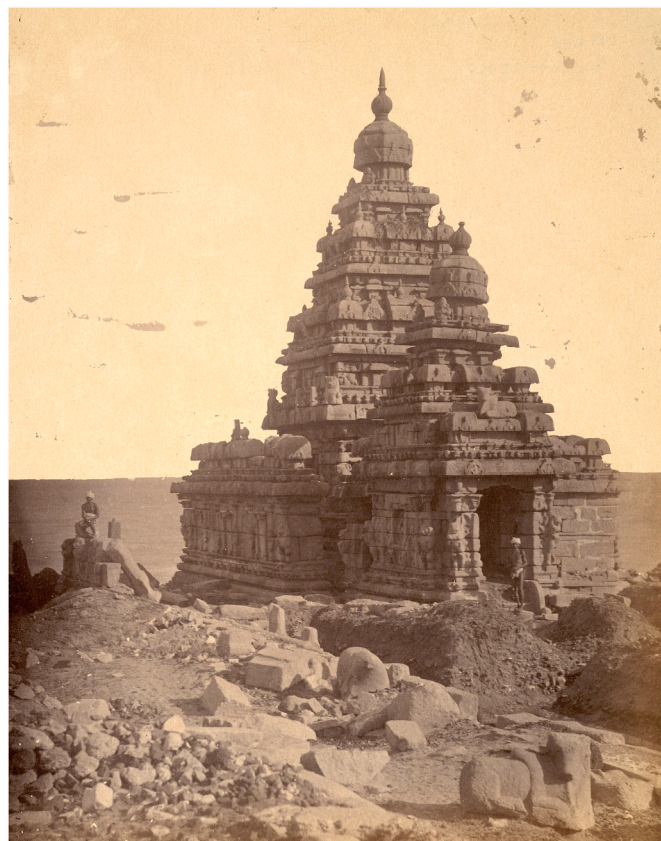
Fig. 3. Shifted blocks on top of shore temple: both are shifted towards the left, in the direction of the ocean, probably due to seismic shaking. Photographed in 1885. Intensity I = IX. [https://www.reddit.com/r/HistoryPorn/comments/85i2hs/the\\_shore\\_temple\\_8th\\_century\\_shiv\\_temple\\_built/](https://www.reddit.com/r/HistoryPorn/comments/85i2hs/the_shore_temple_8th_century_shiv_temple_built/) Accessed 20 July 2020.

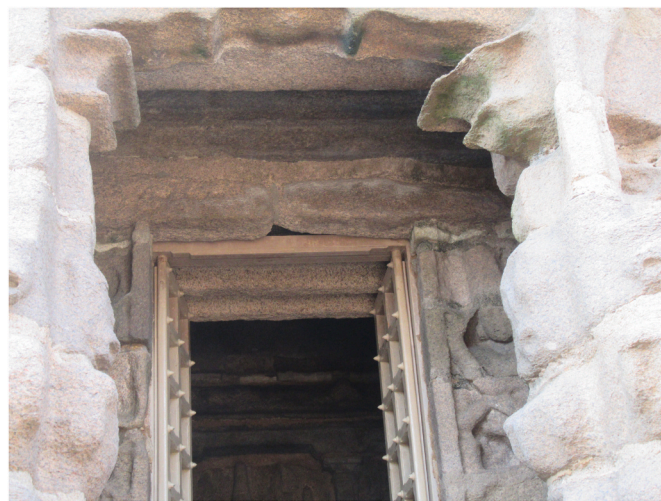
Fig. 4. Broken lintel on the west gate of the Shore Temple. ADB #2226. Penetrative fracture in masonry block. Intensity I = VII or higher. (Rodríguez-Pascua et al., 2013).

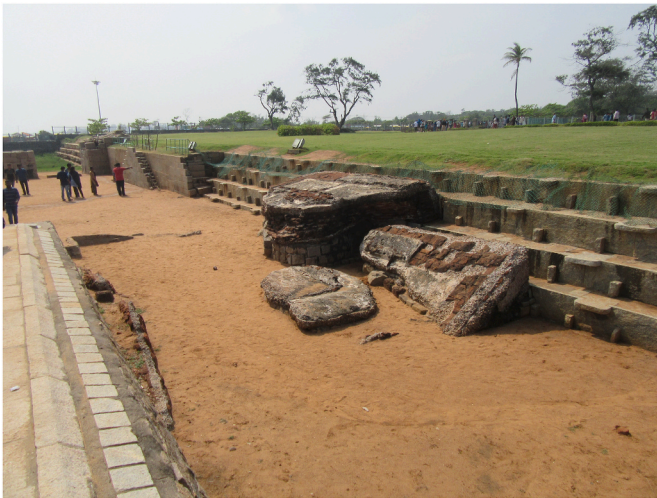
**Fig. 5.** Remnants of a construction postdating the Shore Temple. These were built while the sea canal was already uplifted to become part of land. Blocks are visible in various degree of tilting due to liquefaction of enclosing and underlying sand by seismic shaking. Much of masonry armour is modern restoration, overlapping the tilted walls. ADB #2166.

The sediment-filled canal, which separated the Shore Temple island from the mainland, is bordered by two stone walls. Heavily restored portions partly underlie and partly overlie various stone-and-brick masonry constructions. These walls and floors deviate from the vertical and

the horizontal, respectively (Fig. 5). This deviation, yielding up to 80° westward tilt for a former floor (Fig. 6), is a feature of subsoil liquefaction. It can happen during seismic shaking: increasing pore pressure separates grains in water-saturated sand, making it behave like fluid. Walls, heavier than water, tilt, overturn, and sink in the fluidized sediment (Khan-Mozahedy, 2015). This happened to the building(s) built on

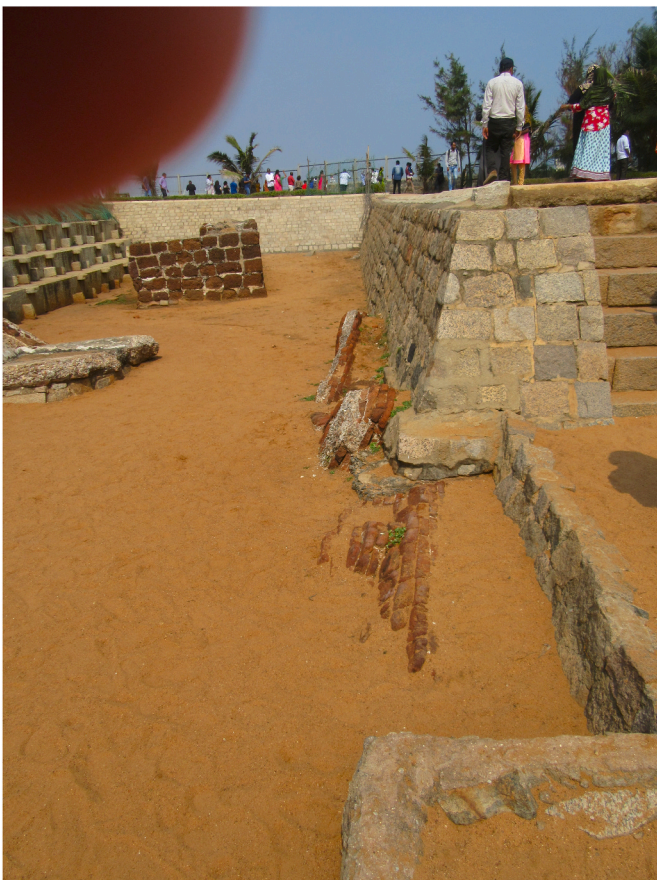
**Fig. 6.** Vertical layers of brick masonry wall, result of liquefaction of sandy soil due to seismic shaking. ADB #2173.

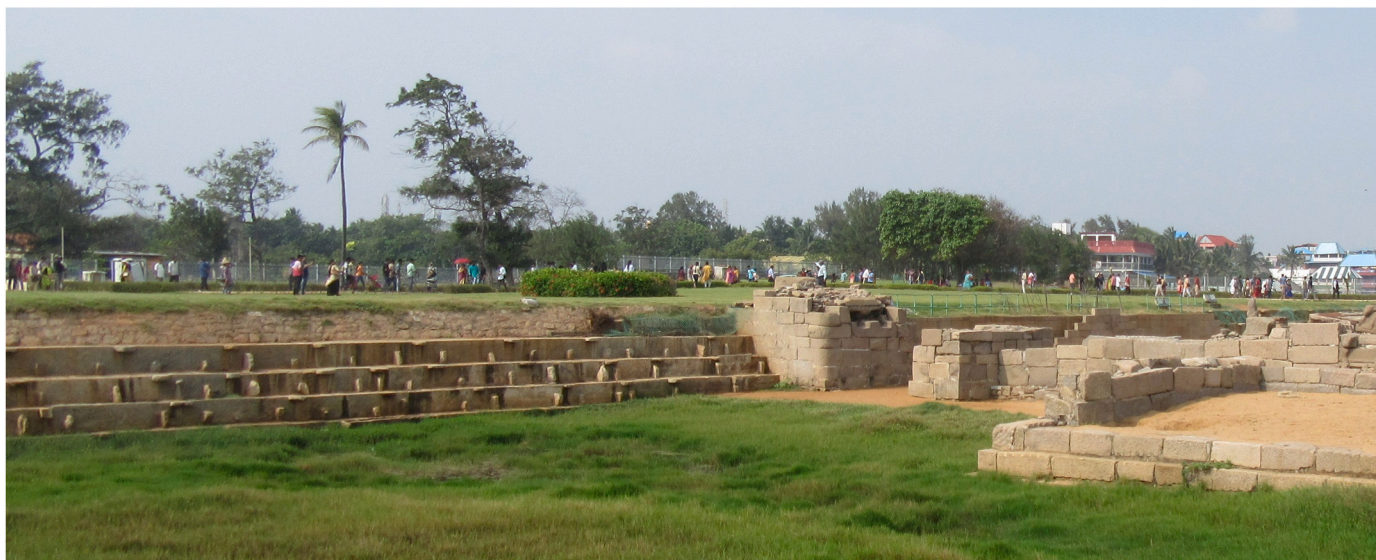
Fig. 7. Seawall protecting the shore (left). Bridgeheads of the ruined bridge (right) are above the canal surrounding the Shore Temple island. View to northwest. ADB #2212.

The canal which separates the Shore Temple island from the mainland is bordered by two walls: a modern, simple stone wall on the eastern, island side, and a complex, unusual, ancient wall on the landward side (Fig. 7). The latter rises to a height of up to 3.5 m. It was exposed in 20–25 m length, now extended by modern restoration. Further 150–200 m extensions southward and 150 m extension northward almost parallel to the seashore are known. Opinions on its purpose vary (summarized here after Sivaramamurti, 2006, pp. 81–83). Some say it was a wharf. We think that it would be impractical to be used in a port: a stepped wall rather hinders than facilitates easy loading and unloading of boats. Others say it was a bathing-ghat. However, it is too steep of easy and safe access to the sea by masses of pilgrims. Another idea is that it was a wall protecting the shrine from blowing sand. As dominant winds are from the northeast and southeast, sand is rather blown from the beach towards the land than in opposite direction.

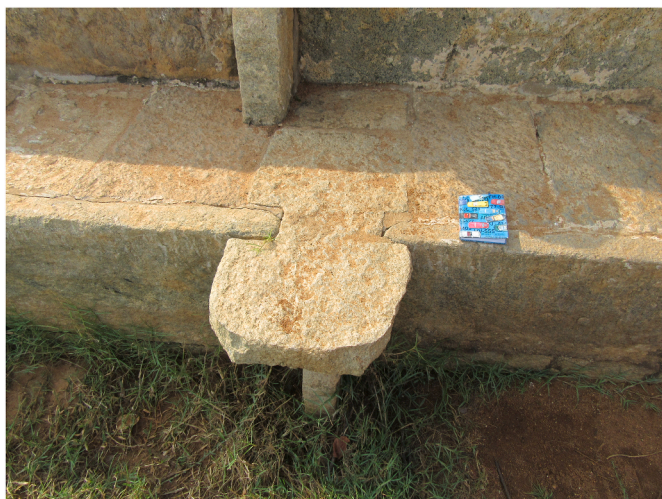
Fig. 8. Detail of masonry armour protecting the soft coast. Intricately carved blocks are tied together to resist suction force of retreating waves. ADB #2274.

Each hypothesis neglects the curious form of masonry blocks in the wall (Fig. 8). Blocks are rectangular, set vertically and horizontally to form a stepped surface. There are specially formed horizontal connecting blocks, extending beyond the vertical faces. Having lateral grooves on both sides (a kind of mortise-and-tenon joint) these fix the vertical blocks in the desired position, preventing any displacement out of the wall. This pattern of stones made the structure resistant to wave action, esp. to the suction of returning waves. We suggest that this was a seawall, erected to protect the coast from wave-induced retreat.

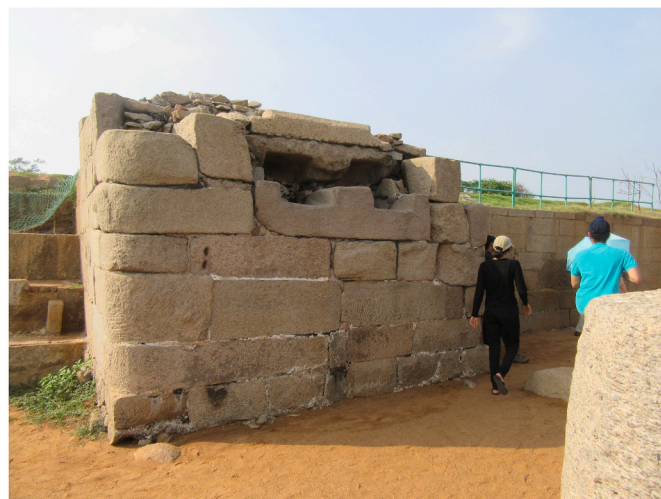
Fig. 9. Western bridgehead. Nests for two, massive stone beams are visible. The canal is never filled by the sea today. ADB #2271.

There are remnants of a former bridge, connecting the island to the mainland visible in the middle of the seawall. Two nests to hold former stone beams which connected two bridgeheads across the canal (Fig. 9) mark a sea level functionally at the same place as indicated by the elevation of the seawall. A bridge is a very rough sea-level marker.

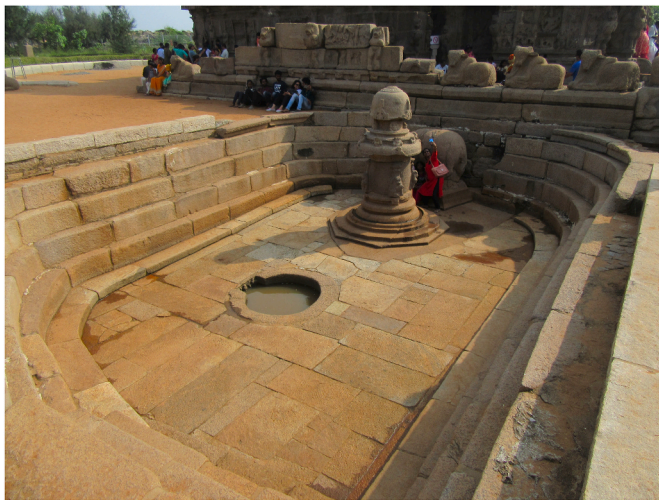
**Fig. 10.** Varaha well within the apsidal temple to the north of the shrine. Overlapping row of stairs indicate that the apsidal temple was built later than the shrine, after coastal uplift. Depth of the platform is 2.2 m below the shrine floor. ADB #2258.

There is another archaeological sea-level marker in the Shore Temple: there is an apsidal temple, including a holy well, adjacent to the main shrine (Fig. 10). Its floor is about 2 m below the temple floor. Water table was 20 cm deeper than the apsidal temple floor at the time of visit on 25 December 2018. Wells are water-level markers, both at the seaside (Vunsh et al., 2018) and at rivers (Mészáros and Serlegi, 2011). This Varaha well was built by King Rajasimha, attested by his inscribed name on the small shrine (Saxena, 2016). As this well is reaching the modern groundwater table, and the floor of the enclosing apsidal temple is only 20 cm higher, it means that both the apsidal temple and the well were built after the uplift, subsequent to the construction of the Shiva temples (Fig. 11). We disagree with the remark of Sivaramamurti (2006) that the Shiva temples were built in the last phase of construction. There would have been no need for a well in the absence of the adjacent temple.
