Evaluation and Damage Detection of Highway Bridges with Distinct Vulnerabilities

EVALUATION AND DAMAGE DETECTION OF HIGHWAY BRIDGES WITH
DISTINCT VULNERABILITIES

DOCTOR OF PHILOSOPHY

CIVIL ENGINEERING

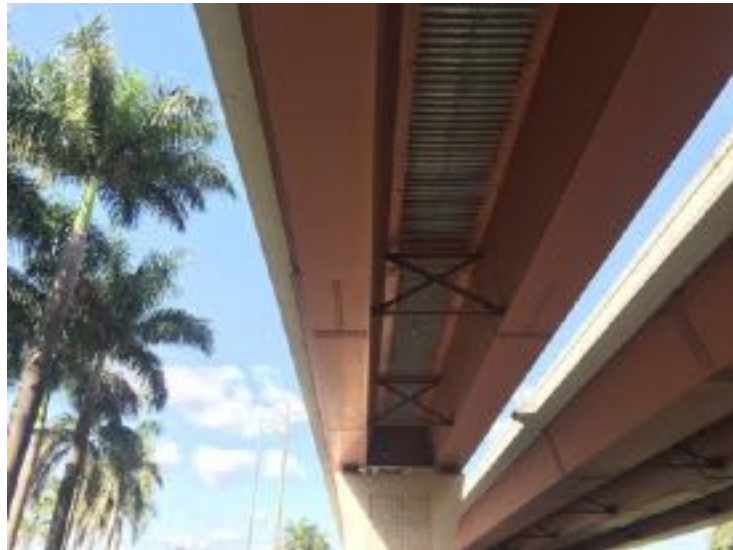
Figure 1-3. Twin steel box girder bridge classified as fracture critical.

In steel girder bridges, fatigue cracking is one of the most important phenomena affecting structural performance and integrity [7]. Development of fatigue cracking may lead in time to a full-depth fracture of one girder without noticeable bridge profile changes. It is critical to ensure that the bridge will have adequate capacity to prevent collapse until the next cycle of inspection discovers the damage. Investigations on the steel bridge collapses show that a failure in an individual member, known as fracture critical members (FCMs), could result in the total collapse of the structure [8]. The AASHTO Bridge Design Specifications [9] classify several types of bridges as fracture critical that require biennial arms-length in-service inspections, including twin steel box girder bridges (Figure 1-3) [10].

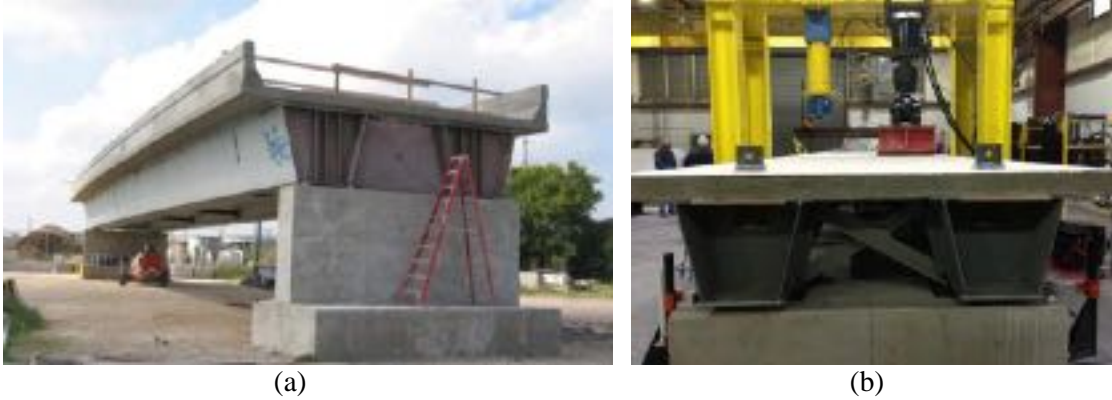
Figure 1-4. Twin steel box girder bridge tests; (a) University of Texas at Austin, (b) Florida International University.

Recent research results indicate that twin steel box girder bridges could be redundant because of their high torsional resistance even after a full-depth fracture of one girder. The most notable study is the series of full-scale tests carried out by the University of Texas at Austin [20–22] that demonstrated a high level of internal redundancy of twin steel box girder bridges even after a full-depth fracture in one of its girders (Figure 1-4(a)). A study on the twin box girder structures in the Marquette Interchange, through non-linear numerical analysis, also demonstrated the high level of internal and structural redundancy of twin steel box girder bridges [23]. Connor et al. [24] have recently developed a series of recommendations and requirements for twin steel box girder bridges to be considered non-fracture critical. The recent study conducted by Van Pham et al. [12] shows that the deck and intact girder together are able to provide stability and reserve load-resisting capability for twin steel box girder bridges even after a full depth fracture of one girder (Figure 1-4(b)). It was concluded that the railings, continuity, and external intermediate cross-frames could further improve the redundancy level in these bridges. Moreover, during the experimental tests, unzipping or progressive failure of shear studs was not observed in the bridge.

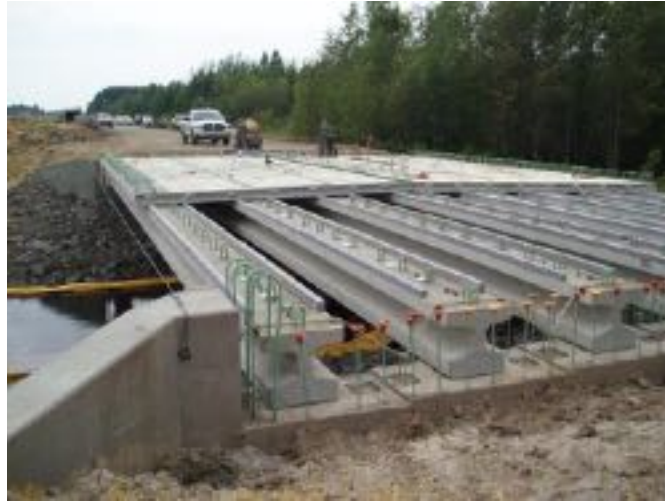
Figure 1-5. Prefabricated bridge system with transverse and longitudinal joints.

longer spans, the prestressed slab units are thickened, and tubular voids are added, known as side-by-side box-beam bridges, to reduce the self-weight of the superstructure. Moreover, transverse post-tensioning bars, usually at two locations along the span, are added to keep the precast bridge panels transversely in compression and avoid problems such as leaking, cracking, and spalling at the longitudinal joints.

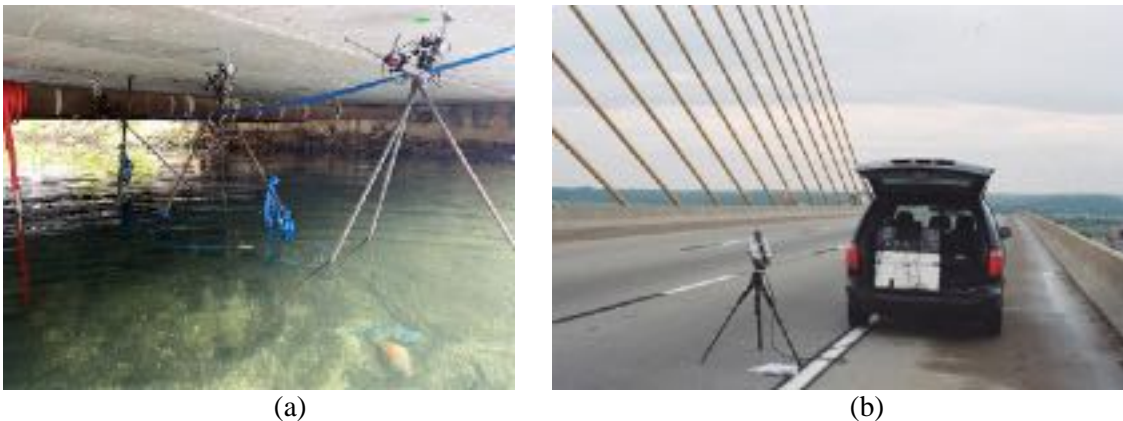
Figure 1-7. Structural health monitoring; (a) Sensor-based technique, (b) Remote non-contact sensor technique.

based SHM system typically has three major subsystems: a sensor (and wirings), a data acquisition, and a diagnosis subsystem. The diagnosis subsystem generally includes data processing, data mining, damage detection and can go further to expand to model updating and structural safety and reliability determination. The accuracy of results is largely dependent on not only the type and sophistication of the sensors and instruments but also on the variety, quantity, and quality of the measured data.

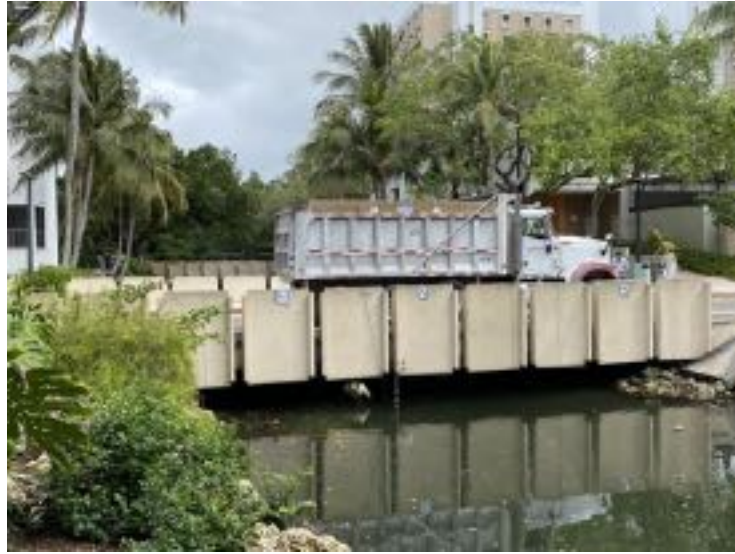
Figure 1-8. Non-destructive bridge load testing for the assessment of damaged bridges.

Non-destructive bridge load testing can also be used for the assessment of damaged or deteriorated in-service bridges [60,61] (Figure 1-8). The information obtained from load testing can be used to reduce uncertainties associated with actual bridge conditions, material properties, and assumptions made during the bridge design. This becomes even more effective when accurate information on design and construction is not available. The verification of the design assumptions can be carried out by comparing the measured structural response and the analytically determined response. Due to a large number of old bridges, interest in the use of non-destructive load testing has increased significantly in recent years to provide a better understanding of the bridge behavior in its actual condition. To date, this method is used for a variety of goals, such as providing better estimates for bridge load rating [62–64], bridge rating using system reliability assessment [65], transverse load distribution of existing bridges [66], redundancy evaluation of damaged bridges [67], residual bridge capacity after damage [68], and performance evaluation of new bridge structural systems [69].

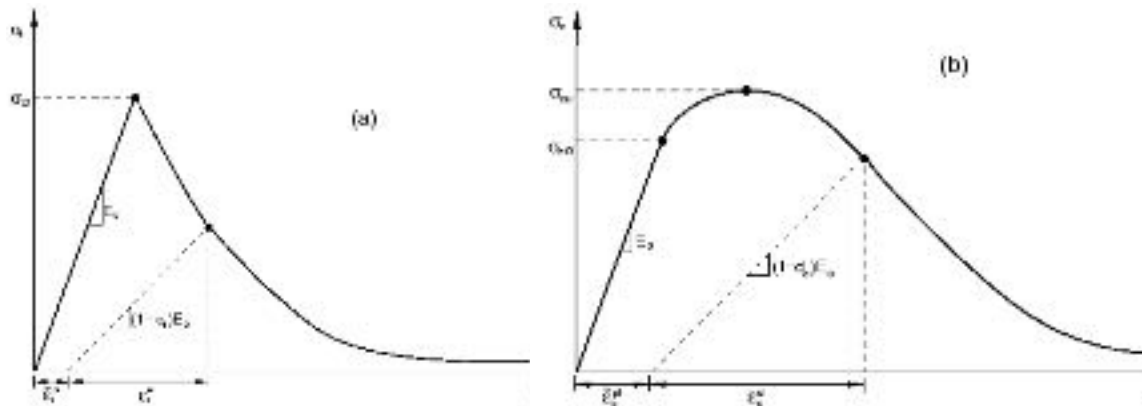
Figure 2-15. Response of concrete to uniaxial loading: (a) in tension; (b) in compression. [108]

A linear elasticity with the concrete damage plasticity is used in the FE models [113]. For the initial elastic behavior, the modulus of elasticity is calculated based on the ACI 318-14 [114] ($E_c = 57,000\sqrt{f'_c}$ (in psi) for normal-weight concrete) and a Poisson ratio of 0.2 was used. The concrete damage plasticity is a continuum, plasticity-based, damage model for concrete. It assumes that the main two failure mechanisms are tensile cracking and compressive crushing of the concrete material, and the uniaxial tensile and compressive response of concrete is characterized by damaged plasticity, as shown in Figure 2-15 [108].

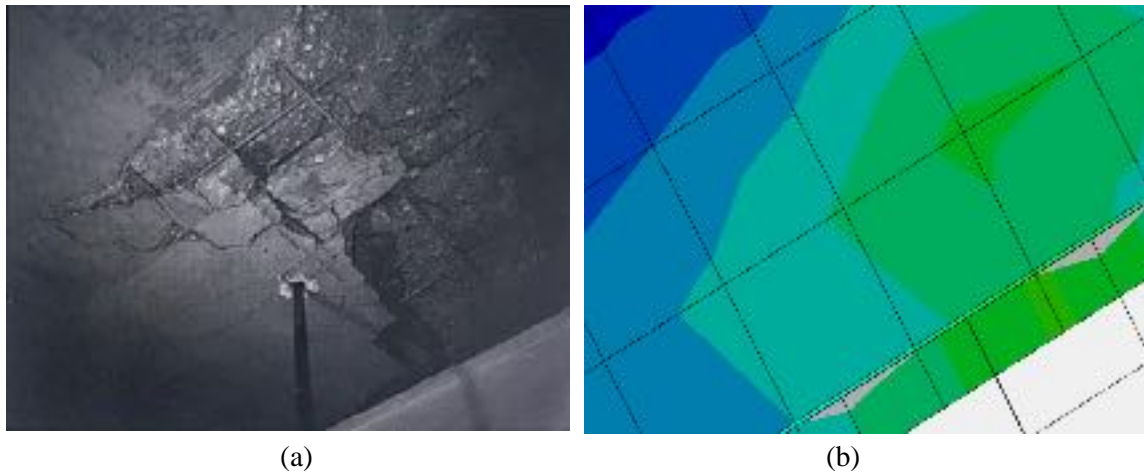
Figure 2-21. Typical punching shear failure: (a) Experimental test; (b) Finite Element Model.

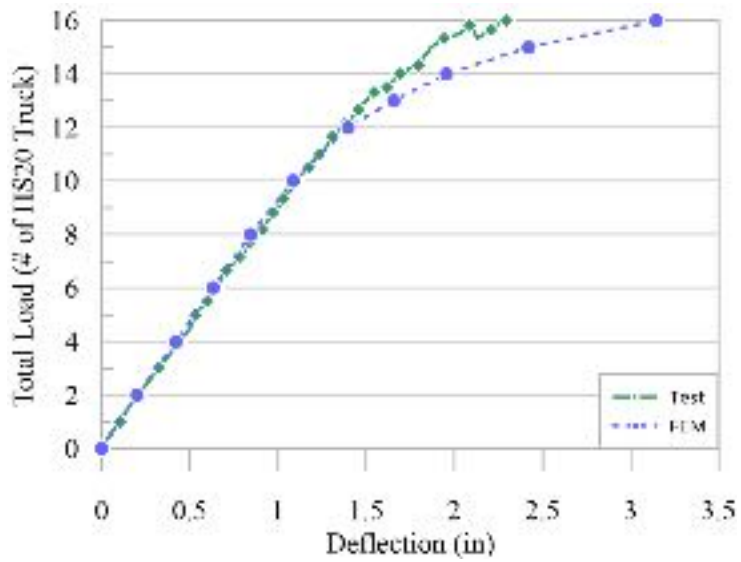
Figure 2-23. Comparison of load-deflection curves for north exterior girder obtained from experiment and FE model.

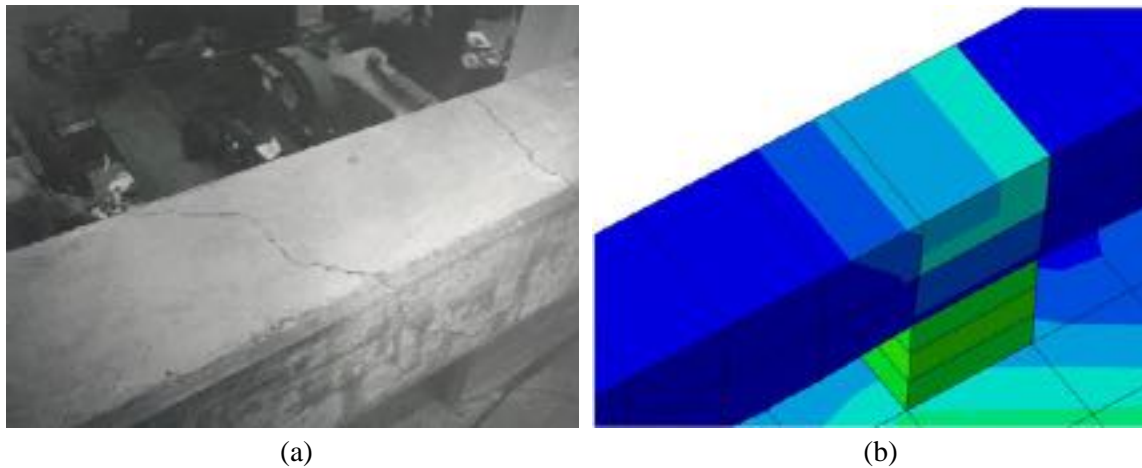
Figure 2-26. Torsional cracks in the rails: (a) Experimental test; (b) Finite Element Model.

Figure 2-26 compares the local cracking in the railing during ultimate load testing for the experimental test and FE model. The results and comparisons show that the FE model can predict the global behavior of the bridge during the elastic and plastic states and simulates the local failure due to punching shear in the deck and cracking in the railing.

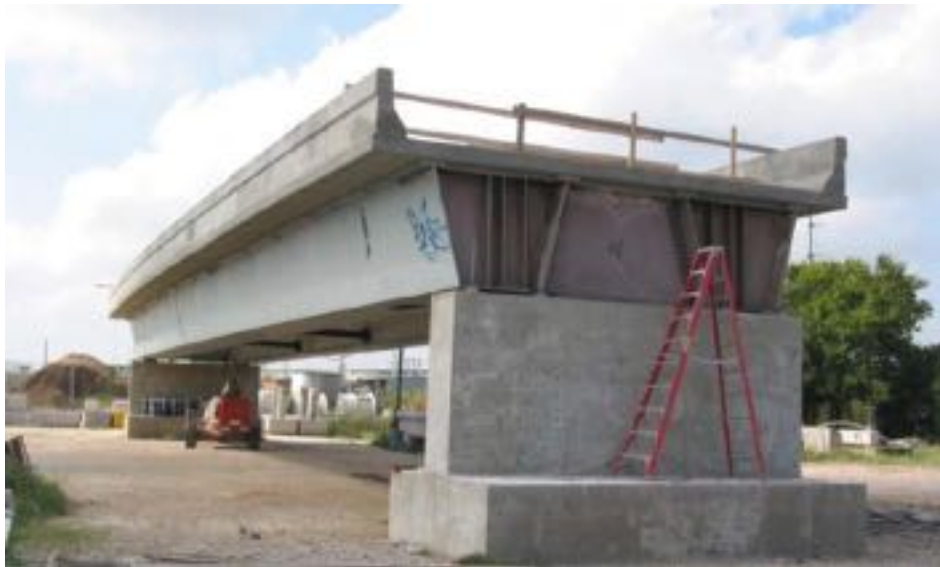
Figure 2-27. The University of Texas twin steel box girder bridge.

ultimate load-carrying capacity of the fractured bridge. The ultimate test was performed by increasing a uniform load applied using sand over the HS-20 truck outline area until the bridge collapsed. These three tests were used for verification of the FE model for the fractured bridge scenario.

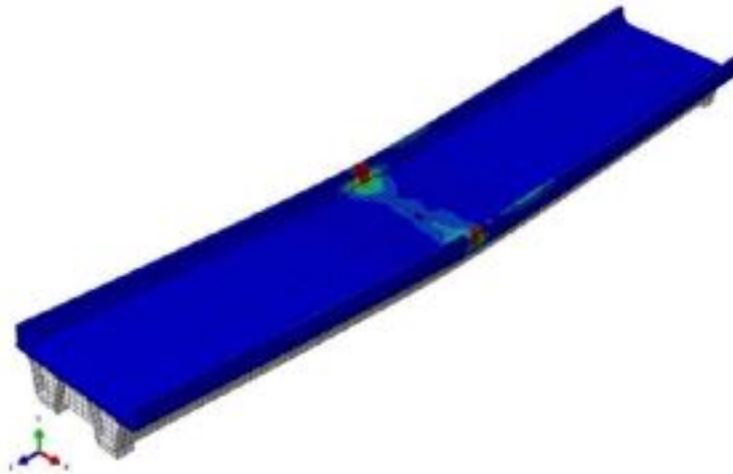
Figure 2-29. Crushing of the railing due to contact surface.

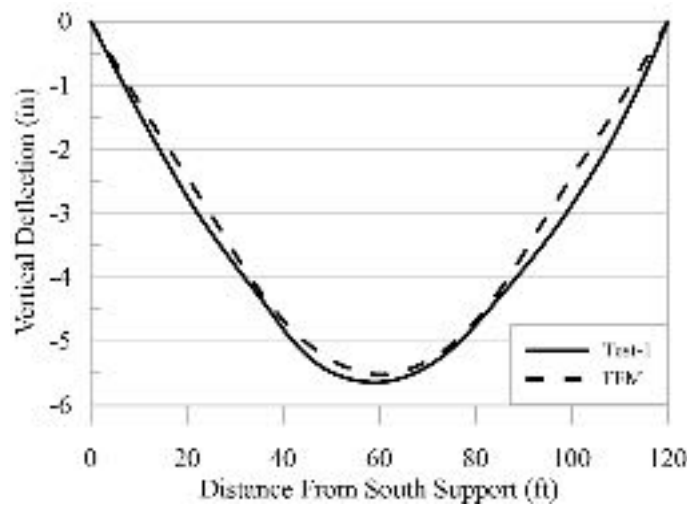
Figure 2-30. Comparison of the deflection curve of the first test for fractured girder obtained from experiment and FE model.

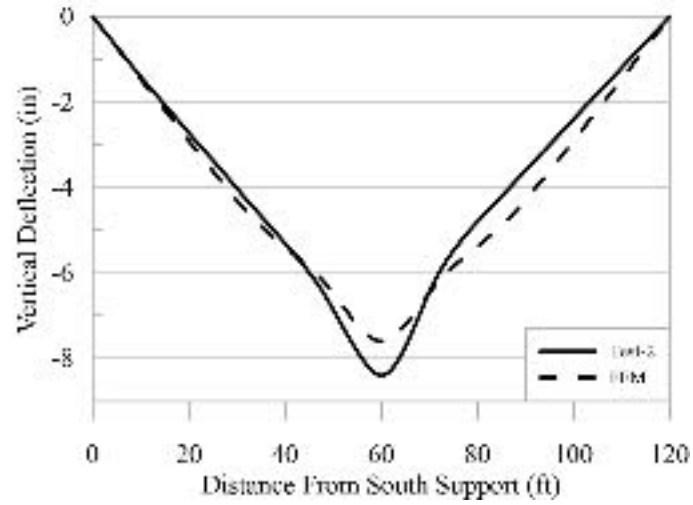
Figure 2-31. Comparison of the deflection curve of the second test for fractured girder obtained from experiment and FE model.

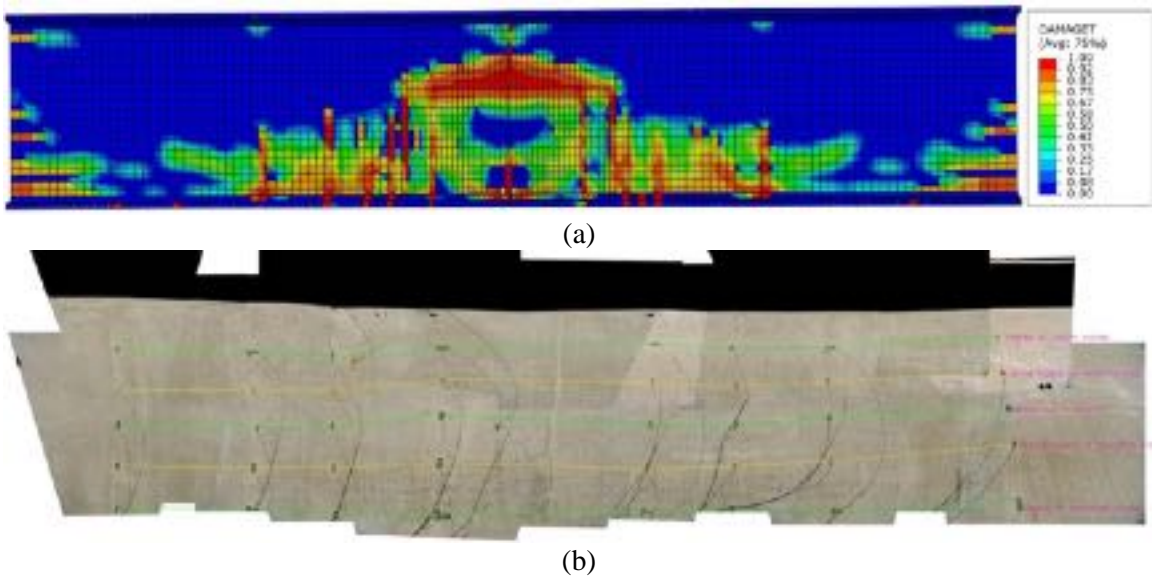
Figure 2-32. Crack patterns on concrete deck; (a) Finite Element Model, (b) Experimental test.

Experimental results of the University of Texas test show that extensive cracking developed on the top surface of the concrete deck in the second test. The most prominent cracks were located longitudinally above the intact girder due to one-way shear failure, and the cracks extended toward the supports. Furthermore, some transverse cracks were observed starting from the railing of the fractured girder toward the intact girder. Figure 2-32 and Figure 2-33 show the crack pattern on the surface of the concrete deck from both experimental test and FE analysis. As shown, the FE model can predict the transverse and longitudinal crack pattern of the concrete deck due to load distribution after the fracture.

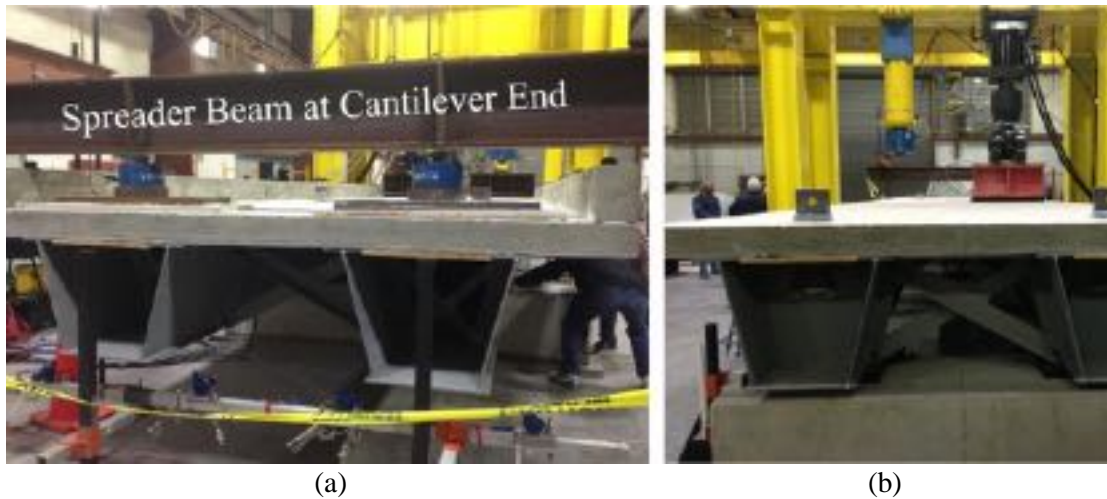
Figure 2-34. The FIU test setup: (a) View from the cantilever end; (b) View from the simply supported end.

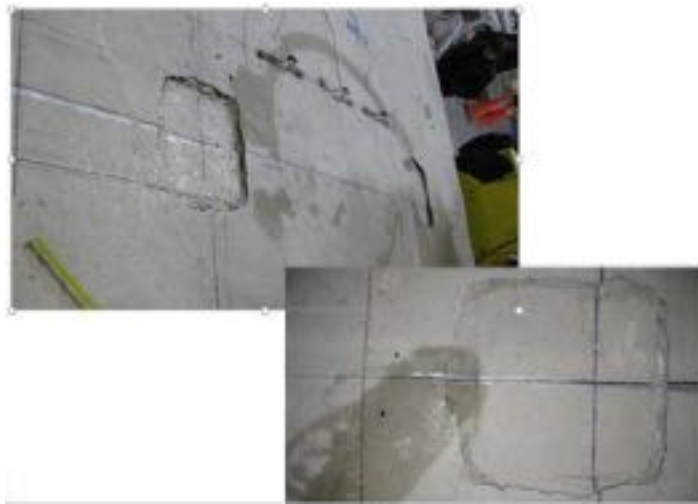
Figure 2-36. Punching shear failure in the Test E-2 of FIU bridge.

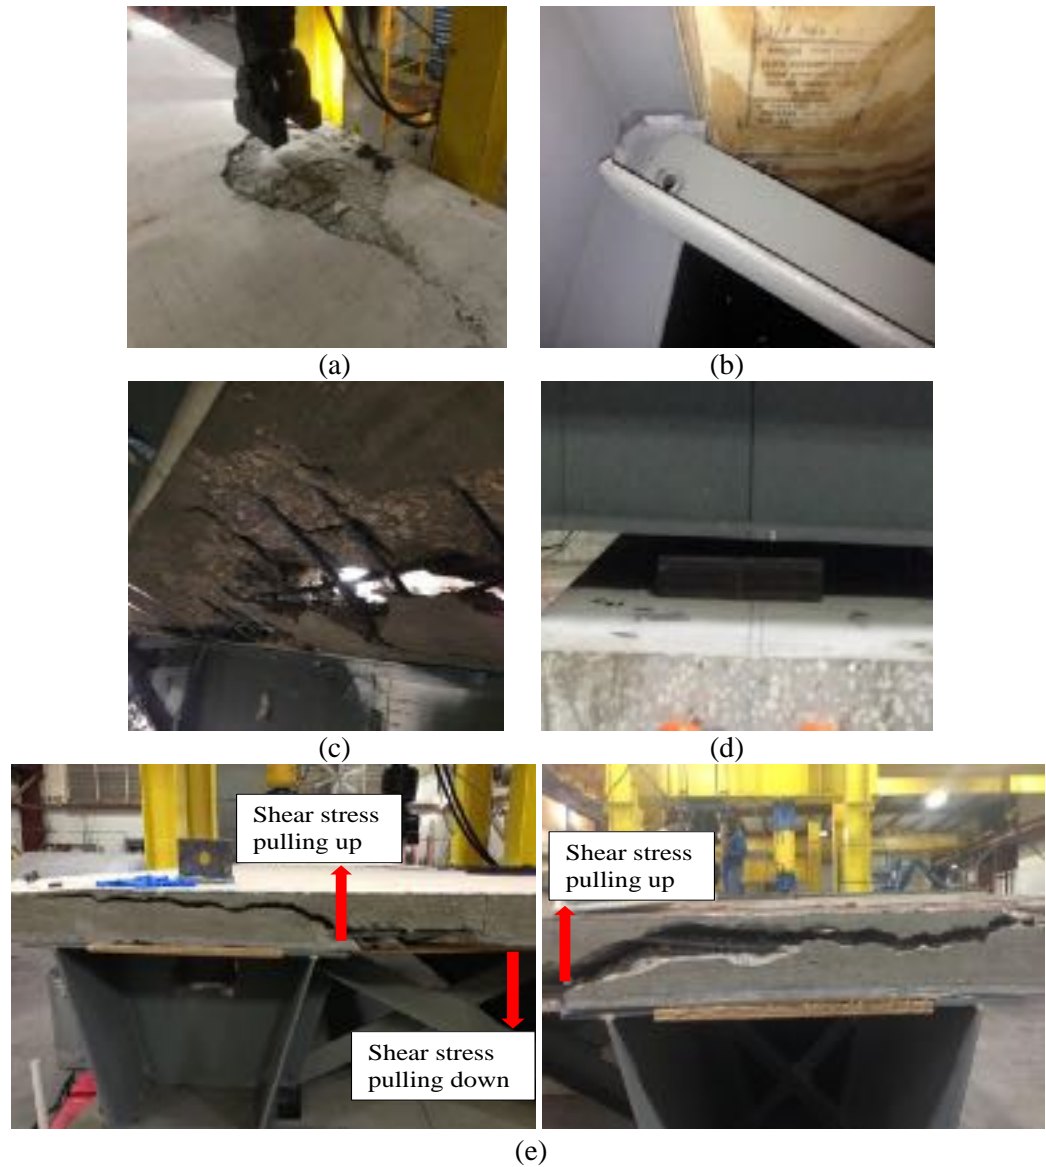
Figure 2-37. Damages in the Test E-1 of FIU bridge.

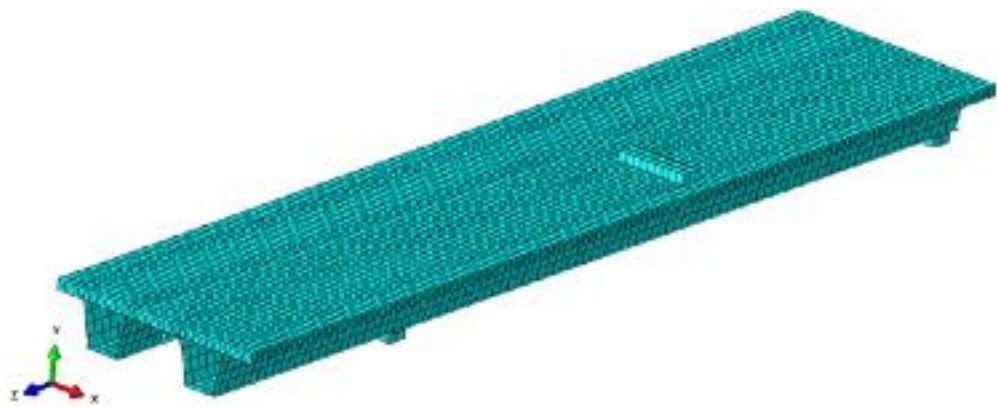
Figure 2-38. The FIU bridge FE model.

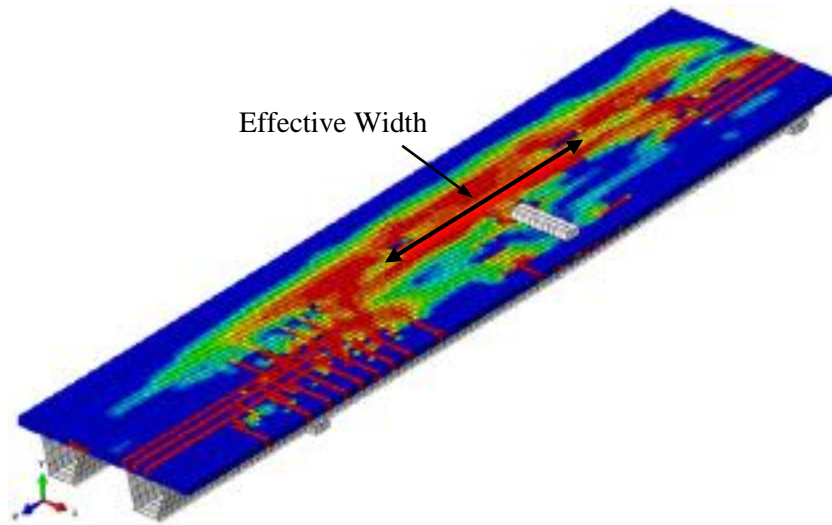
Figure 2-40. One-way shear effective width in the FE model.

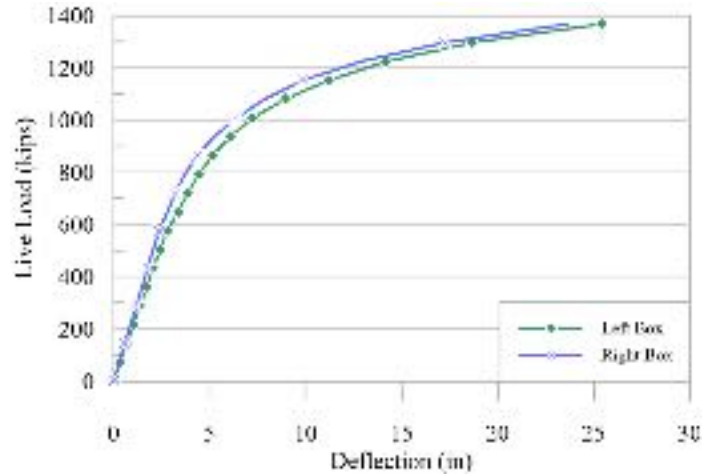
Figure 2-47. Load-deflection curves of intact bridge obtained from the FE model.

Figure 2-47 shows the load-deflection curve for the intact bridge scenario at the middle of the span under the center of the girders due to truck loading. The truck loading increased until the load-displacement curve flattened, indicating approaching the maximum load capacity of the bridge. This condition was associated with the development of plastic strain over the entire section of both girders. Before reaching this stage, local failures in the deck were also observed. The first local failure, as shown in Figure 2-48, was the punching shear pattern under the rear wheels around nine times HS-20, after which one-way shear occurred above the right box. After the local failures, the bridge still continued to carry higher loads until 19 times the HS-20, at which the bridge response (load-deflection curve) plateaued, indicating reaching maximum capacity due to the formation of a hinge in the girders. Figure 2-49 shows the plastic stress over the entire sections at 19 times the HS-20 load.

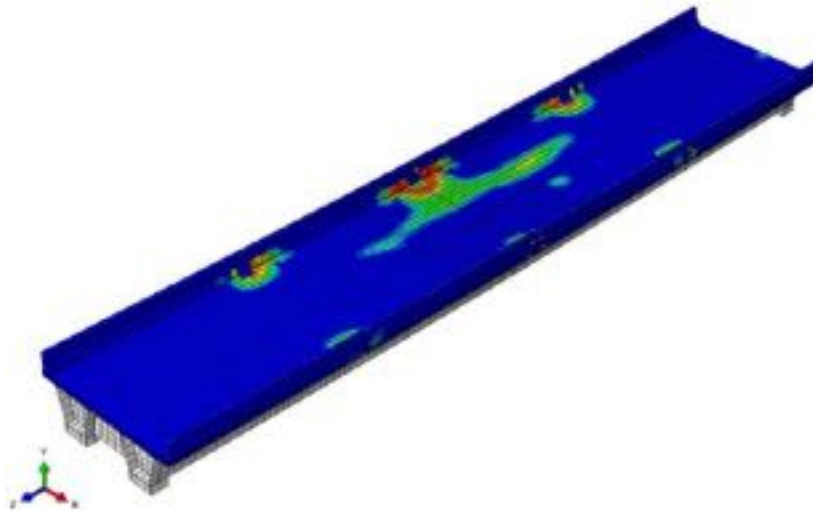
Figure 2-48. The punching shear failure of the concrete deck under 9xHS-20.

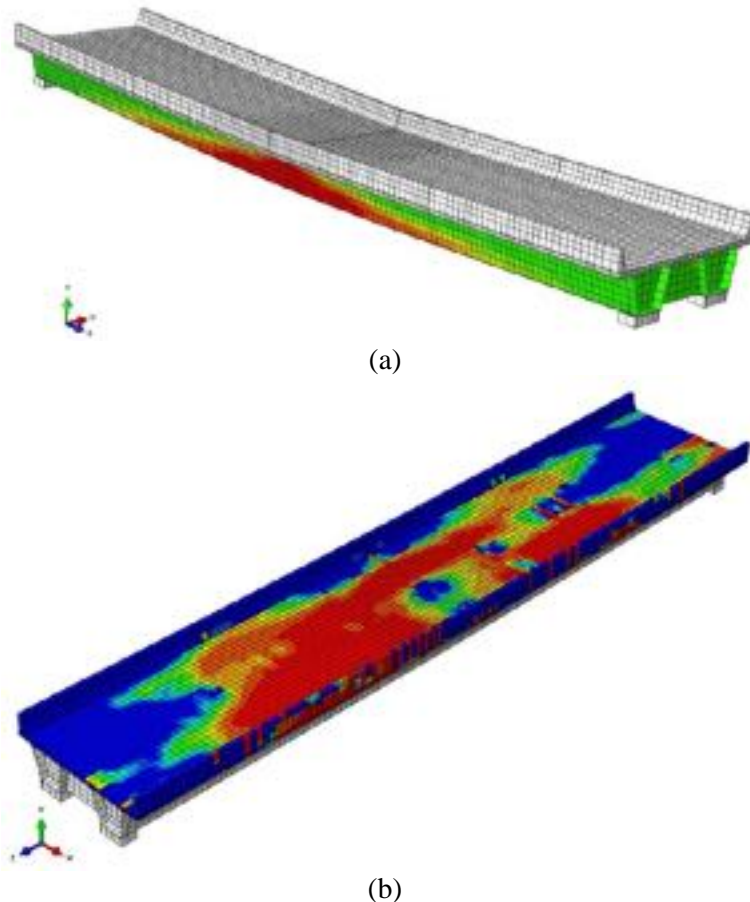
Figure 2-50. Fractured bridge under 6xHS-20: (a) Yielding of the intact girder; (b) Concrete tension damage.

the middle span deflection of the fractured girder reached 11.51 in. At this level (defined here as failure), the concrete deck experienced extensive damage leading to tension stress at the intact girder due to flexural and torsional moment reaching the yielding point. Figure 2-50 (a) shows the yielding of the intact girder under six times HS-20 loading, and Figure 2-50 (b) shows the concrete tension damage at the top of the deck at this load level.

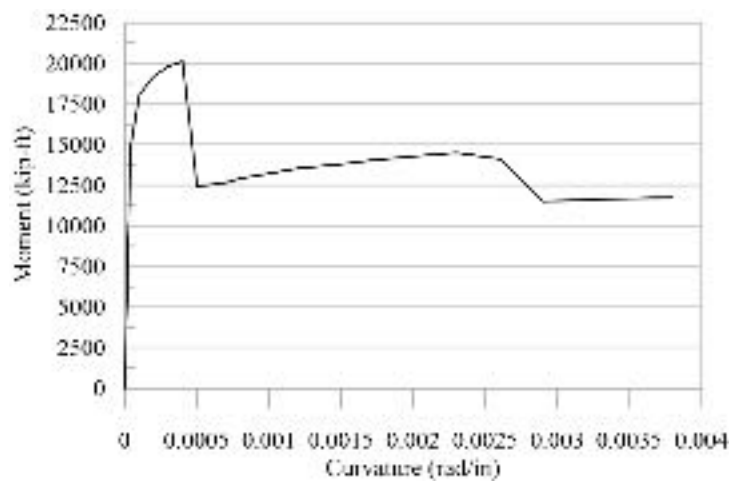
Figure 2-53. Moment curvature curve with nonlinear material properties ($f'c=6$ ksi).

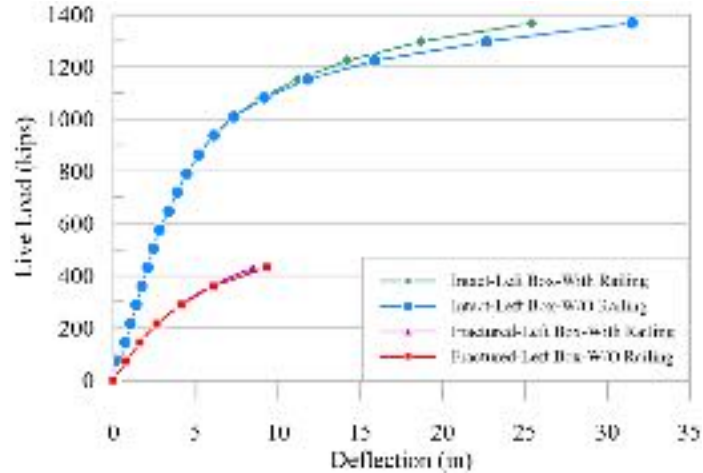
Figure 2-54. The effect of railing on the fractured bridge.

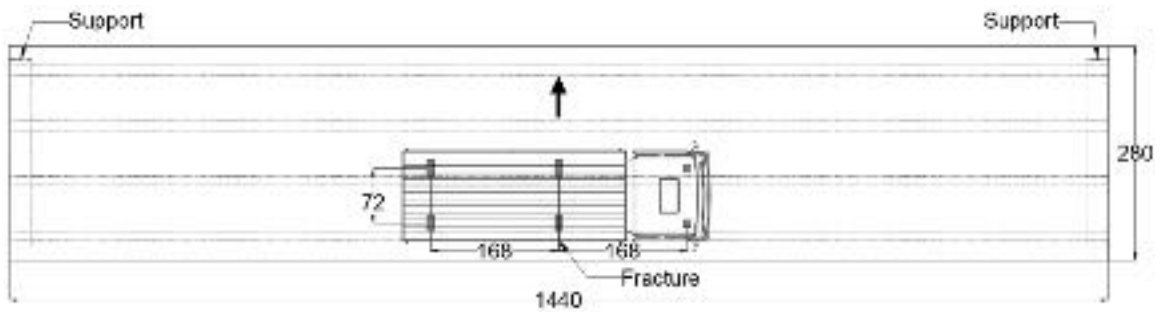
Figure 2-55. Loading Configuration in the one-way shear analysis.

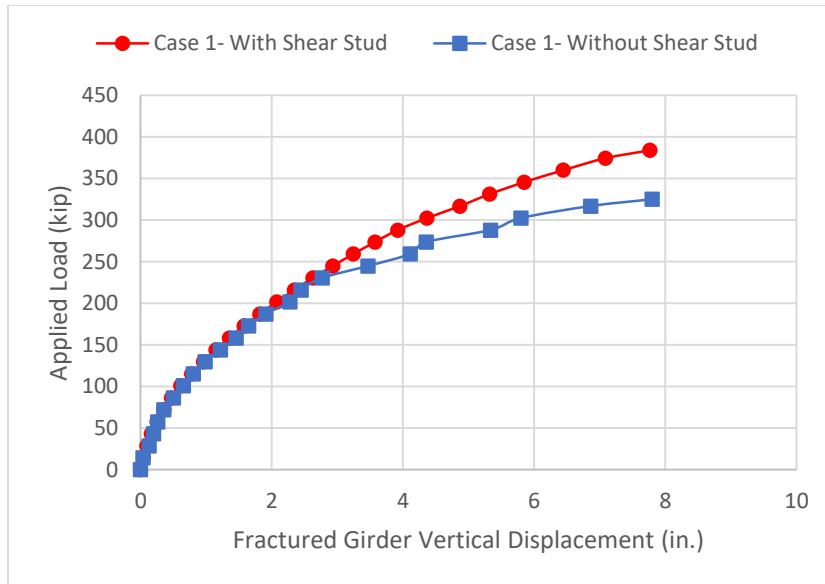
Figure 2-63. Comparison between the load-displacements curves for Case 1 loading with and without modeling the studs.

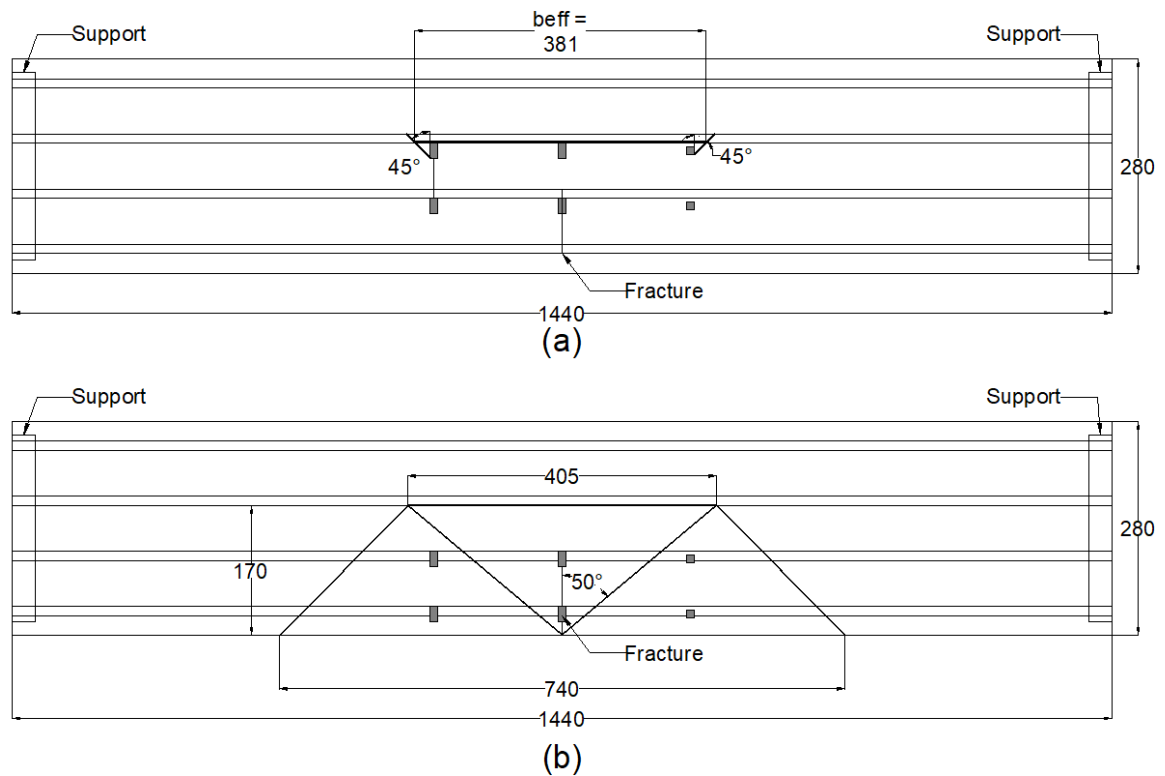
Figure 2-66. The University of Texas bridge failure mechanisms; (a) One-way shear in Case 4, (b) Yield line failure in Case 1.

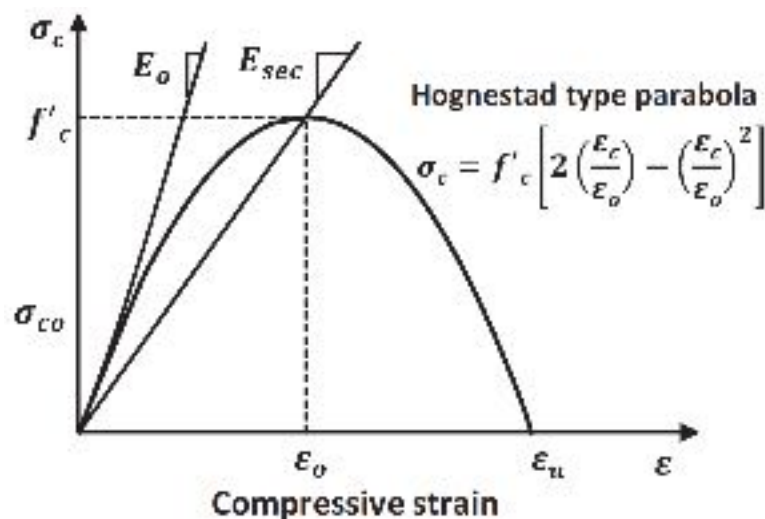
Figure 2-67. The uniaxial compressive stress-strain relationship for concrete.

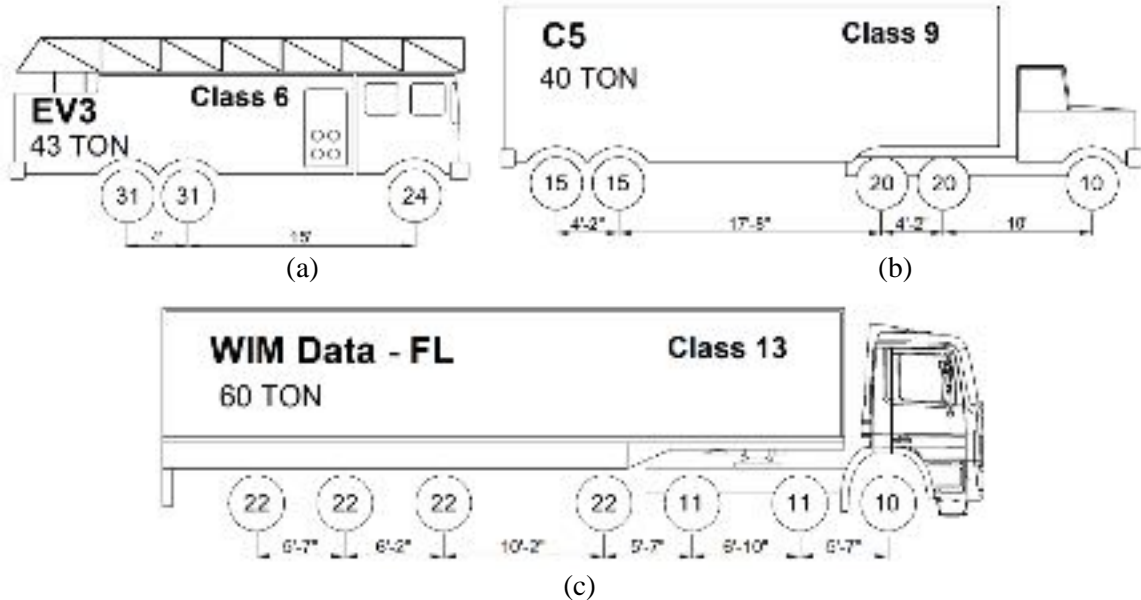
Figure 2-69. Vehicle loading configuration: (a) Florida emergency vehicle (EV3); (b) Florida legal load (C5); (c) Florida typical truck (WIM Data –FL).

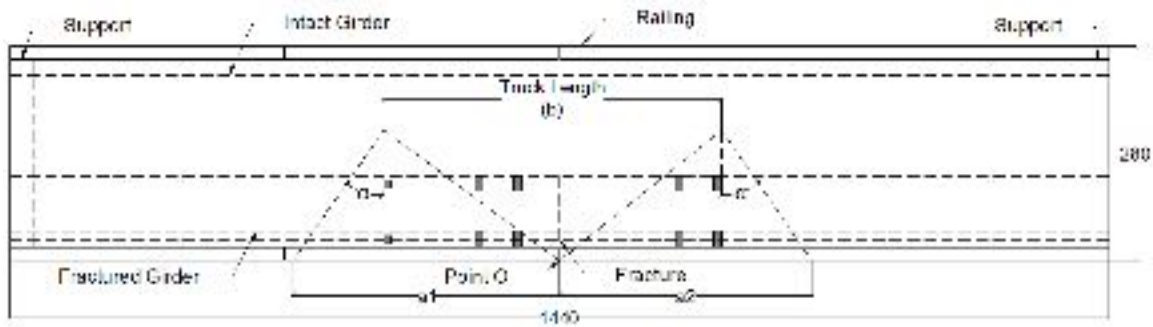
Figure 2-72. Simplified yield line pattern for different loading configurations.

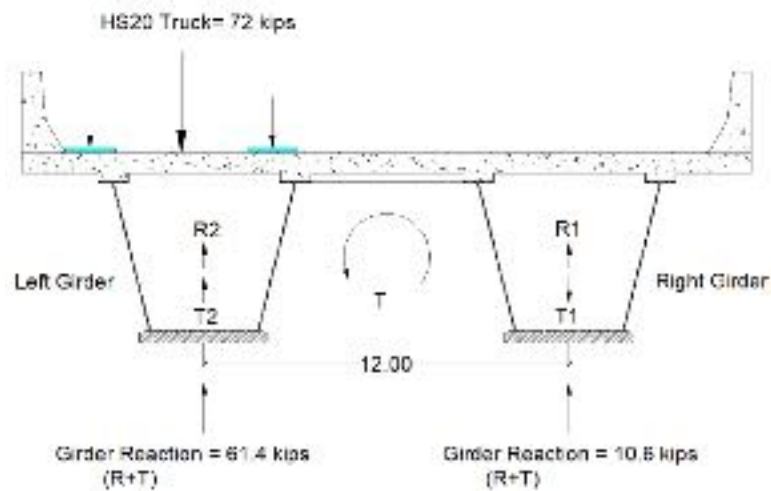
Figure 2-76. Bridge support reaction for the intact bridge obtained from FE analysis.

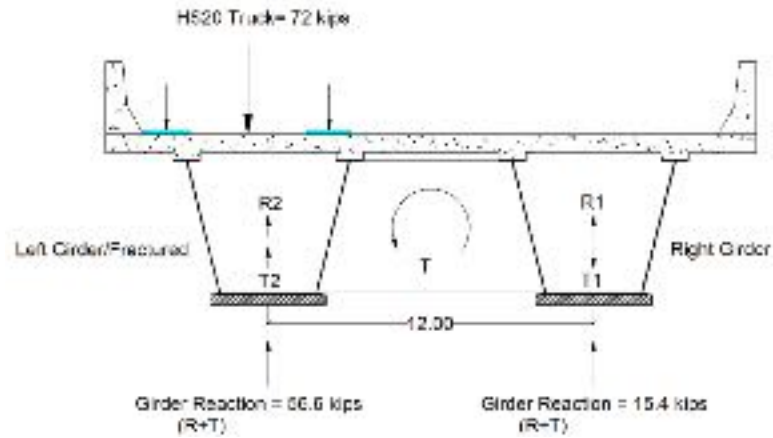
Figure 2-77. Bridge support reaction after the full-depth fracture.

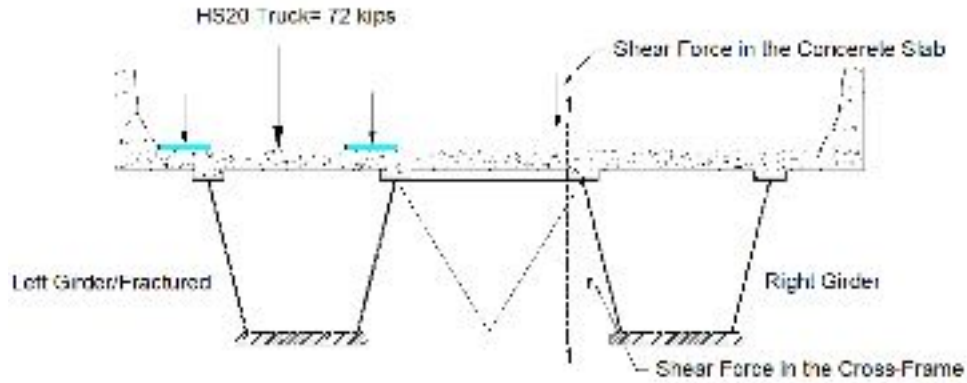
Figure 2-78. Shear force in Section 1-1.

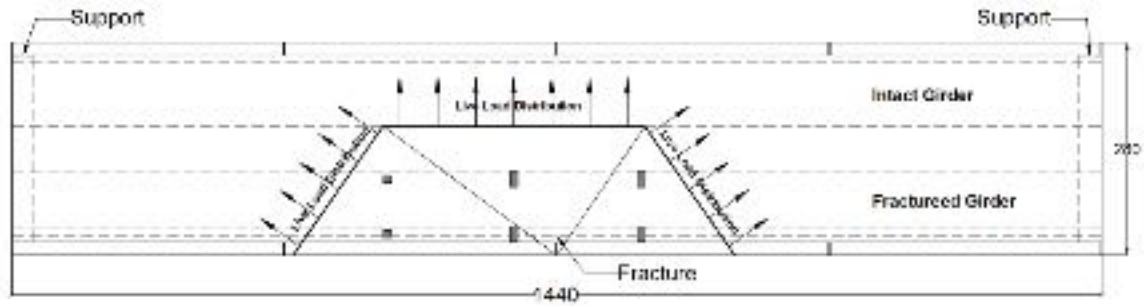
Figure 2-79. Live load distribution based on the yield line analysis for HS-20 loading.

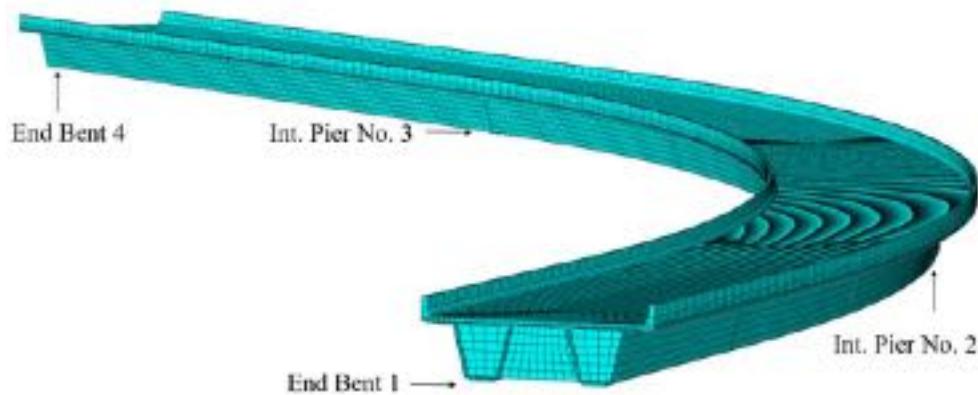
Figure 2-81. Finite element model of the three-continuous span bridge.

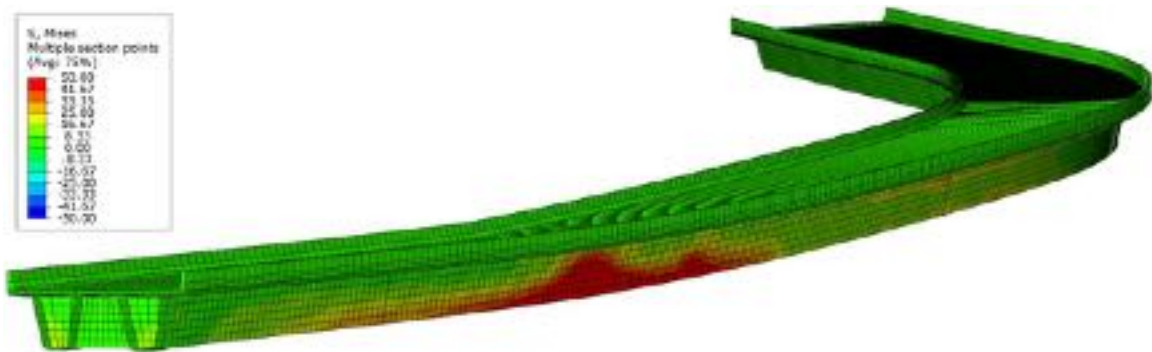
Figure 2-82. Intact girder failure under dead load and eight times HS-20 design truck at the middle of Span. 1.

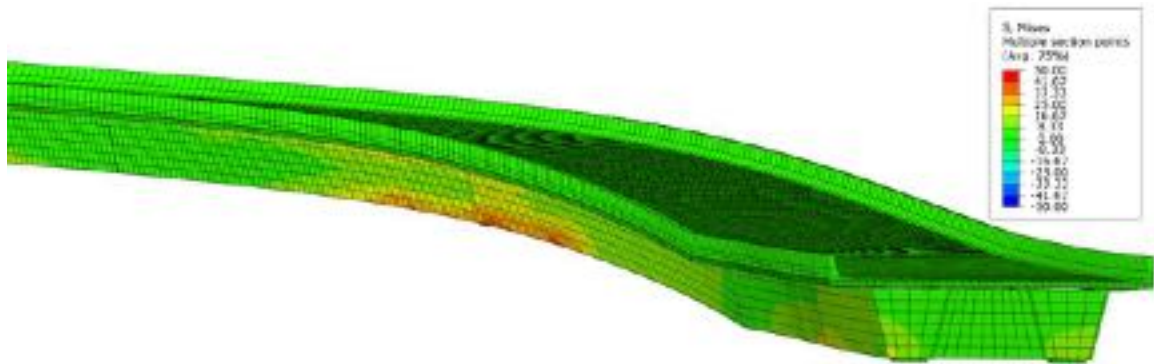
Figure 2-83. Contribution of the fractured girder in carrying a portion of the loads as a cantilever beam.

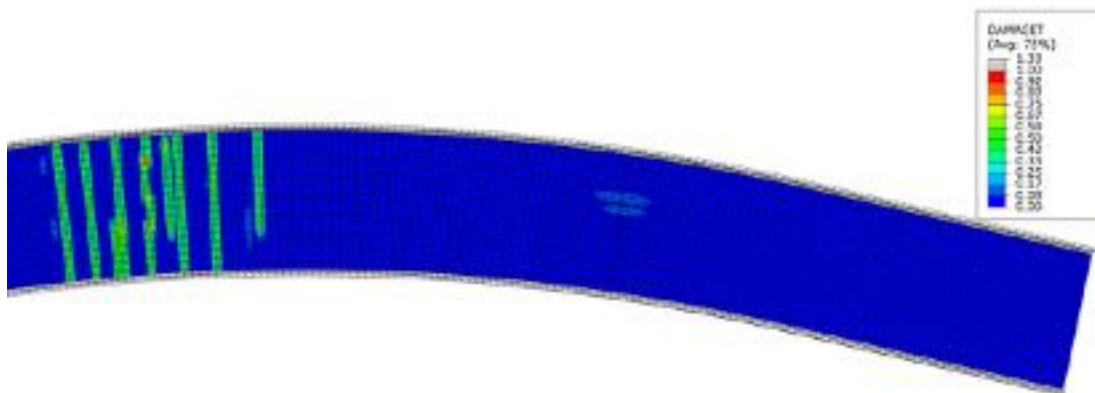
Figure 2-84. Deck crack pattern after a full-depth fracture of one girder in the continuous bridge in Span 1.

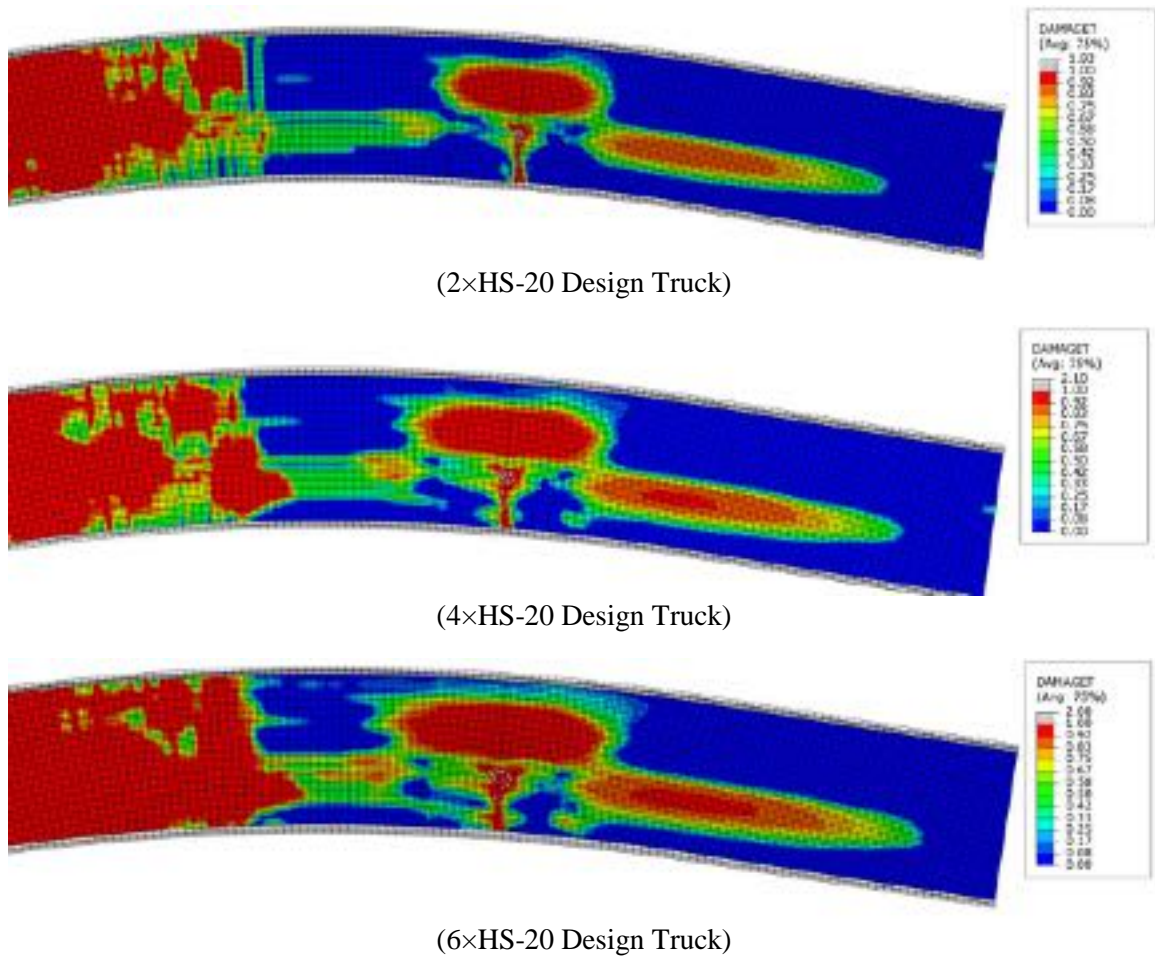
Figure 2-85. The yield line pattern of the deck in the Finite Element Model of the continuous bridge in Span 1.

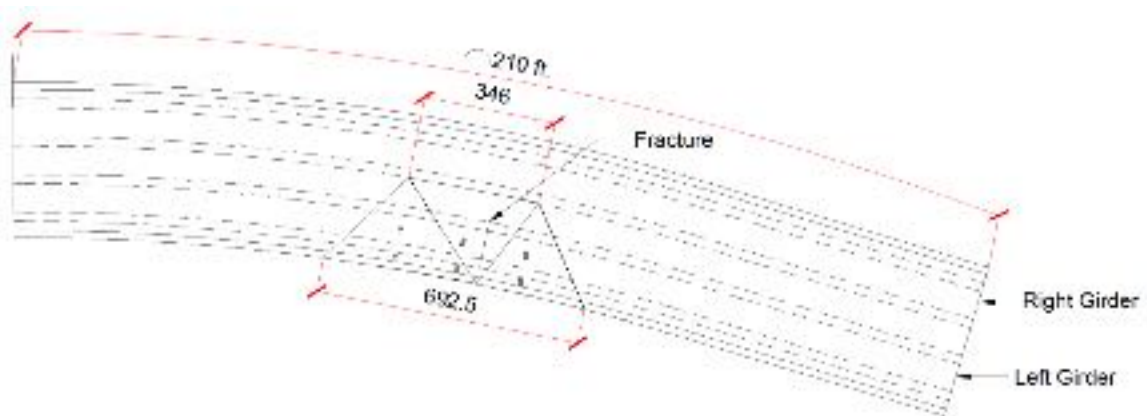
Figure 2-86. The yield line pattern for the continuous span bridge subjected to HS-20 design truck.

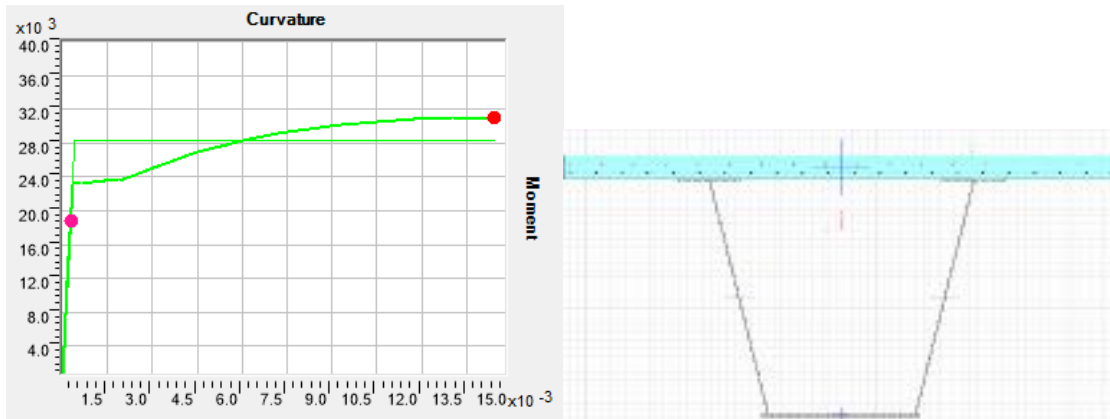
Figure 2-87. Moment curvature curve of one girder at the middle of span 1.
