Evaluation and Damage Detection of Highway Bridges with Distinct Vulnerabilities

EVALUATION AND DAMAGE DETECTION OF HIGHWAY BRIDGES WITH
DISTINCT VULNERABILITIES

DOCTOR OF PHILOSOPHY

CIVIL ENGINEERING

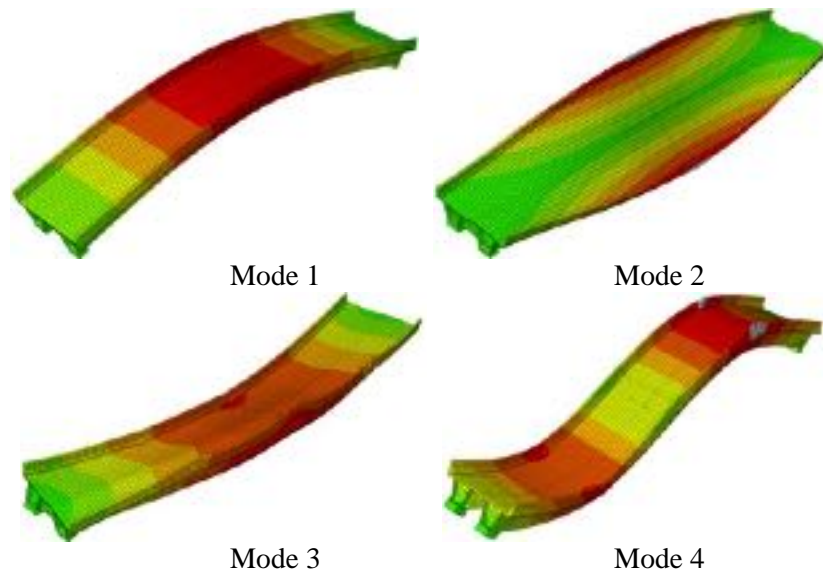
Figure 2-92. The first four mode shapes of the intact simple span bridge.

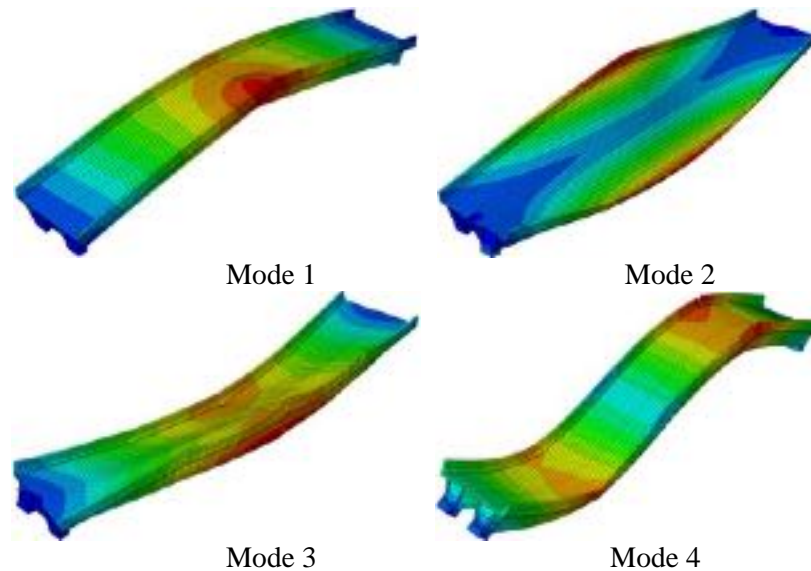
Figure 2-93. The first four mode shapes of the simple span bridge with a full-depth fracture at the middle of the span with distinct changes at damage location.

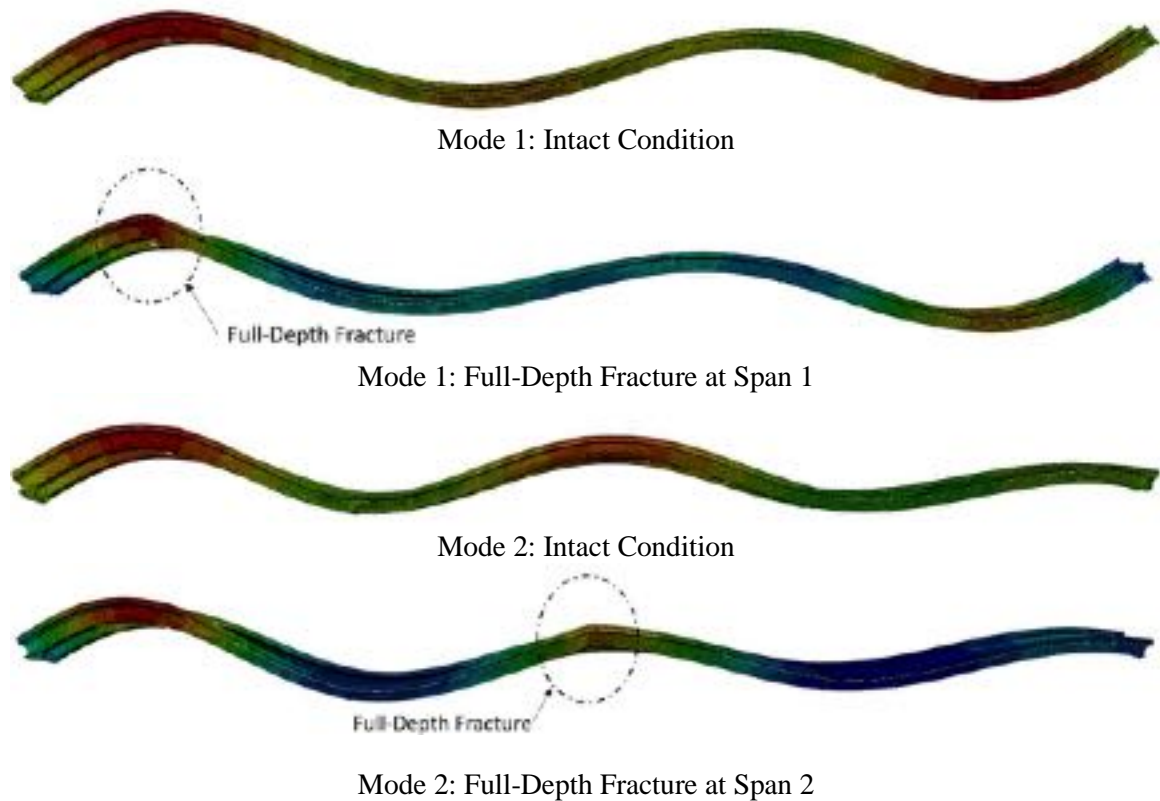
Figure 2-94. The changes in the mode shapes of the continuous span bridge.

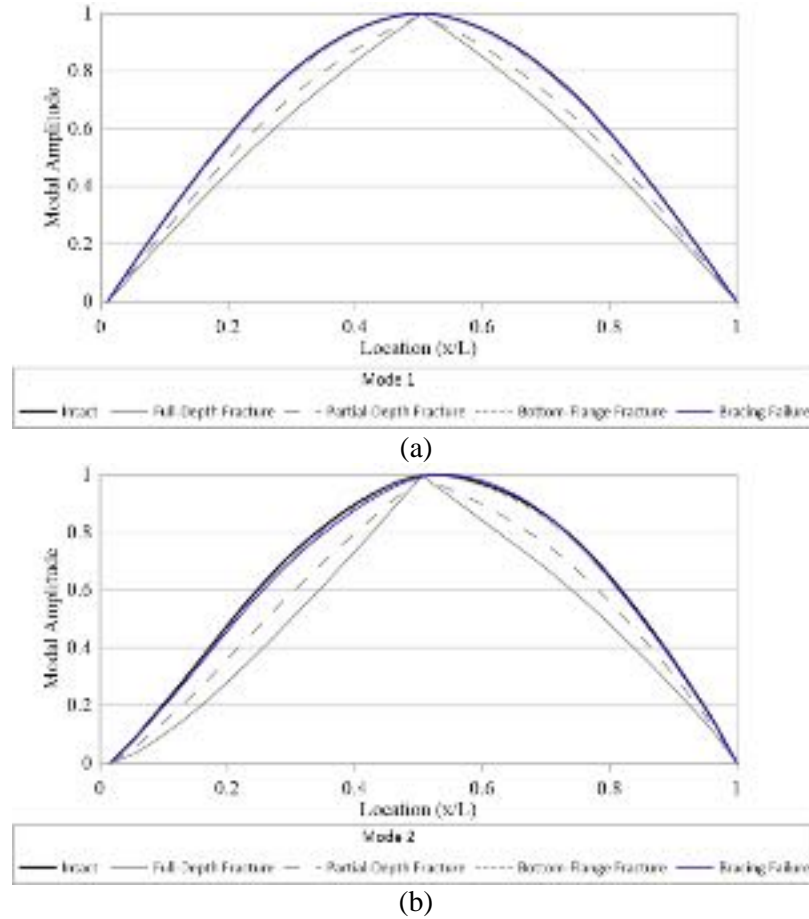
Figure 2-95. Comparison of mode shapes in the simple span bridge: Intact vs. damage scenarios; (a) Mode 1, (b) Mode 2.

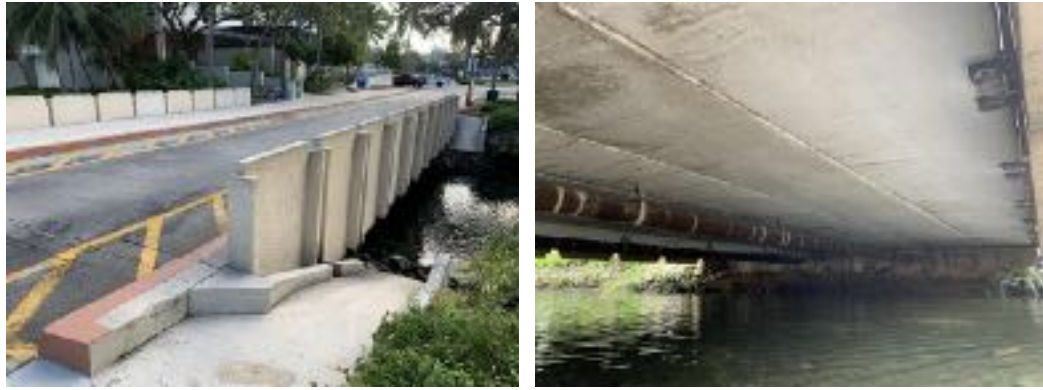
Figure 3-1. College Drive Bridge. (a) Top view; (b) Bottom view.

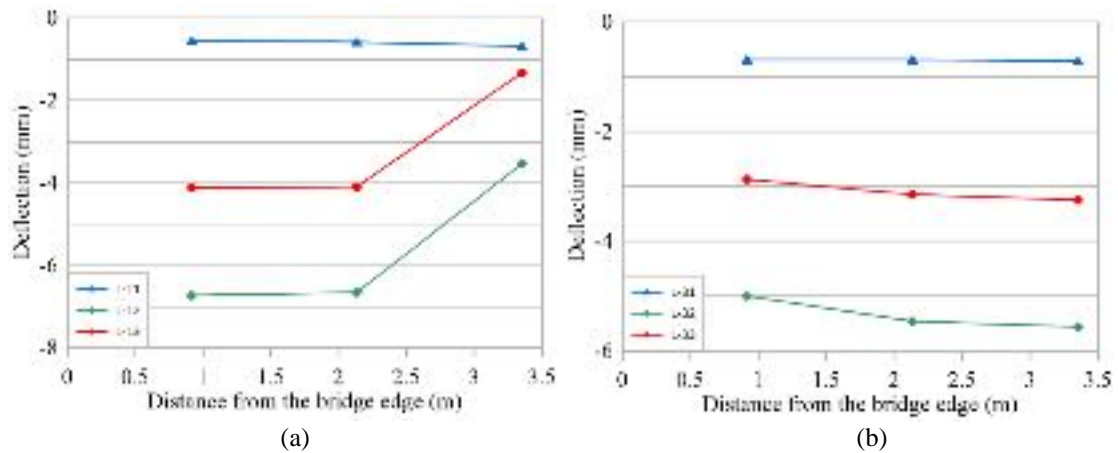
Figure 3-11. Dial Gauge displacement measurements for the three instrumented panels relative to pass number, (a) Pass 1;(b) Pass 3. (1.0 mm = 0.04 in.).

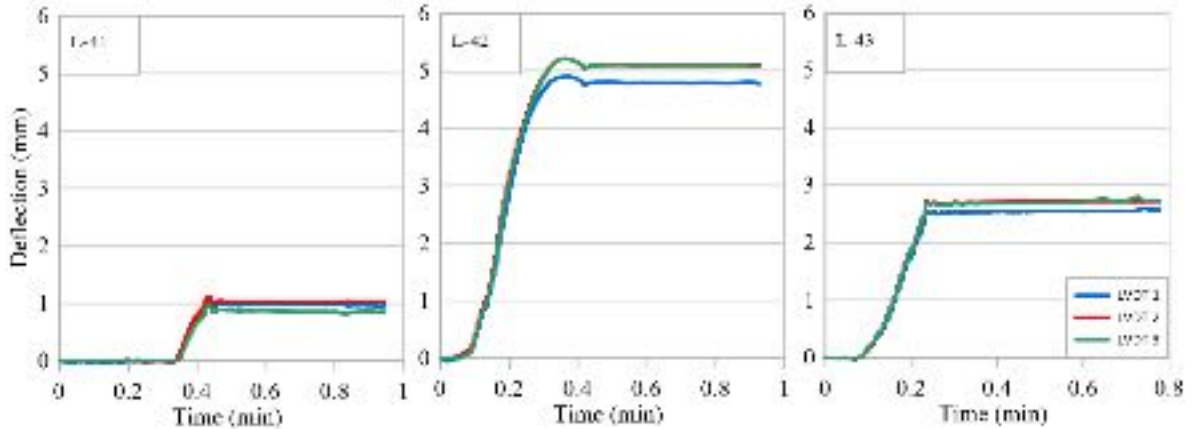
Figure 3-12. Representative vertical displacement versus time during the load test for pass 4-stop 1 (left), pass 4-stop 2 (middle), and pass 4-stop 3 (right). (1.0 mm = 0.04 in.).

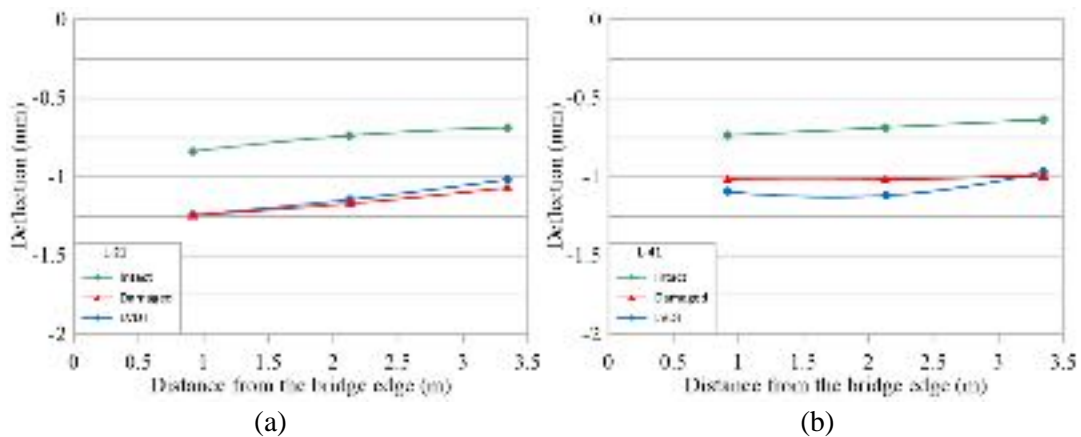
Figure 3-19. Finite Element Models (Intact and Damaged bridge models) to load test comparison for the truck at Stop 1; (a) Pass 1 (b) Pass 4. (1.0 mm = 0.04 in.)

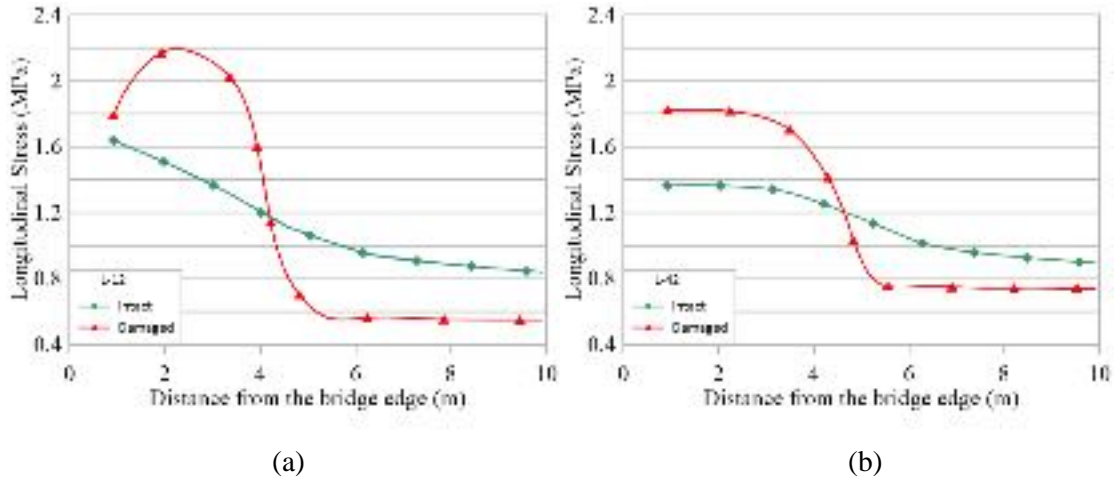
Figure 3-21. Load distribution comparison for the intact and damaged bridge.; (a) L-12, (b) L-42 (1.0 MPa = 0.145 ksi)
