## Stackpole Bridge: Rebuilding a Connection to the Past

STACKPOLE BRIDGE: REBUILDING A CONNECTION TO THE PAST

A Thesis Submitted in Partial Fulfillment  
of the Requirements for a Degree with Honors  
(Civil Engineering)

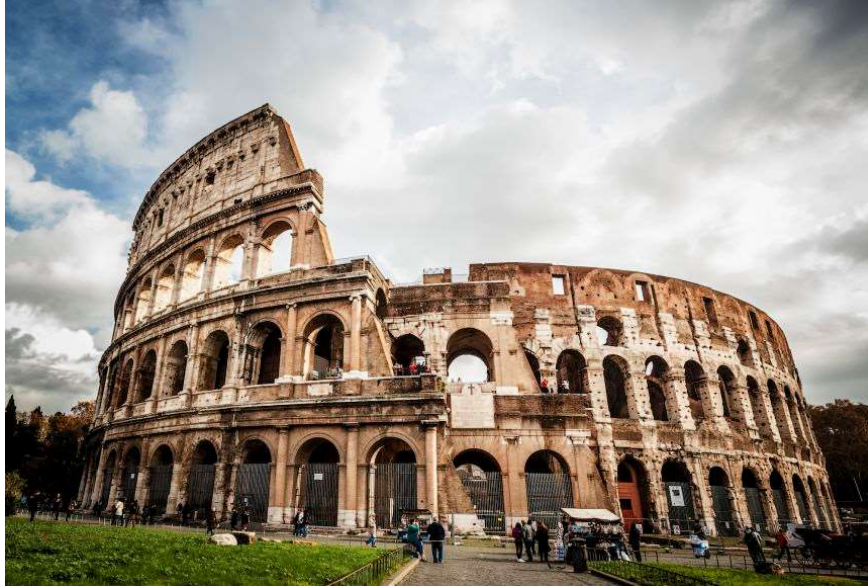
The most notable and well-known instances of stone arches from great civilizations come from the ancient Roman period. Structures like aqueducts, bridges, and buildings, such as the Colosseum (see Figure 1) and Pont Du Gard (see Figure 2), utilize various arch shapes in their designs. The Colosseum was a center of entertainment for the population of Rome where gladiatorial games and reenactments were held. This structure utilized the keyhole-shaped vaulted arch, also referred to as the Roman arch, that is characteristic of Roman architecture.

*Figure 1. The Colosseum (Design Pics Inc.)*

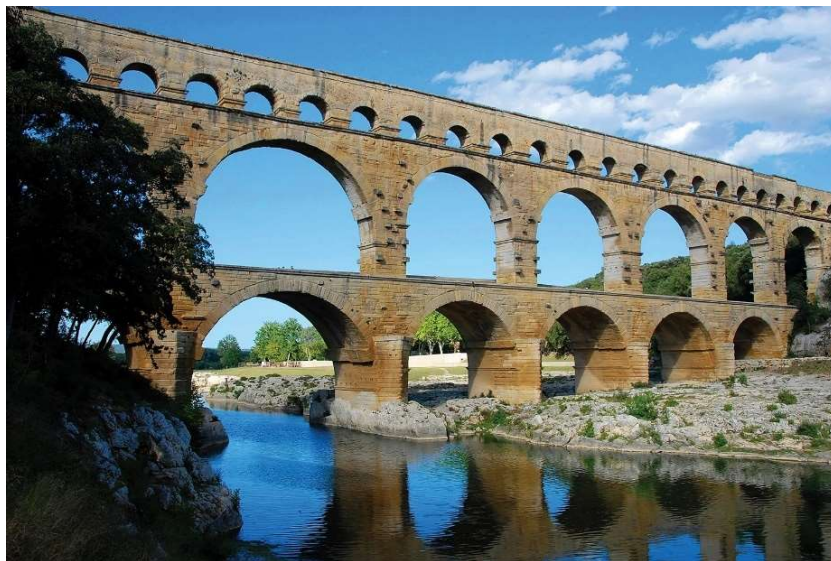
The Pont Du Gard was built in the first century AD to bring clean water to Nîmes, a city in southern France which was ruled by the Roman empire at the time (UNESCO World Heritage Centre). This structure used two levels of stacked pure compression arches, and small arches across the very top that carried water. Structures like these were incredibly valuable to the vast Roman empire and were designed and constructed for reliability and durability.

*Figure 2. Pont Du Gard (Gallas)*

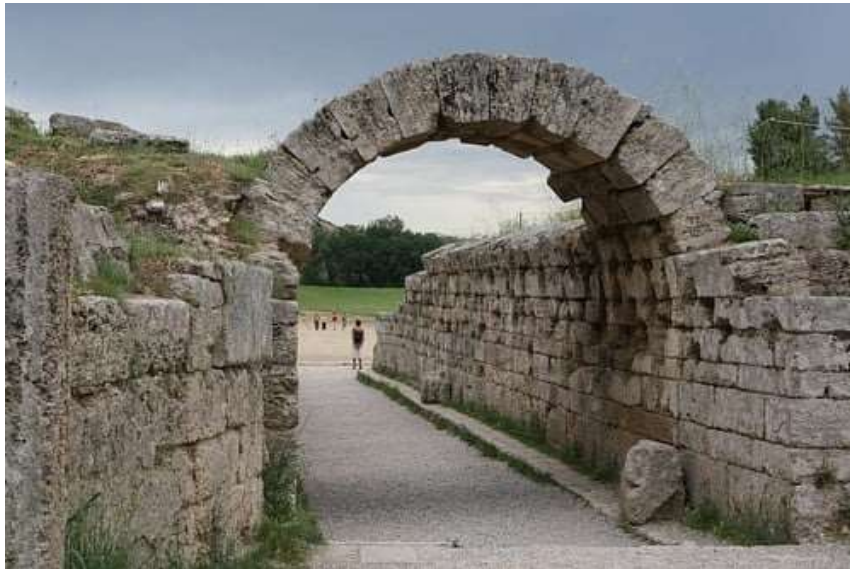
Another great civilization that employed arches was ancient Greece. Although arches were not as predominant as they were in ancient Roman architecture, arches can still be found in structures built by the Greeks. One such structure is the Stadium Entrance in Olympia (see Figure 3), constructed in the late third century BC, making it over 2000 years old. This is where athletes competing in the ancient Greek Olympics entered the stadium for the games (Cartwright).

*Figure 3. Stadium Entrance in Olympia, Greece (Cartwright)*

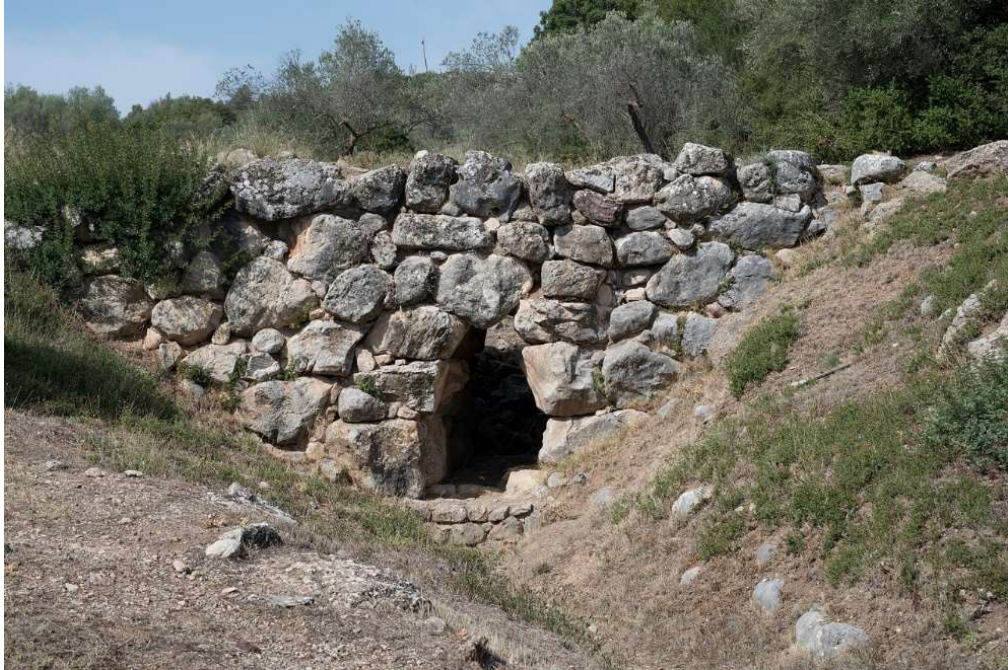
*Figure 4. Arkadiko Bridge, Greece (Wikimedia Commons)*

One of the oldest stone arch structures that still remains in use today is the Arkadiko Bridge in Greece (see Figure 4), which dates to 1300 BC, making it over 3,000 years old (“This Bronze Age Highway”). This bridge is a primitive stone arch bridge. Its primary function when it was initially constructed was to allow chariots to travel across the rocky slope and water runoff from heavy rain to flow through the arch and along the small riverbed. The Arkadiko Bridge is one bridge that is a part of a Bronze Age highway that connected the Greek cities of Mycenae, Tiryns, Tolo, and Epidaurus (“This Bronze

The Arkadiko Bridge is a testament to the lasting nature of both stone as a material and the arch as a design form. This bridge and the aforementioned ancient structures still standing today are tangible examples of the excellence, skill, and practicality of the building methods of ancient civilizations.

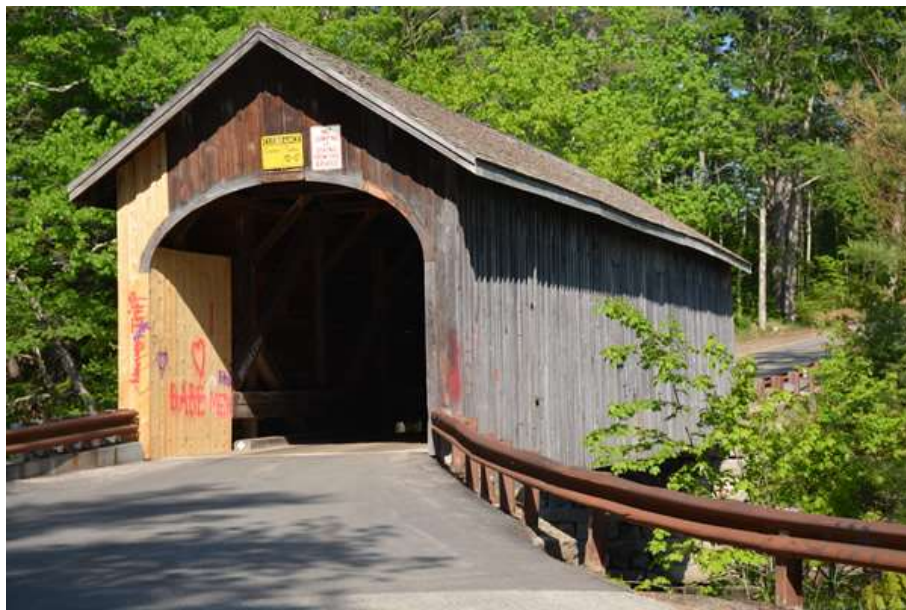
*Figure 5. Babb's Bridge, Maine (Maine Department of Transportation)*

One timber bridge type that is characteristic of New England is the wooden covered bridge, which became increasingly popular in the nineteenth century (see Figure 5). Covered bridges were widely used at this time, since timber was available in the region and was relatively inexpensive for bridge construction. Timber is much lighter than stone or iron, and easier to cut and transport to a project site. Timber also possesses

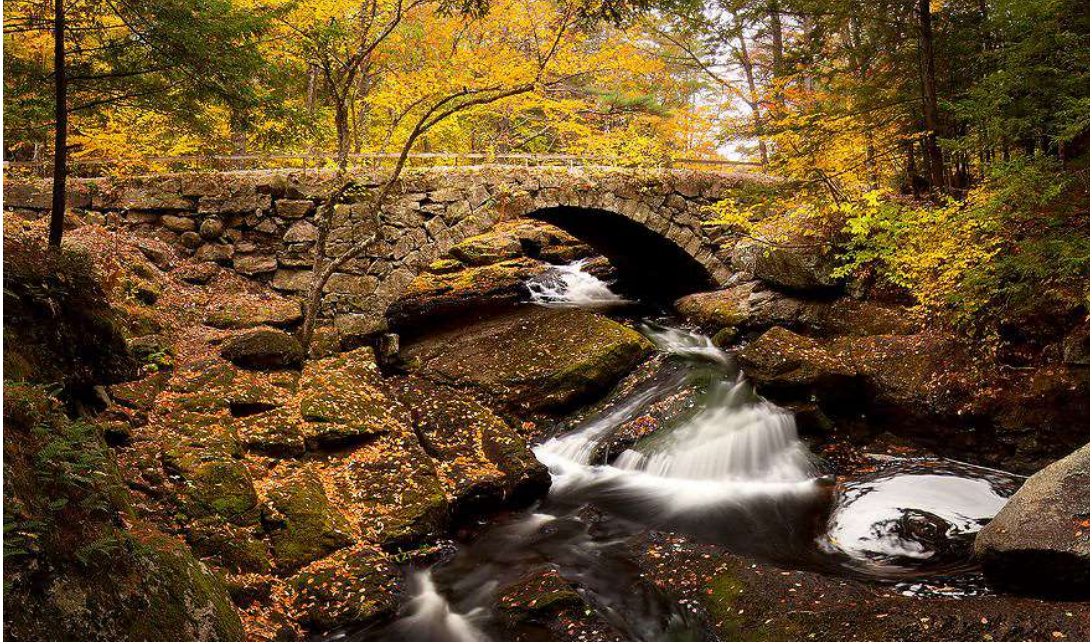
*Figure 6. Gleason Falls Bridge, Hillsborough, New Hampshire (Salge)*

An example of a stone arch bridge in New England is Gleason Falls Bridge (see Figure 6), built circa 1830 (American Society of Civil Engineers). This bridge was built over rocky ledges and a modest waterfall. Though the impetus for this bridge's construction is not specified, it serves the practical purpose of allowing people to cross over the turbulent waterfall and treacherous ledge safely. Gleason Falls Bridge also frames the picturesque and reflective scene of a stone arch bridge, waterfall, and forest. It is important to consider the aesthetics of structures like the Gleason Falls Bridge so that they can visually harmonize with their surroundings and complement the natural landscape.

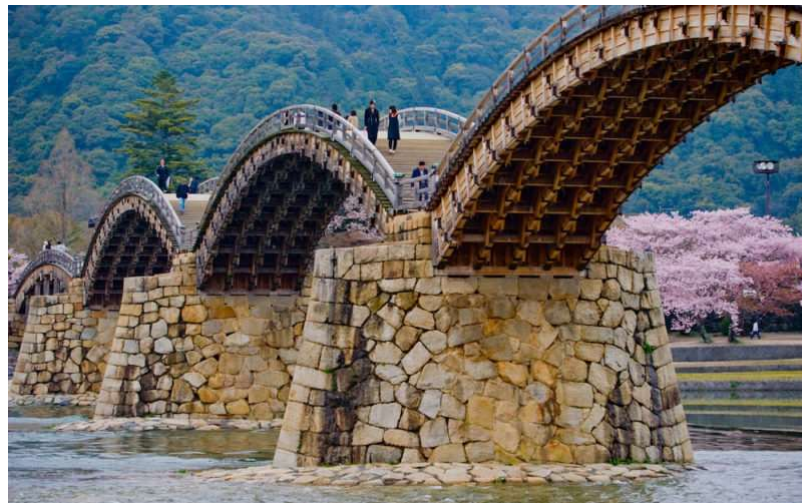
**Figure 7.** Kintaikyo Bridge, Iwakuni City, Japan (GaijinPot Travel)

It is unusual to find timber arch bridges, but one can be observed in the Kintaikyo Bridge in Iwakuni City, Japan (see Figure 7). This arch bridge for pedestrians is a combination of stone and timber that was originally built in 1673 and extensively rehabilitated in 1953 after a severe typhoon struck the area (Iwakuni City Industry Promotion Department). This bridge blends seamlessly with the natural landscape and though it is a man-made structure, it almost functions like a part of the landscape. A unique feature of this bridge is the walkway, which is not flat. Instead, it mimics the surrounding hills by following the shape of the arch, minimizing the amount of material used for construction.

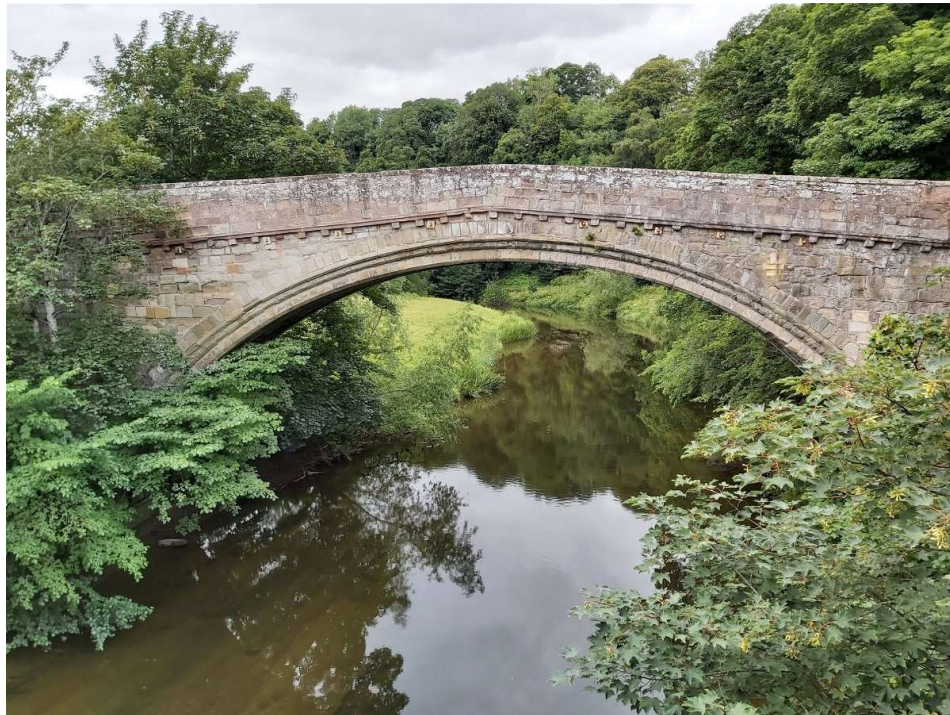
*Figure 8. Twizel Bridge (Hawkins)*

Twizel Bridge (see Figure 8), located in England, is a shallow stone arch bridge built during the early sixteenth century (Co-Curate). It is a bridge with a high round arch

and a single 90-foot span, that was constructed from small stones and arches serenely over the River Till. This bridge was important to the area because it provided a dry crossing over the River Till and aided English troops in battles against Scottish troops (National Transport Trust). Twizel Bridge is a good example of a stone bridge that was created for practical purposes, yet also serves as a beautiful physical link over a geological feature.

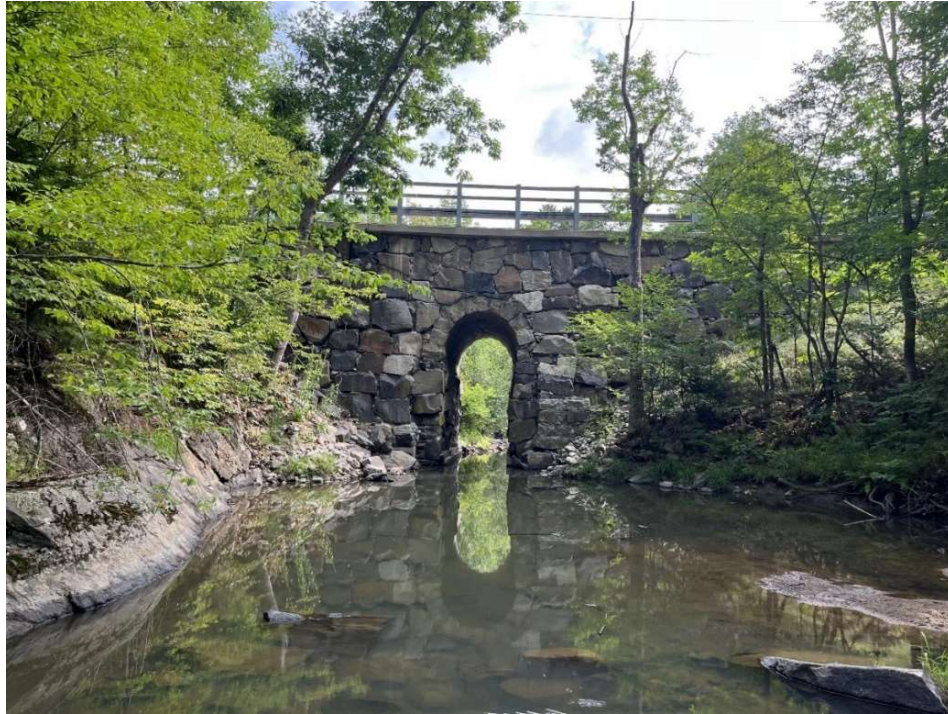
*Figure 10. Stackpole Bridge after rehabilitation*

Stackpole Bridge was built in 1848 and is located in southern Maine in the city of Saco (see Figure 10). It is a dry-laid, stone arch bridge spanning Stackpole Creek, with an arch that has a springline opening of seven feet and a rise of 18 feet. The full width of the bridge, including the walls, is approximately 50 feet and it carries two-way traffic.

The final award of the contract went to CPM Constructors, a Maine general contractor from Freeport, for \$1.2 million (Ouellette). While the original proposal envisioned a new bridge deck supported by micropiles driven into the structure, analysis of the rubble inside the bridge required the contractor to adjust their approach. They proposed the blended rehabilitation of the existing Stackpole Bridge. This included retaining the existing arch (see Figure 13) and addressing internal structural issues by using a partial concrete structure within the existing bridge dimensions, while keeping the exterior stone façade of the bridge virtually unchanged (see Figure 10).

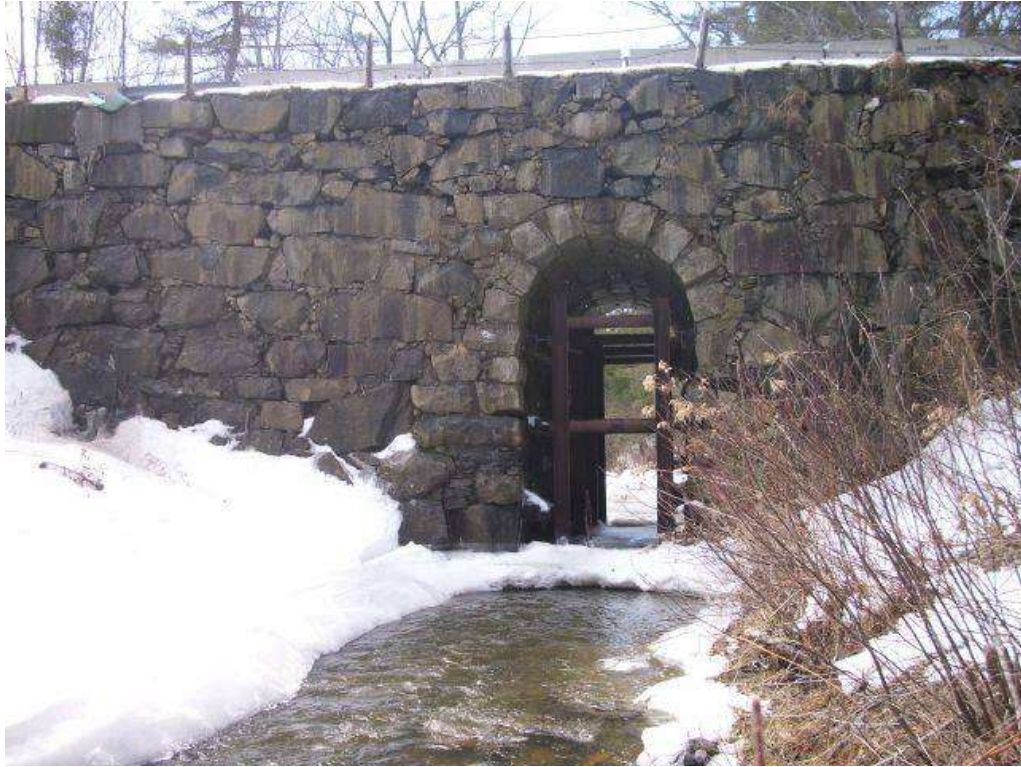
*Figure 11. Steel structure in the arch of Stackpole Bridge prior to rehabilitation (Maine Preservation)*

In the early 2000s, the Maine Department of Transportation reviewed Stackpole Bridge because the city thought it needed to be replaced, since there were visible signs of structural distress. The inspection revealed that a temporary steel structure made with columns and girders located underneath the arch would be a satisfactory temporary fix (see Figure 11). However, in 2001 this steel structure caught debris from floodwaters which flowed through the arch and entangled the steel girders, causing problems with the bridge to accelerate (*Stackpole Bridge: The Story in Stone*). Over time, water from floods had flushed any sand or gravel that was in between the stone in the bridge. Additionally, larger live loads from increasingly heavy vehicles crossing the bridge caused the sides to bulge out. In 2002, traffic over the bridge was limited to one lane because the bridge continued to deteriorate (Maine Preservation). Also in 2002, a report from the Maine Department of Transportation recommended that Stackpole Bridge be monitored for maintenance and repair (Graham).

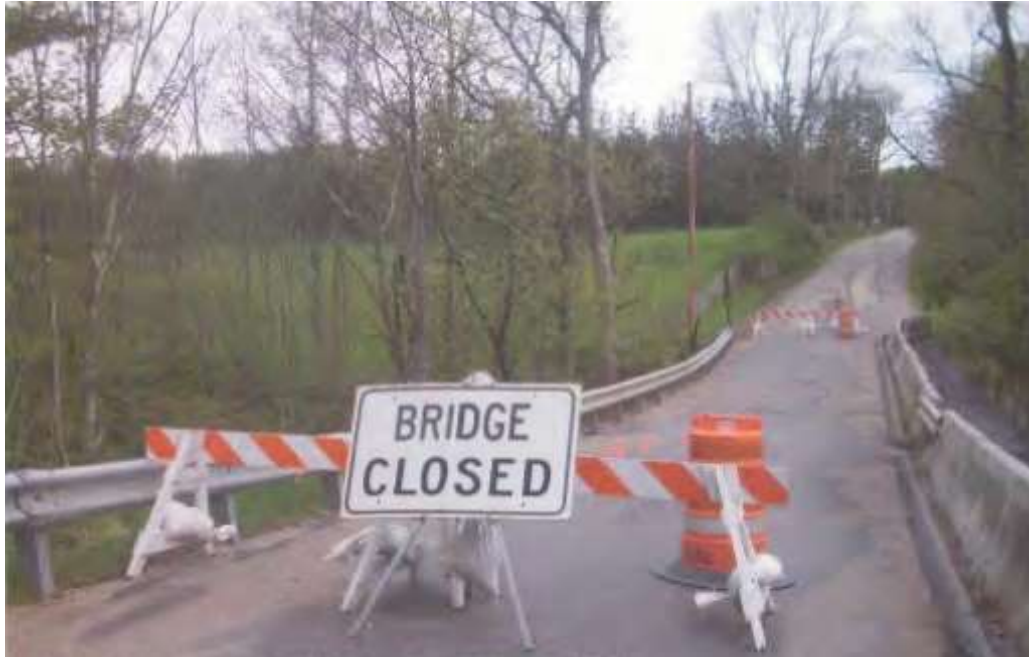
*Figure 12. Stackpole Bridge when it was closed in 2013 (Maine Preservation)*

In 2013, Stackpole Bridge was fully closed to all traffic due to its severely overstressed condition (see Figure 12). City officials began discussing more seriously what should be done to make the bridge usable and safe. A committee was formed by the Saco Public Works department, Fire Department, and the residents who lived near Stackpole Bridge to discuss the options for the bridge.

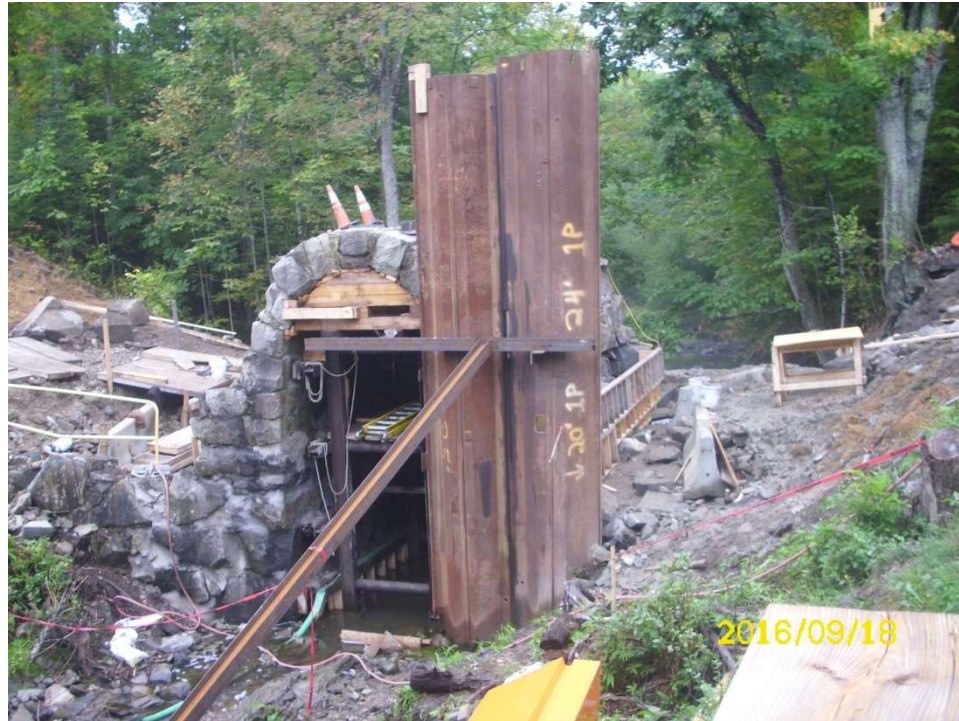
*Figure 13. Stackpole Bridge during rehabilitation (Friends of Stackpole Bridge)*

Construction of the bridge started in the summer of 2016 and continued through the winter until the bridge was completed in the summer of 2017. As part of the revised approach by the contractor, the stones of the bridge were taken apart piece by piece, while the complete arch remained in place. The stones were marked and stored by their original location for proper placement in the rehabilitated structure. A cast-in-place reinforced concrete structure was constructed around the remaining arch to create a stable bridge superstructure (see Figure 13). The original steel bracing from the early 2000s was left in place during construction to aid as formwork, and it was fully removed prior to the completion of the rehabilitation. Precast concrete pieces provided a skeleton for the rehabilitated bridge walls. The original stones were then used as a façade for the bridge, serving no structural function, but maintaining the look of the historic Stackpole Bridge.
