X International Conference on Structural Dynamics, EURODYN 2017

The Different Response of Apparently Identical Structures: a Far-Field Lesson from the Mirandola 20th May 2012 Earthquake

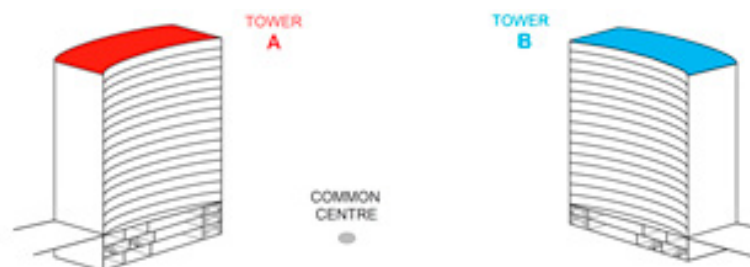
Figure 1. Sketch of the two towers.

North East off the Old City of Bologna (Northern Italy) there exist two modern structures (tower A and tower B) - identical to the sight - characterized by the same geometry and construction style, set at about 120 m distance one from the other (Figure 1). The height of both towers is 56 m and their basement area is approximately 20 by 40 m. The horizontal section of the towers is a portion of annulus with a common centre. The two structures are located at different distances from the centre, which results in a slightly different curvature, hardly perceptible to the sight. However, the different curvature is mostly an architectural element since the façade, built with lightweight steel

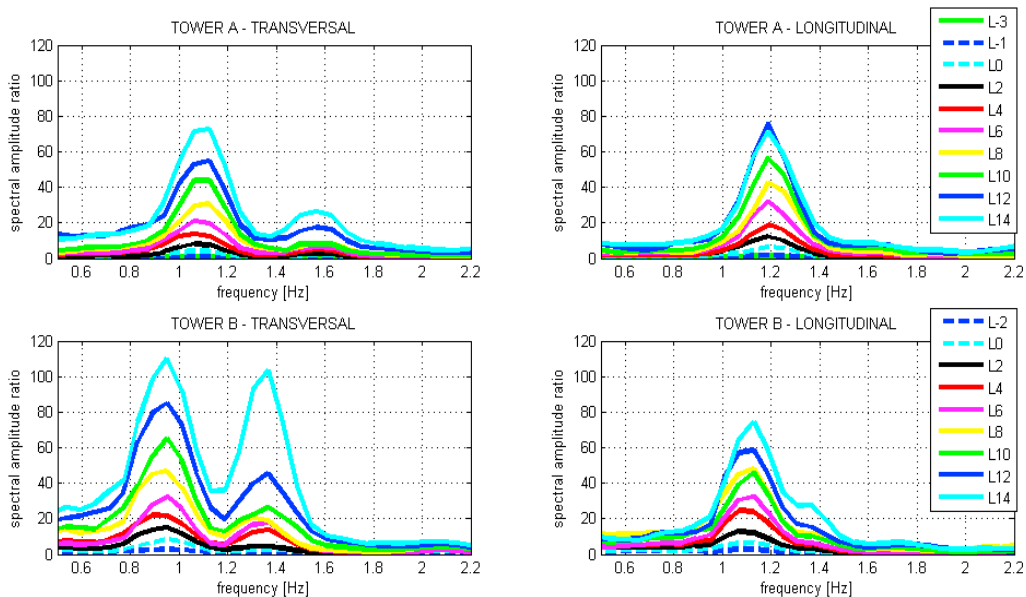
Figure 2. Modal frequencies of towers A and B obtained from the ratio of the spectra recorded at the different levels and those at the reference level (foundation floor). We observe that the behavior along the longitudinal axis is rather similar, while a substantial difference (both in terms of frequency and amplitude) appears on the transversal axis.

The dynamic characterization of the structures was conducted in passive mode, using seismic microtremors as an excitation function. On each tower we recorded the motion at all the even levels on a vertical alignment close to the barycentre (as close as possible, compatibly with the tower accessibility) and on a vertical alignment close to a corner. Since in passive surveys the source is spatially distributed and may change with time (e.g. due to wind, traffic etc.) a reference instrument was set at the foundation level of each structure while moving the other instruments at different levels along the same vertical axis. Eventually, all the measurements were referred to the reference instruments, which therefore acted as a 'normalization'. In order to ensure the stationarity of the excitation, the survey was conducted in a short time span (approximately 3 hours), by sampling microtremors for 15 minutes at each location and continuously at the reference sites. Longer measurements (6 hours) were conducted at the topmost levels of the two towers to characterize their damping. The experiment was conducted simultaneously on the two structures using four Tromino[®] digital tromographs (MoHo srl). Each instrument is a stand-alone unit which can be linked to the others through the built-in radio and which measure both velocity and accelerations. The instruments were simply laid down on the surveyed floors with no particular anchorage other than the instrumental weight (~1 kg). The survey was conducted twice, the first time in July 2012 and the second time in May 2013. The analysis allowed us to obtain: 1) the modal frequencies, 2) the modal shapes and 3) the damping. The modal frequencies appear as peaks in the horizontal spectra of the recorded motion at each floor. However, in order to normalize for the possible amplitude drifts of the natural input during the measurement, spectra recorded at each floor were divided by the corresponding (in time) spectrum measured by the reference instrument at the foundation floor. This results in plots with a dimensionless y-axis, since they represent ratios between amplitude velocity spectra. Due to the absence of wind during the surveys, we assumed that the main difference in the excitation function came from the subsoil and this is the reason for putting the reference instruments at the foundation level. Results are shown in Figure 2 and indicate that the first flexural mode of tower A

is at 1.1 Hz in the transversal direction and at 1.2 Hz in the longitudinal direction. The modal shapes for the transversal and longitudinal direction are shown in Figure 3. This tower was analyzed also 3 years before [1] and the modal frequencies and shapes obtained from the present survey coincide with those obtained from the previous survey, thus indicating that neither earthquake nor ageing have caused any structural damage to the tower. Measurements on the B tower had unexpected features: the first flexural mode in the transversal direction appeared at 0.9 Hz (that is 20% lower than the twin tower A) and at 1.1 Hz along the longitudinal axis (i.e. 8% lower than the twin tower B). From the above comparison we observe that the dynamics of the two towers is rather similar along the longitudinal axis (in terms of both frequency and amplitude) while - as anticipated - the transversal behavior is very different for two supposedly almost identical structures. Since the mass distribution of the two towers is very similar, a lower stiffness of tower B compared to tower A must be responsible for this difference. The slightly different curvature of the two towers is mostly an architectural element, therefore it is not expected to play a role higher than a very small percentage in this difference. The different depth of the foundation embedment could instead play a bigger role but, as we will see later from the results of a numerical model, can only account for about 6% of the difference. Other factors must therefore determine this difference: variations in structural layouts, structural details and material properties are the best candidates. In fact, the dissimilar layout of steel columns might also explain why the variation between natural frequencies is larger among the transversal rather than among the longitudinal modes.

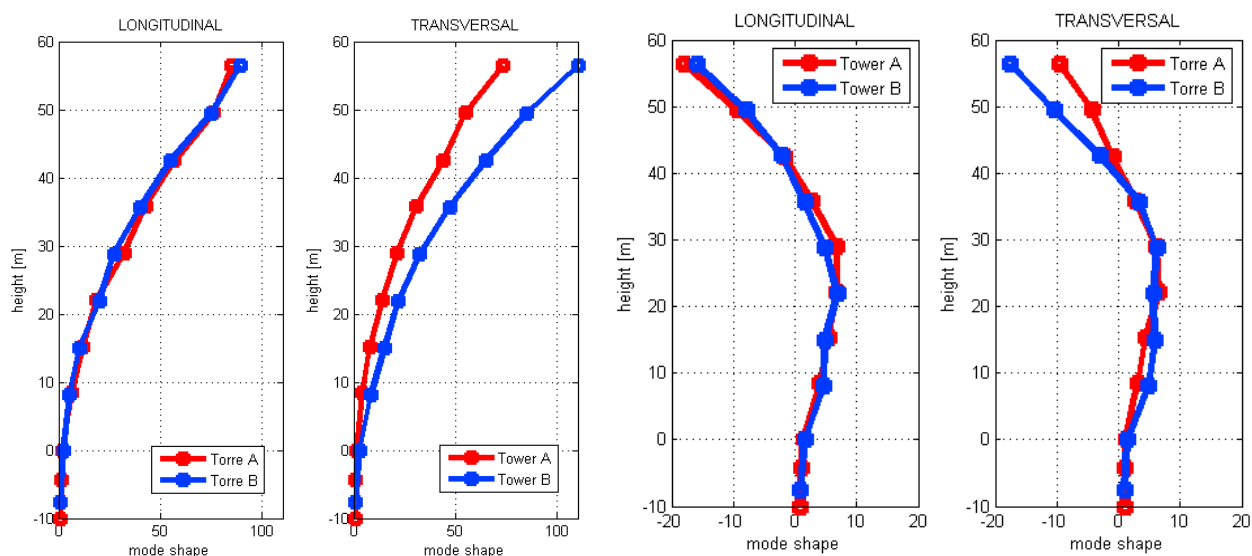
Figure 3. First flexion and second mode shapes (normalized to the foundation level) of tower A and B in the longitudinal and transversal direction.

For what refers to higher modes, the modal analysis revealed that the second mode (1.6 Hz for tower A and 1.4 Hz for tower B) is a torsion mode. This emerges from the correlation of the intra-floor (corner to centre) measurements which emphasizes the torsion modes. The second flexion modes appear at frequencies of approximately 4-4.5 Hz and shapes the structures as illustrated in Figure 3.
