10th CIRP Conference on Intelligent Computation in Manufacturing Engineering - CIRP ICME '16

High speed machining of Inconel 718: tool wear and surface roughness analysis

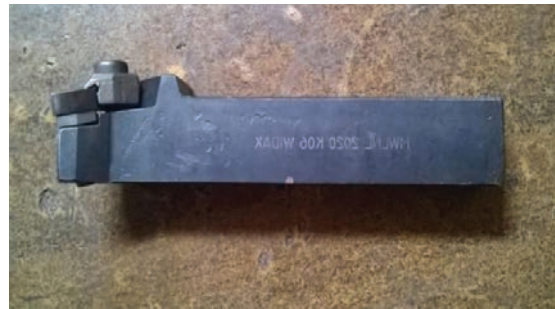
Fig 2.Tool Holder with Cutting Insert.

For the analysis rods of Inconel 718 are used with 30 mm in diameter and 60 mm in length (Fig. 1). The hardness of the material is 45 HRC. From 60 mm length of workpiece, 25 mm length is used for holding and 30 mm length is used for turning. The Carbide CVD coated insert with grade K 05-K25 and specifications WNMA 060408 are used for the machining. The tool holder is MWLNL 2020 - K06. Tool holder with insert fixed on it is shown in Fig. 2.

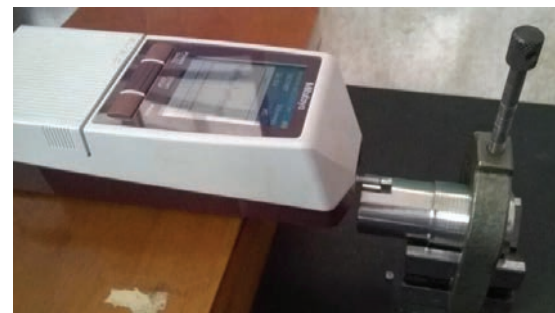
Fig. 3 Roughness measurement setup.

During the surface roughness measurement, cut off length is kept at 0.8 mm and evaluation length is 4 mm with probe speed. The set for surface roughness measurement is shown in Fig. 3. Tool wear is measured by Mitutoyo make Tool Maker's Microscope with L.C of 5 μ m.

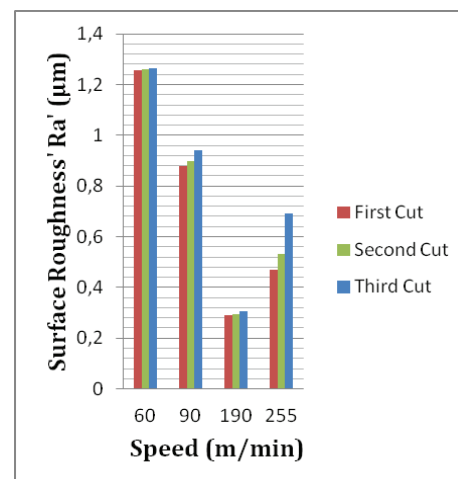
The graph of surface roughness (Ra) (Fig. 4) against speed reflects that surface roughness values are high at low cutting speeds i.e. at 60 and 90 m/min and low at higher cutting speeds i.e. at 190 and 255 m/min. This trend is because at high speeds there may a thermal softening of material and also at high speed there is a possibility that surface flaws gets wiped out as mentioned by [11].

Fig.4 Variation in Surface Roughness for Different Speeds

Interesting observation made during the investigation is that when cutting speed is changed from 190 to 250 m/min surface finish again deteriorate this is because at high cutting speed due notching of tool gets damaged immediately during the turning which is also visible in insert SEMs and high resolution photographs of tools.

One more thing must be taken into consideration that during the speeds 60, 90 and 190 m/min surface roughness is approximately same for all three cuts. But for highest speed of 250 m/min it increases with every cut this also because of rapid wear of tool. At lower cutting speeds during initial cuts tool wear is not so significant so with the speeds 60 and 90 m/min there is not much difference between the Ra values. For 60 m/min speed, the variation in surface roughness is 1.258, 1.259 and 1.264 (Table 1) so it can be concluded that at low speed tool will produce same surface roughness pattern for a longer period.

The similar trend is observed for 90 and 190 m/min speeds also. But for highest speed of 255 m/min it can be seen that roughness value goes on increasing with every cut. For this speed the variation in surface roughness is 0.469, 0.531 and 0.691. Therefore it can be seen from above pattern that though these surface values are very good the increase in roughness value with every cut is on higher side which indicates rapid wear of tool.

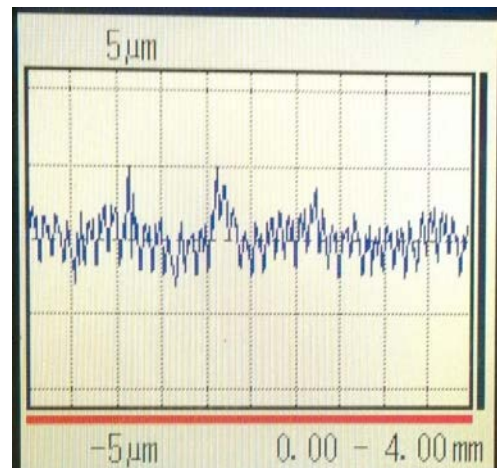
Fig.8 Roughness pattern at 255 m/min

The roughness patterns are shown in Fig 5-8. The patterns indicate that though the surface roughness values are high at lower speeds, the pattern is uniform throughout the turning length. At high speed pattern is not uniform at some point it suddenly increases which may be due to either vibration caused because of high speed or may be to instant notching of tool at high speed.

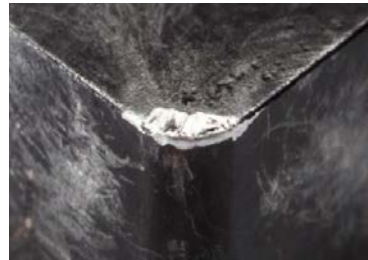
The measured values of tool wear after final cut are given in Table 2. SEM and HRP images are shown in Fig. 9. From Table 2 and Fig. 10, it is clear that, for same cutting parameters, tool wear is highest at cutting speed 255 m/min.

Fig. 9 Tool wear pattern at various speeds (SEM and HRP)

At high cutting speeds tool gets worn out at very faster rate with major tool failure patterns like heavy notching. Tool gets worn out almost up to tool life criterion at high speed which can be seen from Table 2 and graph shown in Figure 10. At high speeds burn marks are also visible on tool this is due to large amount of heat is generated during machining of Inconel 718 and most of this heat is diverted to tool because of poor thermal conductivity Inconel 718. Tool wear at 255 m/min is almost twice to that at 190 m/min and 3 to 3.5 times that at 90 and 105 m/min.

In conventional low speed machining at 60 and 90 m/min, tool wear rate is very less because of low temperature in cutting zone. At low cutting speeds no major signs of tool damage are observed. Wear observed is uniform along the nose radius along with some traces of peeling coating are also visible. At lowest speed of 60 m/min some traces of crater is observed on the tool.

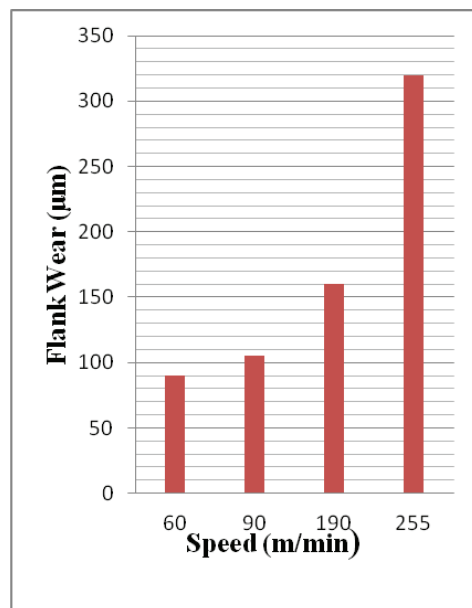
Fig.10 Variation in Tool Wear for Different Speeds
