The use of transverse connectors as reinforcement of multi-leaf walls

Marco Corradi · Antonio Borri · Elena Poverello · Giulio Castori

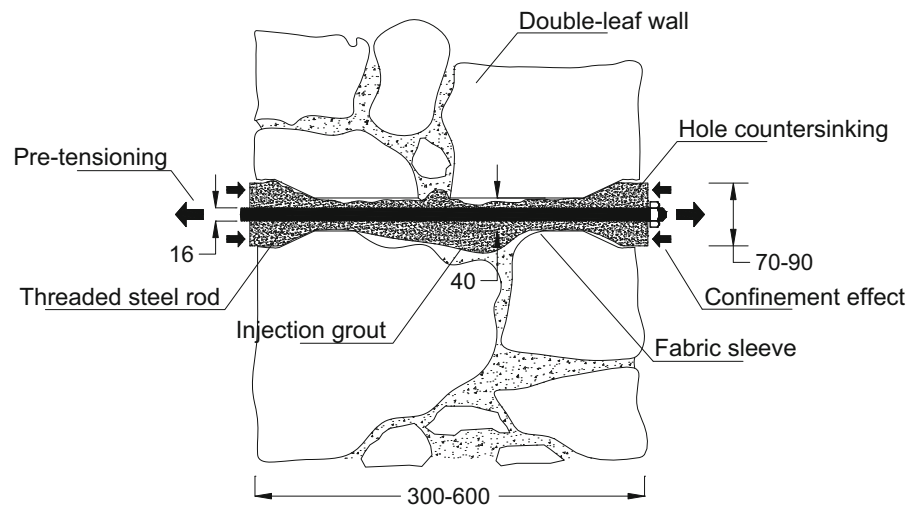
Fig. 3 Detail of the 16 mm-diameter connector (dimensions in mm)

90% greater than the diameter of the hole. Installation of the rod into the core-drilled hole (Fig. 3) was also followed by a pre-tensioning operation up to 10–20% of the rod yielding strength. Finally, the fabric sleeve was injected in pressure (2.5–5 atm, depending on the quality of the masonry material) using a high-strength ready-to-use cement-based grout. The effect of pre-tensioning and countersinking produced a confinement of the masonry material and increased the level of connection between wall leaves (Fig. 3). The fabric sleeve avoided unexpected scattering and wastefulness of the grout between the masonry. Thanks to its flexibility, it could expand, moulding itself into the shape and voids within the walls, providing mechanical bond. Although the use of cement is generally detrimental in heritage structures due to its scarce compatibility with historic masonry, the cement-based grout provided by the producer was still used here for the tests. In fact, the fabric sleeve encasing the anchor did not allow the cement-based grout to spread freely within the masonry, thus largely limiting the used quantity. The grout's mechanical and thixotropic properties and its low porosity also guaranteed the needed characteristics for the transmission of the loads between the masonry leaves.

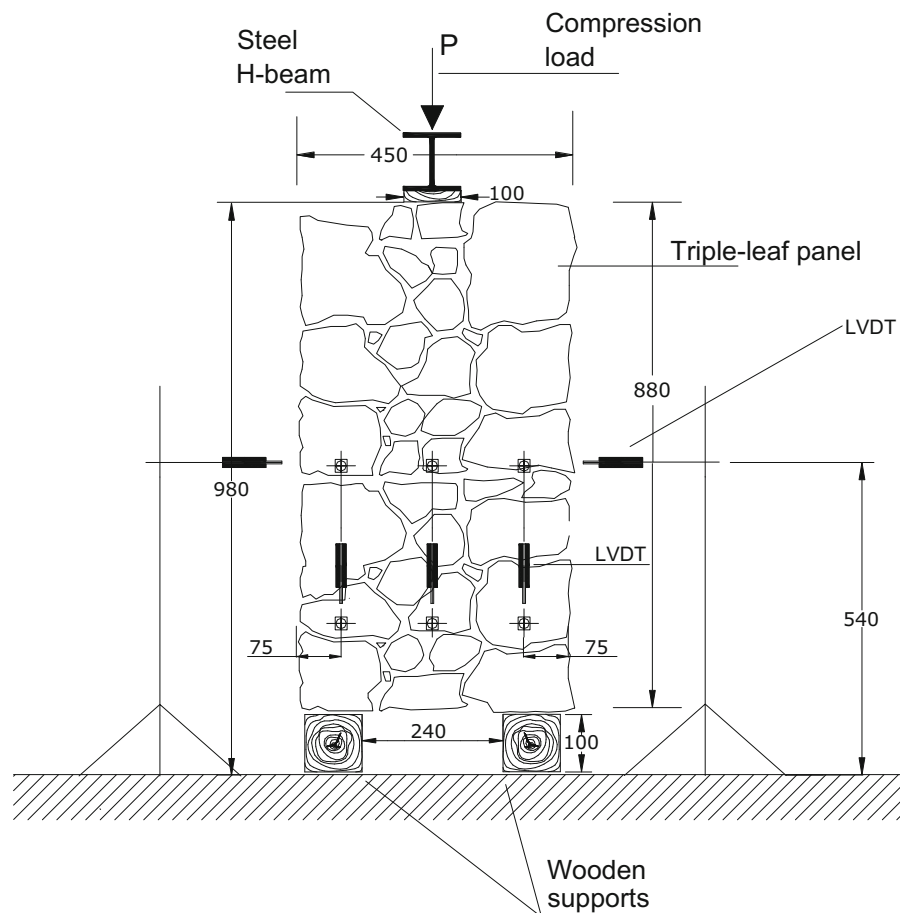
**Fig. 4** Shear test arrangement (dimension in mm)

external masonry leaves rested on timber prisms and the inner rubble core was loaded by the application of a compression force on the top of the panel. A drawing of the test setup is shown in Fig. 4. A 50-tons hydraulic jack was applied centrally to generate the vertical compression load on the inner rubble core. A steel H-shaped beam (flange's width = 100 mm) was inserted between the jack and the panel to achieve a uniform distribution of the vertical load along the panel's width. The width of both the panel and the steel beam was 0.88 m. The two wall panels were loaded at a rate of approximately 4 kN/min up to failure. The deflection of the inner core—critical to structural assessment—was obtained with contact instrumentation. Six LVDTs were used to measure the deformations of the three masonry leaves. Two more LVDTs were placed horizontally near the leaf's centroid to monitor the out-of-plane movements. All deflection measurements were logged continuously by LVDTs and readings included panel load and 8 LVDT over the duration of the test. Figure 5a shows the position of the transverse connectors used for shear testing.

Two full-scale masonry wall panels were built in the laboratory for shear tests. Each panel was made of a triple-leaf wall and the inner core was loaded in compression in order to study the shear response of the adjacent masonry leaves (Fig. 4).

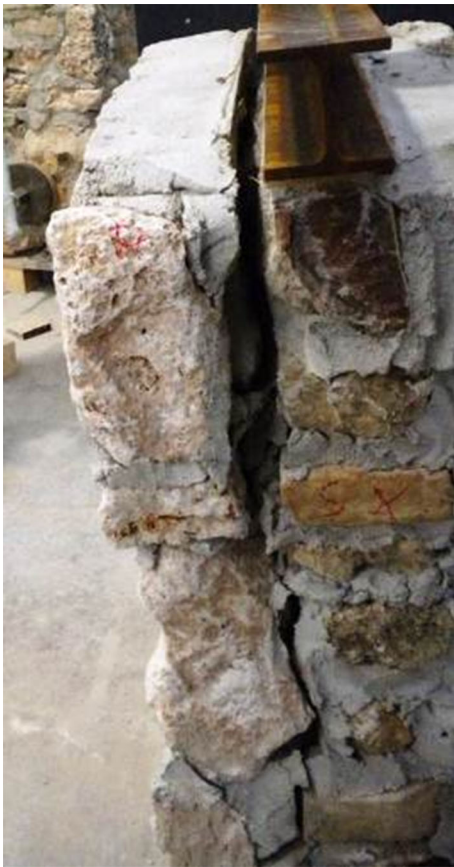
**Fig. 7** Failure mode (unreinforced panel)

Results of unreinforced Panel 1Un clearly demonstrated that the vertical planes between masonry leaves were critical for the overall behavior of a triple-leaf wall. Mechanical interlocking was not able to prevent the separation between masonry leaves. A maximum compression load P_{\max} of 34.11 kN was recorded (Table 3). Failure was by splitting of the inner rubble core from one of the two external wall leaves. The failure occurred progressively in a non-brittle manner: a vertical crack opened near the point of application of the load and propagated toward the wall base (Fig. 7).

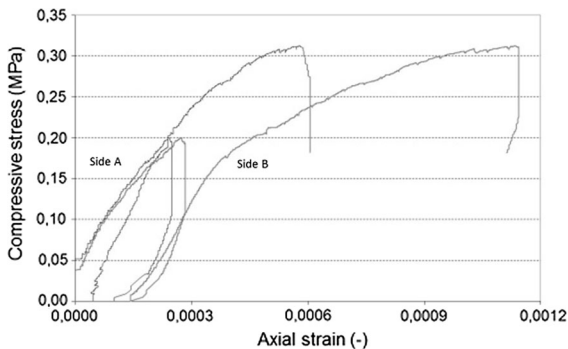
Fig. 9 Stress versus axial strain of masonry leaves for unreinforced panel 3Un
