Built Cultural Heritage and Energy Efficiency. The Sicily Case: Pros and Cons of an Innovative Experience

To cite this article: A Buda *et al* 2019 *IOP Conf. Ser.: Earth Environ. Sci.* **296** 012001

A Buda^{1*}, V Pracchi¹ and R Sannasardo²

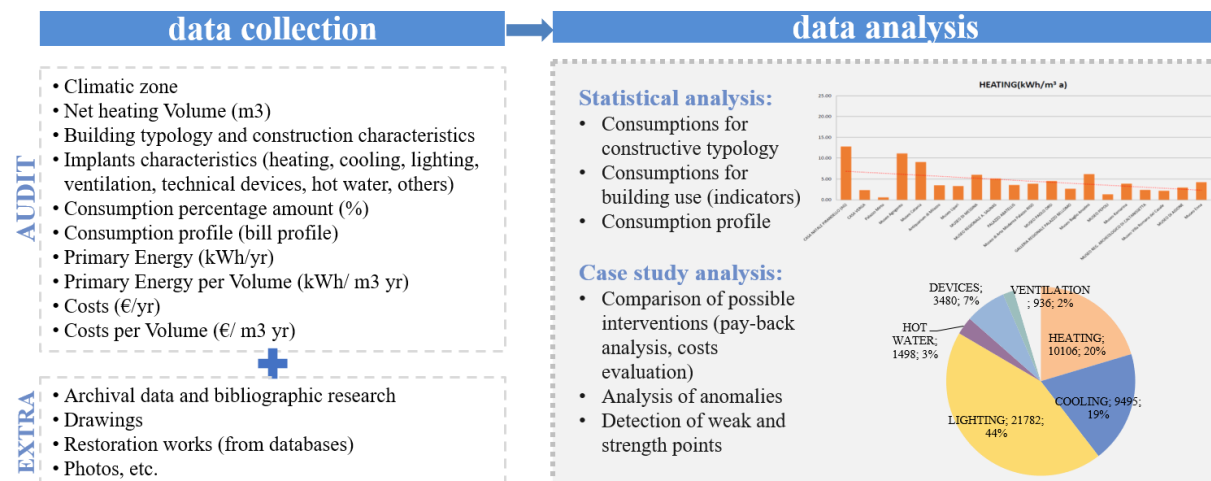
Figure 1. Data analysis method.

After that, we collected all data to compare them systematically, in order to obtain consumption profiles, incidence rates of consumption type, hourly variation of the building use and assessment of the current management costs (Figure 1.).

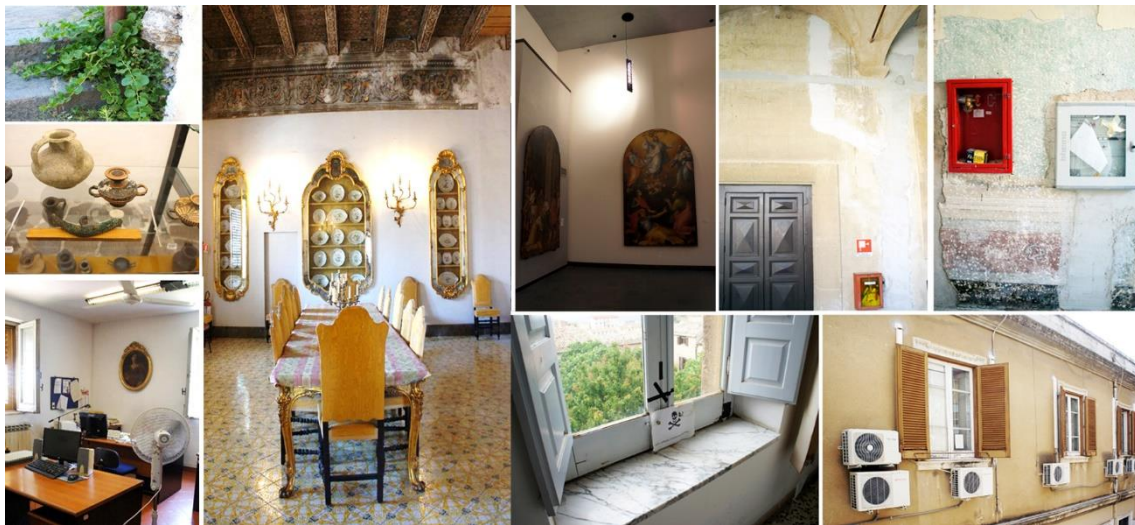
Figure 2. Collection of examples: buildings and artworks with poor maintenance conditions; implants insertion without an explicit logic. (Photos by Buda 2018)

For almost all case studies a common problem is the lack of maintenance, both of building and plants. One of the main issues for older buildings, as with porous materials, is the presence of water and the variation of the relationship between T° and Humidity [14]. In the Antiquarium of Milazzo, we find huge problems due to a rainwater percolation from the rooftop, causing widespread efflorescence and microbiological formations on the north-west walls. Observing the roof, it was seen how the downspouts, embedded inside the walls, are obstructed by caper weeds, also present at the building basement. A simple periodic check and the predisposition of a leaf filter grill would have been enough to remedy the problem. Pirandello's House presents important problems of water capillary ascent, but during the visit it was possible to recognize the cause in a drainage water pipe just in correspondence of the masonry. The simple verification and replacement of the pipe could easily solve this long-standing question. In Palazzo Abatellis, on the other hand, there was a mould problem due to condensation damp in the basement floor corresponding to the staff changing room. During the survey it was observed how some cabinets were closing an air channel causing this problem, easily to be solved with the reopening.

In the case of the archaeological sites, problems are mostly linked to a wrong positioning of the lamps or to a bad choice of lighting fixtures for lighting the remains. Hence, high consumptions with low yield. But even in this case, the lack of maintenance disadvantages a more sustainable and efficient use of lamps. In the case of Baglio Anselmi, for example, recent restorations have provided only the implementation of the pathway along the routes in the archaeological area; however, the presence of weeds, the lack of recognizable flooring as well as the negligence in which the entire roofing and lighting system over the Roman mosaics occurs, makes the site not fully accessible.

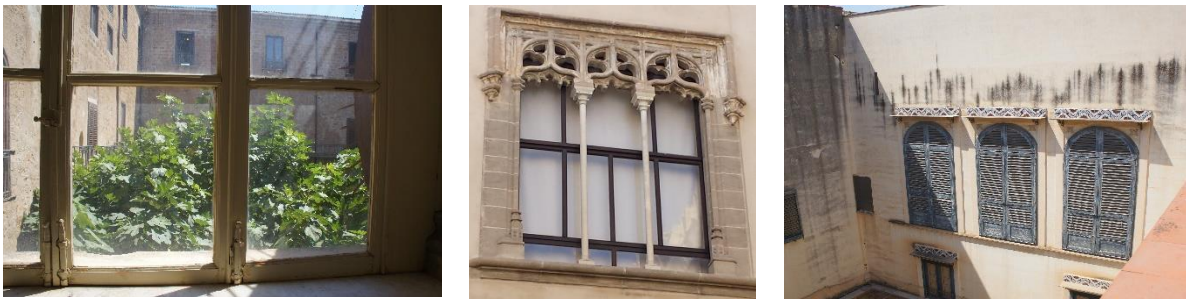
Figure 3. Few examples of windows and shadings to be preserved.

Also the windows substitution is claiming as a compromise between the needs of increasing the asset performances and the necessity of maintaining the architectural integrity of the construction: the replacement will be done only where the architectonic constraints or the state of decay allows it (e.g in the Superintendence of Enna); in the other cases, a restoration will be carried on, perhaps adding a reflective film, only after the compilation of an abacus for every case.
