THE FARMHOUSES OF THE ROMAN COUNTRYSIDE: CENSUS AND CATALOG. THE CASE OF THE ESTATE OF FARNESIANA

KEY WORDS: Cultural heritage, Digital archive, Cataloguing, Virtual reconstruction, Digital Survey

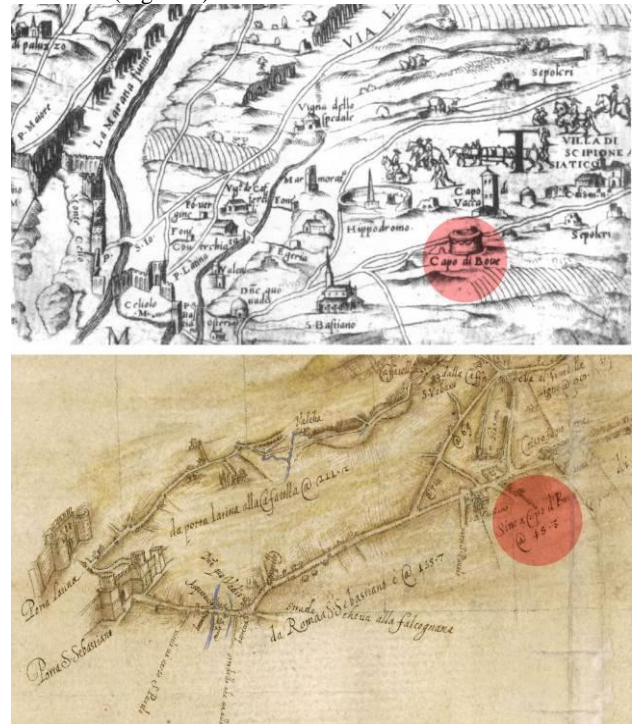
Figure 1. The first representations of the Roman Agro, above Eufrosino della Volpaia (1547), Catasto Alessandrino (1660). Identification of locality Capo di Bove.

Definitely, an attempt in this direction is made by the Catasto Alessandrino, although, depending on the surveyors who compiled maps, the information we actually find, cannot be really easily compared: sometimes with details and quality, other times poor even of basic notions. Besides the metric scales

and orientation are not always the same, creating more confusion (Figure 1).

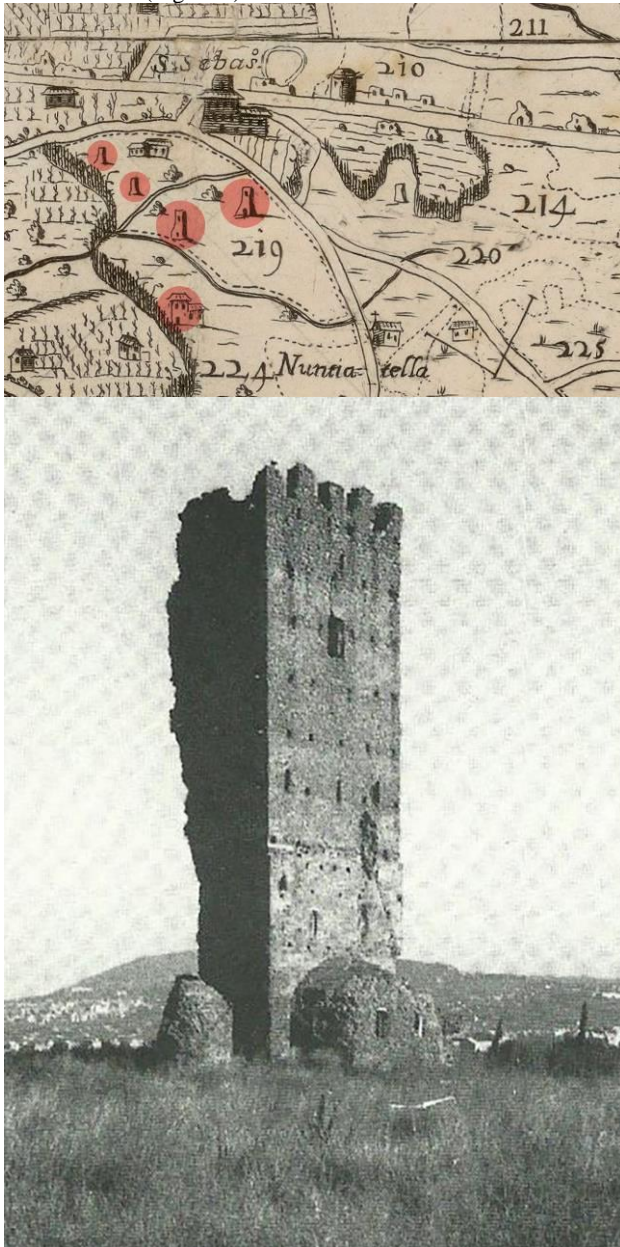
Figure 2. Planimetry of Giovanni Battista Cingolani della Pergola (1692) with identification of the Cinque Torri estate, the old name of Capo di Bove and of the respective defensive towers inside it. Below, Zampa di Bove, the last of the five towers, collapsed in 1985, due to the lack of maintenance interventions adequate for stability.

which, although with a worse graphic quality, gives more detailed information even in terms of visual emergencies. In particular, the estate of Capo di Bove, once called the five towers, is easily recognizable, both from the neighboring emergencies of the mausoleum of Cecilia Metella or from the Annunziatella estate, and from the presence of the five towers, the last of which, the "Zampa di Bove" tower collapsed during a storm in 1985 (Figure 2).

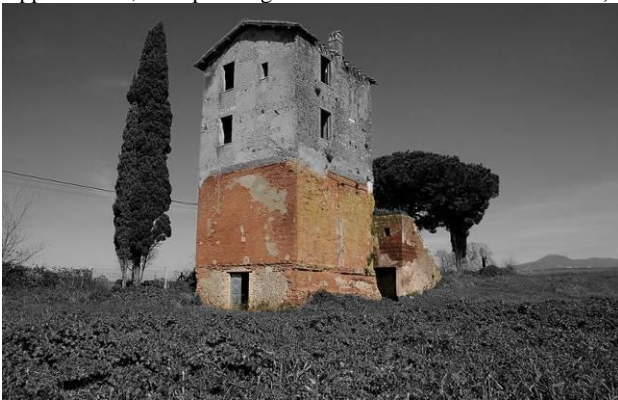
Figure 3. An example of reuse of Roman pre-existing buildings: the tower of Santa Maria in Fornarola, built on the remains of a domuscultae (in color in the image).

On the other hand, these features are also common to the productive villas built at the Roman time, and the countryside is rich in archaeological remains in this sense (Figure 3). It often happens, in fact, that the houses are built on Roman pre-existences, in some cases adopting the original functions, as for the cisterns (Ashby, 1970). In other cases, the ruins become foundations for new masons, while the old hypogeal rooms turned into warehouses or ice-houses (as in the Farnese estate). As often happened in Rome, the Roman remains become open quarries for the recovery of materials to be used in the construction of the houses, and it is common to find, set in the new walls, pieces of travertine, marble and decorations used to interpose the joints of bricks, or for architraves and door or window frames.

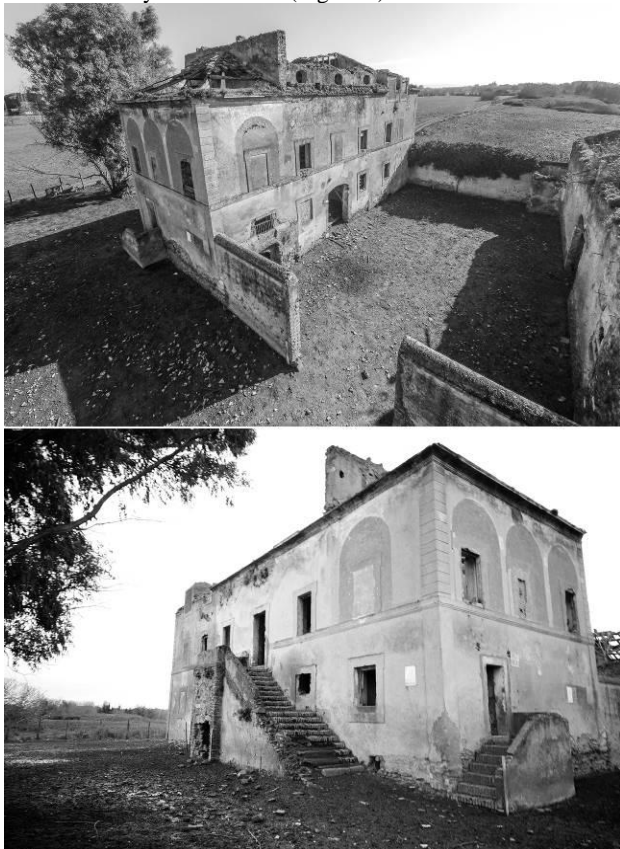
Figure 5. Two views of the Vigne Viola farmhouse.

This is precisely the case of the Vigne Viola farmhouse, built at the end of the 18th century, probably by of the Farnese family used as a hunting reserve, also for the peculiar characteristics that the territory presented, like the presence of a very thick tree cover of which today only the "Farnese grove" remains near the building, later sold, together as well as the estate, to the Torlonia family around 1810 (Figure 5).

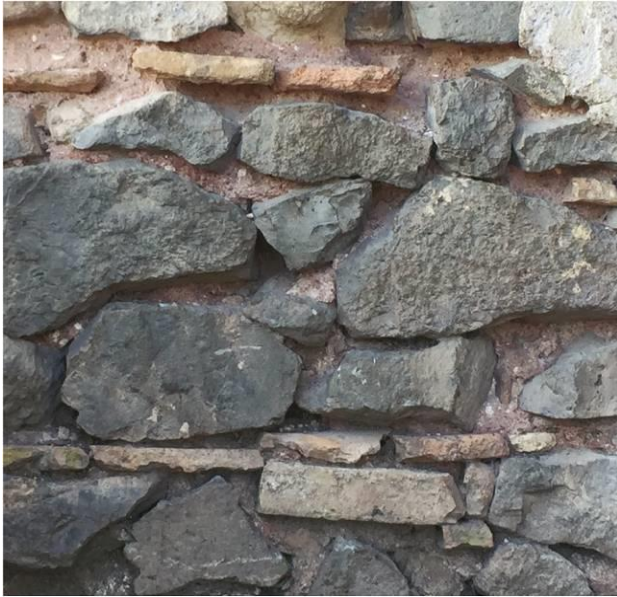
WALL BASEMENT

COMPOSITION:

Basalt , Full Bricks

COLOURS and DIMENSION:

Black basalt variable dimension, Straw yellow Bricks
length 11 /30 cm , width 15/18 cm , thickness 2.5 / 5
cm

MORTAR DESCRIPTION:

The mortar shows itself tenacious, with a pinkish color, with small and medium-sized aggregates such as red pozzolana.

DESCRIPTION:

Mixed masonry composed of basalt and brick. The stone material is the most present, worked by roughening it. The bricks have the function of regularizing the laying surface.

STATE OF PRESERVATION:

Poor. As the original plaster layer has gaps that have accelerated the alteration process of the wall face

Figure 6. Example of knowledge, survey and analysis of one of the present wall hangings of the Casale delle Vigne Viola.

The wall layer resting on the basement can be seen in the south elevation where there is a collapse that reveals an *opus incertum* type of masonry composed of a conglomerate of mortar and stones, mainly basalt and light-yellow sandstone; hypothetical layer also on the remaining sides of the building (Figure 6).

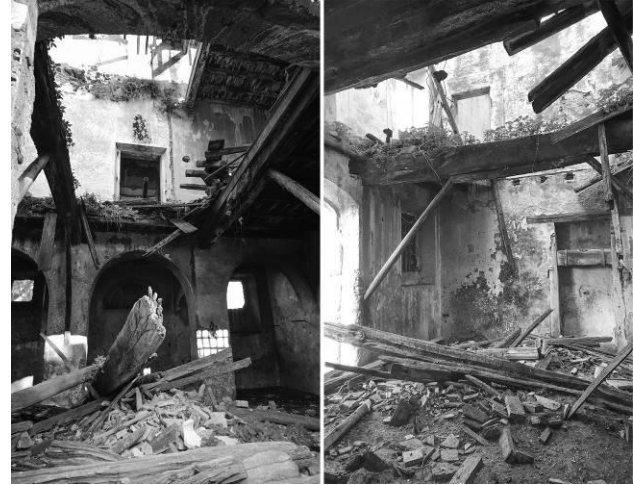
Figure 7. Internal collapses denounce the state of abandonment and the impossibility of detecting some Casale's areas.

The numerous collapses make it difficult to read the parts of the floor that still have a pavement (Figure 7). The visible parts described above for the floors which were partially walkable do not have a significant historical interest as they have recently been replaced. The only traces of original flooring are those found on the landing of the first-floor landing point of the *profferlo* and is presented in a discreet state of preservation with perimeter bands and internal herringbone mirroring typical of the farmhouses of the '700. The wooden roofs have suffered a greater degradation due to the atmospheric agents which were followed by collapses, even for the surely reconstructed parts. At this time the house has small portions of the roof still intact, but visibly unsafe, the main beams are in a state of irreversible decay. Most of the shingles used for the covering, seem to be of more recent invoice but in any case, also in a state of advanced degradation. Observing what remains visible through a photographic analysis with drone, the covering is assumed to have a double pitch starting from the south side for the first 3/4 of the building, up to the masonry where a second 3-pitch roof was supported, above the environment of the loggia, today completely collapsed.

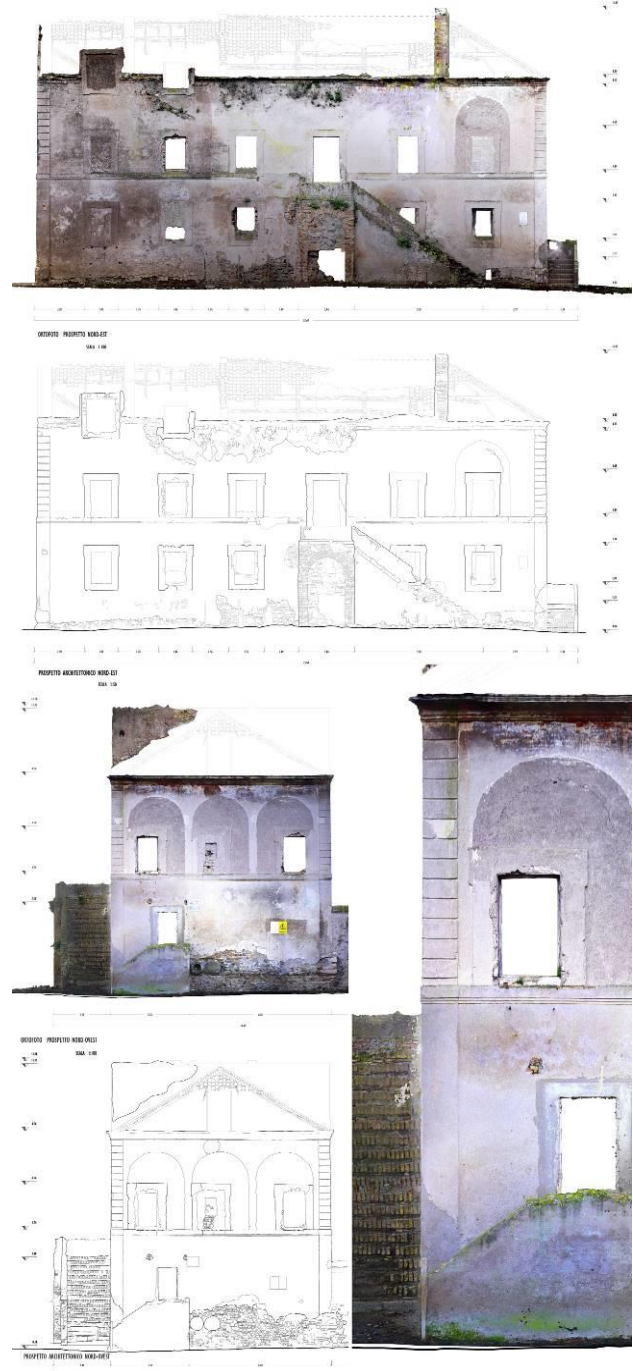
Figure 9. Survey of the elevations and identification of deterioration, superfetations and wall lesions. Orthophotoplans made from the three-dimensional photo-model allow easy mapping of materials and deterioration. Below, the loggia on the first floor is clearly visible, whose walls have been walled up in recent times.

transformations undergone, it is possible to detect structural lesions. This complexity highlights a process that in itself hides both an objective component, which leads to wanting to know and show a given building in its current forms, and a subjective component, which obviously depends on what one wants to represent of that given building at the expense of what, instead, leave out (Figure 9).

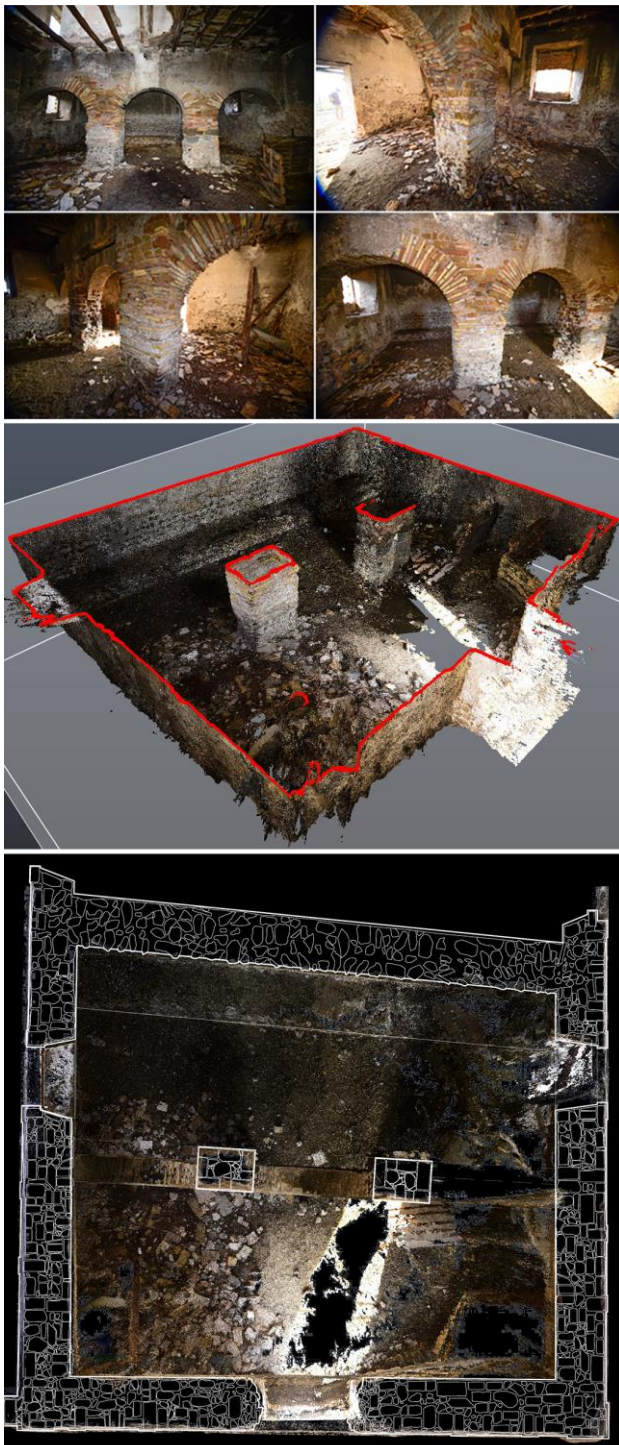
Figure 11. Photomodeling of the sheepfold on the ground floor: two point clouds (external and internal) were connected through the openings. The cloud was used to recreate the geometries of the room.

The collapses in the roof also weighed on the floors between the ground floor and the first floor causing further disruption making the central hall inaccessible. An additional photographic campaign has also allowed to detect the internal environments, which are also deeply degraded and in conditions of abandonment (Figure 11).
