18th International Conference on Rehabilitation and Reconstruction of Buildings 2016, CRRB
2016

Seismic Vulnerability Mitigation of a Masonry Church by means of CFRP Retrofitting

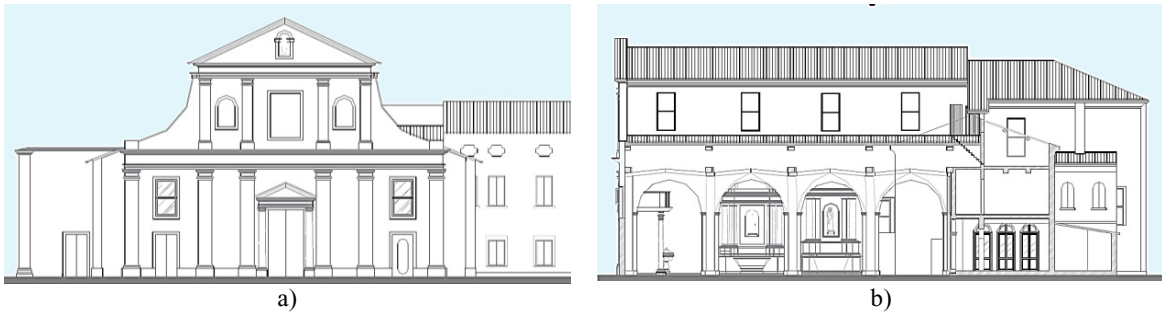
Figure 1. Natività della Beata Maria Vergine Church. a) Frontal view; b) Longitudinal Section.

The church of *Natività della Beata Maria Vergine*, is located in Vigarano Mainarda, a small city near Ferrara, Italy. This church is a structure constituted by three naves, with approximate dimensions equal to 31 m × 20 m × 13 m (length × width × maximum height). The frontal view and the section along the aisle are shown in Figure 1. The façade results poorly interconnected with perpendicular walls, thus making the hypothesis usually done in global finite element analyses (perfect interconnection among transversal walls) rather questionable. The lateral walls of the central nave result highly perforated, both for the presence of large openings surmounted by arches interconnecting central and lateral naves and for the presence of relatively large windows in the upper part. The church is connected in the rear to a secondary sacristy on the left and to a large oratory on the right; only a part of this latter structure is considered in the FE model, since the focus remains the analysis of the church. Finally, it is worth emphasizing that a light wooden roof is present, which is in agreement with the building traditional technology of such typology of structures in the region considered. Its membrane stiffness is safely assumed negligible for horizontal loads, as well as the box behavior induced by its presence in the FE models. For this reason, only vertical loads transferred by the roof to the head of perimeter walls are introduced in the models.

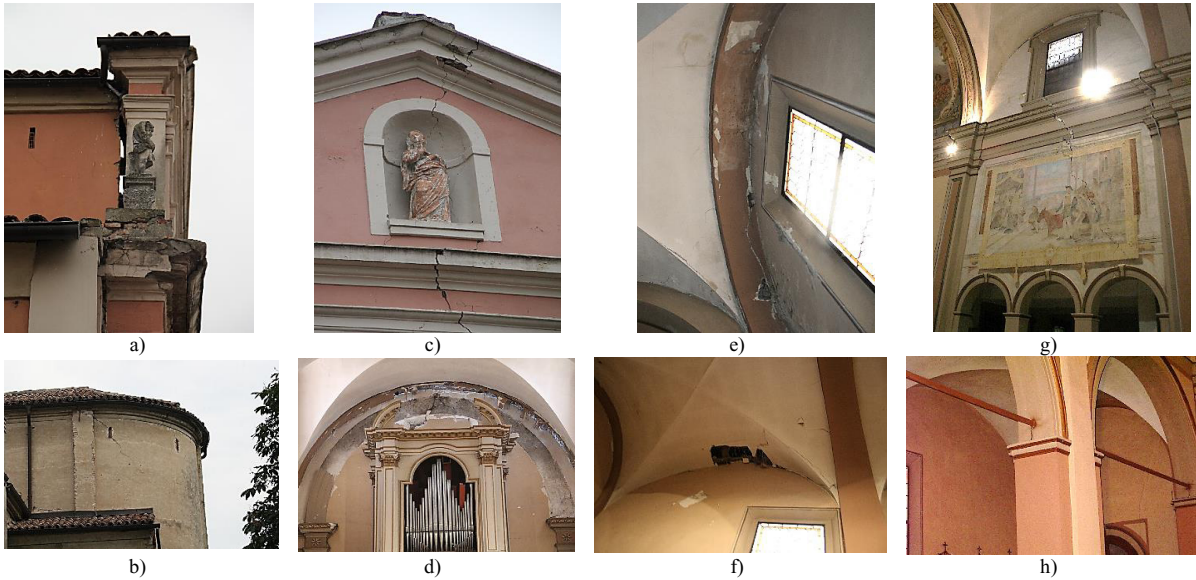
Figure 2. Observed damages after the Emilia Romagna Earthquake. a, b) Overturning of the structural elements. c) Overturning of the tympanum. d, e, f) Detachment of the vaults from the walls. g) Diagonal cracks in the chorus walls and h) longitudinal tie rods.

The church exhibits a fully active first mode failure mechanism on the façade, with visible overturning along a straight horizontal yield line. In correspondence of the upper part, the façade shows a large detachment from lateral walls, with displacements exceeding 10 cm, also demonstrating the rather poor interconnection between perpendicular walls, see Figure 2. This mechanism is evident in the upper part of the façade, the tympanum, because the lower part is connected with the rest of the construction with tied rods, which seem to have worked properly during the seismic event, see Figure 2 - h. The apse exhibits an almost active failure mechanism, with the formation of a 45° inclined crack departing from the upper part and developing for a couple of meters, see Figure 2 - b. The failure mechanism, albeit not fully active, suggests the out-of-plane rotation of a portion of the apse around a horizontal hinge placed in correspondence of the middle height. A notable detachment between the ceilings and the walls in almost all the vaults is present. The arches and ribs of the vaults are conceived with a wood frame, with a lathing surface and finished with plaster. Its low stiffness compared to the stiffness of the masonry walls made to concentrate the deformations in the joints, see Figure 2 - d, e, f. In absence of experimental data available, mechanical properties adopted are generally those available in the Italian code for masonry made by clay bricks and lime mortar (the common one in that region). They are the following: 1500 MPa for the Young modulus; 2.4 MPa for the compressive strength; 0.1 MPa for the tensile strength [15]. A smeared crack total strain material model for masonry, which allows for an investigation of the non-linear behavior, is adopted for the FE code.
