AIIT 2nd International Congress on Transport Infrastructure and Systems in a changing world
(TIS ROMA 2019), 23rd-24th September 2019, Rome, Italy

GPR research on damaged road pavements built in cut and fill sections

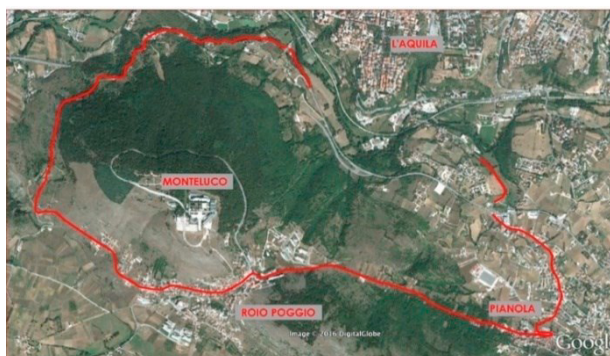
Fig. 1b. Non-urban roads of L'Aquila investigated with GPR (red color).

Therefore, the inquiry was performed on fourteen sites (Figs. 1a, 1b) chosen to be representative of the combination of the variables analyzed. The same sites were identified on the non-urban road network located close to L'Aquila (central Italy). Be informed that the studied area is placed at an altitude of 700 m above sea level and is characterized by cold winters.

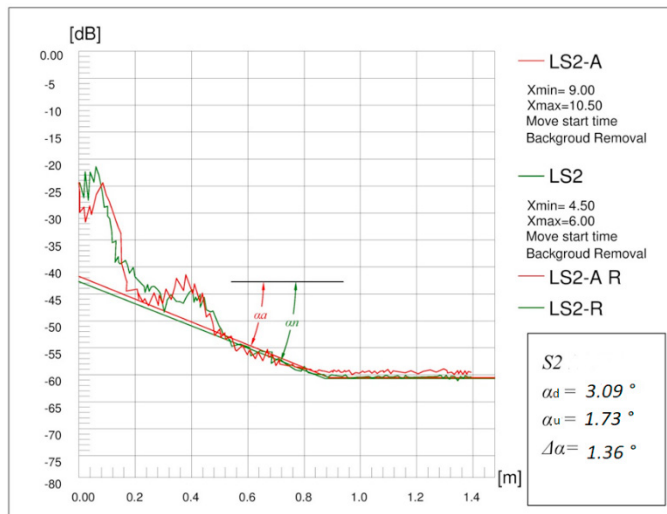
The relative diagrams for the two contiguous sections surveyed (both damaged and undamaged area) were included in the same graph to highlight their differences. The red colored diagrams are related to the degraded road sections; while those of green colored diagrams belong to the intact portions (Colagrande et al. 2011). By making comparisons between attenuation corners of damaged areas (α_d) and undamaged (α_u), it is expected that if the difference between these values ($\Delta\alpha = \alpha_d - \alpha_u$) tends to zero, then the probable cause that generated the deterioration of paving is attributable to phenomena of fatigue or thermal shrinkage. These phenomena are due to horizontal tensile stresses that develop in the S1 layer of the road pavement (Figure 2a). In fact, in this case, in the S2 layer the energy curves are almost coincident, which means that the subgrade terrain relating to the two examined road sections, display the same degree of densification and there are no compactations in place (Figure 3).

Fig. 3. Example of the $\Delta\alpha \cong 0$ case.

In this regard, it is noted that the accuracy in the interpretation of radargrams is a function of the antenna resolution and sampling the electromagnetic signal; in our case they are respectively of 1 cm and of 1024 samples per second. Furthermore, the resolution in the power sweep diagrams is of 1 dB for the signal attenuation (y-axis), and of 4 cm from the road surface to the depth (x-axis). This approach provides a detailed resolution to be able to evaluate areas up to 1 cm² in a thickness of road pavement/cut and fill section up to the depth of 1.5 m (Figures 3, 4 and 5).

For the findings, we can state that, in the light of the considerations set out in the preceding paragraph, the deterioration caused in the S1 layer (Figures 2a, 3) are normally generated by horizontal tensile stresses due to fatigue or thermal shrinkage affecting the surface layers of the road pavement. Generally, the rupture of the road pavements depends from the undersize of layers respect to traffic loads. Moreover, the breaking of the surface layers in S1 may depend on deep settlement, which originate at the base of the detecting portion of the embankment of the cut and fill section (Figure 6).

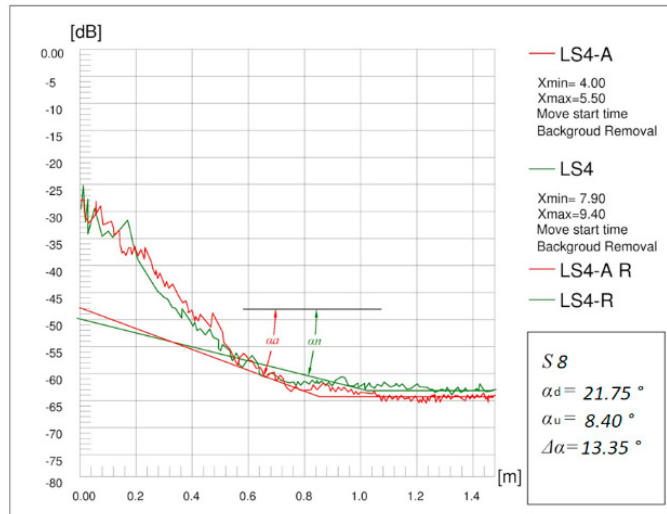
If instead, $\Delta\alpha \neq 0$ the probable cause that triggers the degradation of the road pavement is attributable to the change of soil compaction portion of the cut and fill section present in the S2 layer due to the action exerted by vehicular traffic. In this circumstance, we must make a further distinction between the case in which $\Delta\alpha > 0$ and the case in which $\Delta\alpha < 0$ (Benedetto and Benedetto 2002). In the first, the energy curves for the damaged areas (red) are at a lower energy content than those undamaged (green). This means that the deteriorated areas are more compacted of the not deteriorated areas. More precisely, the energy curves for the damaged areas (red) are positioned beneath those undamaged (green), and this confirms the fact that a lower power consumption level corresponds to an index of lesser void ratios (Figure 4).

Fig. 4. Example of the $\Delta\alpha > 0$ case.

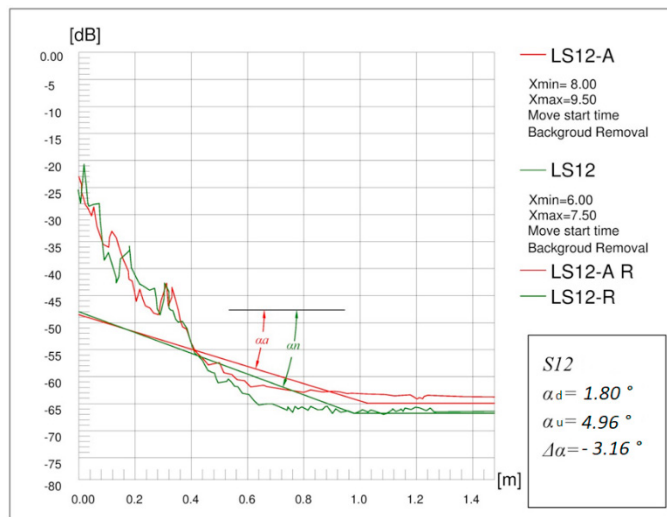
Fig. 5. Example of the $\Delta\alpha < 0$ case.

More precisely, the energy curves for the damaged areas (red) are positioned above those undamaged (green), and this confirms the fact that at a power level absorbed corresponds a higher void ratio greater (Figure 5).
