25th International Conference on Fracture and Structural Integrity

Fatigue assessment of the collapsed XXth Century cable-stayed Polcevera Bridge in Genoa

Stefano Invernizzi^{a,*}, Francesco Montagnoli^a, Alberto Carpinteri^a

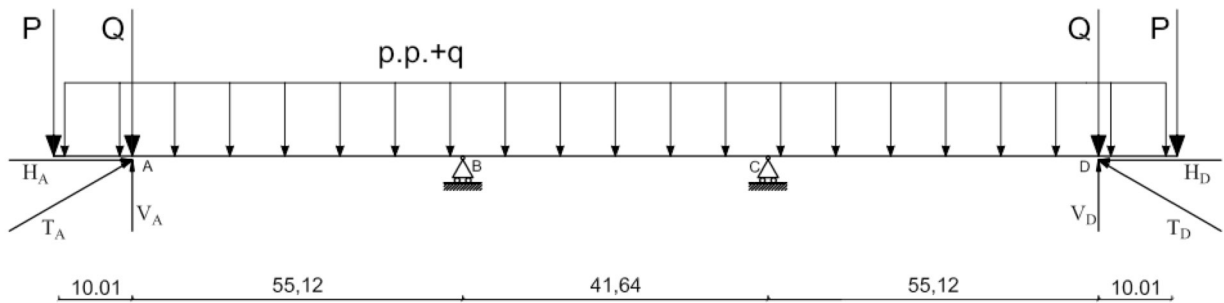
Fig. 3. Static scheme used for the evaluation of stresses in the stay cables due to the permanent loads.

According to Morandi's design concept (Morandi, 1967), the principal stay cables were supposed to support the permanent loads. The tension in the strands was set such as the vertical displacement of the deck at the connection point with the stay cables would vanish. As a consequence, the static scheme shown in Fig. 3 allows for an easy determination of the axial force in the two couples of stay cables due to the permanent loads, whose values are reported in Tab. 1. The tensile forces in the stay cables are obtained by projection of the vertical reaction forces in A and D on the cable direction. The statically indeterminate reactions in A and D are identical due to structural symmetry and can be derived imposing compatibility equations.

Notice that the construction process was highly complex also because of the use of temporary strands, which were removed once the main stays were in place. It is worth noting that, the structural scheme represented in Fig. 3 provides the value of the axial force in the stay cables with a good approximation.
