2017 J. Phys.: Conf. Ser. 778 012008

Laser doppler and radar interferometer for contactless measurements on inaccessible tie-rods on monumental buildings: Santa Maria della Consolazione Temple in Todi

M Gioffré¹, N Cavalagli¹, C Pepi¹, M Trequattrini²

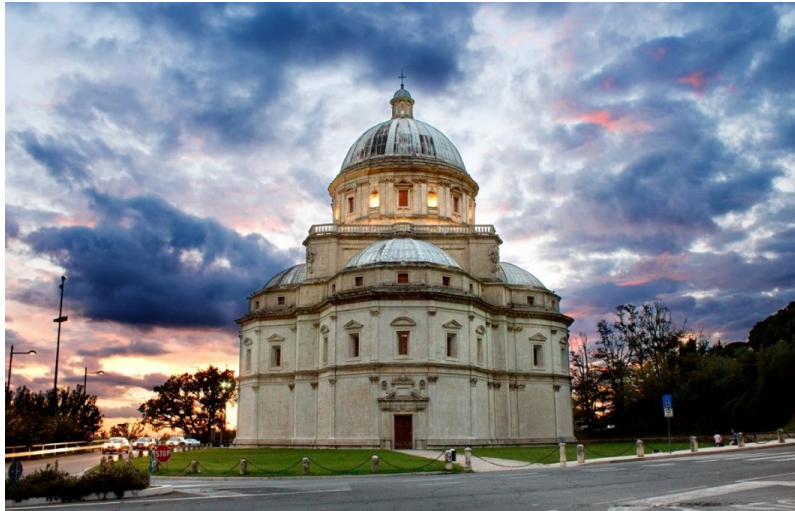
Figure 1. Temple of Santa Maria della Consolazione in Todi.

The Santa Maria della Consolazione Temple (Figure 1), one of the most important monumental buildings in Umbria Region, in Central Italy, is located in the South West Area of Todi's city. It is a Renaissance style church and it was built between the 16th and the 17th centuries. Although direct evidence is lacking, the first design of the structure can be assigned to Bramante [12].

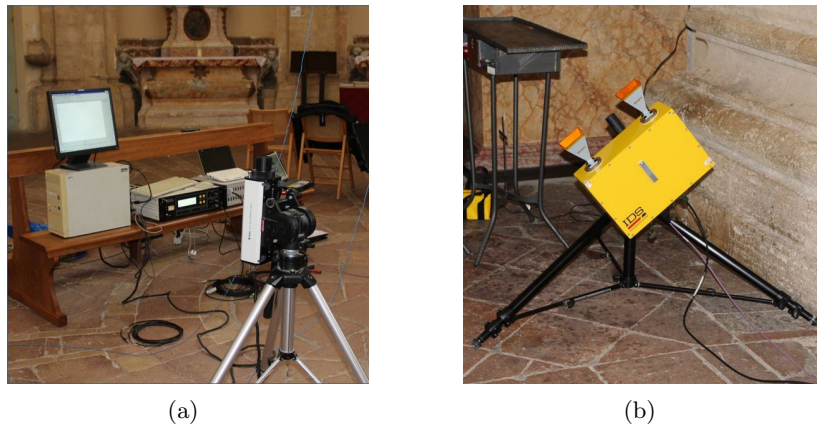
Figure 4. (a) Laser Doppler vibrometer system. (b) Radar Interferometer.

The laser doppler vibrometer used in this work is a Polytec OFV 3001 - OFV 303, controller and sensor head (Figure 4(a)), with resolution 0.25 nm, constant in the whole frequency range from 0 Hz to 250 kHz.
