CONDITION ASSESSMENT OF RC BRIDGES. INTEGRATING MACHINE LEARNING, PHOTOGRAMMETRY AND BIM

P. Borin ^{1*}, F. Cavazzini ²

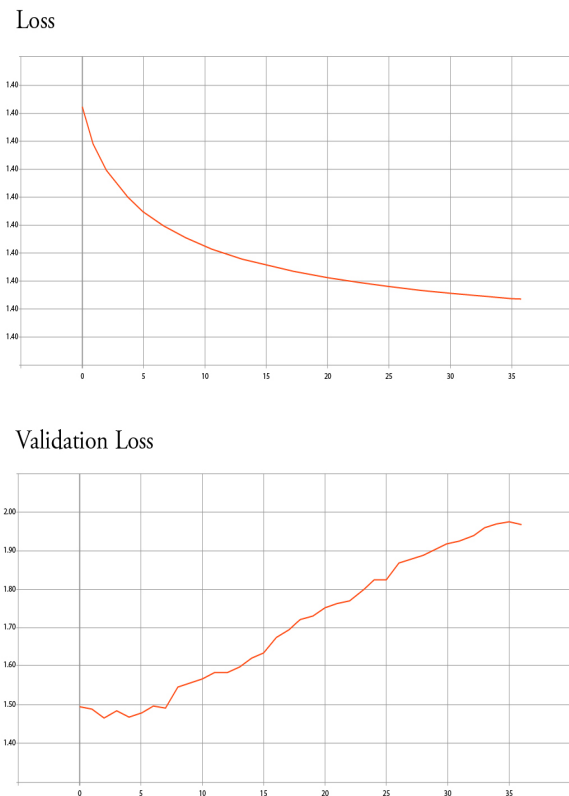
Figure 2. Loss and Validation Loss graphs from Tensorboard

The training phase was executed for 16 hours and a total of 80 epochs, each one with 575 steps and a batch size of 1 image per step. The tenth epoch model was used to perform the recognition of the degradation, in addition to which overfitting was beginning to occur (Figure 2).

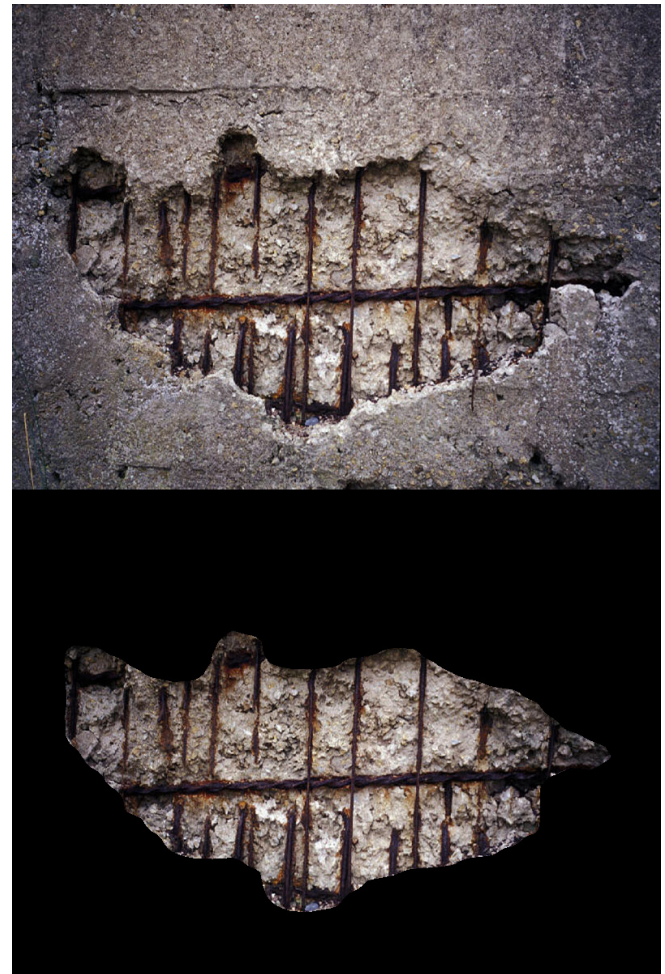
Figure 3. Example of spalling detection

detection, the algorithm extracts the images containing only the detected spalling (Figure 3).

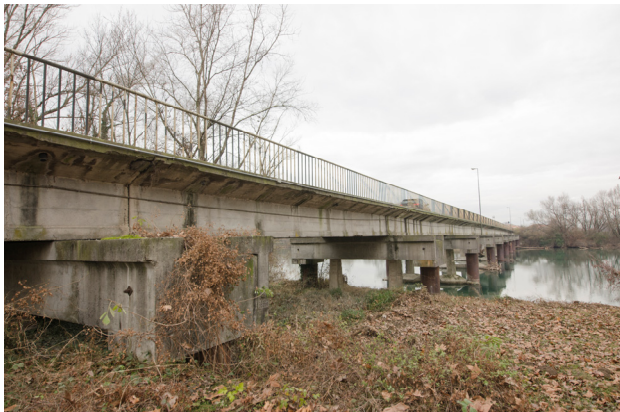
Figure 4. Current state of the bridge

A road bridge located in northern Italy was chosen as a representative case study. The bridge, about 250 meters long, is divided into 15 spans. The study analyzed the first three on the east bank.

The structure of the bridge is in reinforced concrete, composed of three longitudinal beams, supported by girder spans each supported by four pillars.

There is an evident state of degradation, with widespread concrete spalling, an ideal condition to test the validity of the proposed method.

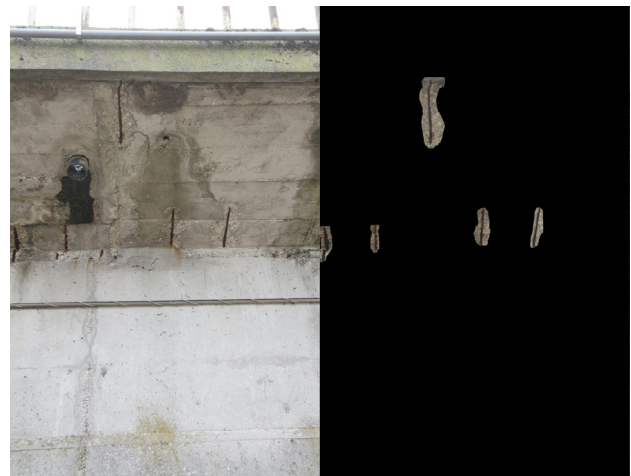
Figure 6. Detailed image of the slab intrados, at right recognized damages
