# Seismic risk of critical facilities in the Dominican Republic: case study of school buildings

## Abstract

## 6 Case study: the Fernando Cabral Ortega School

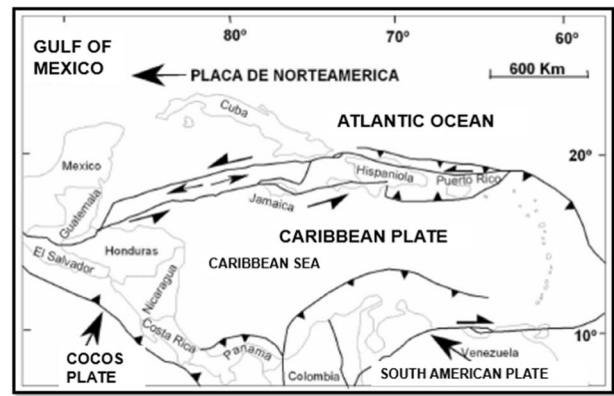
Fig. 2 a Tectonic plate locations and b seismic faults in the Hispaniola Island. Adapted from (COE 2009)

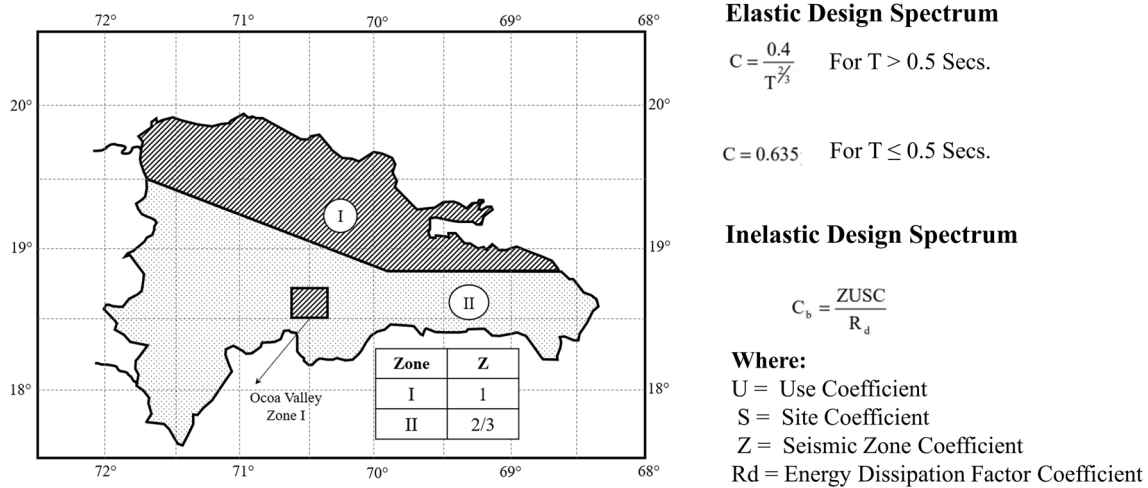
Fig. 4 Elastic and inelastic design spectrum according to the 1979 Dominican seismic code. Adapted from (SEOPC 1979)

The provisional recommendations for the seismic analysis of structures (SEOPC 1979) divide the country into two seismic zones: (1) high seismicity and (2) medium seismicity zone, as shown in Fig. 4. The design spectra, both elastic and inelastic, are shown in the same figure. It is important to mention that the  $U$ -,  $S$ -, and  $R_d$ -coefficients are tabulated values that depend on the importance of the structure, the site in which the structure is located, and the type of structural system, respectively.

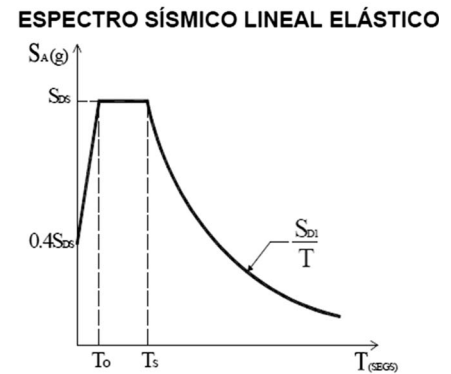
**Fig. 6** Elastic and inelastic design spectrum expressions as per R-001 seismic code. Adapted from MOPC (2011)

**Elastic Design Spectrum**

$$S_a = 0.6 \frac{S_{DS}}{T_0} * (T) + 0.4 S_{DS} \quad \text{For } T \leq T_0$$

$$S_a = S_{DS} \quad \text{For } T_0 < T \leq T_s$$

$$S_a = \frac{S_{D1}}{T} \quad \text{For } T > T_s$$

**Inelastic Design Spectrum**

$$C_b = \frac{U * S_a}{R_d} \geq 0.03$$

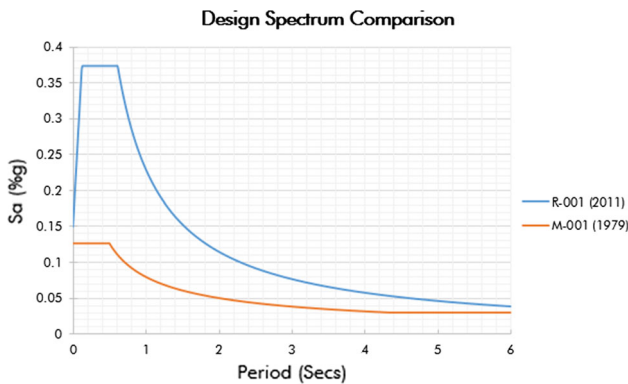
**Fig. 7** Design spectrum comparison for the San Cristobal Province

The comparison of the design spectra by both the 1979 and 2011 codes for a concrete frame school structure located in the San Cristóbal Province is shown in Fig. 7. Considering that, as first estimate, the fundamental period for a reinforced concrete (RC) frame structure can be evaluated as  $0.1 N$ , where  $N$  is the number of levels of the structure, for a typical school building of three levels, the seismic forces obtained from the 1979 code could underestimate such load in 61% (Table 2). Thus, it is necessary that school buildings designed with the former provisional regulations need to be assessed in order to determine the degree of vulnerability that such structures pose.

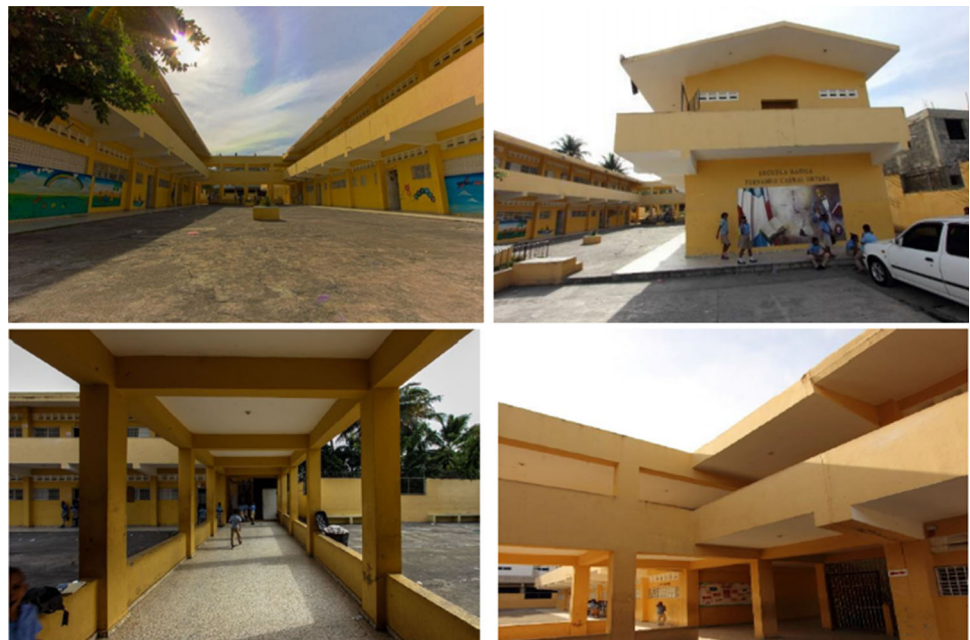
Fig. 12 Fernando Cabral Ortega School

The Fernando Cabral Ortega School is located in the community of La Jeringa, Municipality of San Cristóbal. The structure has a capacity for 400 students and was built in 1996. According to the School Vulnerability Report presented by ONESVIE, the structure resulted with a high vulnerability index. The structure consists of three building modules of two levels each connected by a corridor as shown in Figs. 12 and 13. The structural system is composed by RC frames in both directions enclosed by

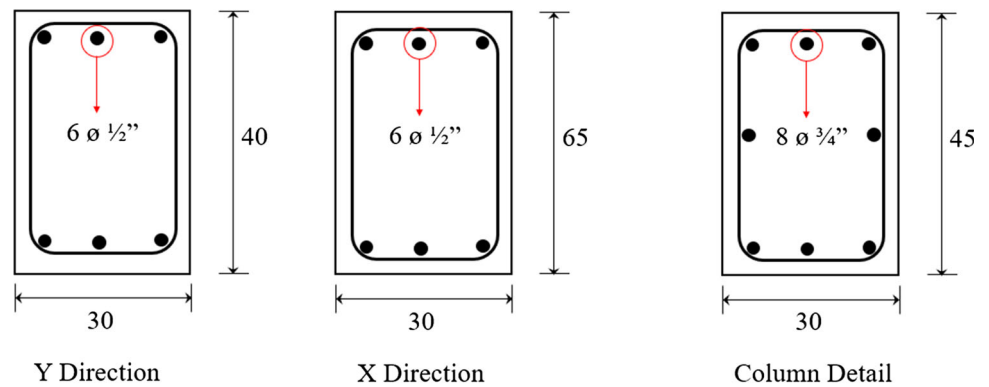
Fig. 14 Beam and column details

Beam Detail

The structural drawings of the sample building were not available; therefore, the cross-sectional dimensions of the elements, the concrete strength, and the reinforcement details were obtained from both the architectural and structural surveys, respectively. The cross sections of beams and columns are depicted in Fig. 14.

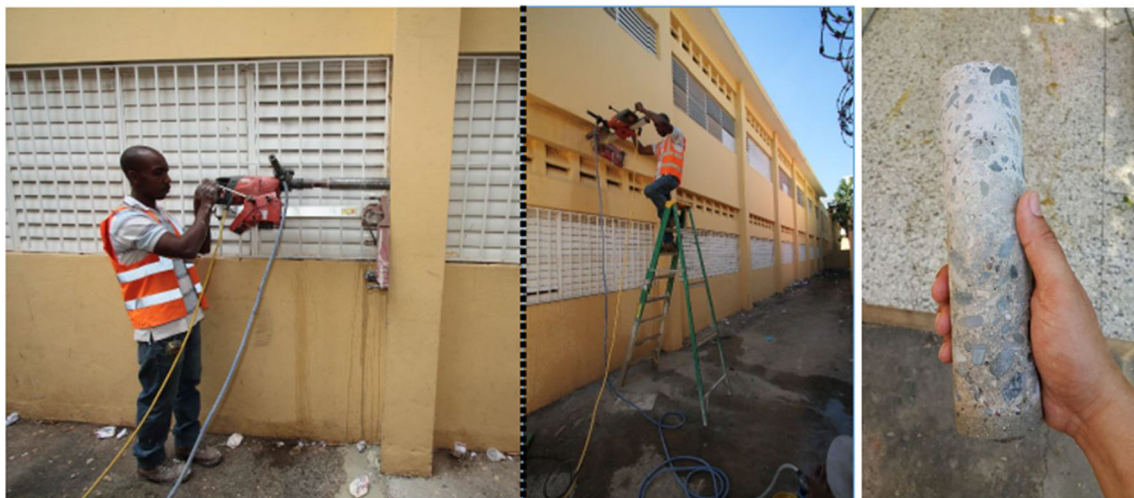
Fig. 15 Concrete core extraction

(three in beams and three in columns), in structural elements that resulted with higher load demand according to a preliminary structural analysis. The concrete core extraction process is shown in Fig. 15. The concrete test results for the beams and columns are shown in Tables 3 and 4, respectively. It is noteworthy to mention that three samples were extracted for the beams; however, the stress obtained from one of the tests was only 55 kg/cm<sup>2</sup> (5 MPa), which is clearly an outlier and thus was discarded.

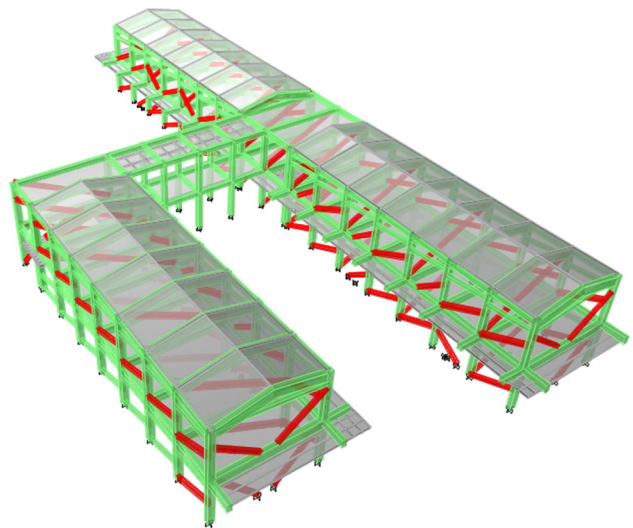
**Fig. 16** Structural model

In order to evaluate the behavior of the building structure, a numerical finite element model was created using the ETABS software (Computer and Structures 2005). Such model is shown in Fig. 16. Beams and columns were modeled according to the sections as depicted in Fig. 14. In both elements, the cracking effect as required by the R-001 was considered. To take into account, the effect of the masonry infill walls as an equivalent diagonal as suggested

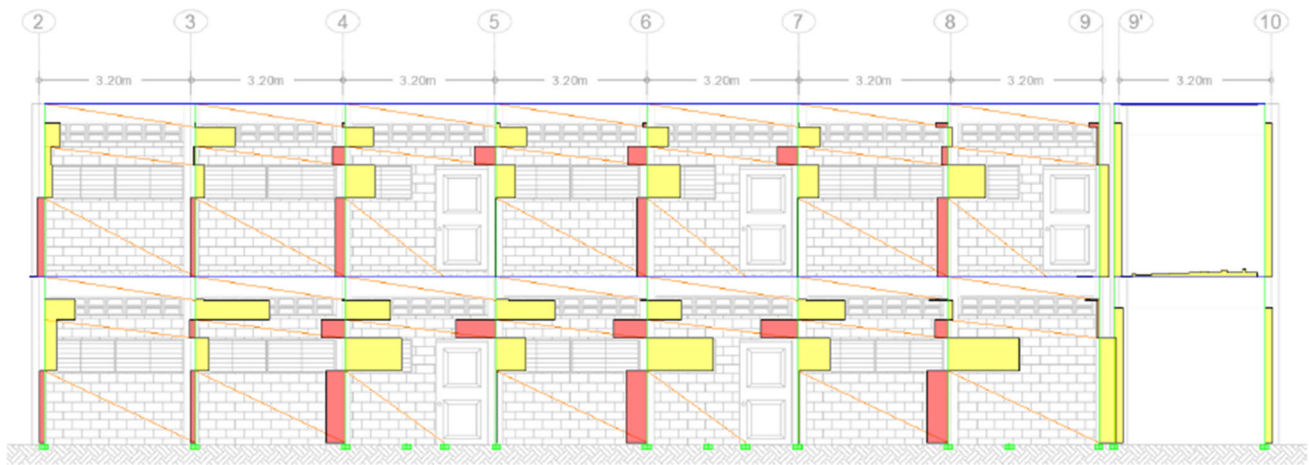
Fig. 17 Shear diagram in columns at the corridors

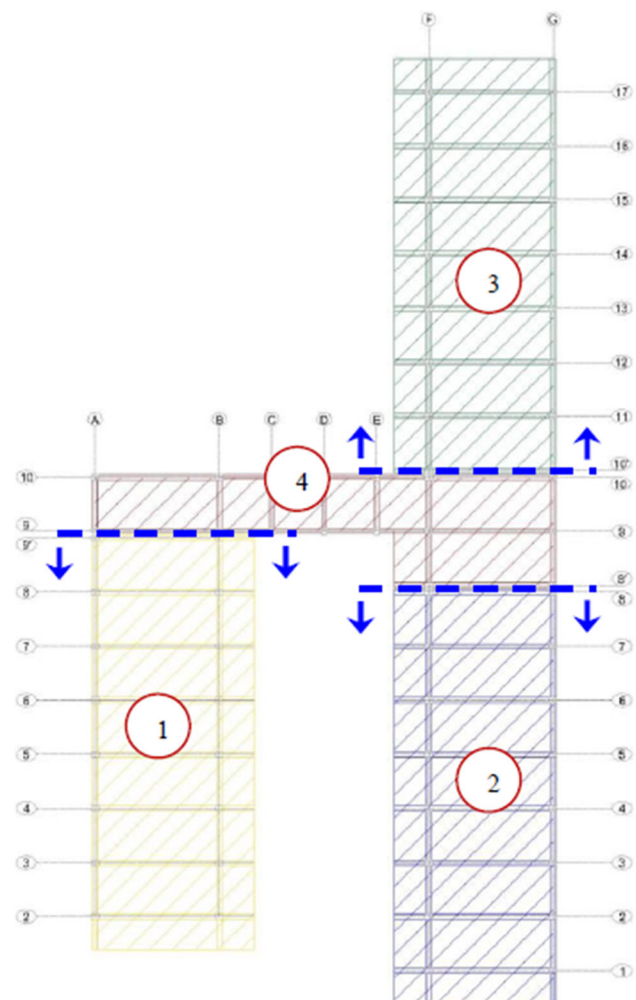
Fig. 18 Suggested construction joint

identified that the structures are separated by construction joints, however, the slab was cast in place continuously, which makes it behave as one body instead of four.

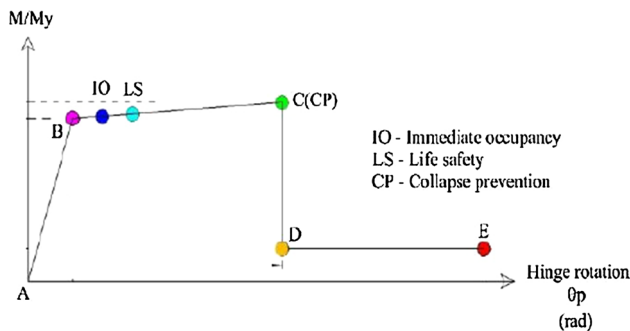
**Fig. 20** Plastic hinge model for flexural member

To evaluate the performance of the proposed modified structure, a nonlinear static analysis (pushover) was carried out. The properties of the plastic hinges for the beams and columns were defined according to the recommendations of the standard ASCE7-05 (ASCE 2005). The behavior of the plastic hinges (Fig. 20) was evaluated at the performance point of the structure, in terms of the rotations limits established by the ATC-40 (Applied Technology Council 1996) for buildings with special occupation. To these buildings corresponds an immediate occupancy (IO) level.

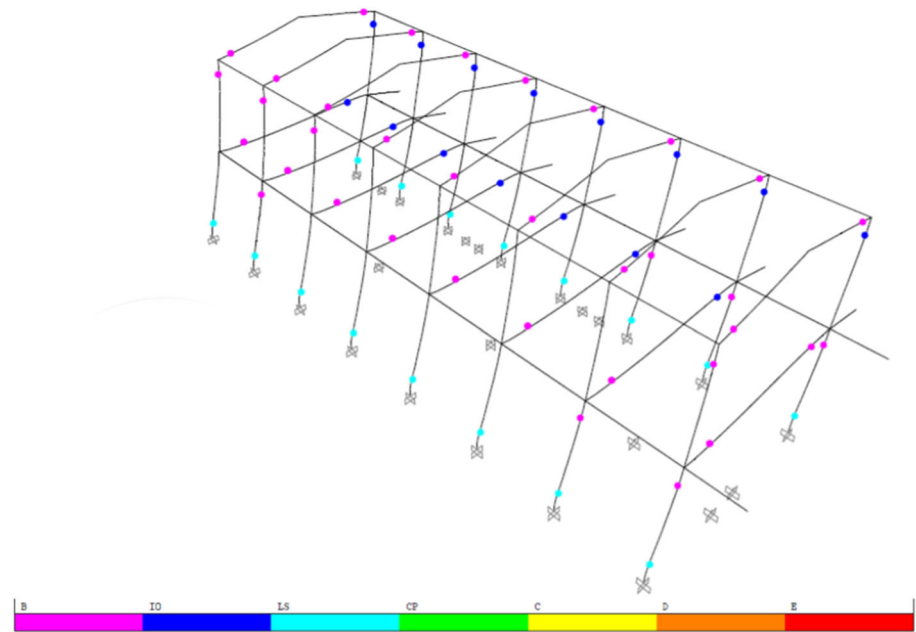
**Fig. 21** Plastic hinge behavior for pushover analysis in the X-direction

The pushover analysis results for the case of building I only are shown in Fig. 21 (X-direction) and in Fig. 22 (Y-direction). The results for the other buildings are not shown due to space constraints. It can be seen in these figures that all the columns of the first level reached the life safety limit state and thus do not satisfy the expected performance level for the structure. These results suggest that the structure must be reinforced. As a solution, it is proposed to reinforce the columns and beams of the structure with the detail as shown in Fig. 23.

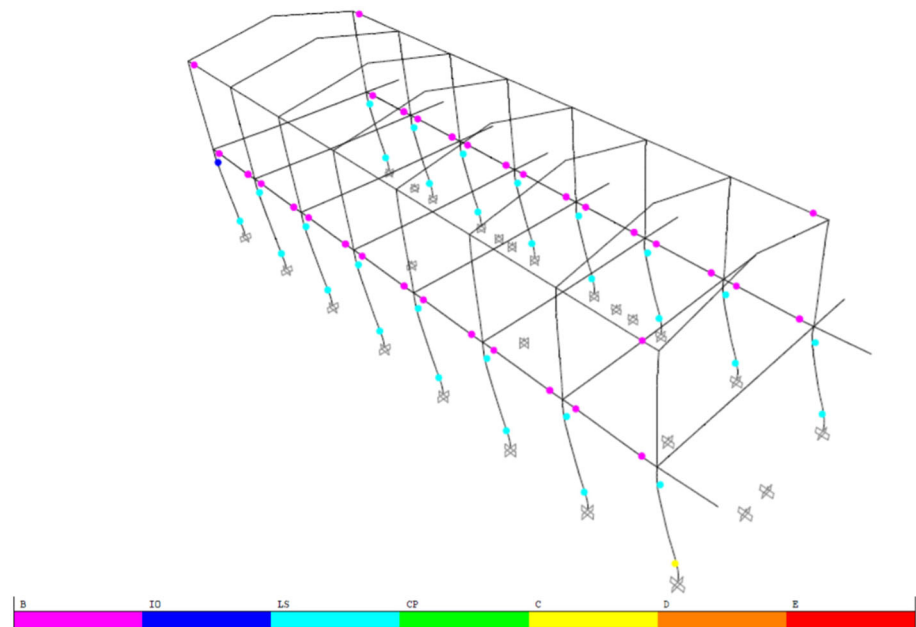
**Fig. 22** Plastic hinge behavior for pushover analysis in the Y-direction

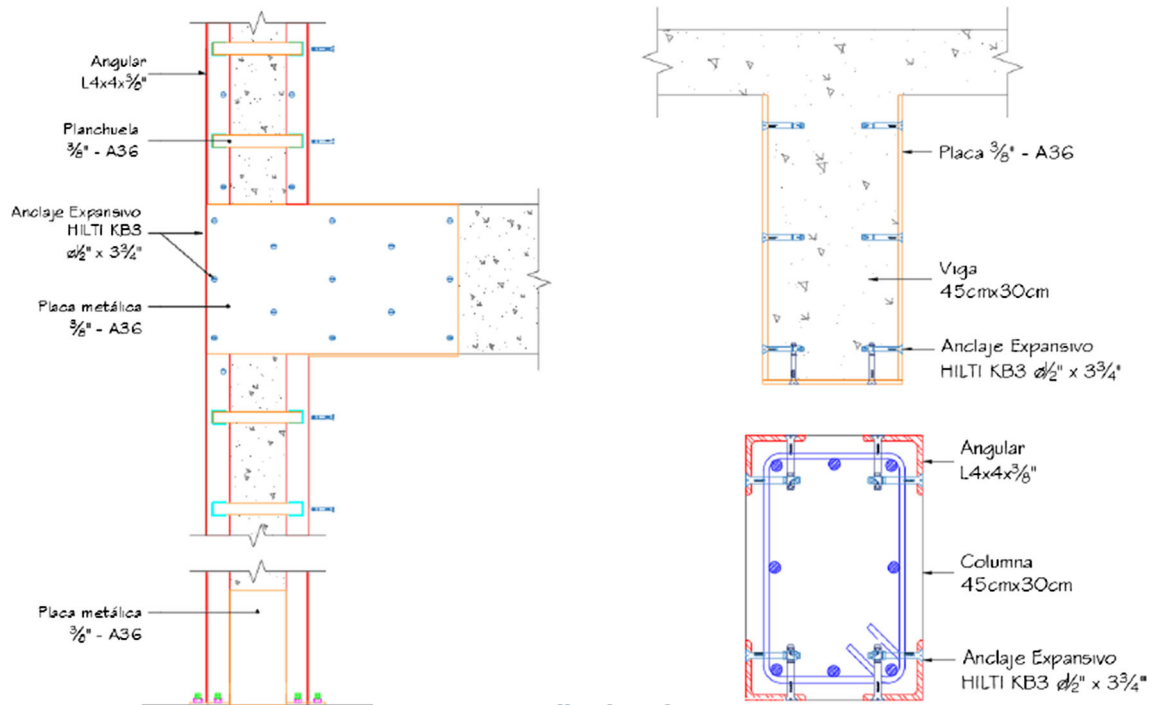
Fig. 23 Proposed reinforcement detail for beams and columns

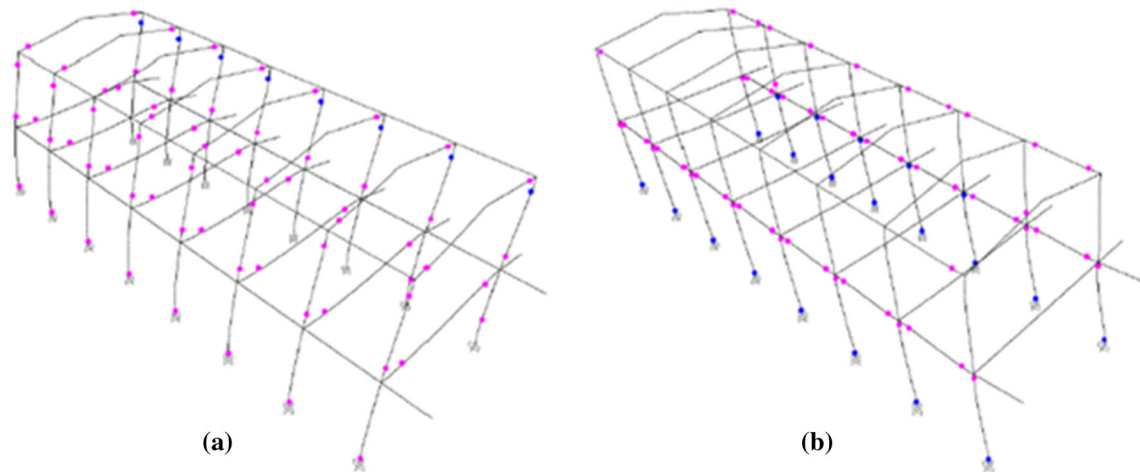
Fig. 24 Plastic hinge behavior for pushover analysis: **a** x-direction and **b** y-direction

In order to validate the behavior of the reinforced structure, a new analysis was performed. The results are shown in Fig. 24 (X-direction) and in Fig. 24 (Y-direction). It is noted that for the performance point, the plastic hinge is kept within the limits of immediate occupancy. These results suggest that the proposed reinforcement is adequate.
