Energy Procedia 133 (2017) 327-335

Climamed 2017 – Mediterranean Conference of HVAC; Historical buildings retrofit in the Mediterranean area, 12-13 May 2017, Matera, Italy

Reuse of an ancient church: thermal aspect for integrated solutions

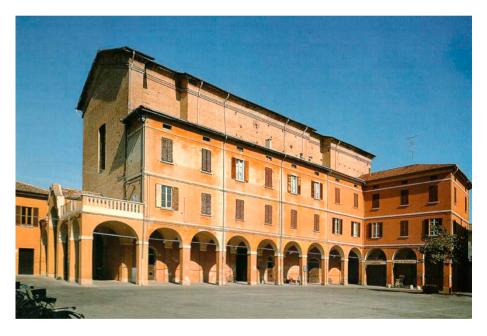
Fig. 1. San Francesco Church in San Giovanni in Persiceto.

The monumental church, outside, appears sober for the lack of decorative elements, with the exception of a frame located under the roof (Fig. 1). The single-spired façade has a rectangular central window, very simple, as well as the underlying portal, since the building was originally to enjoy great brightness, while today almost all the windows have been blocked. The overall length is about 44 m, with an internal height between 18 m and 21 m at the dome, and a total volume of about 10.400 m³.

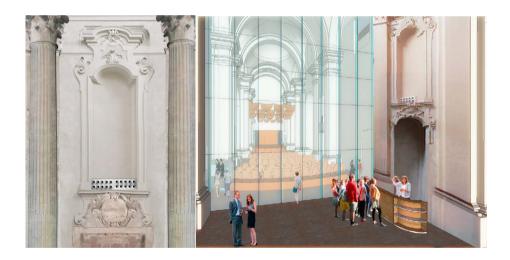
Fig. 7. Design view of the atrium. On the right side, multidirectional nozzles are visible, installed in the recess with a plasterboard wall to hide the presence of the air channel.

Air vents should be placed on the external edge of the recess, in order to ensure a correct launch. The lining wall in plasterboard, to cover air ducts within the recesses, is moved back as possible so as to preserve the perception of depth and shading of the recess (Figg. 6-7).
