THE VERNACULAR HERITAGE OF GJIROKASTRA (ALBANIA): ANALYSIS OF URBAN AND CONSTRUCTIVE FEATURES, THREATS AND CONSERVATION STRATEGIES

L. Dipasquale¹, M. Carta¹, S. Galassi¹, A. Merlo^{1,*}

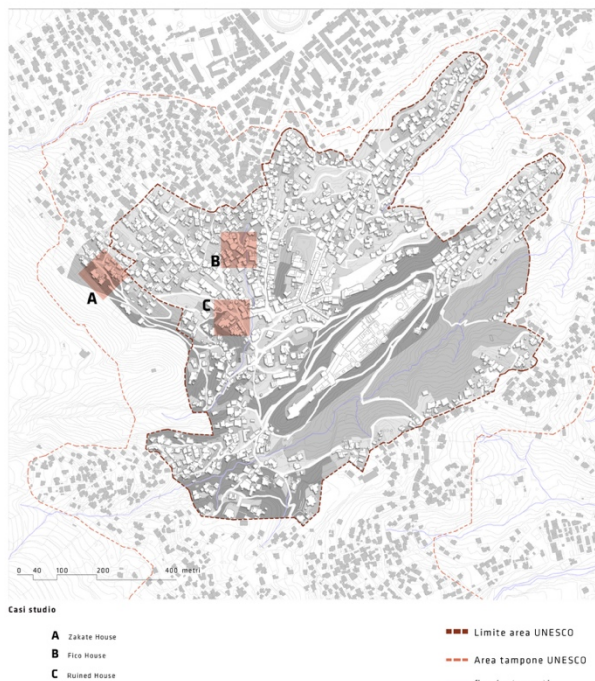
Figure 1. Plan of Gjirokastra and selected case studies
(© L. Giannone, E. Lamacchia).

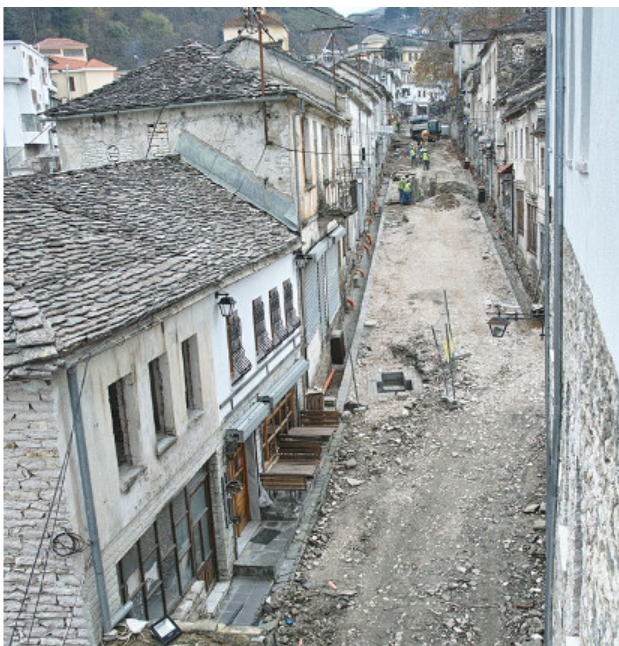
Figure 2. Gjirokastra roads being restored (© M. Carta, 2019).

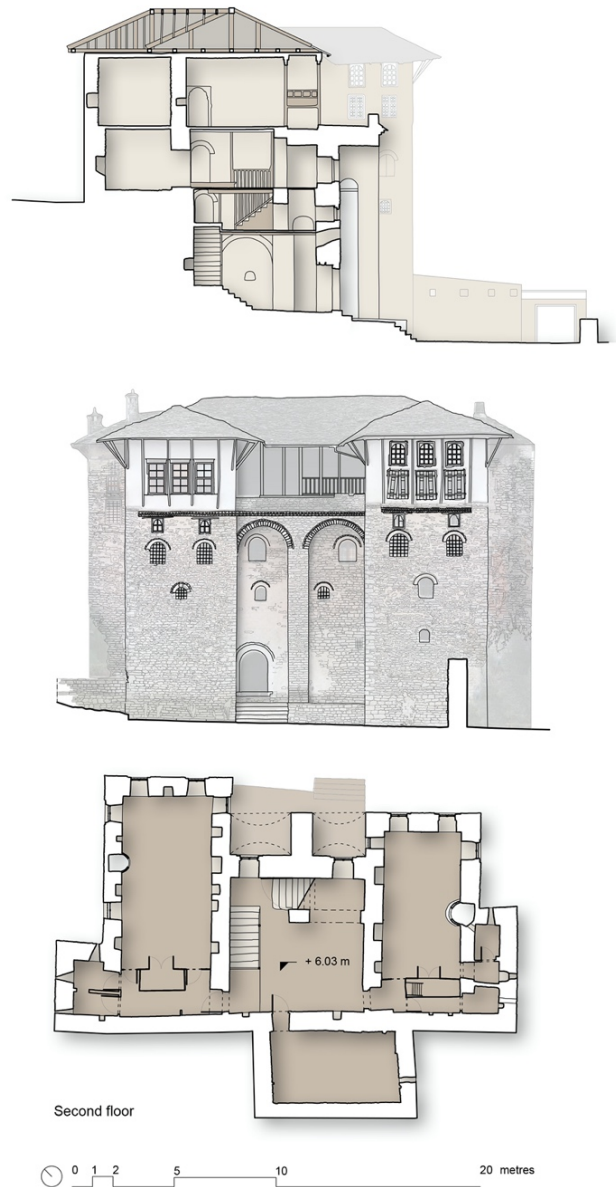
Figure 3. Plan, main façade and cross section of Zekate house (Survey: G. Cara, K. Kumi, M. Gega, F. SHillaku, J. Tuci. Graphic editing: E. Lamacchia).

The first selected building stands out for the good state of conservation of its architectural and construction elements, that constitute a good starting point for the study of the fortified house type, called *kulla* (Figure 3).

The Zeko family's house, is located on the edge of the town, on a steep slope, in a dominant position towards the south-western part of Gjirokastra. A north-eastern garden and three stone-paved courtyards on the main south-west front surround the building. The house is slender and compact and has the typical defensive characteristics of this typology of building, with few openings on the lower floors and high walls all around the courtyard. The house is included in the national list of first class monuments. The building, now used as a museum house, was built starting from 1811, and underwent a first restoration in the years 1968-1975 (Riza, 2015), and a second one in 2004-2005. The restoration measures were carried out with a conservative approach and did not alter significantly the planimetry and the used construction systems. The planimetric scheme is composed of two lateral rectangular blocks and a central connection element, with two large arches (*kemer*) on the facade, which connect the two wings and support the top floor terrace, a privileged point of view towards the valley of the Drino.

The functional organization is based on the distribution of the service spaces on the ground and mezzanine floors and the residential rooms on the upper floors. The ground floor hosts a small space for the reception of occasional visitors and a vaulted storeroom (*kube*) to store and mill cereals, as well as to keep agricultural equipment. The ground floor is also the location of the water cistern, a common and often present element in the traditional houses of Gjirokastra. In fact, when choosing the city construction site, the defensive needs prevailed, and people preferred the most protected, but also the driest part of the Drinos Valley (Mamani, Mexhani, 2015). The supply of water was guaranteed by rainwater collected from the roof and stored in large cisterns located at the lower level of the house. The mezzanine floor contained a reception chamber and, over the cistern, a room used by the women for the storage of food and other household purposes.

The two residential floors have very different characteristics, due to their use in different seasons. The second floor, 2.8m high, with small windows and thick stone walls, was used in winter (it is called *dimerore* which means the wintry floor). The third and last floor, 3.4 m high, with larger windows on the façades and thin walls with timber structure, was used in summer (it is called *beharore* which means summer floor). The location of the residential rooms on the upper floors has a defensive purpose too. The basic unit of the house is the residential room (called *oda*), which while maintaining the same dimensions on the different floors, presents different decorative elements in accordance with the people, family members or guests, who used it.

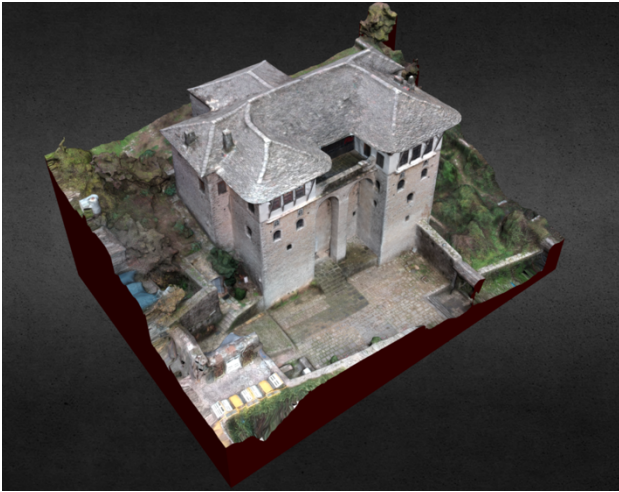
Figure 4. 3D model of Zekate house (© F. Frullini).

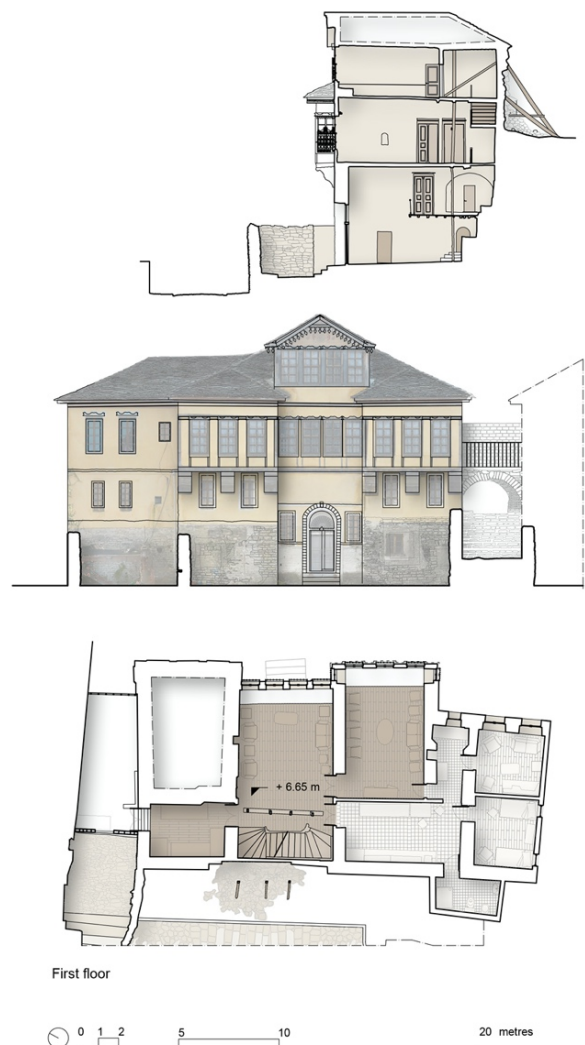
Figure 5. Plan, main façade and cross sections of Fico house (Survey: E. Barhi, F. Bregaji, J. Demiraj, G. Koli, J. Myftaraj. Graphic editing: E. Lamacchia).

The Fico House can be easily identified within the historic building fabric of Gjirokastra because of its golden yellow facade. Built in 1902, it is included in the national list of first class monuments. This building allows us to understand the changes that the Gjirokastra dwellings had at the beginning of the 20th century. In this period, in fact, the new buildings, while maintaining traditional planimetric and structural aspects, showed a stylistic evolution towards more western models. The present condition of the house is the result of the changes after two main phases of restoration, in 2012 and in 2014. The house is built on four levels and belongs to the two-winged typology, with the addition of a block in the southeastern part (Figures 5 and 6).

The functional organization follows the typical scheme of the tower house. With a central distribution space where the stairs are located, and the rooms on the sides. Between the building and the road there is the stone-paved courtyard surrounded by high walls, which is accessed by a large portal with a canopy. A door surmounted by an arch finely decorated with wrought iron provides the access to the building. On the ground floor there are the service spaces: the cistern (*stera*), the warehouse for food supplies and a storeroom. The ground floor is made of exposed masonry, while the others are plastered. The first floor, with a few windows, hosts the area dedicated to the preparation of the meals and the toilets. The second floor is the largest, with large windows on the main facade. Here there were two large guest rooms and the owners' master bedroom. The characteristic built-in wardrobes (*musandra*) are replaced by "modern" ones which are not fixed furnishings. The two projecting volumes of the second floor (called *erker*), rest on solid corbels and allow to increase the surface of the floor. The attic, located in the center of the house, on the top floor, is the most important space of the house (*oda e mire*) originally used as a summer residence. It has painted walls, a richly decorated ceiling and large and numerous windows that allow natural ventilation and lighting. The building is connected to the adjacent by means of a passage on the first floor and supported by a stone vault.

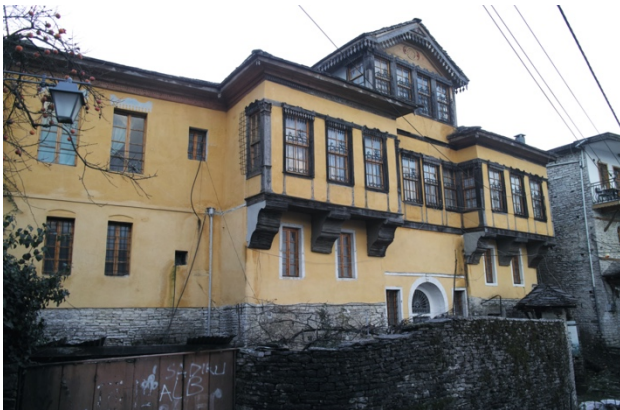
Figure 6. Main façade of Fico house (© M. Carta).

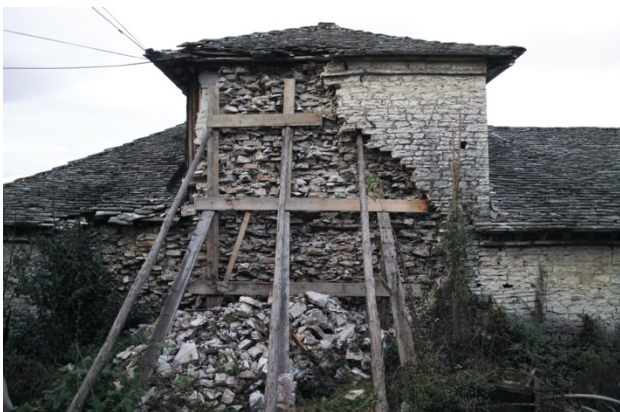
Figure 7. Back of Fico house (© M. Carta).

More recent restoration works mainly concerned the interiors and the distribution stairways, neglecting the structural health of the building. The most important deteriorations to date concern the deformation of the ceilings and floors and, above all, the partial collapse of the external facing of the stone masonry wall of the upper floor (Figure 7). The collapse is probably due to the lack of maintenance of the roof which may have caused water infiltration into the masonry.

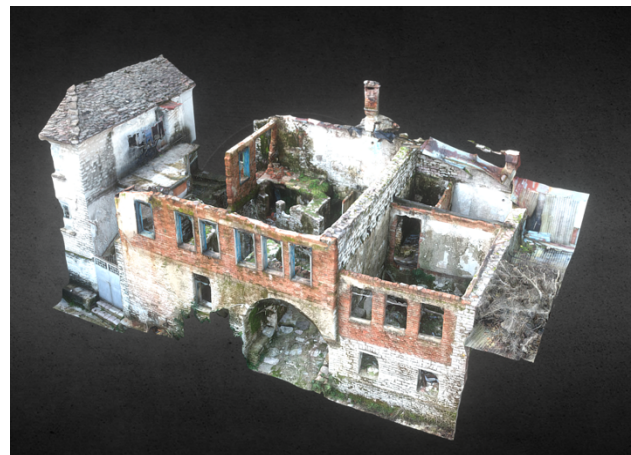
Figure 7. 3D model of Zekate house (© F. Frullini).

The first floor, originally built with a wooden structure called *çatma*, was destroyed by a fire, and was rebuilt in brickwork, courses of mixed headers and stretchers. After the fire, the wooden floors were replaced by a reinforced concrete and hollow tiles mixed structure. In the communist period the building was confiscated and entrusted to many families. During this period, the complex underwent further changes, including the opening of the ground floor windows. After 1999 the house was again entrusted to the Dalipi family. In this period a small room to the north-east was added, with timber structure walls. Between 2009 and 2010 part of the coverage collapsed. The collapse of the roof is a frequent event in Gjirokastra and it is probably due to the infiltration of water caused by the lack of maintenance of the roof slabs, which weaken the wooden support elements. Currently the building is in a state of abandonment with a process of increasing degradation, and continuous loss of wall portions (Figures 7 and 8).

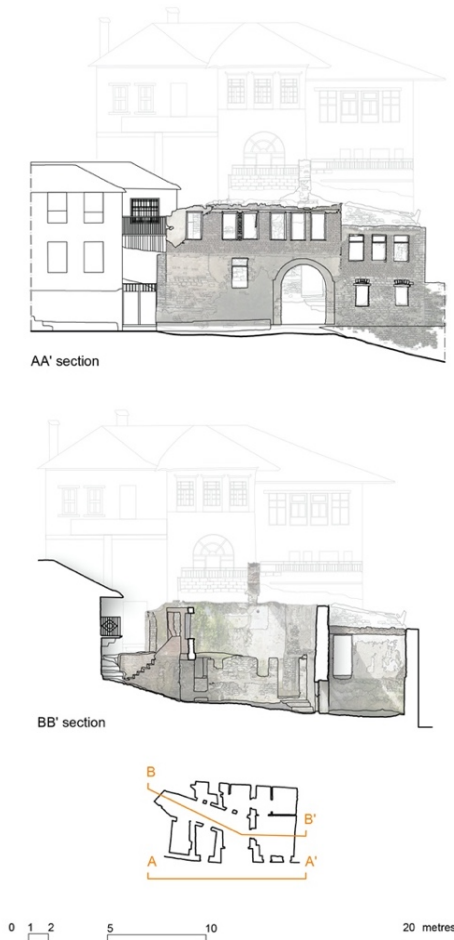
Figure 8. Cross sections and main façade of Dalipi ruins (Survey: K. Neli, J. Lamaj, E. Miho, J. Zajmi, M. Ballanca. Graphic editing: E. Lamacchia).

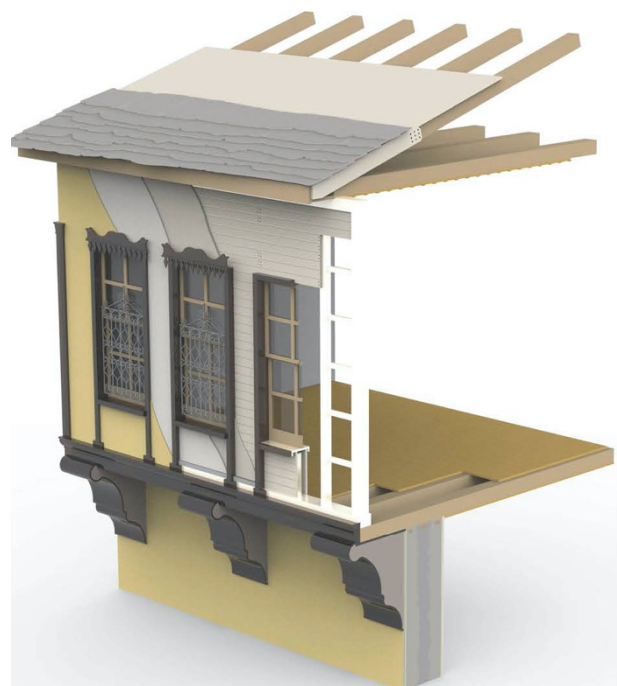
Figure 9. Detail of the *çatma* technique in Fico house (© Koli Gentiana).

Çatma is the building technique used for the walls of the upper floors, characterized by wide windows and reduced thickness. The *çatma* technique consists of a structure of vertical posts and horizontal battens, on which wooden boards are nailed (Figure 9). The filling of this frame is made of waste material and stones. The first layer of covering is composed of a 2 cm thick straw-earth plaster. After the drying and the subsequent cracking of the plaster, a second 5 cm straightening coat of lime and wool, with a small amount of sand, is applied. The wood and clay plaster is laid on the first layer with a trowel and then it is floated for three or four days. A coat of lime milk paint is applied on it.

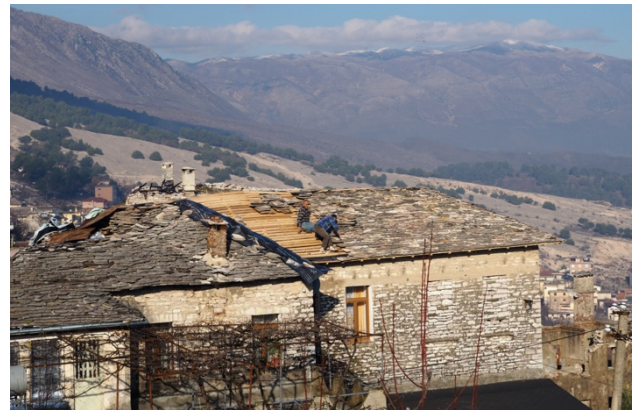
Figure 10. Traditional roof under restoration
(© L.Dipasquale, 2019).

an entire slate roof (Figure 10) represents a great financial burden, 12 time greater than installing one of clay tile, and is not considered a priority by most of the inhabitants. Roofs maintenance and restoration are hampered by the restoration costs but also by a shortage of skilled craftsmen (Lamprakos, 2010).
