XIV International Conference on Building Pathology and Constructions Repair – CINPAR 2018

Monotonic and low-cycle fatigue properties of earthquake-damaged New Zealand steel reinforcing bars. The experience after the Christchurch 2010/2011 earthquakes

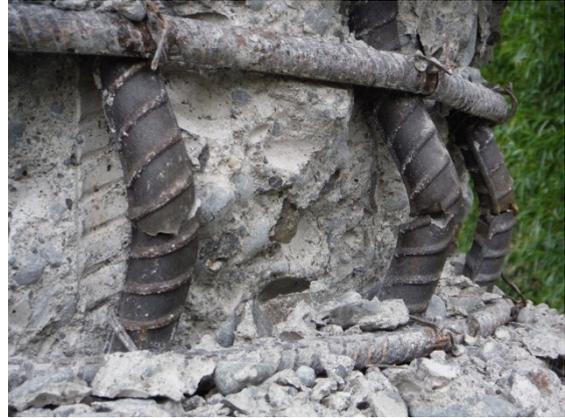
Figure 2 Fractured longitudinal reinforcing bars in a bridge pier close to the Mw 7.8 Kaikoura earthquake epicentre.

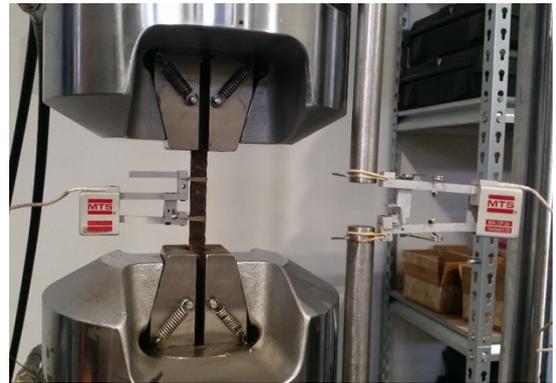
Figure 6 Test set-up employed in order to perform the low-cycle fatigue tests.

The objective of the test was to determine the low-cycle fatigue behavior of reinforcing bars used in RC members. Therefore, contrary to the common approach in material testing, the rebars were not machined and buckling was not prevented (ASTM, 2012). An example of the 180-mm long unmachined rebar samples is represented in Figure 5. Consistently with previous works by Mander et al. (1994) and Brown and Kunnath (2004), the unsupported length selected was 72 mm, which is six times the bar diameter. Strain-controlled cyclic tests conducted on unmachined rebars prone to buckling could potentially cause machine instability when the extensometer controlling the tensile machine is directly attached to the testing specimen. Thus, an “indirect method” was used to conduct the strain-controlled fatigue tests. A steel device was rigidly mounted to the top and bottom head of the tensile machine. The device was made by two L-shaped steel elements welded to two smooth steel rods. The extensometer responsible for controlling the machine was attached to the top and bottom rods (see Figure 6). The indirect method required an initial
