## Sand bag barriers for coastal protection along the Emilia Romagna littoral, Northern Adriatic Sea, Italy

### ABSTRACT

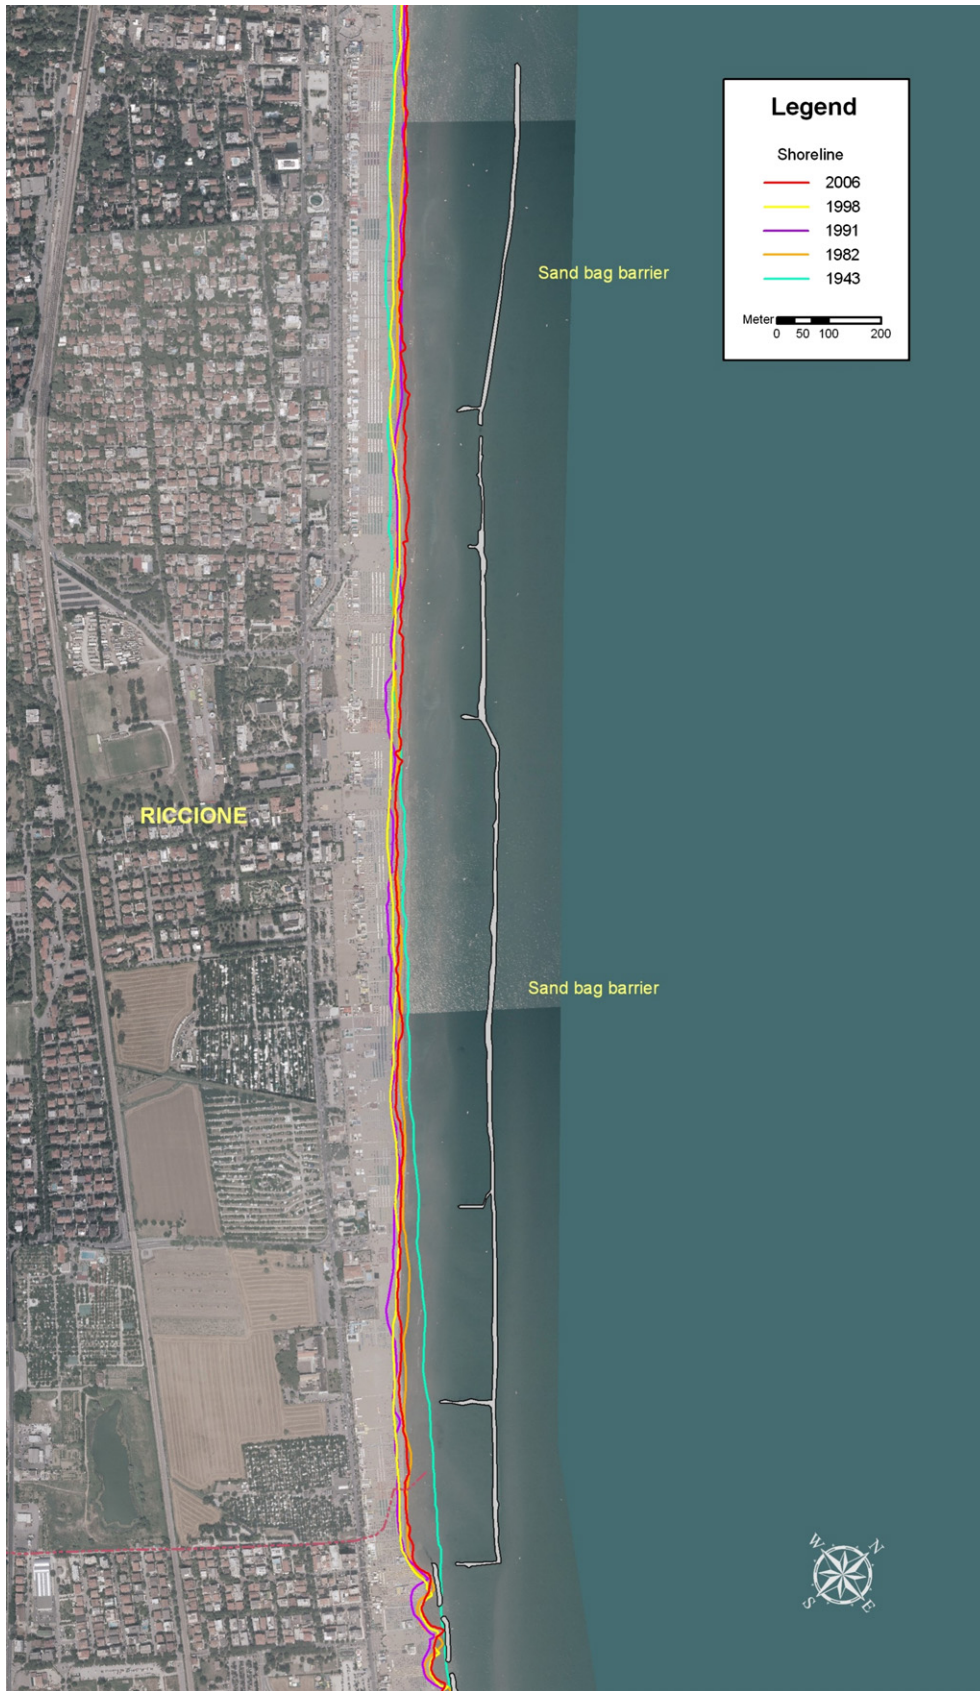
Fig. 2. Aerial view of Riccione littoral, showing the geosynthetic barrier and the shoreline evolution within the last 20 years.

In 1995 another sand bag barrier of the “second generation” was built up (Fig. 2). The barrier characteristics are akin to those documented by Liberatore (1992) with reference to Punta Marina:

The barrier cross section is presented in Fig. 3 and the plan view is shown in Figs. 2 and 4. The plan disposition was designed to keep the barrier toe at an almost constant depth, which actually varies between  $-2.5$  and  $-3.0$  m asl (crest level from  $-1.3$  to  $-1.8$  m asl). The construction of the new barrier 3000 m long was coupled with a 180,000 m<sup>3</sup> nourishment. This second barrier is still working, with 1 small maintenance recharge of sand bags in 2007 and one (with 600 bags coupled to a nourishment of 60,000 m<sup>3</sup>) in Spring (2010). In early Autumn 2010, an additional intervention was carried out (with 1200 bags), aiming at rising the barrier crest to a minimum of  $-1.5$  mbsl.

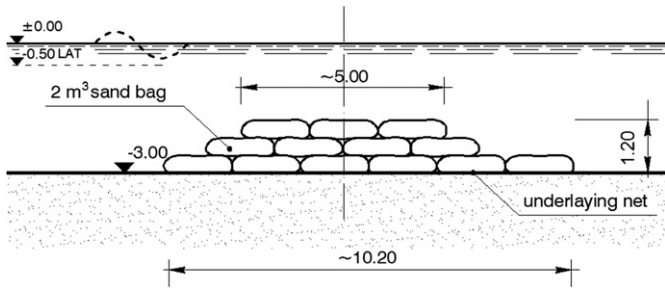
Fig. 3. Cross section of the barrier built in Riccione in 1995.

- the sand bag was of 2 m<sup>3</sup> (approximately 3 m × 1.7 m × 0.4 m) instead of 1 m<sup>3</sup>;
- the barrier was placed much closer to the shore (200 m from the shore);

- the barrier was wider (crest width 5 m);
- an additional line of sand bags was placed inshore for scour protection purposes.

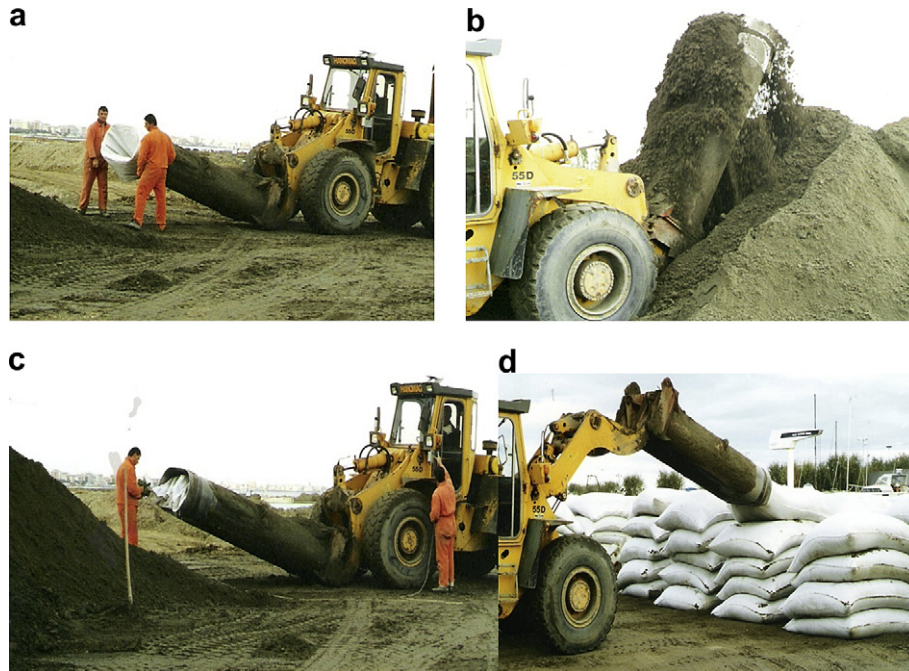
Fig. 5. Construction techniques: a) preparation of the 2 m<sup>3</sup> sand bag, b) bag filling with nourishment sand; c) seam; d) preparation of bag stocks.

The filling technique adopted for the sand bags composing the barrier in Riccione, which can be used for few or many units, is shown in Fig. 5. The filling was performed by two technicians and a machine properly equipped with a pipe. The sand bag was placed in the pipe bending the upper part of the bag (Fig. 5a) for a length properly selected to reach the desired filling level; the bag was filled (Fig. 5b), seamed (Fig. 5c) and prepared to be stocked (Fig. 5d).

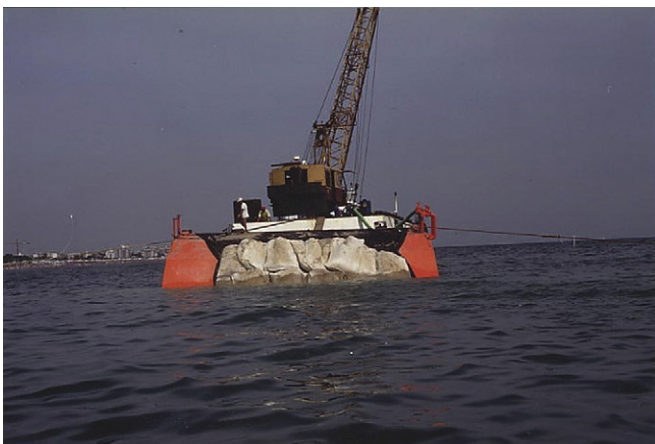
Fig. 6. Construction techniques: the geotextile and the whole cross section, sliding over a suitable slipway, are laid down from the pontoon.

The laying technology of the barrier was totally new. Instead of using a bucket, as in the past, a sort of slipway was used, so that the cross section base was prepared on board, and two rows were let slowly slide down (Fig. 6). The upper layer was placed at the end, with a special bucket. This method overcomes the disadvantage of an almost random positioning of each bag, with probable misplacement of the underlying geotextile. The bags are aligned with their length parallel to the barrier axis, and interlocking is provided by bags overlapping in such direction; the final bag seam lies in the horizontal plane.

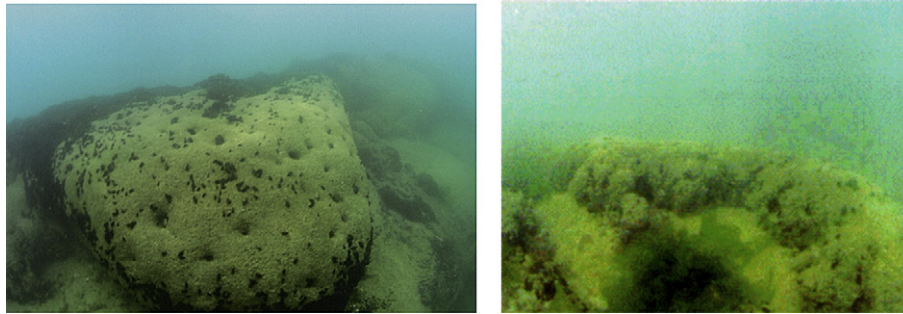
Fig. 7. Sand bags covered by polychaetes (to the left) and by hard seashells (*mytilus gallusprovincialis*, to the right).

In Riccione an underwater inspection was performed every year within the first three years following the barrier construction in 1995. These inspections demonstrated that algae and mussels soon populated the sand bags (Fig. 7) but did not cause damages. Moreover, the analysis of 10 water samples in 1995 and in 1997 showed that water quality remained excellent as before the works.

The presence of species that usually colonise defence structures in the area (Zanuttigh et al., 2005) can be regarded as an indicator of low environmental impact of the geosynthetic barrier and at the same time an increase of species biodiversity with respect to the pre-existent soft bottom assemblages.

The presence of colonizing organisms increases the barrier roughness and thus the efficiency in reducing the incident wave energy.

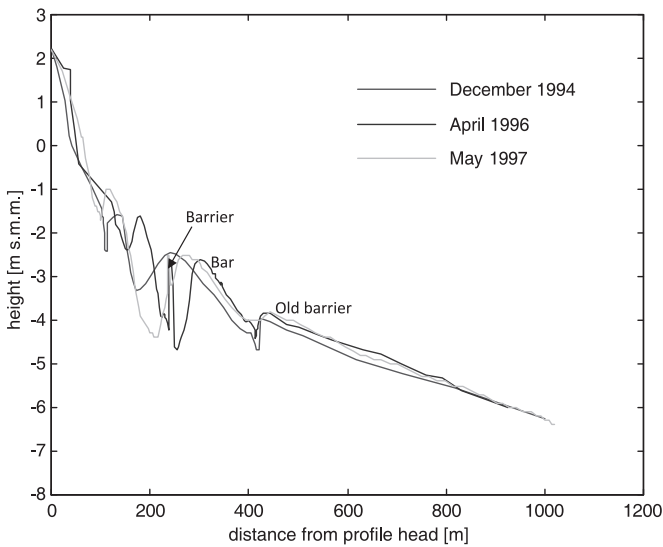
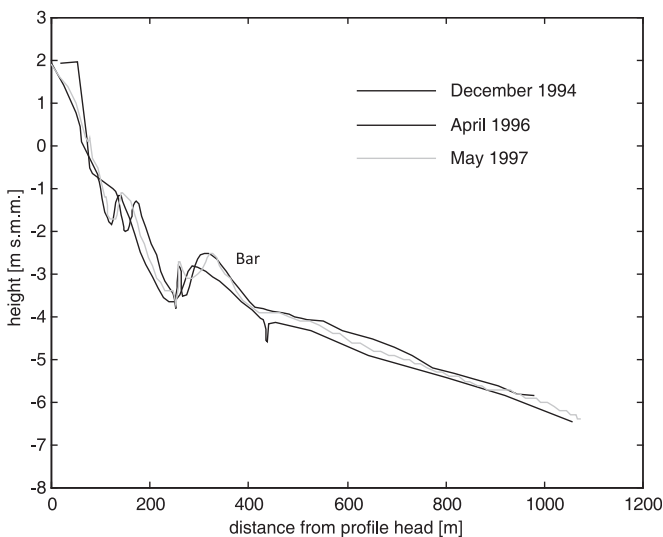
Fig. 8. Migration of the sandy bar towards the barrier, comparison of cross-shore profiles in the period 1994–1997, sections 10 (top) and 11(bottom).

Comparisons among cross-shore profiles are shown in Figs. 8 and 9. The position of the old barrier constructed in 1983 is still visible in the profile of 1994, while it is partially sunk and covered by sand in the more recent profiles, thanks to the strong accretion visible in the offshore zone.

Where the artificial barrier was placed in the trough in front of the natural bar, the existing natural bar slowly migrates over it, see the profiles in Fig. 8.

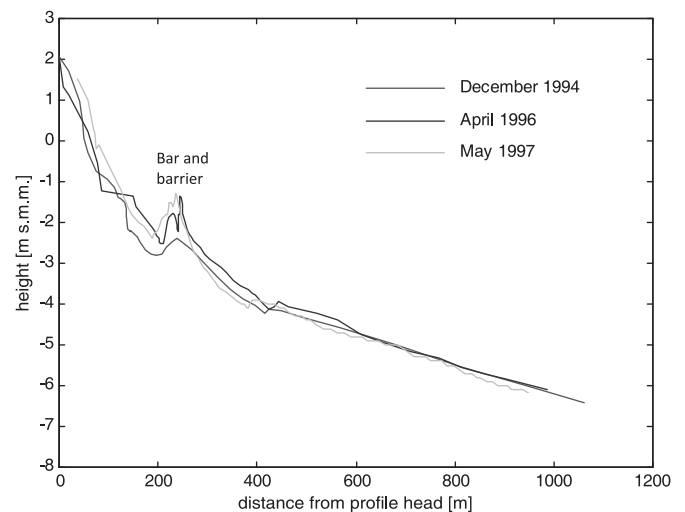
Fig. 9. Stability of the barrier, comparison of cross-shore profiles in the period 1994–1997, section 6.

The barrier results more efficient when it is placed exactly on top of the existing bar see the profiles in Fig. 9, because of the greater concentration of wave breaking over the barrier and consequently the greater dissipation of incident wave energy. Fig. 9 shows the formation of a deep trough on the barrier inshore crest and considerable accretion at the barrier seaward crest. The submerged barrier looks like a natural bar, with the exception that its inshore slope is steeper. This steep front can be interpreted if one considers that the sand in the barrier trough is unstable because of turbulence induced by wave breaking and would be naturally carried offshore, producing a bar migration. Indeed the sand bags do not move, thus avoiding offshore barrier migration and leading to a deep trough in front of it. This picture is fairly different from those typical of other low crested barriers (Burcharth et al., 2007) which are dominated by piling up (see Zyserman et al., 2005; Martinelli et al., 2006). In case of the sand bag barrier, piling up accordingly to the prediction model by Zanuttigh et al. (2008) is of the order of just few centimeters (0.1–2 cm), due to the low barrier height and the important return flux over the barrier crest. Consequently the long-shore currents driven by piling up are not significant.

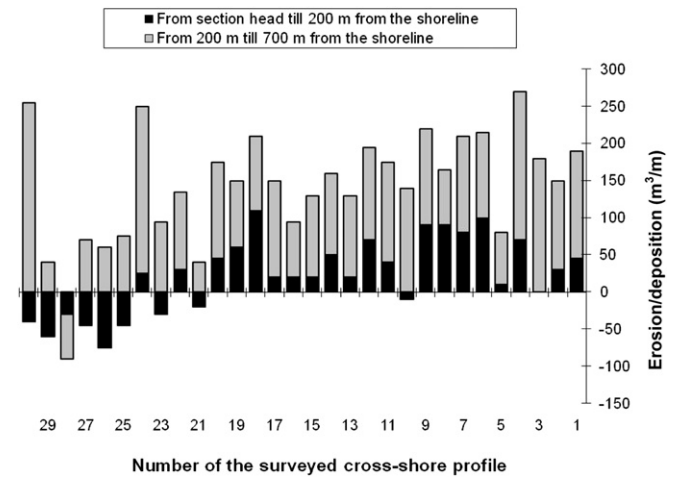
Fig. 10. Eroded or deposited volumes per unit length across the barrier in Riccione during the period December 1994–May 1997. Numbers on the abscissa refer to the numbers of the cross-shore profiles identified in the plan view in Fig. 4; profiles 28 and 29 that do not appear in Fig. 4 are placed Northwards of the Melo river mouth.

The comparison among the measured profiles is synthesized in Fig. 10 in terms of volume variations for each cell defined by two adjacent profiles. Along the monitored beach ( $\approx 3.5$  km), the offshore zone is everywhere in accretion on average of  $40 \text{ m}^3/\text{m}$ , but the accretion occurs in an area far from the shoreline where mainly fine material is present. For the profiles 21–29, there is a marked tendency to erosion in the first 200 m from the shore (up to the position of the barrier), with the loss of almost half of the nourished material (44%). In case of the profiles 1–20 the global tendency is to accretion also inshore the artificial barrier.

According to Fig. 10 the short term performance of the barrier is quite effective, since the nourishment is severely eroded only in the Northern barrier reach and indeed the loss of some of the nourished material is natural.

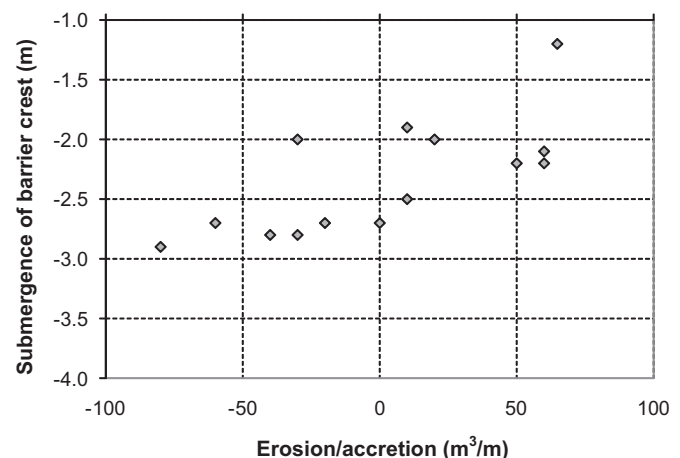
Fig. 11. Submergence of the barrier crest VS average accretion (positive) or erosion (negative) measured between the shore and the barrier.

Some specific effects induced by the barrier can be found from the evident correlation between the height of the barrier crest with the accretion per unit length measured from the shore to the barrier position, see Fig. 11. Where the barrier is placed at depths lower or equal to 3.7 m (that means crest level around  $-2.5$  m s.w.l.) there is only accretion or modest erosion, whereas the nourishment is lost where the barrier is placed below  $-3.7$  m.

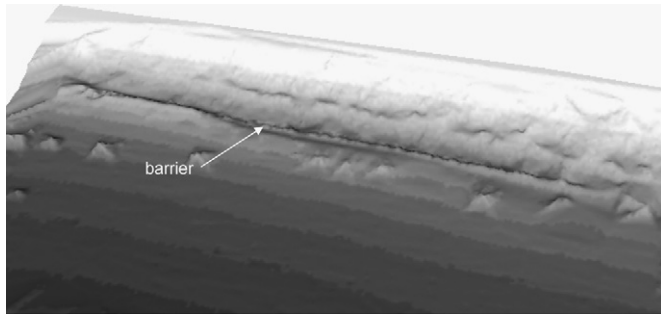
**Fig. 13.** Rendering of the last multi-beam bathymetric survey of Riccione barrier, 2008. Gray colour scales down every 0.5 m, lightest colour denotes emerged beach (+1.0 m) and darkest colour the deep bottom (−5.5 m).

Since the end of the intensive monitoring program, periodic bathymetric surveys were performed across the barrier along 6 selected profiles, allowing to reconstruct bottom evolution and barrier position from the construction till 2006 (see the position of the profiles in Fig. 4 and the labels in Fig. 12). A recent multi-beam survey was carried out in the area to verify the placement and the integrity of the bags (Fig. 13).

Barrier integrity in 2006, i.e. 8 years after the building, is entirely proved by the 2006 multi-beam survey shown in Fig. 13.
