Applied Energy Symposium and Forum, Renewable Energy Integration with Mini/Microgrids,
REM 2018, 29–30 September 2018, Rhodes, Greece

Energy refurbishment of a University building in cold Italian backcountry. Part 1: Audit and calibration of the numerical model

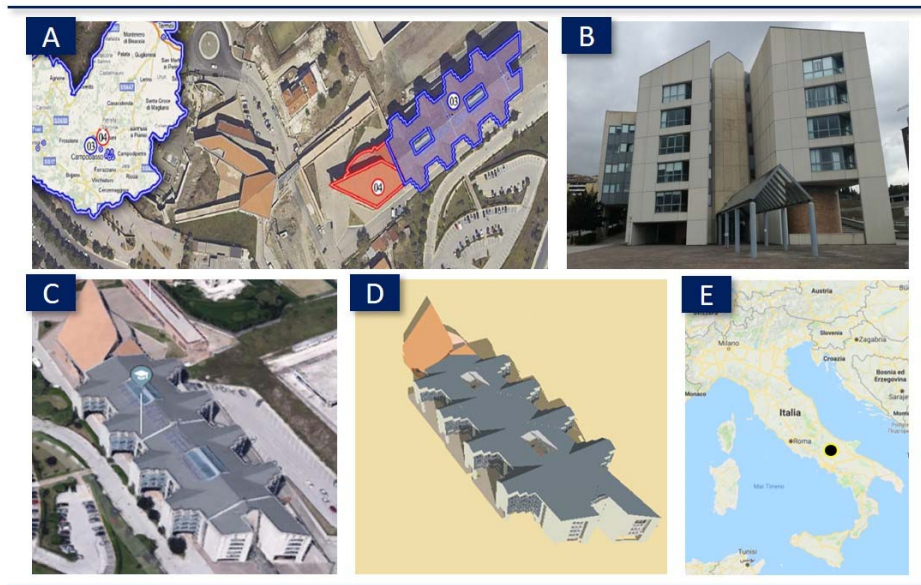
Figure. 1. a) Map of Campobasso with building location, b) picture and c) building geometry, d) model, e) position of Campobasso in Italy

The investigated building (six floors, Figure 1) was built in the early '90s. It is a university building located in Campobasso, one of the coldest cities of center Italy. The most important climatic characteristics of site, building and thermo-physical properties of the building envelope are summarized in Table 1. For what concerns the building energy performance, the envelope audit has been supported with non-intrusively diagnostic techniques, like infrared thermography and by in-situ measurements of thermal transmittance. It presents different types of external walls, mostly made of hollow brick, air cavity, insulation material and full-block or aluminium layer as outer layer. At the present state, the studied building has not good value of thermal transmittance and periodic thermal transmittance (see Table 1), compared to the values established of Italian legislation for new or refurbished buildings. This causes high heat losses transmission and, moreover, also a negative impact on heating needs and on the comfort conditions for occupants. Conversely, during the summer period, the building envelope does not prevent overheating of indoor environments. The building has four types of window elements. The first type is glass blocks, used in the entrance at ground floor and for the hallway at the first floor (north-west exposure). The second type is a double clear glazing, which composes the skylights of the roof. Only the glass walls at the entrance are made of single clear glass, with an aluminum frame. For these types of windows, there are not shading systems. Finally, all other windows are realized with an aluminium frame and double clear glazing (6mm glass/12mm air/6mm glass). Most of this type of windows has an inner shading system, made by white vertical lamellas.

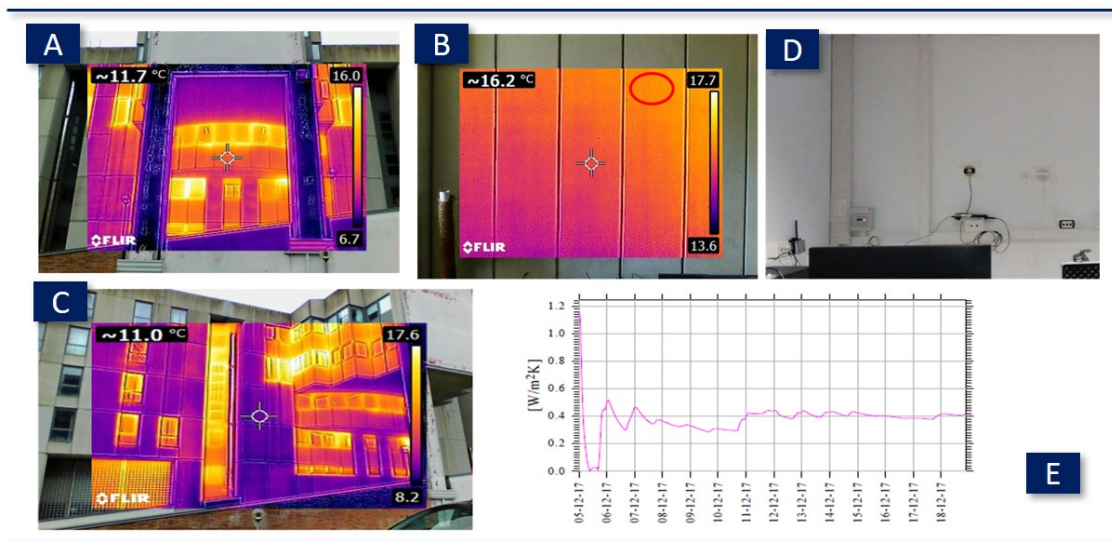
Figure 2. a), b) and c) infrared thermography; d) and e) measures with heat flow meters

Infrared thermography surveys (figure 2) were carried out during winter period, in optimal measurement conditions such as an overcast sky. Moreover, this survey has been used to identify a proper positioning of the sensors for the measurements of thermal transmittance, according to the standard ISO 9869 [18]. The difference between the value of the measured thermal transmittance and the value derived by analytic calculation is around 35%.

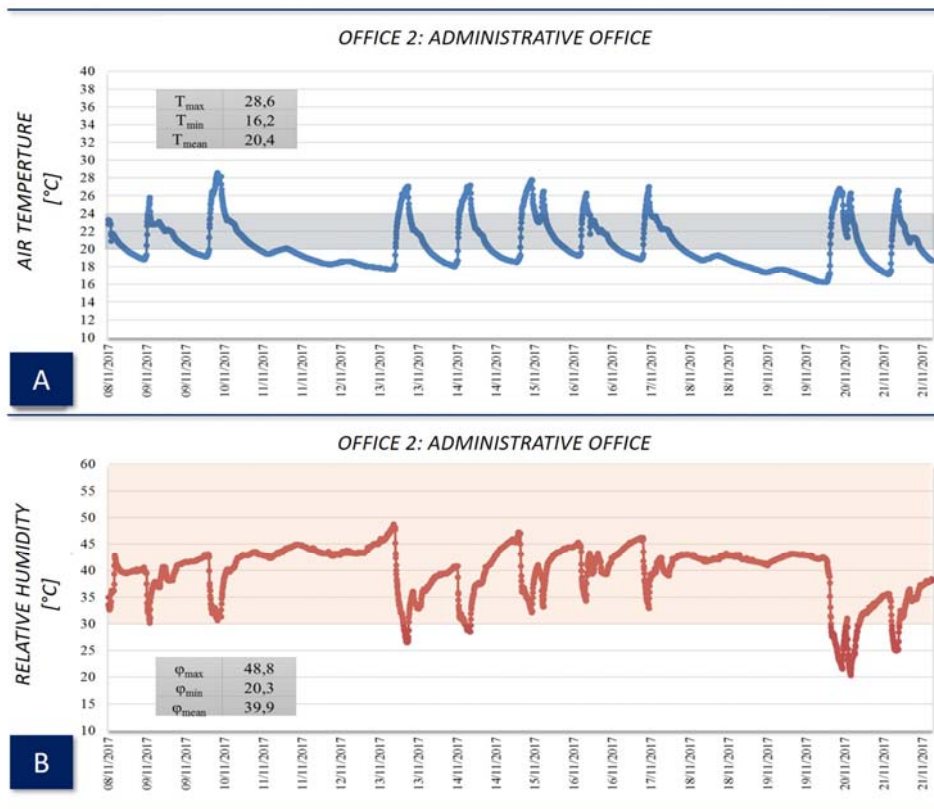
Figure 3. Office 2 - administrative office: a) trend of air temperature; b) monitoring of relative humidity

In this paper, analyses of monitoring results are discussed only for one administrative office (Office 2). In detail, during the monitoring period, from 8th to 21th of November 2017, air temperature and relative humidity have been recorded with a time step of 5 minutes. The recorded values for air temperature are shown in figure 3a: here, it is also evidenced the reference value of comfort range (19–23°C) and calculated mean value (T_{mean}), maximum (T_{max}) and minimum ones (T_{min}). Analogously, for the relative humidity, the comfort range and the mean, minimum and maximum values monitored in the Office 2 are reported in Figure 3b. Briefly, the humidity values are usually very low, and always below the optimum design value of 50%. Indeed, the air system does not balance the latent load and, moreover, the air temperature are too high. Similar trends have been recorded for the other selected areas and these confirm that often the air temperature and relative humidity are outside the range of comfort recommended by current standards [19]. Indeed, from interviews to occupants, frequent discomfort conditions have been arisen.

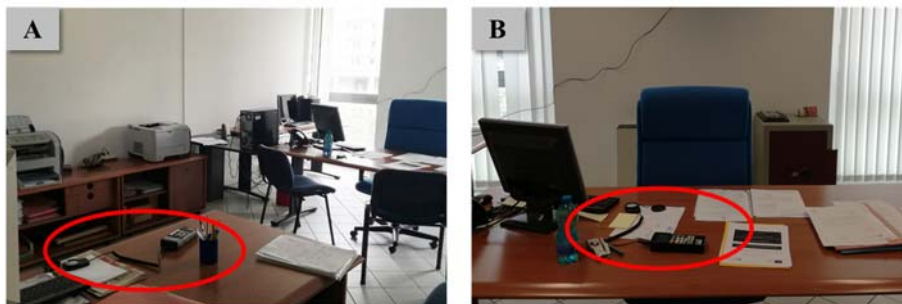
Figure 4. Installed sensor for light level measure: a) desk1; b) desk2.

For what concerns the luminance level, some punctual measurements have been done in correspondence of working surfaces (around 90 cm of height) and by considering different natural and artificial scenarios with a sampling time of 10 minutes. These measures have been compared with illuminance values indicated by the standard UNI EN 12464-1 [20], that suggests 300/500 lux for classrooms/office. Always referring to Office 2, the measurement was carried out on the two work-surfaces (at the centre of desks) as shown in Figure 4. Different scenarios have been considered, by taking into account the external conditions and lighting system consisting of 6 lamps (36W). In detail, the following conditions were considered: scenario 1) opened drapes and lighting system turned on, without sunlight (evening); scenario 2) opened drapes and lamps turned off, whit covered sky; scenario3) closed drapes and lamps turned on, with covered sky.

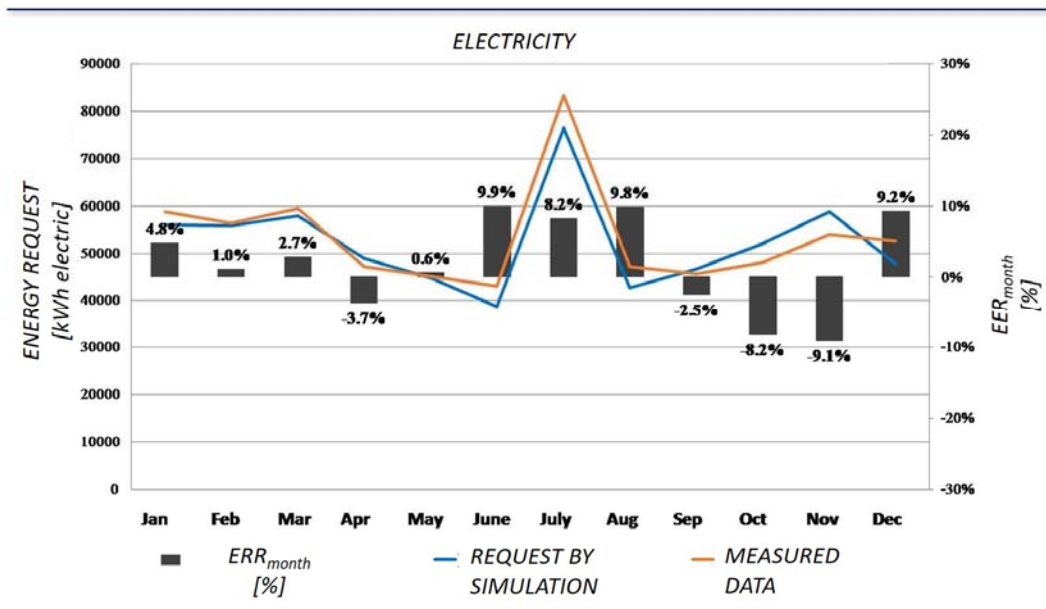
Figure 5. Calibration: electricity energy request.

Moreover, in Figure 5 the comparison between the electricity request of the real building and of the simulated model is reported, with also the indication of monthly gaps. The same analysis for gas request has been performed too. According to the M&V Guidelines, the MBE (Mean Bias Error) and the CV(RMS) (Coefficient of variation of the root mean squared error) have been calculated and these resulted lower than the maximum admitted values. All told, the numerical model is enough in agree with the real building usage. This means that the simulation model describes, as accurate as possible, the real building performances. Indeed, it is important to underline that in this study also the behavior of the occupants and the use of the equipment, which are often not considered, has been adequately modeled as aforementioned.
