2011 International Conference on Green Buildings and Sustainable Cities

## Sustainability in civil engineering: integrated mix of some non-invasive sensing techniques for conservation and restoration of historical buildings and frescoes

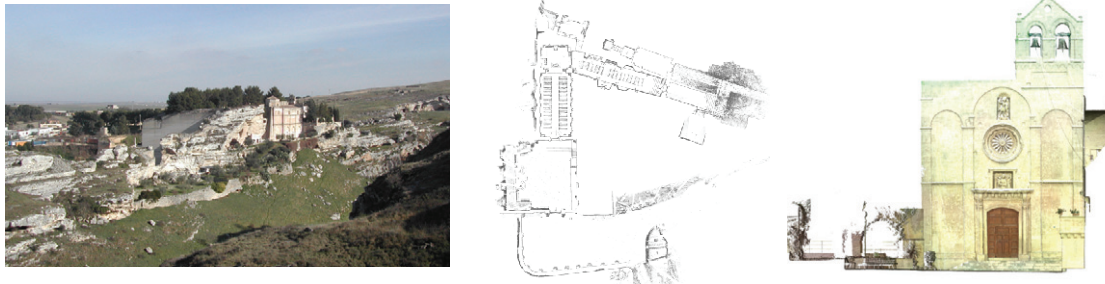
Fig. 1. (a) Photo of the Sanctuary in its context; (b) Plan of the principal level of St. Maria of the Palomba's Sanctuary; (c) Elevation of the façade of partly *sub divo* Church

The research covered the complex of rock churches of Santa Maria of the Palomba's Sanctuary (see Fig.1). It was built in the XV<sup>th</sup> century on a pre-existing medieval crypt, situated in a splendid landscape, on the south facing ravine on which stands the city of Matera, integrating in a wonderful way the underground and *sub divo* building. It is the archetype of a building that has been stratified by hundreds of years and a great number of interventions, with the symbiosis of carved and built architecture, that characterizes the architectural charm of Matera.

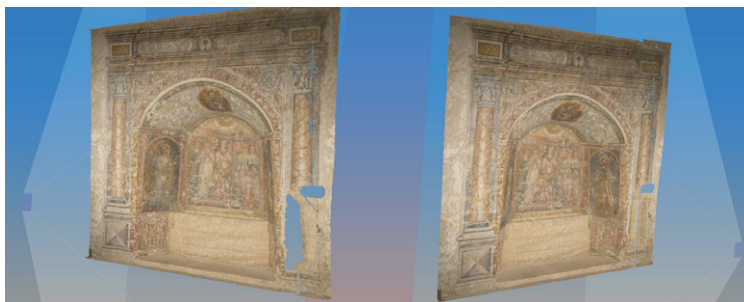
The examination was performed under normal (see Fig.6) and forced conditions, after thermal

Fig. 6. Picture of the case study fresco

The thermographic analysis case study of the fresco, superimposed on the digital model of the survey, ascertained that there are no thermal, humidity and material discontinuity across the surface, and that there has been no millimetric displacement of the wet outline on the fresco [6].

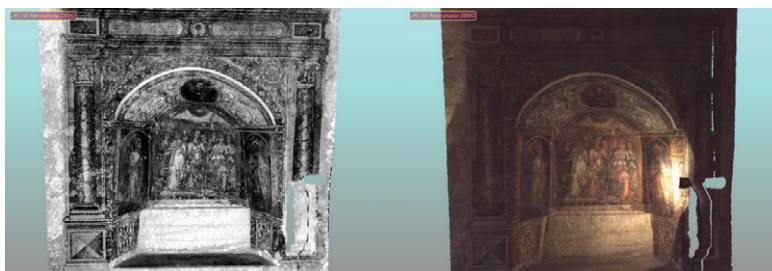
conditioning of the part subject to measurement (see Fig.7).

Fig. 7. Conditioning of case study fresco

The process to artificially and uniformly, as much as was possible, heat the surface of the case study fresco, was carried out with the intention of surveying the distribution of the surface moisture: the temperature reached in each surface element depends strongly on the moisture content locally present, and since the temperature rise is less in more humid zones than in the drier ones, the thermographic recording allowing thus the reach of a comparative mapping of the surface moisture (see Fig.8).

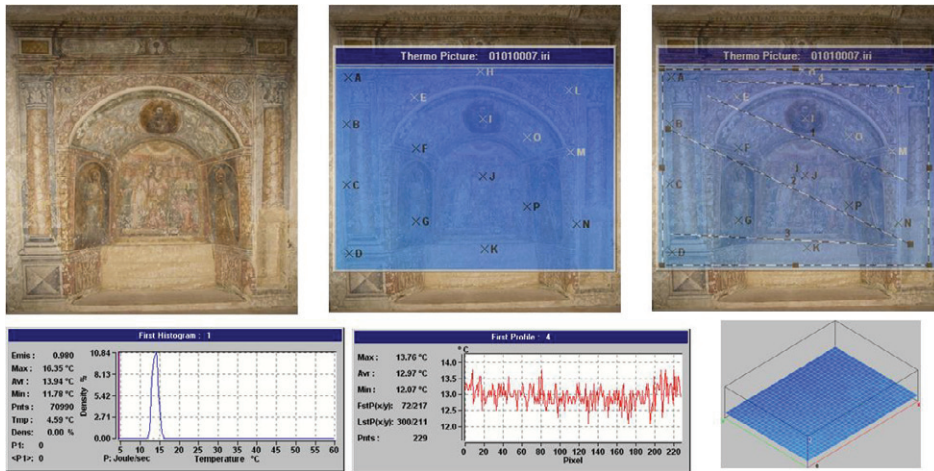
Fig. 8. Thermo picture of case study fresco and thermal analysis

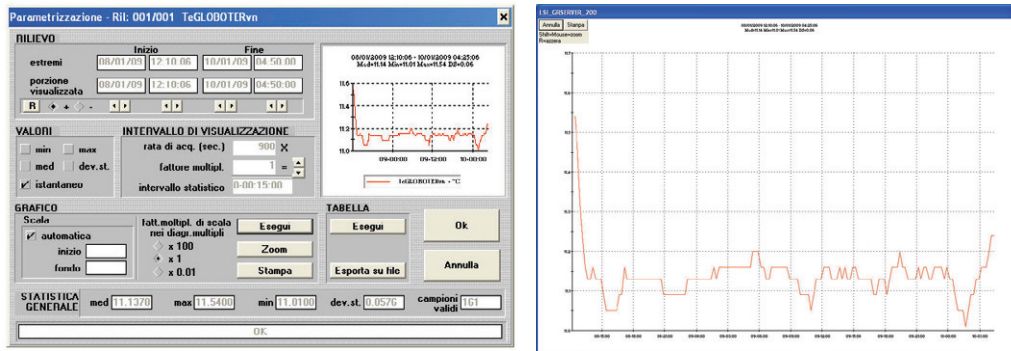
"Babuc A" multi-data acquisition, compared to the ambient air temperature and relative humidity, to the temperature and humidity of the air in contact with the surface, to the ventilation and possible sources of external heating (see Figg.9-10), it has also worked by thermographic means with the aim to determine the possible evaporative flux, through the identification of the presence of areas affected by the cooling caused by the evaporation process.

Fig. 10. (a) Records of analysis and (b) records of operating temperature of the Church, made with globothermometer

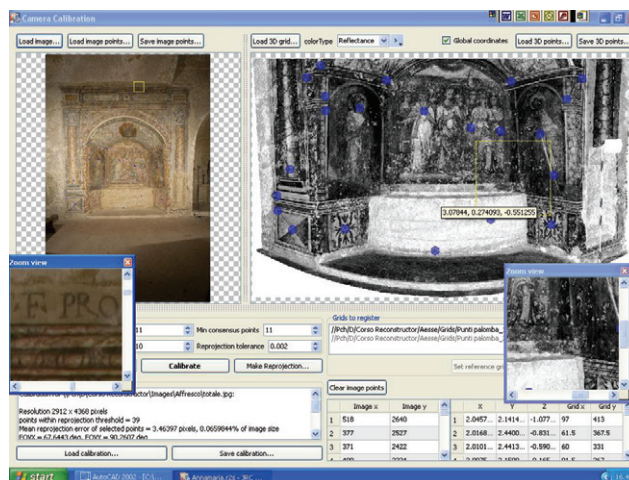
- obtain all georeferencing data for the mapping and monitoring;
- manage a large amount of structured and heterogeneous informations;
- rational organize the checks and display it on a base mapping and stratigraphic and geometric survey by 3D laser scanner [7] [8] (see Fig.12);
- manage display capabilities, query, analysis, control and verification of data collected in the field, in a dynamic way, based on scientific of algorithms.

Fig. 12. Survey by 3D laser scanner

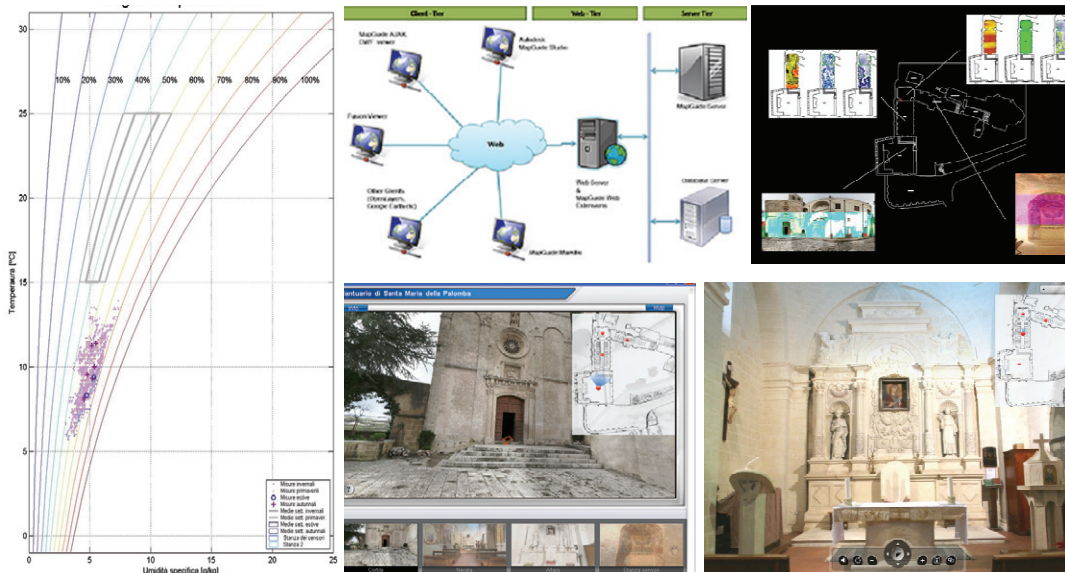
With this system it is also possible to translate and return the precise measures of the sensors, according to a regular grid of points suitably arranged in the form of thematic maps displayed in *WebGIS* (isochores and isotherms) easy to read and effective for visualizing the distribution of the values in the interior of the rooms under investigation, by combining the individual measurements of temperature and RH% (see Fig. 13).

Fig. 13. Symbolic images of the architecture of the remote sensing control, location of areas where there were strongest thermo-hygrometric anomalies and restitution of psychrometric maps through *WebGIS* system

The system allows real-time analysis and consultation of all the measured values of RH%, S.U. and T °C of internal environment to the internal rock construction which, performed with very fast acquisition times of data (in the order of the second), gives comparable measures of the whole area of investigation, under equilibrium conditions.
