AIAS 2019 International Conference on Stress Analysis

## Monitoring of railway freight vehicles using onboard systems

Nicola Bosso\*, Antonio Gugliotta, Matteo Magelli, Nicolò Zampieri

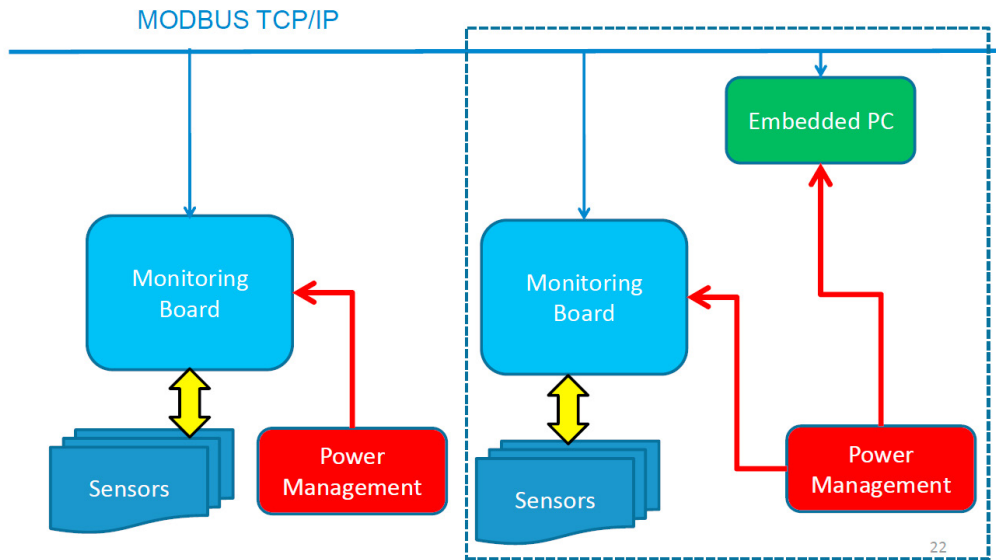
Fig. 1. Architecture of the monitoring system for a wagon with two bogies.

Fig. 1 represents the configuration of the system, which is considerably simpler than the original one shown by Bosso et al. (2018), by comprising a monolithic control unit which communicates with the sensors and deliver the data into the network.

The system is designed to have a monitoring board for each bogie, therefore each vehicle normally has 2 monitoring boards and an Embedded PC, as shown in Fig. 1, or in the case of coupled vehicles (6-8 axles freight Vehicles) 3 or 4 monitoring boards and a Embedded PC only.

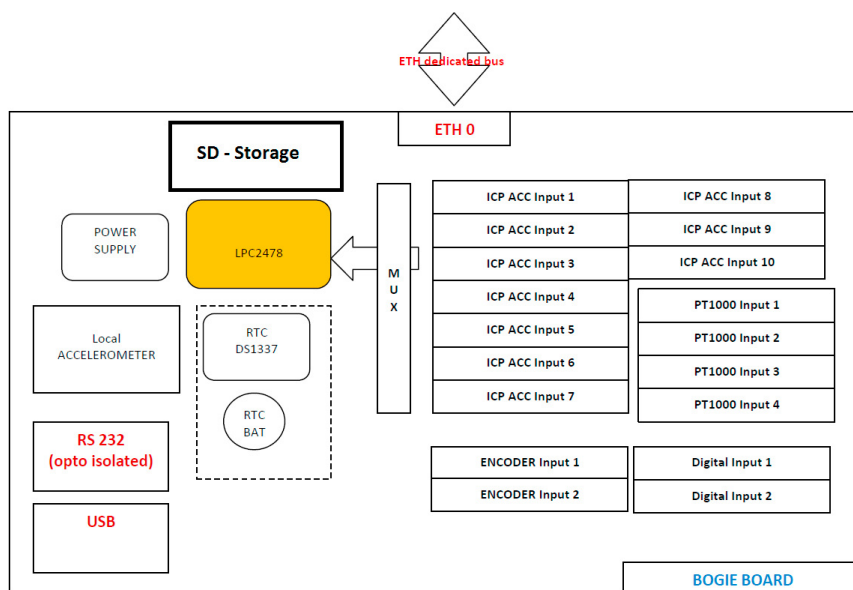
For this architecture, after an analysis of the processors available on the market, it was assumed to use a microcontroller based on ARM7 technology. The basic scheme of the monitoring board is shown in Fig. 2, where the microcontroller indicated in yellow supervises the signal acquisition functions and transmits the acquired data via Ethernet (ETH0). Some of the data, as well as the resident analysis program are stored in an internal memory (SD). The card is equipped with an RTC to synchronize the acquired signals.

Fig. 2. Layout of the Monitoring Board

The monitoring board is designed to equip a vehicle bogie and, for each of the four axle-boxes of the bogie, includes a vertical accelerometer, a longitudinal accelerometer and a thermal probe. On one of the two axle-box of each axle, a lateral accelerometer is also installed, while on the opposite axle-box, an encoder is installed to detect the angular speed of the wheelset. The channels acquired are therefore the following:

- 10 channels for accelerometers (ICP or capacitive)
- 4 thermal probes (PT1000 or semiconductor sensors)
- 2 incremental 1024 pulse / rev encoders.
- 1 tri-axial capacitive accelerometer integrated in the board and mounted on the vehicle body

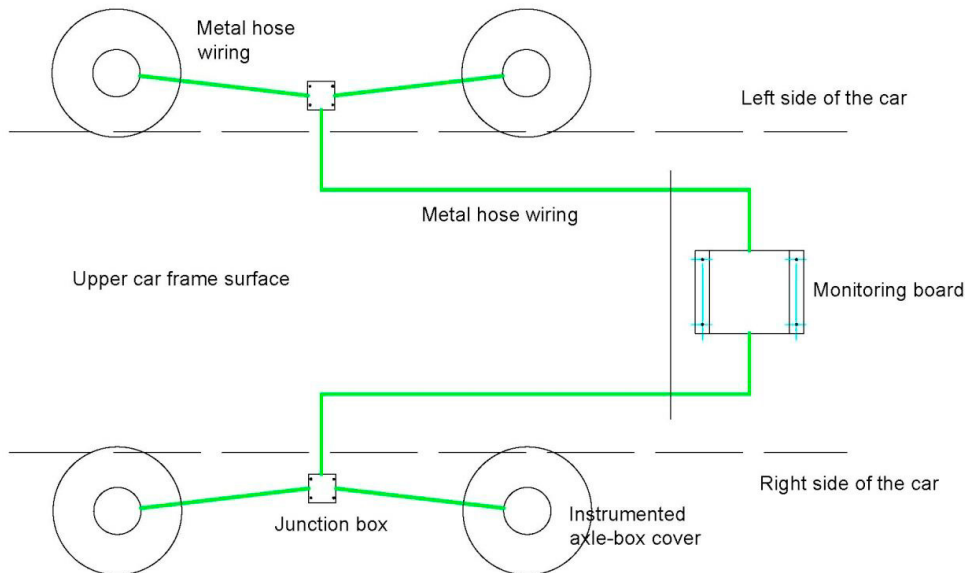
The wiring of the system is carried out according to the diagram in Fig. 3, using two intermediate junction boxes mounted on the side of the vehicle frame and connected to the two axle-box covers of the same side.

Fig. 3. Layout of system installation on the vehicle

The wiring is made using shielded multipolar cables, contained in a folded steel braided hose. The length of the wiring depends on the positioning of the control unit on the wagon. As regards the wiring made between the axle-boxes and the junction boxes located on the side of the wagon, a cable longer than necessary was created to take into account the relative rotation between the vehicle frame and the bogie.

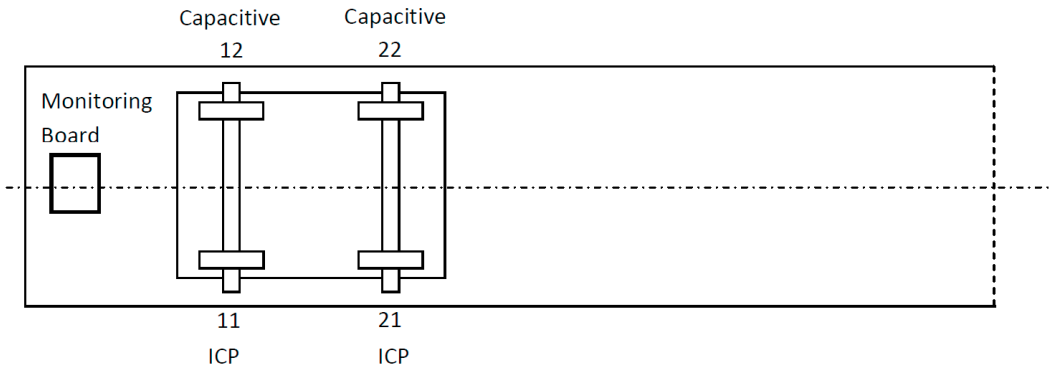
The installation of the monitoring system on the two types of wagon was carried out differently due to the different arrangement of the load on the vehicle. On the CT Light chassis, the control unit was installed on the floor of the wagon in the front portion not occupied by the load as shown in Fig. 4. The axle-box covers fitted with ICP sensors were mounted on the right side, the ones fitted with capacitive sensors on the left side.

Fig. 4. Installation diagram on the CT-Light wagon.

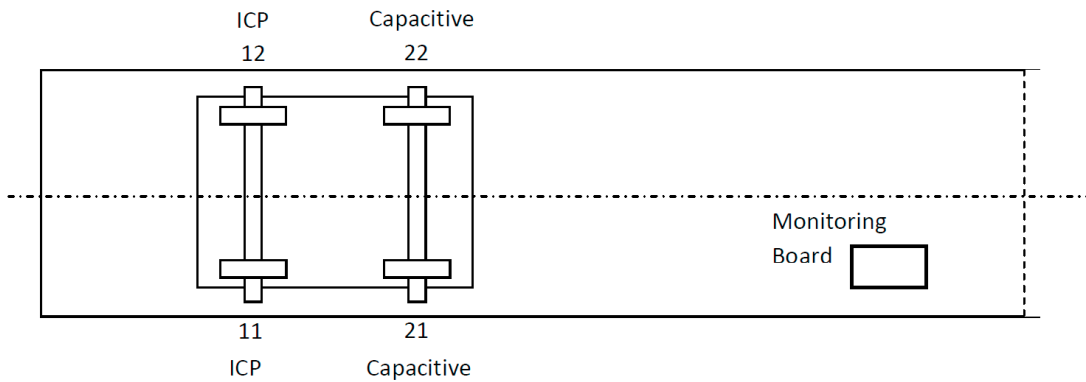
On the Tasca type car, the control unit was installed under the vehicle frame on the right side, in the central portion. The axle-box covers fitted with ICP sensors were mounted on the first axle, the covers fitted with capacitive sensors on the second, as shown in Fig. 5.

Fig. 5. Installation diagram on the Tasca wagon.

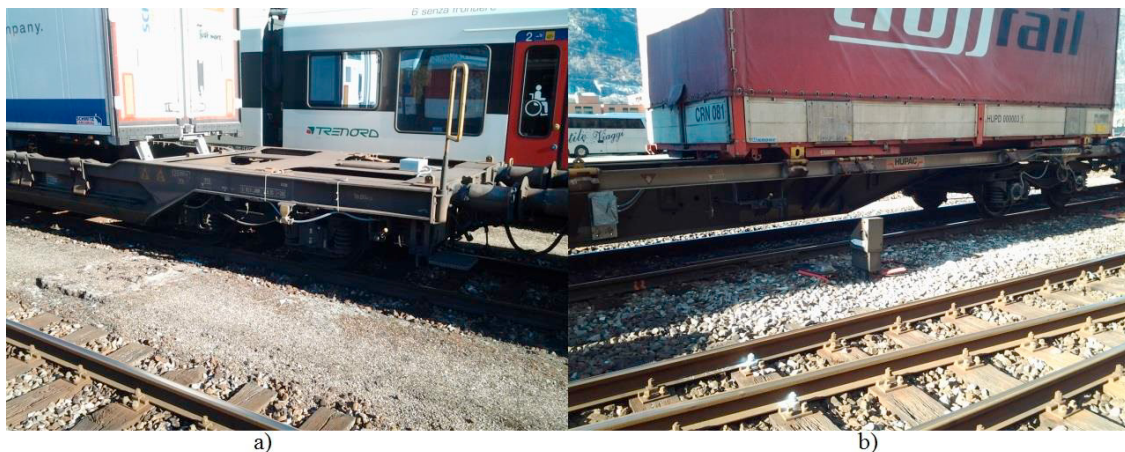
The tests shown in the paper have been performed in Switzerland, on the Gotthard Base tunnel between Biasca and Altdorf and on the old line, between Busto Arsizio and Aarau, in order to compare the performances of the two tracks in terms of vehicle accelerations. The tests on the Base tunnel have been performed considering different axle-load and different speed in order to test the new track under different conditions. Fig. 6 shows the equipped vehicles during the tests.

Fig. 6. Instrumented vehicles during the tests: a) Tasca 4.2 Wagon, b) CT-Light Wagon.

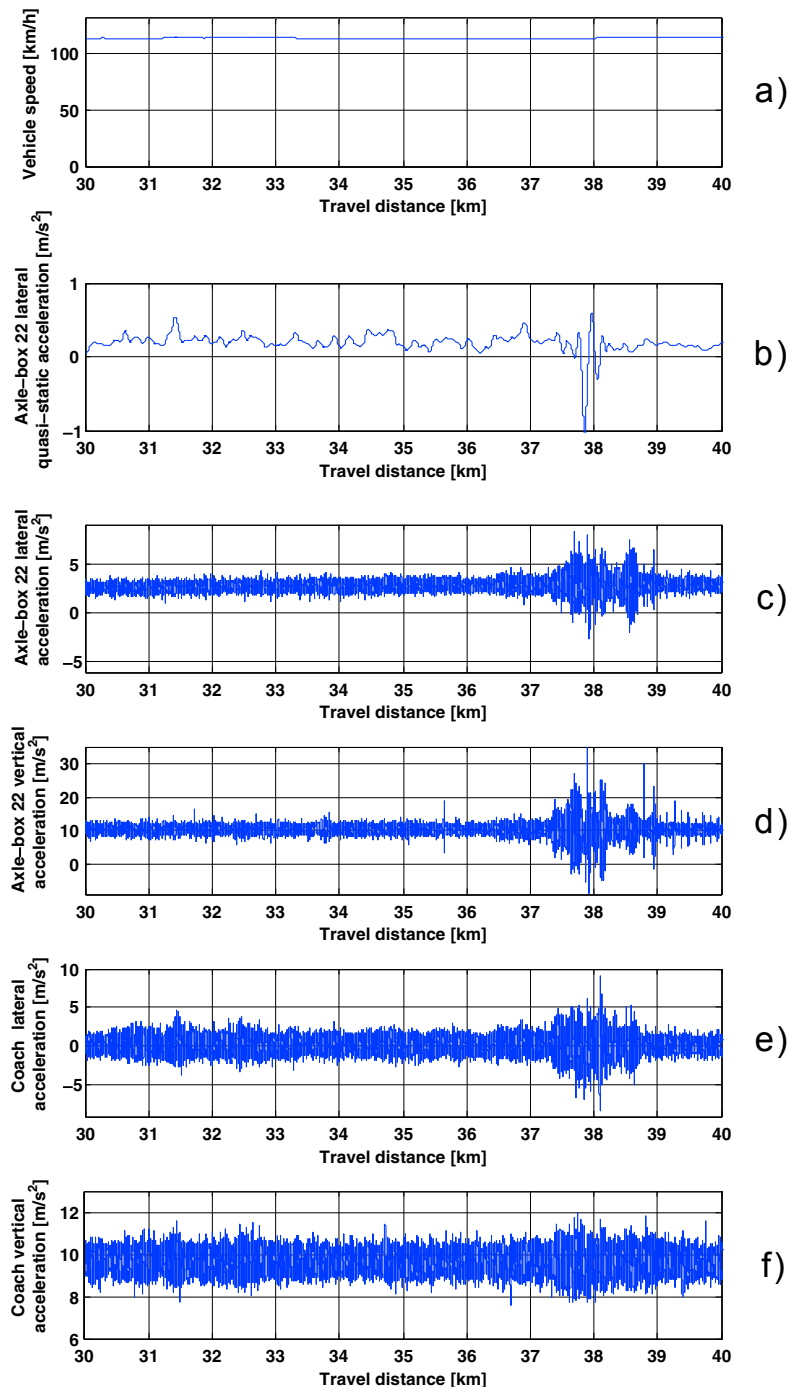
Fig. 7. Accelerations measured on the Gotthard base tunnel on the CTLIGHT vehicle.

Fig. 7 shows the results relative to the CTLIGHT vehicle where Fig. 7.a shows the vehicle speed during the test and Fig. 7.b shows the coach lateral acceleration filtered with a low-pass filter with cutoff frequency of 1 Hz. This acceleration is the non compensate lateral acceleration acting on the vehicle when running on curve or on switches. Fig. 7.c and 7.d show the axle-box 22 lateral and vertical acceleration, while in Fig. 7.e and 7.f are shown the lateral and vertical accelerations measured at the coach level. In this case, the acceleration has been filtered with a 4th order Chebyshev low-pass filter with 40 Hz cut-off frequency.

In Fig. 7 and Fig. 8 it is possible to observe at about km 36 an increment of the accelerations both in lateral and vertical direction corresponding to a coach quasi-static lateral acceleration equal to 1 m/s<sup>2</sup>. In order to better analyze this part of the track a statistical analysis on the data was performed.

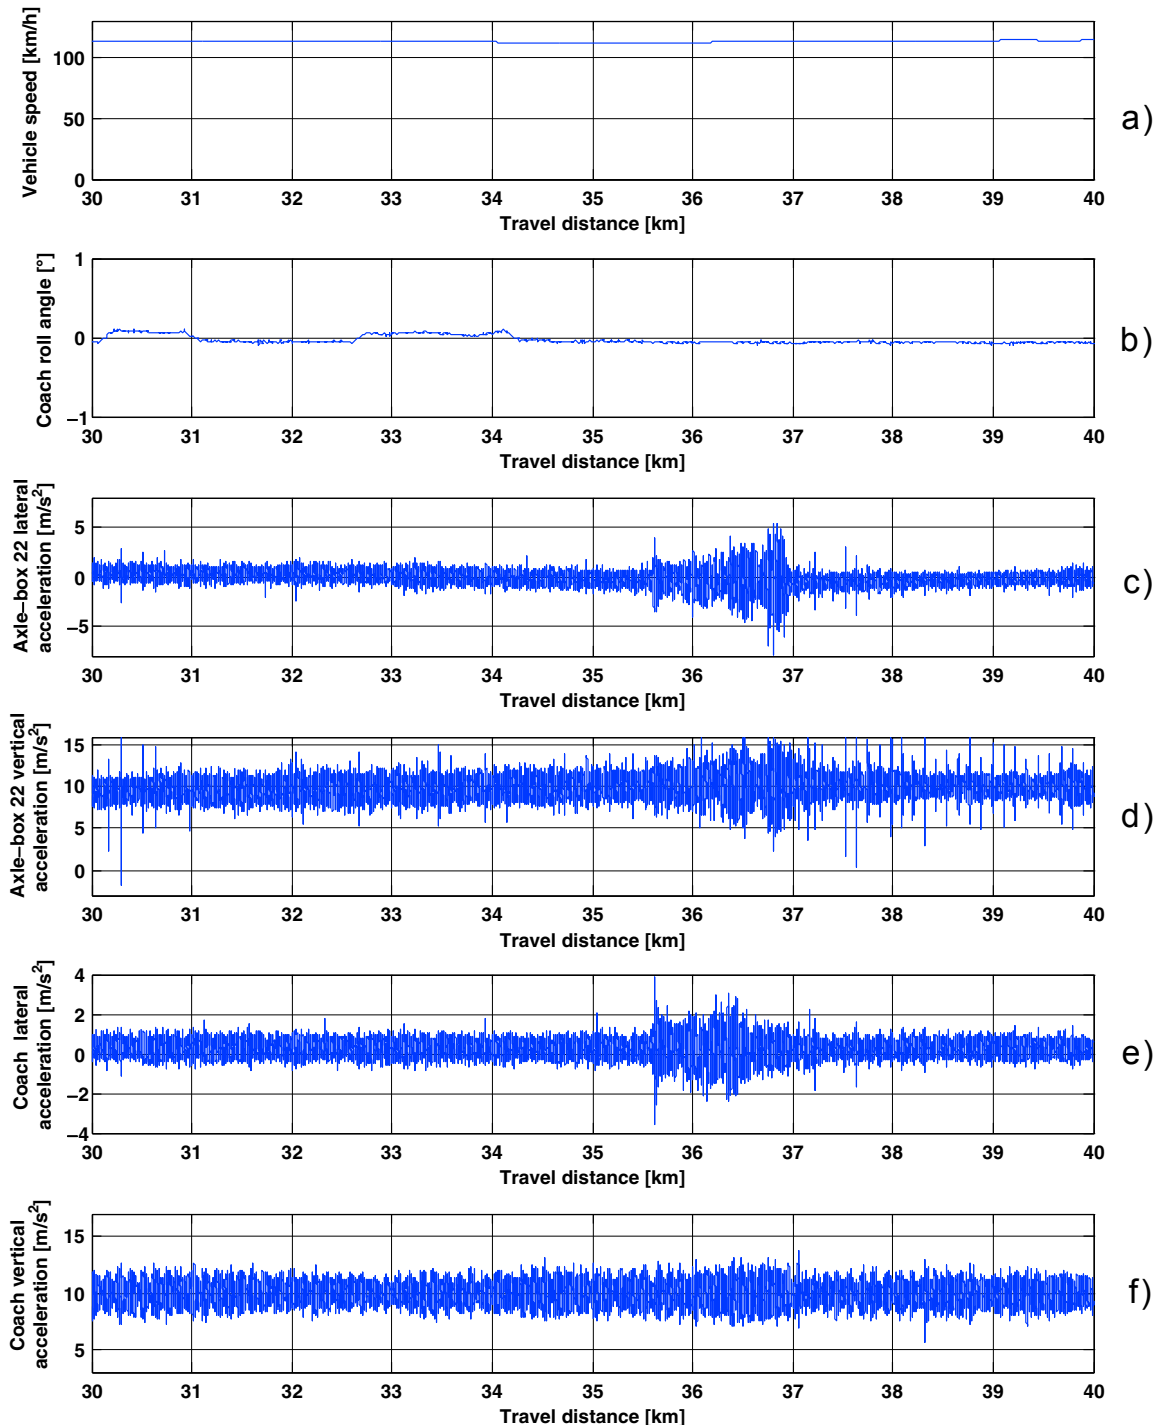
Fig. 8. Accelerations measured on the Gotthard base tunnel on the TASCA vehicle.

Fig. 8 shows the same quantities reported in Fig. 7, but relative to axle-box 31 of the TASCAs vehicle. Fig 8.b, instead of the quasi-static lateral acceleration, shows the coach roll angle measured with the inclinometer included in the measuring system of the TASCAs vehicle.

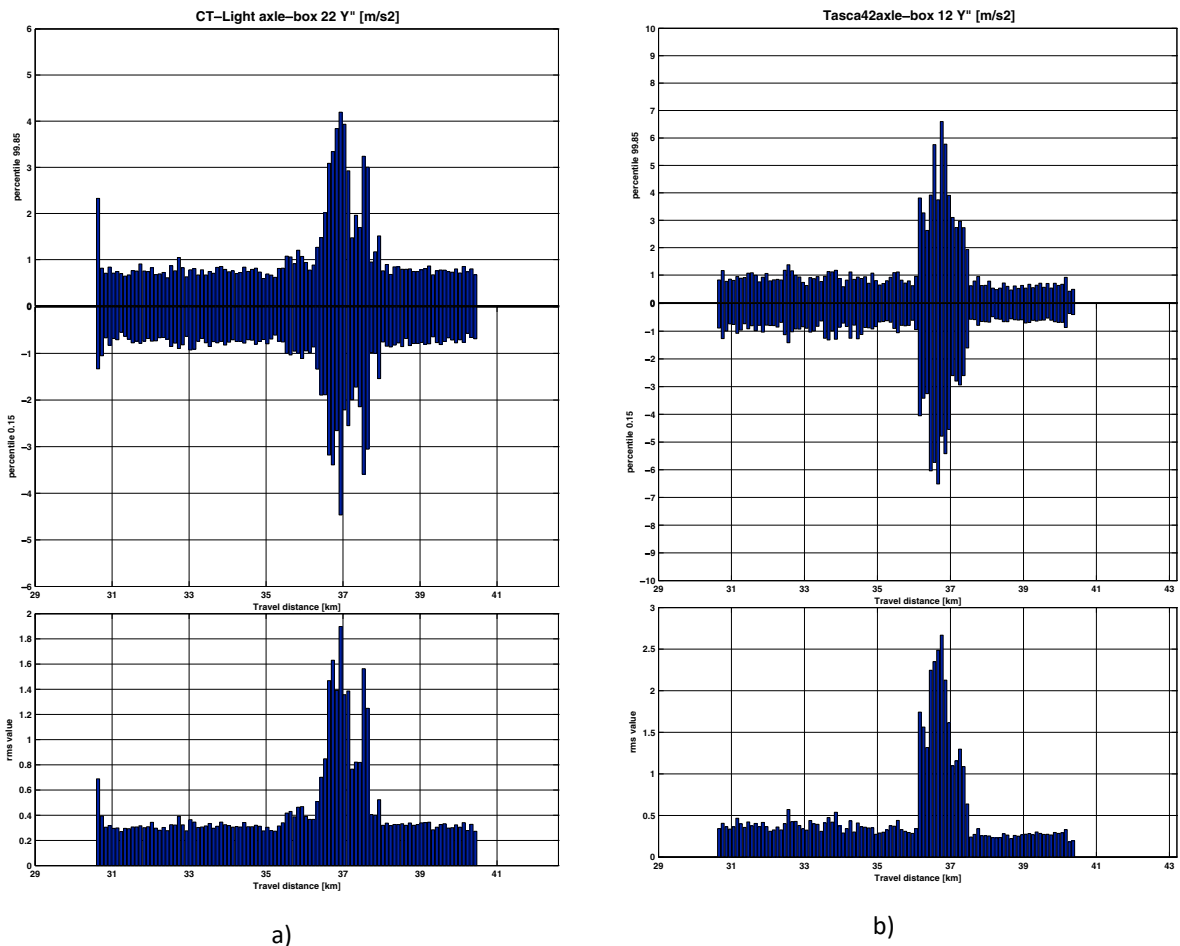
Fig. 9.a and 9.b respectively show the percentiles and the r.m.s values of the coach lateral acceleration for the CT-LIGHT and the TASCAs vehicles. The vertical accelerations for the same axle-box are instead shown in Fig. 10.a and 10.b. The r.m.s. and the percentile values allow to clearly identify the increment of acceleration starting from km 36. Furthermore, the lateral accelerations on the TASCAs vehicle are slightly higher than the accelerations on the CTLIGHT vehicle, while considering the vertical accelerations the situation is reversed and the accelerations measured on the CTLIGHT vehicle are about twice the ones measured on the TASCAs vehicle. This difference in the vertical direction is due to the different axle load and the different position of the freight cars with respect to the train composition. The TASCAs vehicle was tested in tare conditions, while the CTLIGHT vehicle was loaded with a 25 tons load placed on the side of the monitored bogie.

Fig. 9. Percentiles (0.15% and 99.85%) and r.m.s. values of the axle-box lateral accelerations measured on the Gotthard base tunnel on the CTLIGHT (axle-box 22) an TASCAs (axle-box 12) vehicles, passing on the switch section on the diverging route (km 37).

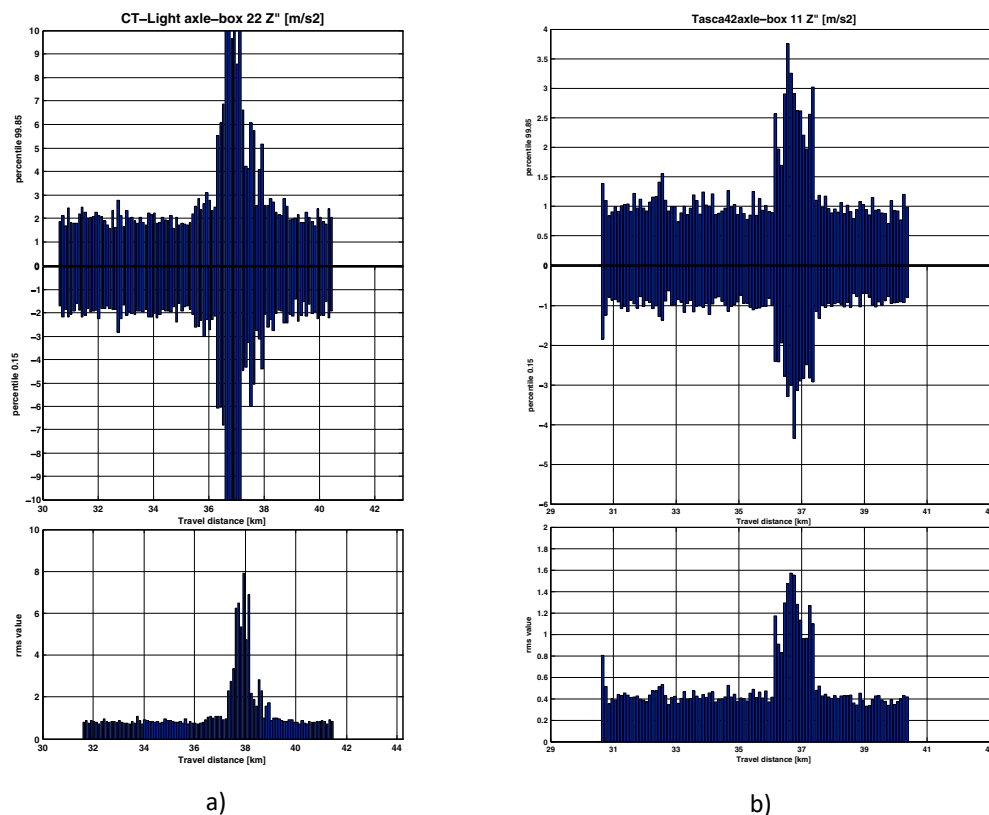
Fig. 10. Percentiles (0.15% and 99.85%) and r.m.s. values of the coach vertical accelerations measured on the Gotthard base tunnel on the CTLIGHT (axle-box 22) and TASC42 (axle-box 11) vehicles, passing on the switch section on the diverging route (km 37).

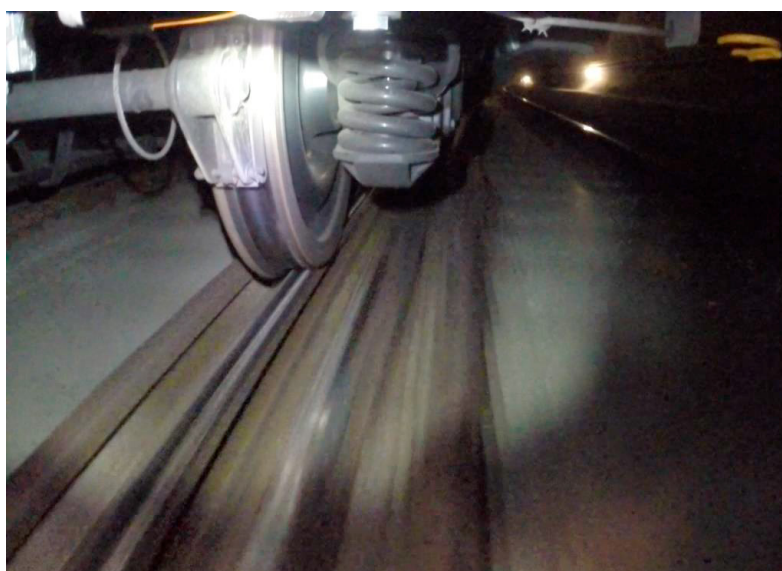
During the test, a camera was fixed on the coach and synchronized with the acquisition system, in order to relate the results with the track defects and singularities. The camera has been oriented to record the track and one wheel of the coach. From the analysis of the video at about the km 37, where the acceleration peak was detected, it is possible to notice the presence of a series of railway switches that is the cause of the acceleration increment. Fig. 11 shows the first railway switch located at the km 37.

Fig. 11. Detail of one vehicle wheel while running on the switch located at km 37 of the Gotthard Base tunnel.

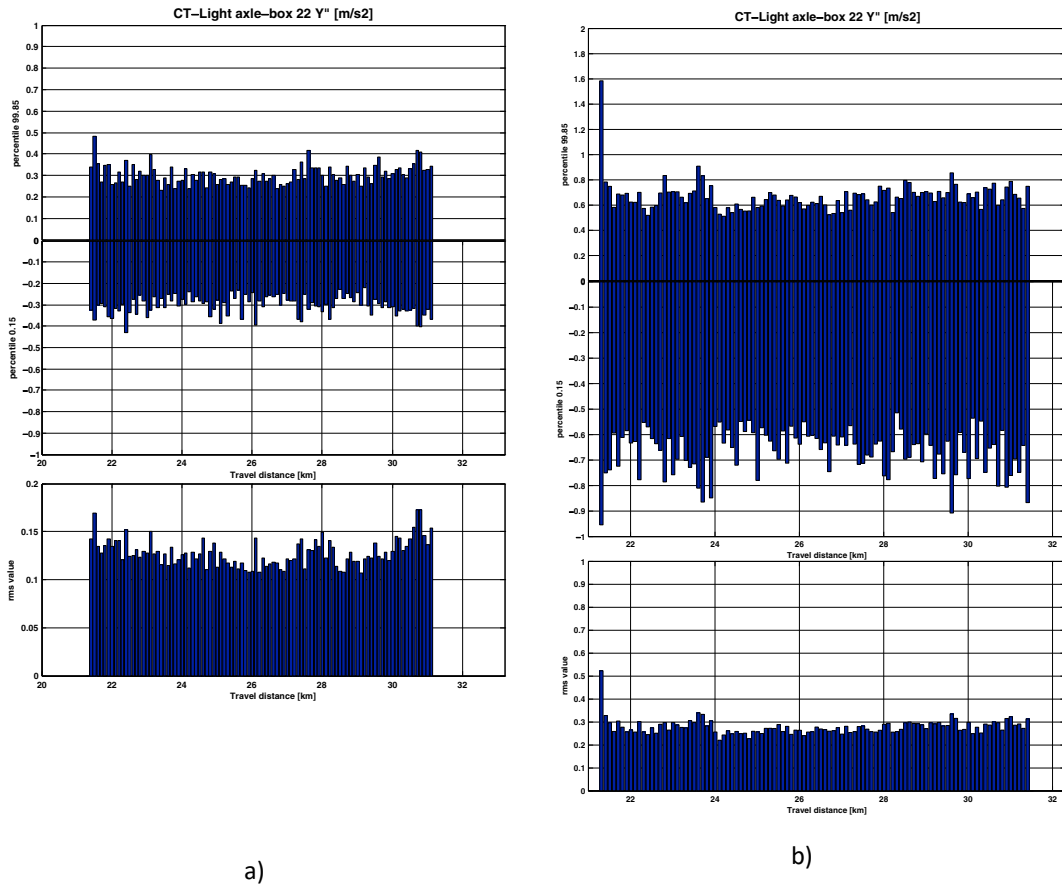
Fig. 12.a and 12.b respectively show the axle-box 22 lateral accelerations measured during the test at about 90 km/h and 115 km/h on the CTLIGHT vehicle.

Comparing the two cases, it is possible to notice that the lateral accelerations on the axle-box are approximately the double when increasing the vehicle speed of the 30%. Also comparing the vertical accelerations, shown in Fig. 13.a and 13.b, it is possible to observe that accelerations are about the double when the vehicle is running at 115 km/h. In any case, the axle-box acceleration values are very low also when the vehicle is running at quite the maximum speed (120 km/h). The maximum percentile values of the lateral and vertical accelerations are respectively equal to 0.9 m/s<sup>2</sup> and 2.6 m/s<sup>2</sup>, which are very low and ensure very low track stresses. Considering the acceleration peaks due to the switches inside the tunnel, shown in Fig. 9 and 10, the maximum value in lateral direction is 6.5 m/s<sup>2</sup> on the TASCAs vehicle, while in vertical direction is 18.2 m/s<sup>2</sup> on the CTLIGHT vehicle. These higher values of accelerations have been measured only where are located the switches and the vehicle is running at the maximum speed, and so are not related with the track quality. In general, on the basis of the accelerations measured on the two vehicles running on the Gotthard Base tunnel it is possible to conclude that the new track has a very high-quality level.

Fig. 12: Percentiles (0.15% and 99.85%) and r.m.s. values of the axle-box 22 lateral accelerations measured on the Gotthard base tunnel on the CTLIGHT vehicle running at about 90 km/h (a) and 115 km/h (b).

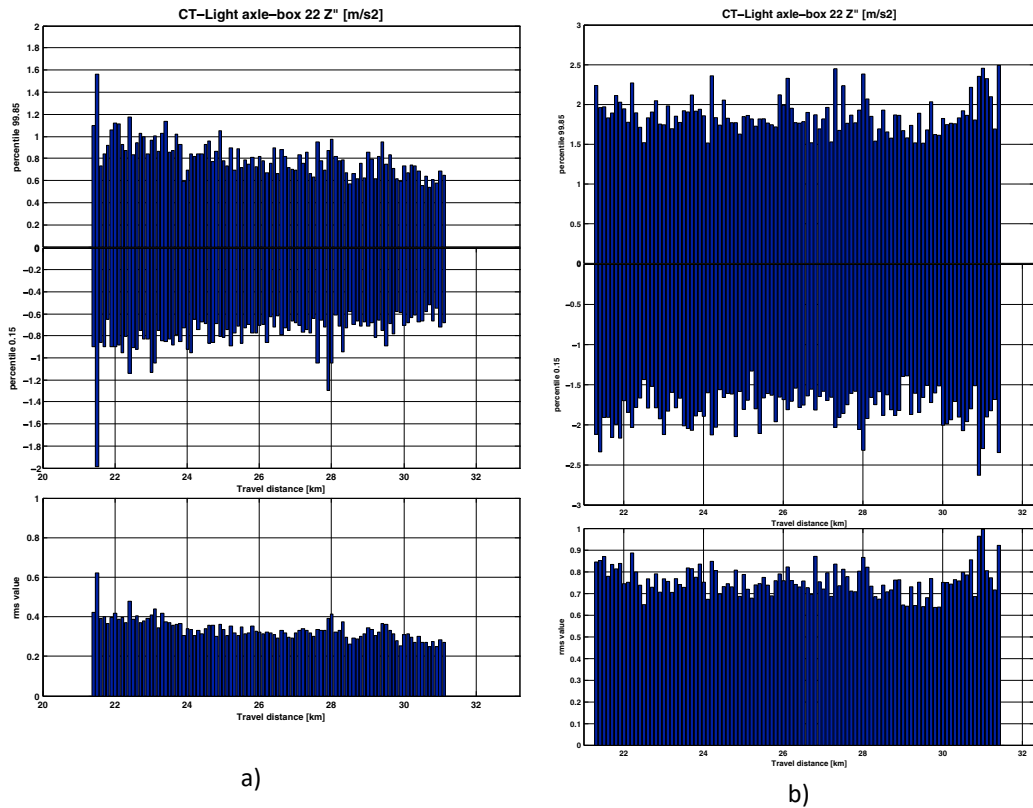
Fig. 13: Percentiles (0.15% and 99.85%) and r.m.s. values of the axle-box 22 vertical accelerations measured on the Gotthard Base tunnel on the CTLIGHT vehicle running at about 90 km/h (a) and 115 km/h (b).

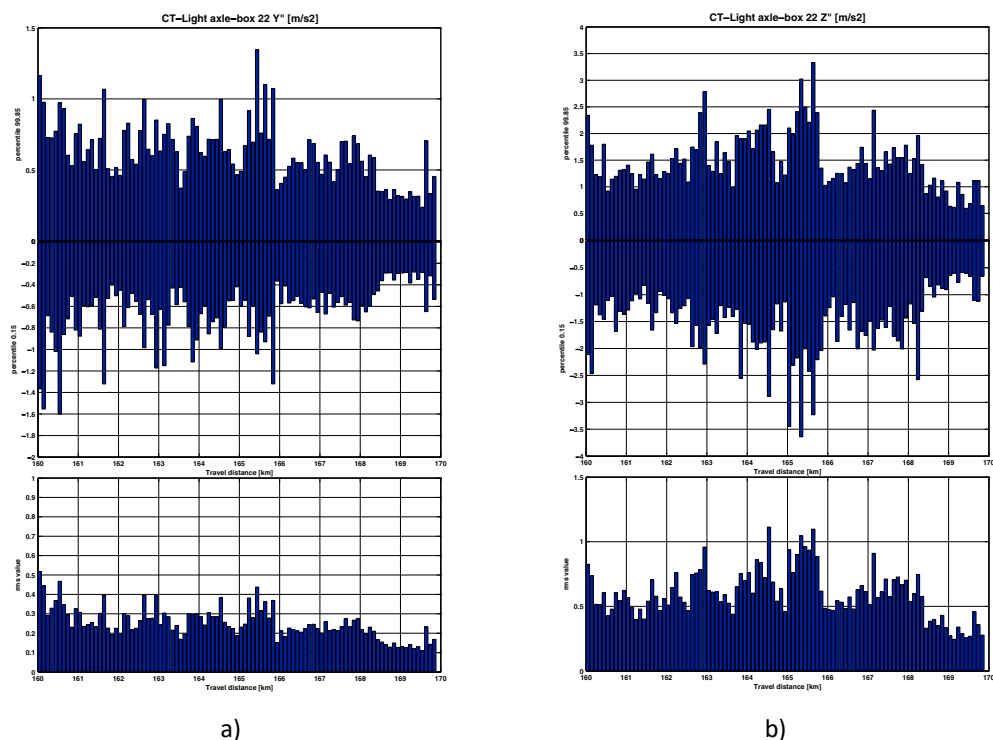
In order to highlight the quality of the new track a further comparison is carried on, comparing the axle-box lateral and vertical accelerations measured on the new Gotthard Base tunnel with the ones measured on the “traditional” Gotthard tunnel. Also in this case, the comparison is performed on the same vehicle with the same axle-load and considering a track section where the vehicle is running at 90 km/h. In Fig. 8.a is shown the axle-box 22 lateral acceleration measured on the “traditional” tunnel which can be compared with the one, measured on the Base tunnel, in Fig. 12.a. Comparing the acceleration percentiles it is evident that the “old” tunnel has higher accelerations than the “new” one, in fact the maximum acceleration in the first case is 1.3 m/s<sup>2</sup>, while in the second case is 0.42 m/s<sup>2</sup>. Also considering the maximum value of the r.m.s. diagram the acceleration value on the “old” tunnel is much higher (0.48 m/s<sup>2</sup> vs. 0.17 m/s<sup>2</sup>). In general, the lateral acceleration on the “traditional” Gotthard tunnel are three times higher than the ones measured on the Gotthard Base tunnel under the same conditions. The axle-box vertical accelerations on the “old tunnel”, see Fig. 14.b, have a percentile and r.m.s. peak values equal to -3.6 m/s<sup>2</sup> and 1.2 m/s<sup>2</sup>, while considering the acceleration measured on the Base tunnel, see Fig. 13.a, the percentile and r.m.s. peak value are equal to -1.3 m/s<sup>2</sup> and 0.48 m/s<sup>2</sup>. Therefore, the same considerations for the lateral accelerations can be extended to the vertical ones and also in this case the ratio between the accelerations measured on the “traditional” and Base tunnels is about three.

Fig. 14: Percentiles (0.15% and 99.85%) and r.m.s. values of the axle-box 22 lateral (a) and vertical (b) accelerations measured on the “traditional” Gotthard tunnel on the CTLIGHT vehicle running at about 90 km/h.

The last analysis allows to conclude that the accelerations measured on the vehicle axle-boxes, when the vehicle is running on the Gotthard Base tunnel with a speed of 120 km/h (see Fig. 12.b and 13.b), are in general lower than the accelerations that occur on the same vehicle running on the traditional tunnel with a speed of 90 km/h.
