World Multidisciplinary Civil Engineering-Architecture-Urban Planning Symposium 2016,  
WMCAUS 2016

## Non-Smooth Dynamic Analysis of Local Seismic Damage Mechanisms of the San Felice Fortress in Northern Italy

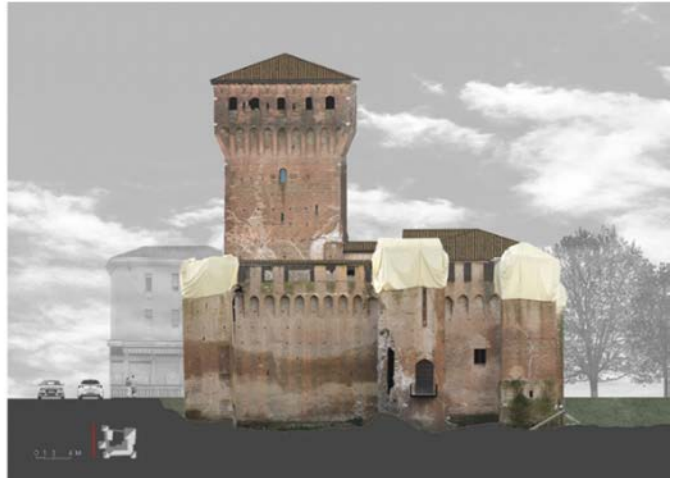
Fig. 2. Plan of the ground floor. The red rectangle identifies the zone that was modelled. Right: the fortress after the earthquake.

In particular, in the north entrance tower, the expulsion of a corner of masonry was generated by the presence of a reinforced concrete floor. On the north side, out-of-plane failure mechanisms affect the battlements and machicolation (Fig. 2). Finally, in the west part the crack pattern is horizontal, extending longitudinally along the side, and is repeated at different heights. A more extensive description of the damages can be found in [3].

The analysis focused on the major collapse mechanisms identified (see Fig. 2): (a) walls curtain battlements; (b) columns of the external stairs; (c) east wall; (d) battlements of the towers; (e) building on the west side. As an example, we report here the analysis of the latter, which is the most complex.

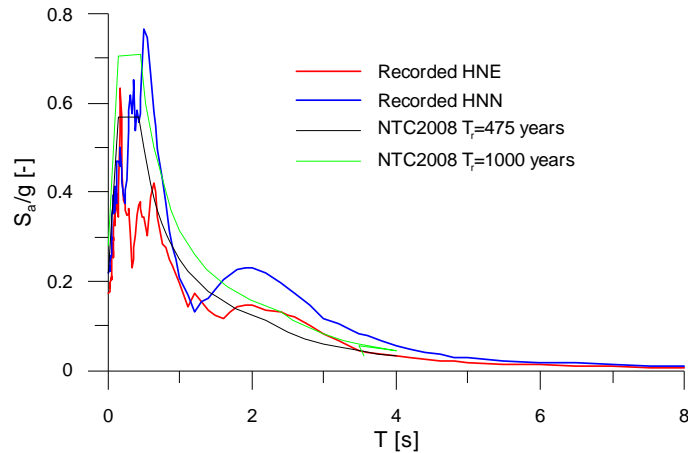
Fig. 3 Response spectra obtained from recorded data.

Currently the fortress shows serious damage caused by severe shocks (5.8 and 5.9 Richter magnitude) occurred in the days of 20 and 29 May 2012 respectively. The effects of the earthquake have been magnified by the vertical component of the acceleration, typical of "near-fault" cases. In addition, by comparing the on-site registered response spectra [11] with those provided by the standard codes for the site, we note that the earthquake of 2012 is comparable with the expected earthquakes for high return periods, well in excess of 475 years adopted by the Italian technical code (Fig. 3). Indeed, it is the first time that the Fortress of San Felice suffers an earthquake of such intensity.
