HBIM FOR THE SURVEYING, ANALYSIS AND RESTORATION OF THE SAINT JOHN THE THEOLOGIAN CATHEDRAL IN NICOSIA (CYPRUS)

KEY WORDS: H-BIM, Photogrammetry, Laser Scanning, Digital Cultural Heritage, Byzantine, Decay mapping

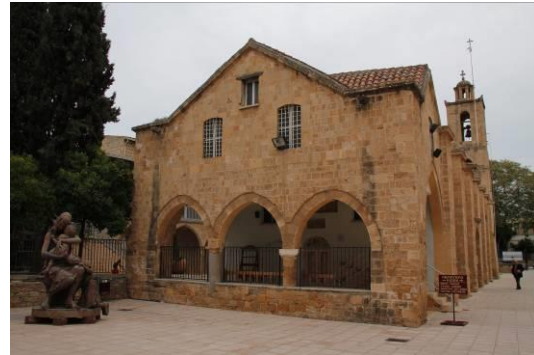
Figure 1. Main façade of Saint John Cathedral in Nicosia

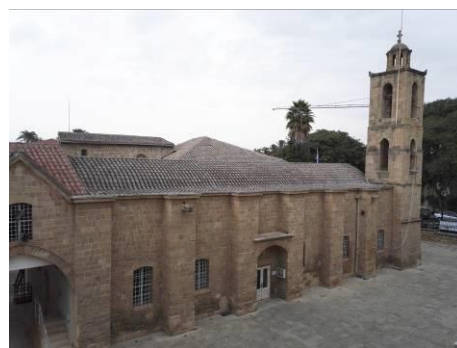
Figure 2. Northern façade with the bell tower

A century later, around 1779, an extension of the women's gallery had as a result the demolition of the upper level of the nave's western wall and the rebuilt of it further to the west (Papageorgiou, 2014). This extension possibly happened since the monastery stopped functioning and the church was transformed to the cathedral of the Orthodox Church of the island. The church became parish and a women's gallery was indispensable. In 1858, when the Orthodox churches got the

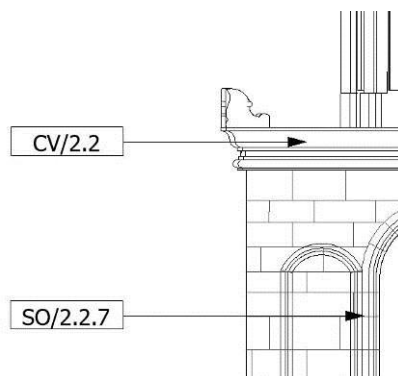
Figure 13. Building techniques identification codes

The cognitive investigation involved a preliminary phase for the classification of the technical-constructive system: we identified, with specific codes, materials and architectural components of the church, comparing surveys and historical data (fig. 13).

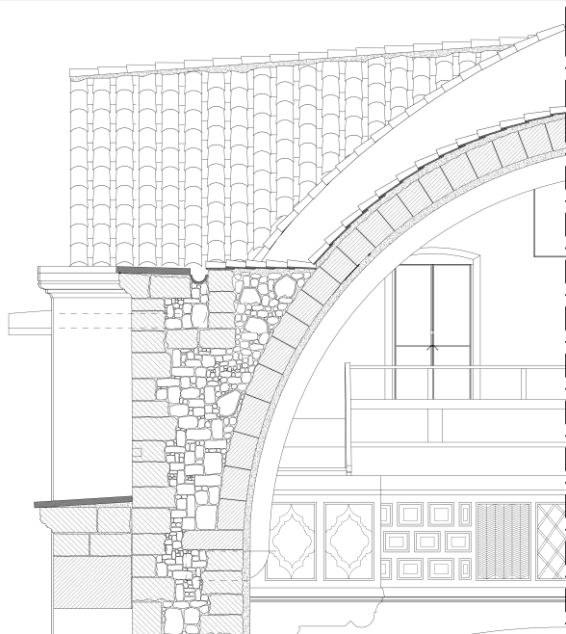
Figure 14. Transversal cross-section with masonry detail

The historical masonries of Nicosia are usually rubble filled (fig.14): two squared stone vestments filled with a conglomerate of smaller stones, river pebbles and fragments of earthenware, plaster-based mortar and local sands (Christou, Elliotis, 2016).

The wall structures (120 cm thick) have external facing made up of rows of well-squared isodomic ashlar, interspersed with diatons. Most of the ashlar come from buildings of previous eras: the columns of the narthex (from the Roman era) and the coats of arms of the Lusignan-Venetian era. The mortar is made, as usual in Cyprus, from a mixture of clay, sand and straw.

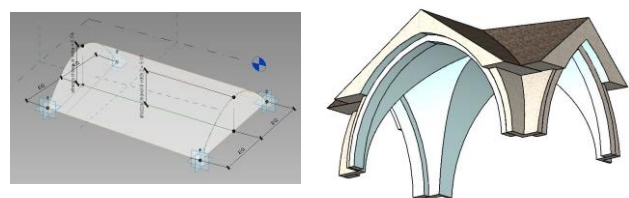
Figure 15. Parametric modelling of a vault (left), generic model of a cross-vault (right)

As regards the vaults, one of the issues was about the possibility to have a geometric modelling against a modelling that would preserve all the irregularities (deformations, depressions) due to the passing of time. For the case study was chosen to follow a geometric modelling for almost all the vaults, using a profile extracted from the point cloud which permitted an enough parametrization (fig. 15), mainly from the informative point of view. Instead, for the cross vault, that presents a strong deformation, it was chosen to model the particular object with real shape, even if at the expense of geometric parameterization.

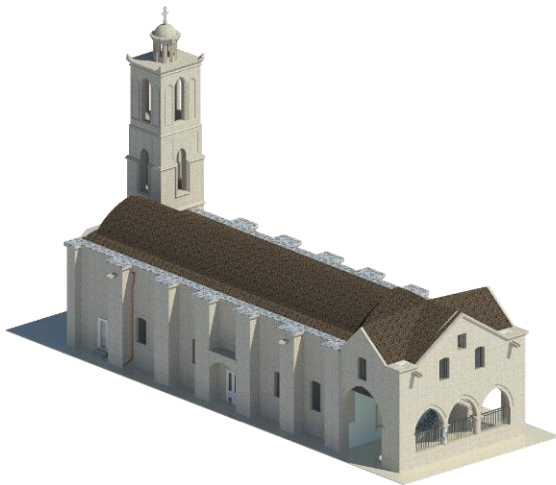
Figure 16. HBIM Model of the Saint John Cathedral

The other architectural components were modelled using Pointsense plugin and the x-ray orthophotos generated by it (fig. 16).

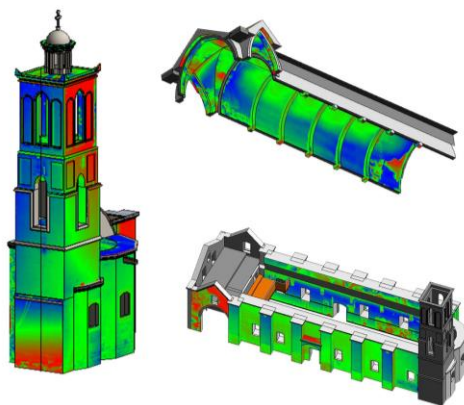
Figure 17. Analytical comparison between point cloud and HBIM Model

At the end it was done an analytical comparison between point cloud and 3d model carrying out the analysis of points deviation and surfaces. There were analyzed some regions of the model, the most problematic, with a range of 10 cm maximum. The plug-in generated a colour duplicated surfaces, with in red the positive deviation and in blue the negative deviation. The instrument shows the errors but also the deformation of artefact itself. For example, they were highlighted the not plumb line wall of bell tower, and the vaults deformation (fig. 17). In this way the plug-in resulted useful.

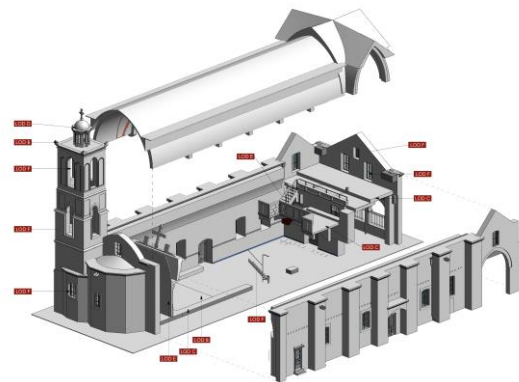
Figure 18. Identification of LODs for each architectural component

In the case of an historical building, the as-built condition corresponds to LOD 400 according to international law and LOD F or G according to Italian one (Pavan et al., 2017). Nevertheless, if we consider the required times for diagnostic investigations, it becomes extremely difficult to achieve the same LOD for each architectural component. A good compromise is to assign a shared parameter that describes the

different LODs, with the possibility of an updating during the time (fig. 18).

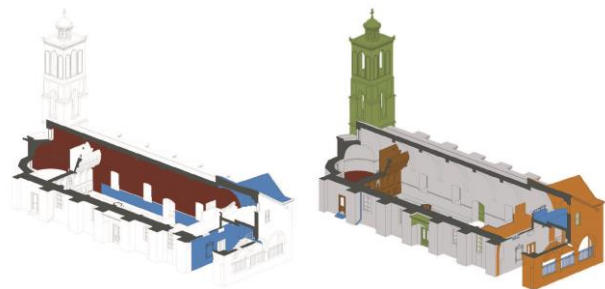
Figure 19. Diachronic analysis with filters and visualization setup

The same approach has been followed for the description of the diachronic analysis (fig. 19): the specification of the construction year/century for each architectural component allows to understand better the different phases of Saint John Cathedral. Working with a commercial software, several technical issues have been faced: the software doesn't permit to assign a different parameter value to the same wall; to bypass this problem we worked inside the panel material and had a different colour for the wall layers showing the different periods creation.

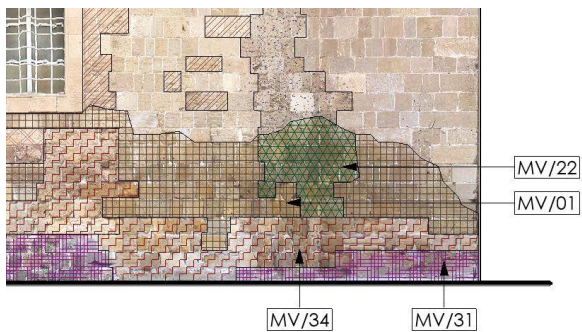
Figure 20. Decays mapping with codes and parametric “filled regions”

As concerns decay mapping, several approaches have been tested in order to obtain a good compromise between the accuracy of the mapping and the time required to obtain it. One possible way was to use the "filled region" a system family that works very well on 2D surfaces and is visible only in 2D views (plan, section and elevation). This family has few parameters to set and it is possible to create different types based on decay classification (fig. 20). However, it's not possible to directly extract quantities from a "filled region" in a schedule, for this reason a script has been written via Dynamo VPL plugin for Revit to convert the area into a scheduled parameter; in this way for each changing of filled
