Roadside Truck Placard Readers for Advanced Notice and Response at Safety-Critical Facilities: Phase 2

Final Report VTRC 23-R18

Virginia Tech Transportation Institute

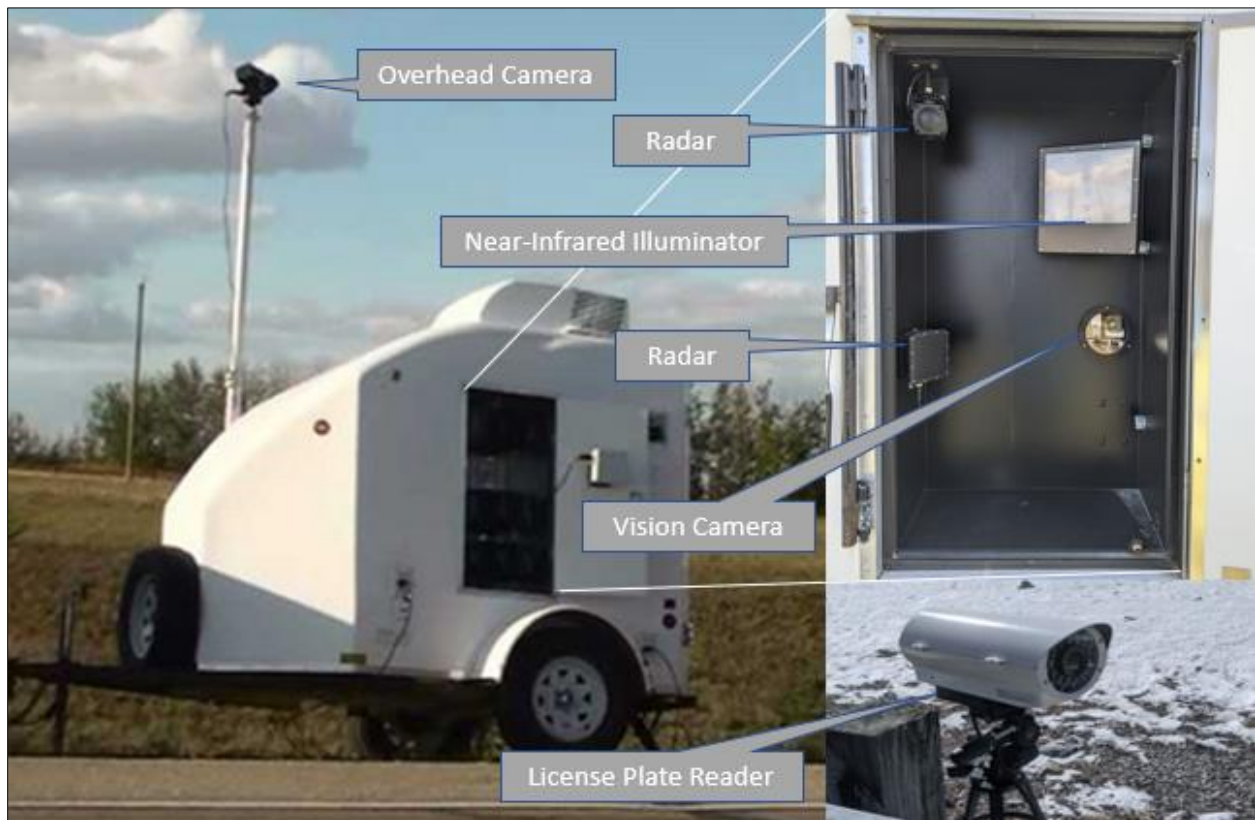
Figure 1. Mobile Automated Placard Reader System (APRS) Trailer with System Component Types and Locations Shown

Two types of APRSs were used for the testing performed in this study. Both systems were manufactured by IIS, the vendor identified during the previous phase of this work. A mobile version of the APRS was acquired by the Virginia Tech Transportation Institute (VTTI) under a multi-month lease agreement. This unit, and key system components, are shown in Figure 1.

The mobile APRS shown previously in Figure 1 was leased from IIS by VTTI to facilitate its evaluation in this study. This trailer-based unit is fully functional and designed for use by law enforcement officers and others for short periods of time (i.e., 1 to 2 days). A separate DOT-type trailer was configured as a base for sensors used to validate APRS operation and to provide additional information on environmental and traffic conditions that might affect APRS performance (Figure 4). The trailer was equipped as described below:

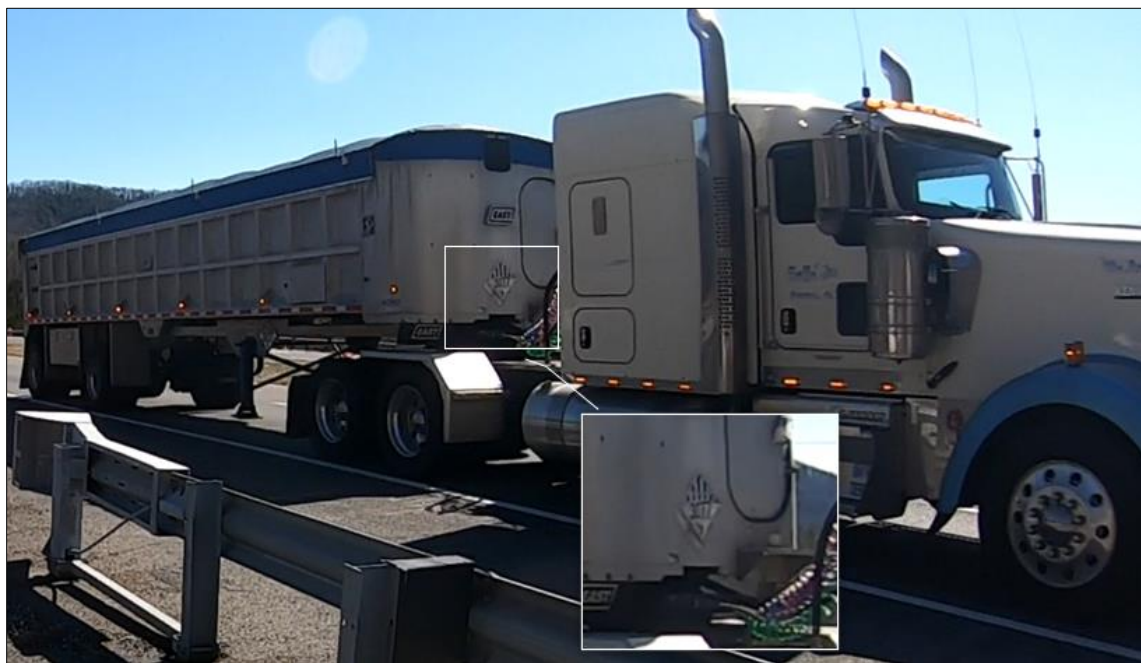
Figure 22. Potential False Negative, Still Image from Captured Footage Showing the Only Visible Placard on the Vehicle, Meaning Likely Not a False Negative

In the HAZMAT-placard-focused survey, the video footage was reviewed for every passing commercial vehicle in the outer lane (Table 10). In the 40 minutes of footage, 13 total commercial vehicles passed by the APRS that the reviewer determined had a placard attached to the trailer. Of those, 11 were captured by the APRS. This would mean a capture rate of 84%. However, in further analysis and research on USDOT guidelines on proper placard placement, it is likely that at least one of these two vehicles not captured were in violation of these guidelines. The first vehicle had only one placard visible by the reviewer, on the front of the trailer, between it and the truck cab, which contradicts the requirement that all HAZMAT carrying vehicles “must be placarded on each side and each end” (Figure 22) (General Placarding Requirements, 2023). The other entry was a propane truck with a placard printed on the curved tank on the rear of this vehicle (Figure 23). Other propane tanks were shown to have passed by the APRS and were captured without issue, so it is unknown why this truck was not captured by the trailer. But if the former truck, likely in violation of USDOT guidelines, was removed from the analysis, the capture rate of passing HAZMAT placard trucks would be 91.7% (11 out of 12 captured).
